Slow-velocity out-of-plane impact tests on double-wythe unreinforced brick masonry walls instrumented with optical measurements

Michele Godio ^{*}, Mathias Flansbjerg, Natalie Williams Portal

RISE Research Institutes of Sweden, Brinellgatan 4, 504 62 Borås, Sweden

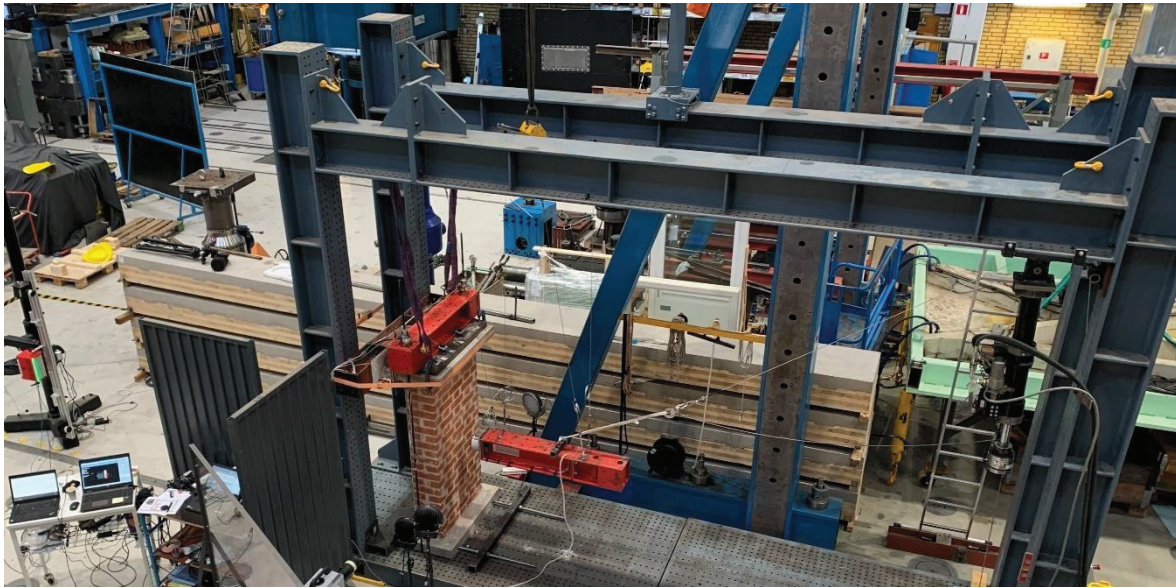
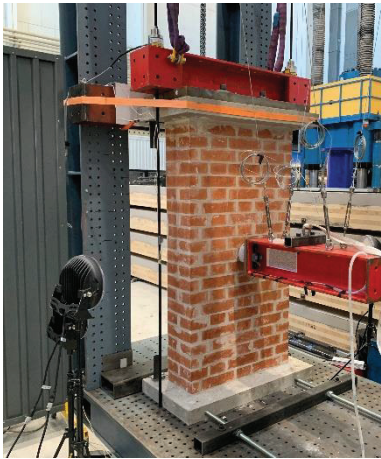
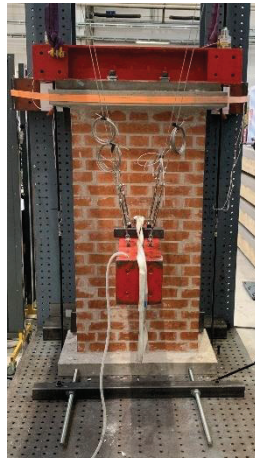
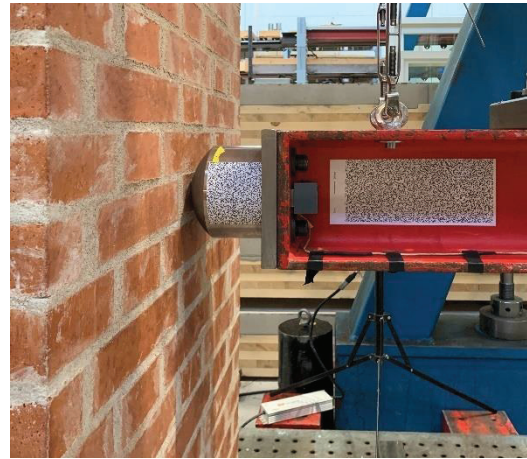
Fig. 3 Bird-eye view of the test setup and non-rigid supports (a). Side (b) and front (c) view of the URM wall. Lateral view on the drop weight (d).

The impact tests were conducted into a test rig that was designed specifically for this campaign. The weight impacting the wall was created by assembling in-house steel components.

The support conditions put in place for the URM walls were designed to experimentally reproduce *non-rigid* boundary conditions for the walls. According to the definition given in [35] such conditions describe cases where the wall is supported by elastic supports and its resistance curve is therefore function of the supports' stiffness.

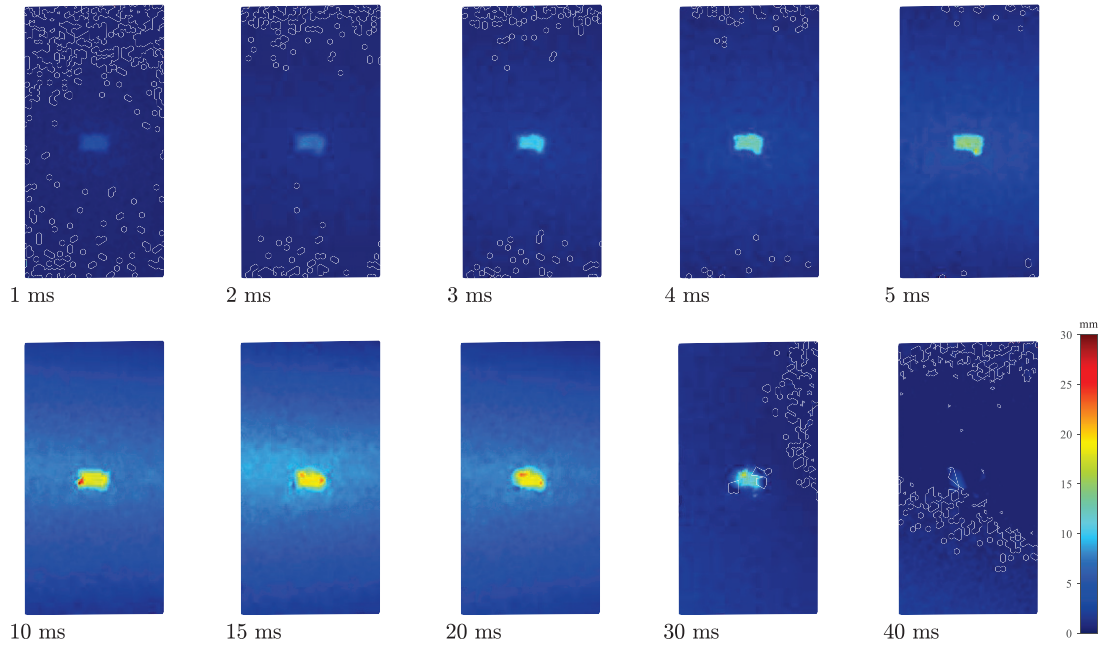
Fig. 13 Out-of-plane displacement of the back face of the walls at different instances of the test W9-1. Source: 3D HS-DIC measurements.

Fig. 14 Out-of-plane displacement of the back face of the walls at different instances of the test W10-1. Source: 3D HS-DIC measurements.

Fig. 15 Out-of-plane displacement of the back face of the walls at different instances of the test W11-1. Source: 3D HS-DIC measurements.

The former mechanism corresponds to the vertical spanning of the wall and resulted in a major horizontal crack dividing the wall into separate blocks; the crack is located between the 6th and 7th course of bricks in wall W9, and between the 10th and 11th course in walls W10, W11. The latter mechanism produced localized damage at the mid-height of the wall. Not only it produced heavy damage around the middle brick, which was punched by the drop weight ([Fig. 13-Fig. 15](#)), but it also generated significant out-of-plane brick dislocations in the area surrounding said brick ([Fig. 10-Fig. 12](#)). The areas where such dislocations occurred extends from 1-2 courses above to 1-2 courses below the middle brick. They are characterized by stepped diagonal cracks, along with an overall horizontal spanning of the wall, the wall being not laterally supported in that region. These areas were particularly visible for the most damaging impact configuration, which was experienced in the test W11-1 ([Fig. 12, Fig. 15](#)).
