# Durability in Alkaline Environment of a Fiber Optic Sensor Bonded at the Surface of Reinforcing Bars for Distributed Strain Measurements in Concrete Structures

Noémie Delaplanque, Sylvain Chataigner, Laurent Gaillet, Marc Quiertant, Karim Benzarti, Arnaud Rolland, Xavier Chapeleau, A. Saravia Flores

Noémie Delaplanque, Sylvain Chataigner, Laurent Gaillet, Marc Quiertant, Karim Benzarti, et al.. Durability in Alkaline Environment of a Fiber Optic Sensor Bonded at the Surface of Reinforcing Bars for Distributed Strain Measurements in Concrete Structures. European Workshop on Structural Health Monitoring (EWSHM 2022), Jul 2022, Palerme, Italy. pp.506-515, 10.1007/978-3-031-07258-1\_52 . hal-03819126

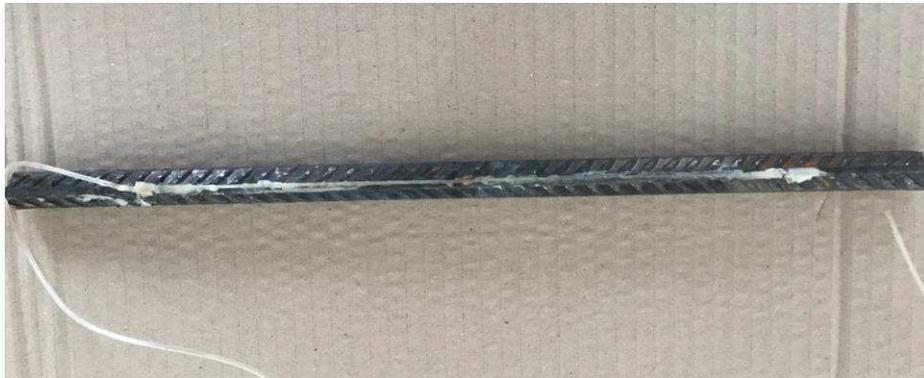
**Fig. 1.** Picture of the steel rebar of  $\varnothing$  12 mm, showing the OF sealed in the engraved groove

The tests were conducted on two steel rebars of diameter 10 and 12mm, respectively. Each rebar was equipped with an OF sensor. Based on previous works of Quiertant et al. [3] and Chapeleau and Bassil [7], a single-mode commercially available OF with a polyimide primary coating was used. For the installation of this OF, a U-groove with a depth of 1 mm, and a length of 220 mm for the first rebar and 300 mm for the second, was previously drilled along each rebar. Then, the OF was placed inside the U-groove and sealed with a two-component epoxy adhesive. The X60 epoxy was used for bonding the OF to the 12mm diameter steel rebar, while the X120 epoxy adhesive

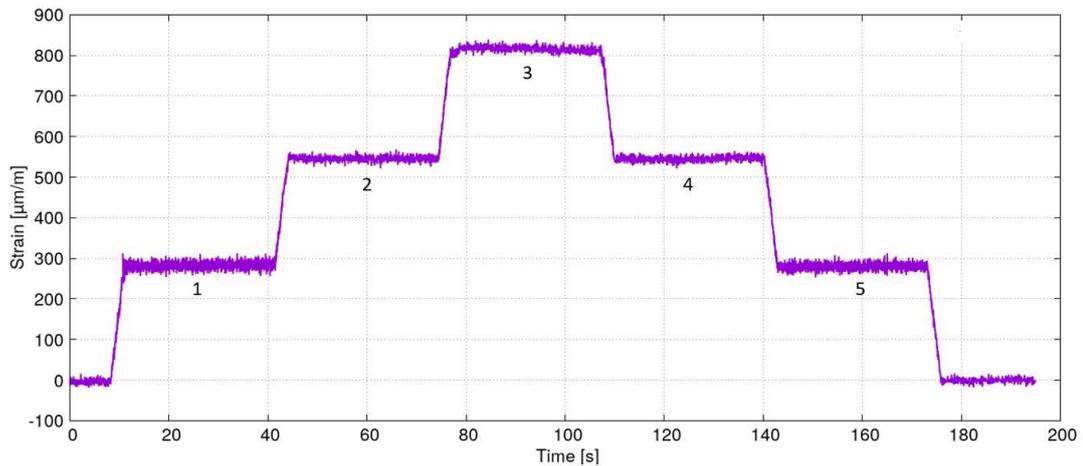
**Fig. 2.** Applied strain history recorded by the DOFS during the tensile test on steel rebars

**Table 1.** Load levels applied during the direct tensile tests. Steps 1 to 3 correspond to increasing load increments while steps 4 and 5 are decreasing increments.

Loading step	Applied tensile force (kN)		Corresponding stress (MPa)
	Steel rebar of diameter 12 mm	Steel rebar of diameter 10 mm	
1 (and 5)	5.65	3.93	50
2 (and 4)	11.31	7.85	100
3	16.96	11.78	150

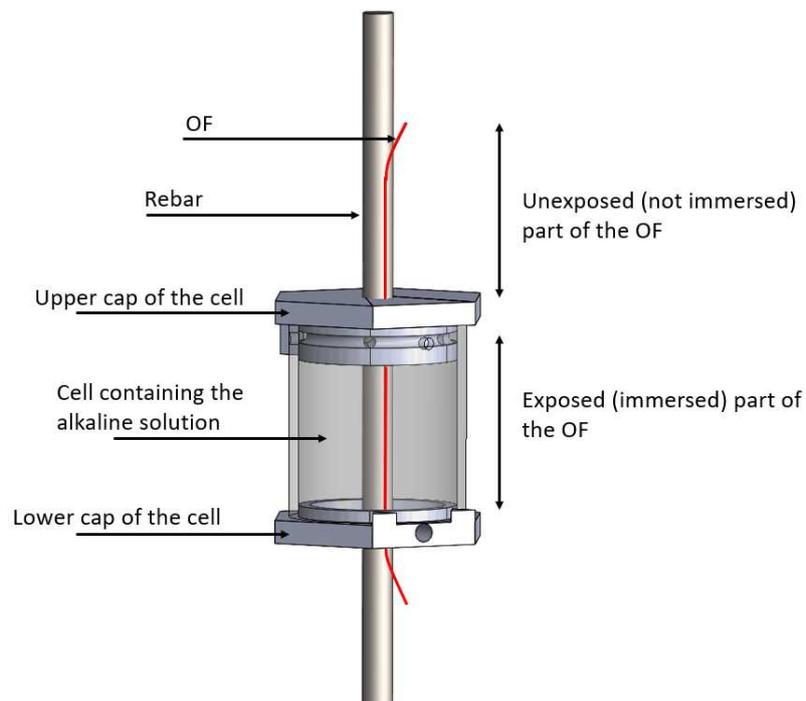
**Fig. 3.** Experimental set-up used for conditioning the instrumented steel rebars

The exposure condition consisted in immersing the DOFS the instrumentation into an alkaline solution at a given temperature (either 20 °C or 60 °C). In this line, each rebar (equipped with the bonded DOFS) was conditioned in an ageing cell, as shown in Fig. 3. A specific cap made it possible to install the cell without damaging the optical fiber. The two parts clamping mechanism was designed to fit the rebar and the OF, hence limiting the risk of damage during installation (See Fig. 4). A polyurethane sealant was used to seal the ageing cell (see Fig. 5).

Only the half bonded length of the OF is immersed in the alkaline solution, as shown in Fig. 3. When performing tensile tests afterwards on the exposed rebars, this configuration allows comparing the strain responses of the immersed and non-immersed sections of the OF, and hence to evidence possible alteration of the OF instrumentation induced by the alkaline environment (that may be related either to a degradation of the adhesive bond, an evolution of the bulk properties of the adhesive, or the alkali attack of the OF itself). It is to note that the overall setup was stored in the laboratory environment for the ageing condition at 20 °C, while it was placed in an oven for the condition at 60 °C.

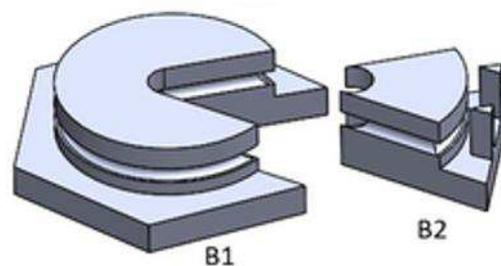
**Fig. 4.** Two parts clamping mechanism of the lower cap of the aging cell

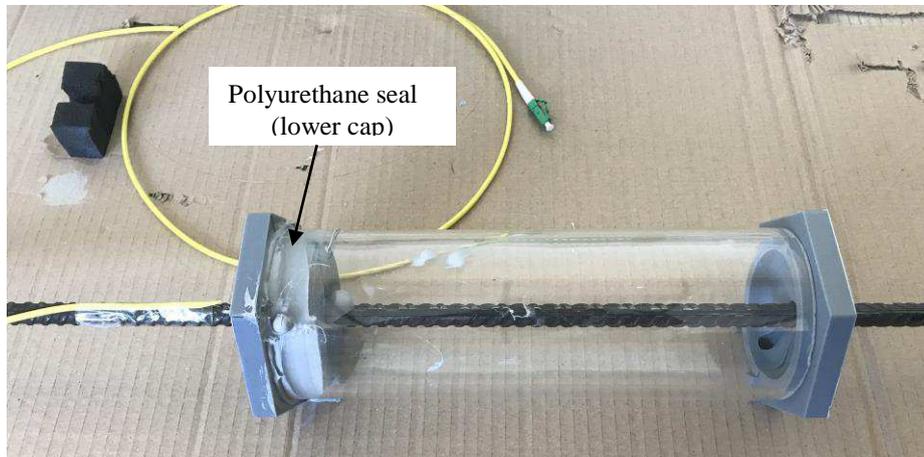
**Fig. 5.** Steel rebar of diameter 10 mm installed in the aging cell

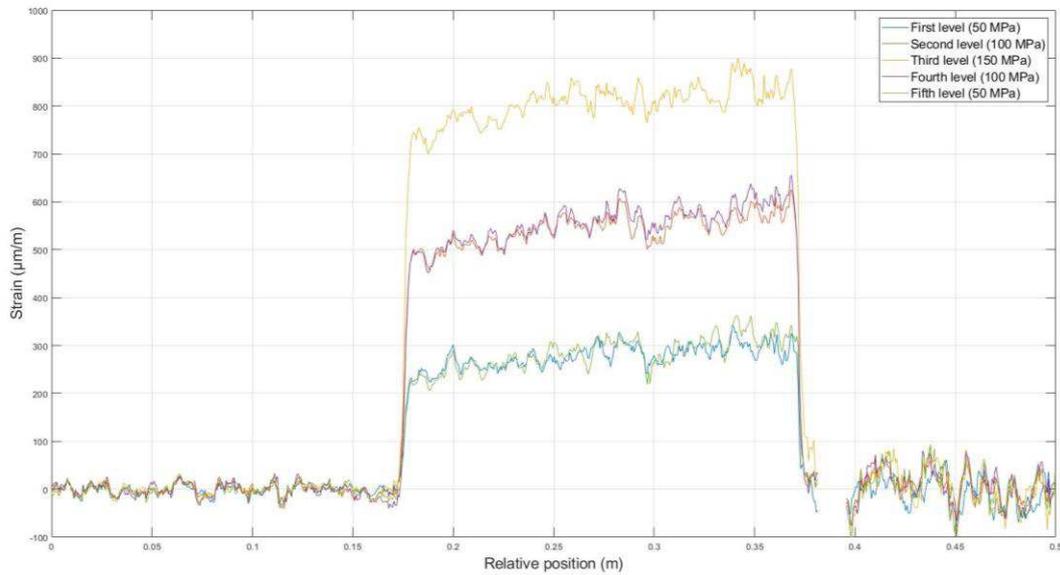
**Fig. 6.** Reference strain profiles recorded during the tensile test on the unaged instrumented steel rebar of diameter 12 mm, at the different load levels 1 to 5 (see Table 1 and Fig. 2)

Figure 6 shows the strain profiles recorded at different load levels during the tensile test on the unaged instrumented steel rebar of diameter 12 mm. The x axis corresponds to the relative position along the rebar, and the bonded section of the optical fiber is located at abscissas between 0.175 and 0.37 m. Strain profiles collected at stress levels of 50 MPa, 100 MPa and 150 MPa are displayed together in the graph. They provide average strain values of about 300  $\mu\text{m/m}$ , 500  $\mu\text{m/m}$  and 800  $\mu\text{m/m}$ , respectively, which can be considered as reference data for the unaged DOFS instrumentation. Furthermore, it is interesting to note that profiles collected at increasing increments (levels 1 to 3) are consistent with those obtained at decreasing increments (levels 3 to 5), showing the repeatability of strain measurements.

Figures 6 and 7 represent acquisitions made on the same frame. However, the two graphs display different ranges of relative positions because the acquisitions in the reference and aged states were made at different times and requested disconnecting/reconnecting the acquisition line to the ODISI interrogator. Therefore, the length of OF connecting the rebar to the interrogator was different from one test to another.

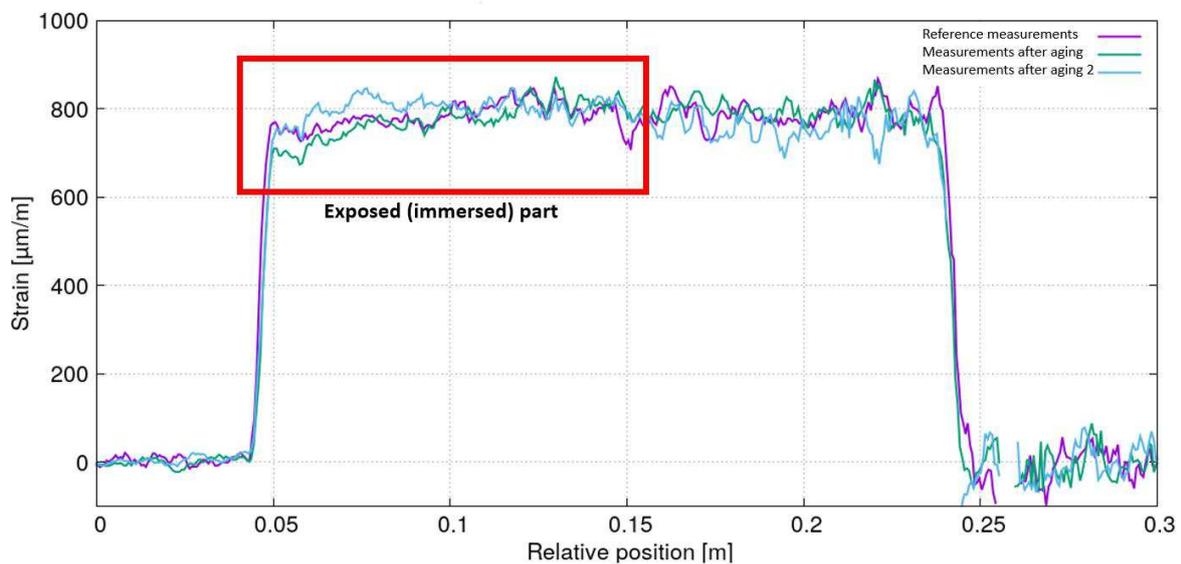
**Fig. 7.** Comparison of the strain profiles recorded during tensile tests on the 12 mm steel rebar at a stress level of 150 MPa, in the reference state and after one-month exposure in the ageing cell at 20 °C ("ageing 2" refers to the aged specimen that was turn upside down in the press)

Figure 7 gathers the strain profiles collected during tensile tests at a stress level of 150 MPa, both for the unaged rebar (reference state) and for the same rebar after one-month exposure in the aging cell at 20 °C. An additional measurement was carried out on the aged rebar after changing its direction upside down in the grips of the tensile machine, in order to verify the symmetry of the test setup (the corresponding profile is denoted “measurement after ageing 2” in the graph).

From Fig. 7, it is found that i) the strain profiles of the aged rebar are superimposed to the reference profile and ii) that the average strain level is roughly constant along the immersed and non-immersed sections of the aged rebar. This result suggests that exposure for one month in the alkaline solution at 20°C did not alter the DOFS measurements, and consequently did not induce any significant degradation of the bonded DOFS instrumentation. However, it is important to note that during aging, some leakage of the alkaline solution occurred in the ageing cell and the level of the solution was lowered by one third. Therefore, it was necessary to perform an additional test to confirm the result.

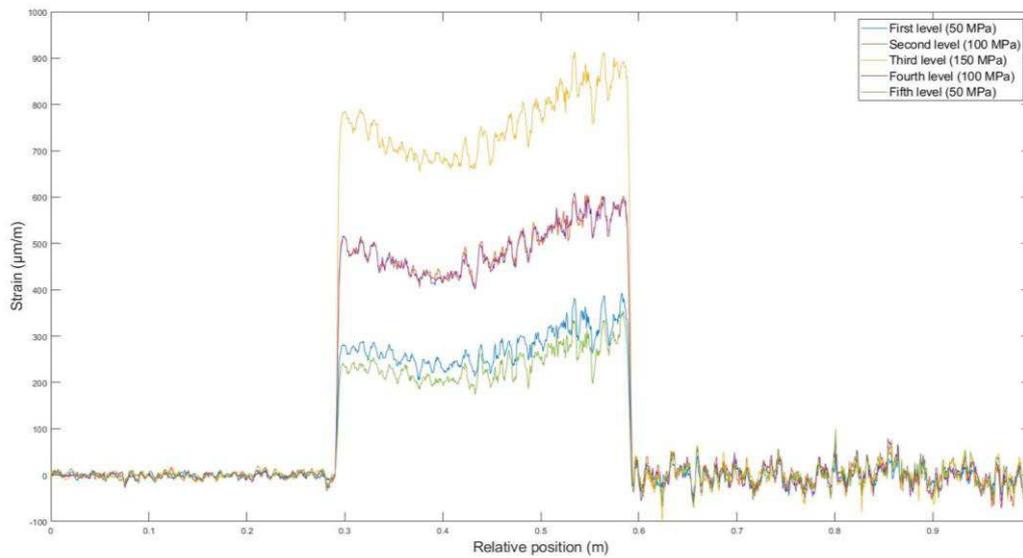
**Fig. 8.** Reference strain profiles recorded during the tensile test on the unaged instrumented steel rebar of diameter 10 mm, at the different load levels 1 to 5 (see Table 1)

Figure 8 displays the reference strain profiles recorded during the tensile test on the unaged specimen, at the same stress levels as for the previous experiment, namely 50 MPa, 100 MPa and 150 MPa (and again for increasing / decreasing load increments as reported in Table 1). At these stress levels, the average strain values are about 200  $\mu\text{m/m}$ , 400  $\mu\text{m/m}$  and 700  $\mu\text{m/m}$  respectively. One can note that the strain profiles are not flat, contrary to what was observed on the first rebar. This suggests a preexisting curvature on the present 10 mm steel rebar. This specific shape of the strain profiles will be taken into account when analyzing the experimental data after ageing.

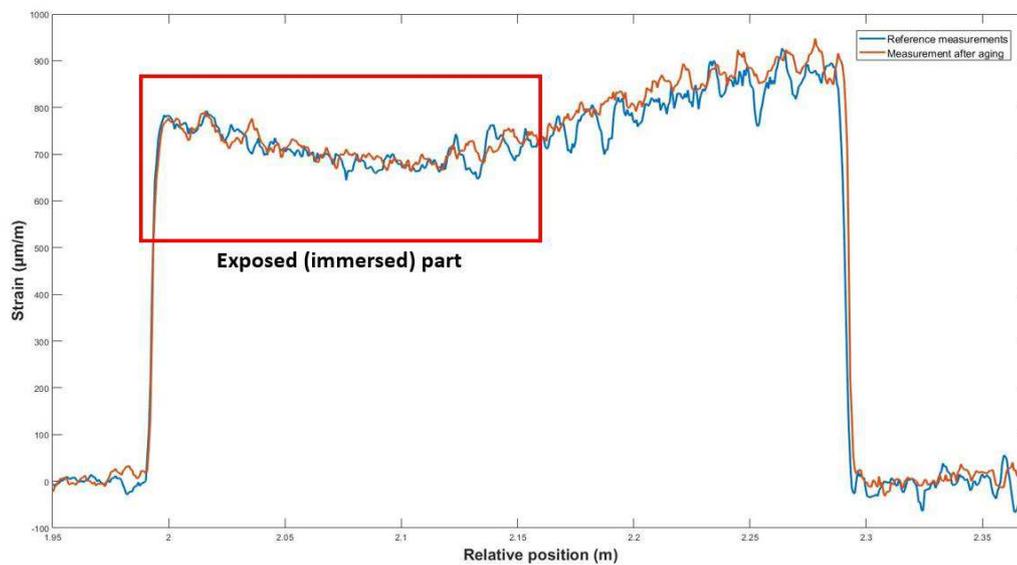
**Fig. 9.** Comparison of the strain profiles recorded during tensile tests on the 10 mm steel rebar at a stress level of 150 MPa, in the reference state and after one month exposure in the ageing cell at 60 °C

Figure 9 gathers the strain profiles collected during tensile tests at a stress level of 150 MPa, both for the unaged 10 mm rebar (reference state) and for the same rebar after one month exposure in the aging cell at 60 °C. Here again, the graph shows that the strain profiles are similar in the reference and aged states, and that the profile of the aged rebar is not modified along the section immersed in the solution. These results confirm the previous observations made on the first rebar, and do not show any significant degradation of the DOFS instrumentation after one month exposure at 60°C in the alkaline solution. However, in future work, ageing tests should be conducted over longer periods in order to confirm the reliability of the DOFS instrumentation in the long term. In addition, a complementary durability study should be carried out specifically on the epoxy adhesive used to bond the OF.
