# Durability in Alkaline Environment of a Fiber Optic Sensor Bonded at the Surface of Reinforcing Bars for Distributed Strain Measurements in Concrete Structures

Noémie Delaplanque, Sylvain Chataigner, Laurent Gaillet, Marc Quiertant, Karim Benzarti, Arnaud Rolland, Xavier Chapeleau, A. Saravia Flores

Noémie Delaplanque, Sylvain Chataigner, Laurent Gaillet, Marc Quiertant, Karim Benzarti, et al.. Durability in Alkaline Environment of a Fiber Optic Sensor Bonded at the Surface of Reinforcing Bars for Distributed Strain Measurements in Concrete Structures. European Workshop on Structural Health Monitoring (EWSHM 2022), Jul 2022, Palerme, Italy. pp.506-515, 10.1007/978-3-031-07258-1\_52 . hal-03819126

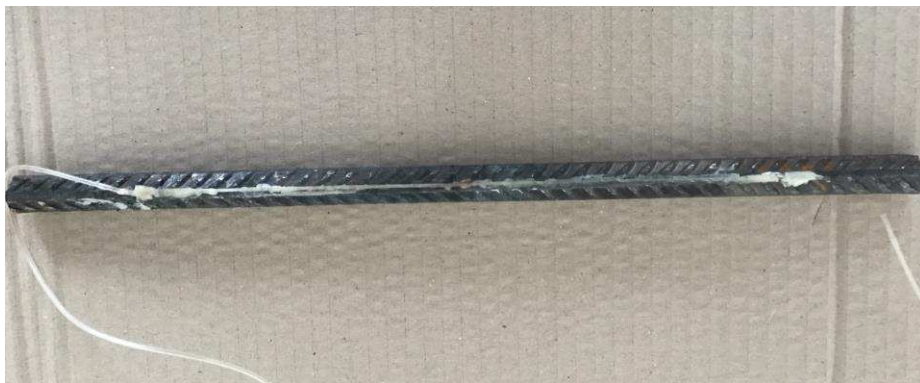
**Fig. 1.** Picture of the steel rebar of  $\varnothing$  12 mm, showing the OF sealed in the engraved groove

The tests were conducted on two steel rebars of diameter 10 and 12mm, respectively. Each rebar was equipped with an OF sensor. Based on previous works of Quiertant et al. [3] and Chapeleau and Bassil [7], a single-mode commercially available OF with a polyimide primary coating was used. For the installation of this OF, a U-groove with a depth of 1 mm, and a length of 220 mm for the first rebar and 300 mm for the second, was previously drilled along each rebar. Then, the OF was placed inside the U-groove and sealed with a two-component epoxy adhesive. The X60 epoxy was used for bonding the OF to the 12mm diameter steel rebar, while the X120 epoxy adhesive

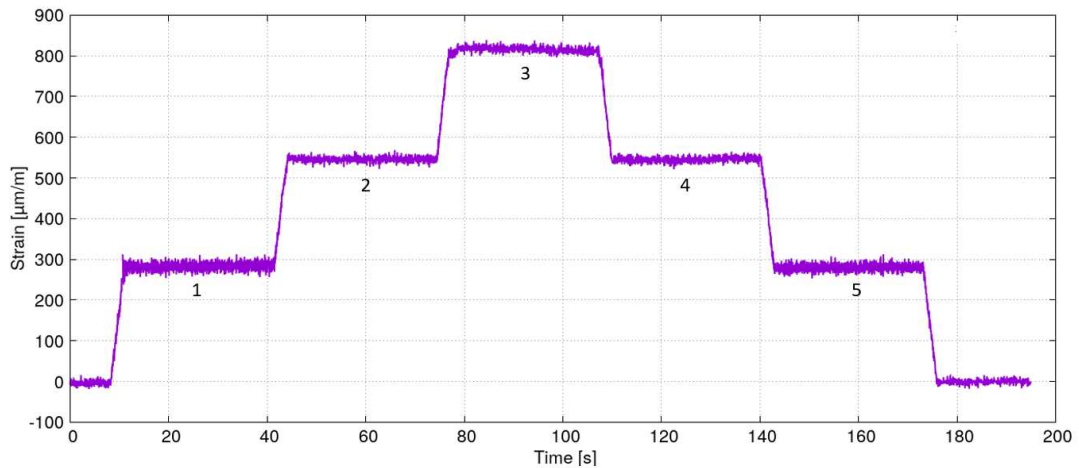
**Fig. 2.** Applied strain history recorded by the DOFS during the tensile test on steel rebars

**Table 1.** Load levels applied during the direct tensile tests. Steps 1 to 3 correspond to increasing load increments while steps 4 and 5 are decreasing increments.

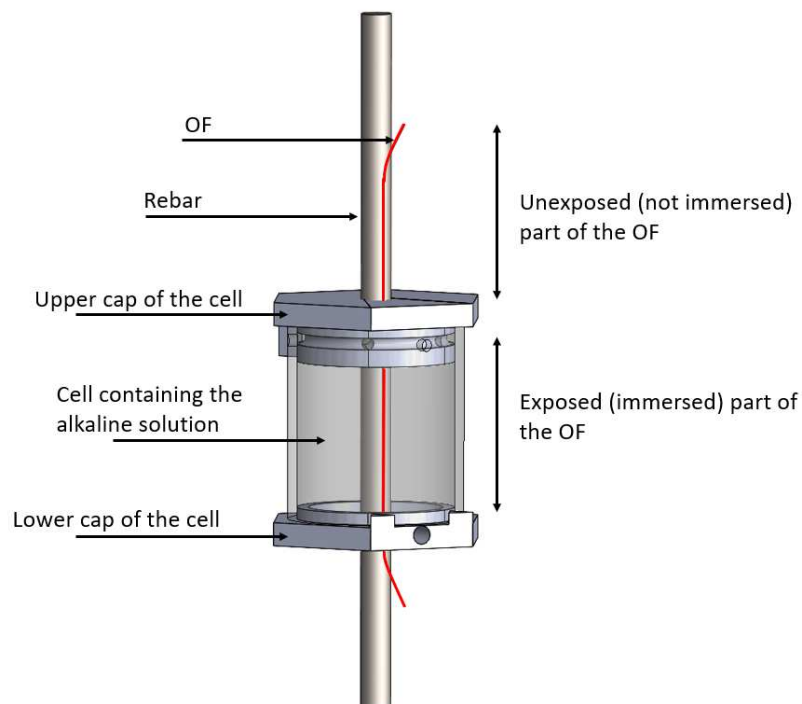
**Fig. 3.** Experimental set-up used for conditioning the instrumented steel rebars

The exposure condition consisted in immersing the DOFS the instrumentation into an alkaline solution at a given temperature (either 20 °C or 60 °C). In this line, each rebar (equipped with the bonded DOFS) was conditioned in an ageing cell, as shown in Fig. 3. A specific cap made it possible to install the cell without damaging the optical fiber. The two parts clamping mechanism was designed to fit the rebar and the OF, hence limiting the risk of damage during installation (See Fig. 4). A polyurethane sealant was used to seal the ageing cell (see Fig. 5).

Only the half bonded length of the OF is immersed in the alkaline solution, as shown in Fig. 3. When performing tensile tests afterwards on the exposed rebars, this configuration allows comparing the strain responses of the immersed and non-immersed sections of the OF, and hence to evidence possible alteration of the OF instrumentation induced by the alkaline environment (that may be related either to a degradation of the adhesive bond, an evolution of the bulk properties of the adhesive, or the alkali attack of the OF itself). It is to note that the overall setup was stored in the laboratory environment for the ageing condition at 20 °C, while it was placed in an oven for the condition at 60 °C.

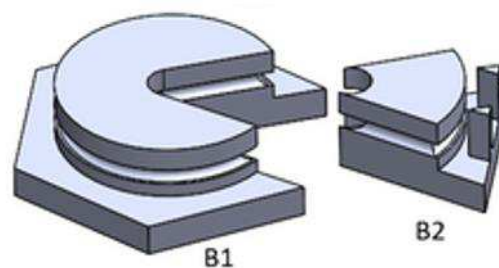
**Fig. 4.** Two parts clamping mechanism of the lower cap of the aging cell

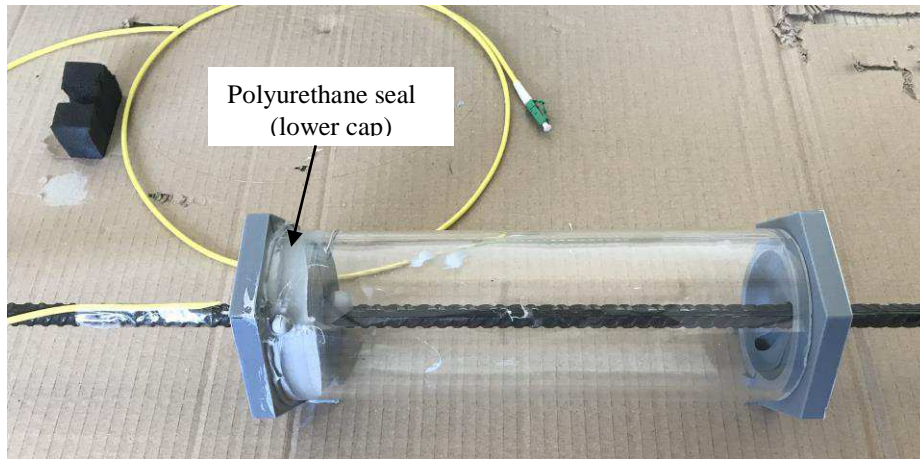
**Fig. 5.** Steel rebar of diameter 10 mm installed in the aging cell

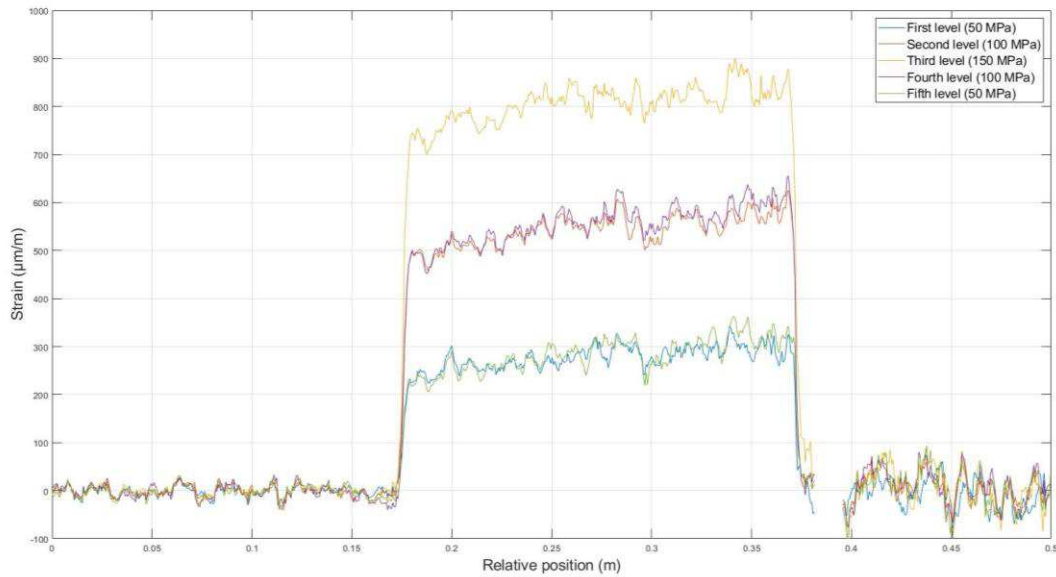
**Fig. 6.** Reference strain profiles recorded during the tensile test on the unaged instrumented steel rebar of diameter 12 mm, at the different load levels 1 to 5 (see Table 1 and Fig. 2)

Figure 6 shows the strain profiles recorded at different load levels during the tensile test on the unaged instrumented steel rebar of diameter 12 mm. The x axis corresponds to the relative position along the rebar, and the bonded section of the optical fiber is located at abscissas between 0.175 and 0.37 m. Strain profiles collected at stress levels of 50 MPa, 100 MPa and 150 MPa are displayed together in the graph. They provide average strain values of about 300  $\mu\text{m/m}$ , 500  $\mu\text{m/m}$  and 800  $\mu\text{m/m}$ , respectively, which can be considered as reference data for the unaged DOFS instrumentation. Furthermore, it is interesting to note that profiles collected at increasing increments (levels 1 to 3) are consistent with those obtained at decreasing increments (levels 3 to 5), showing the repeatability of strain measurements.

Figures 6 and 7 represent acquisitions made on the same frame. However, the two graphs display different ranges of relative positions because the acquisitions in the reference and aged states were made at different times and requested disconnecting/reconnecting the acquisition line to the ODISI interrogator. Therefore, the length of OF connecting the rebar to the interrogator was different from one test to another.

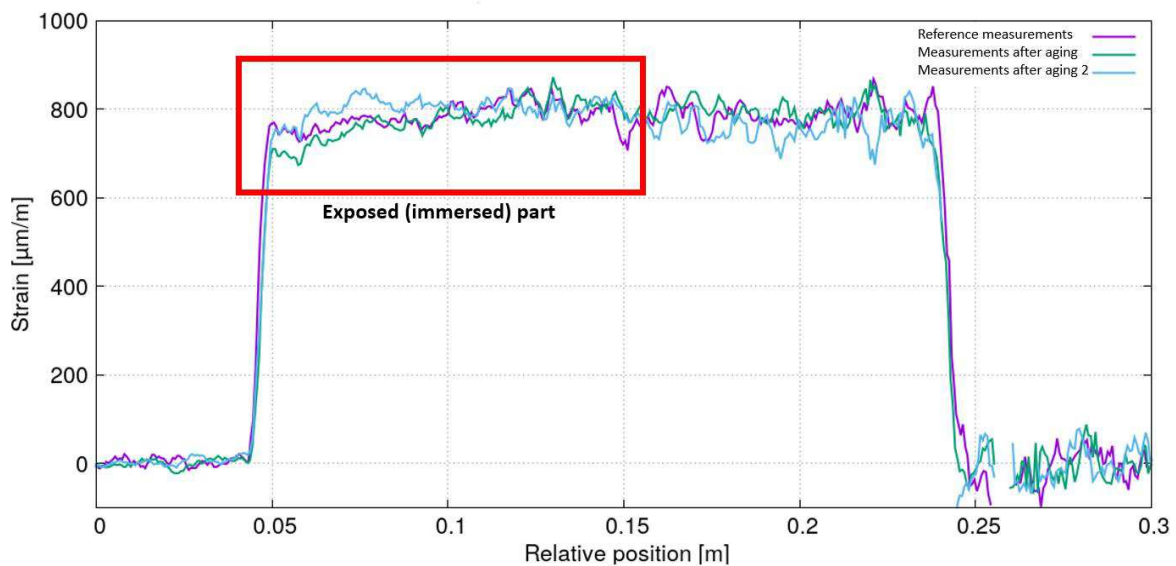
**Fig. 7.** Comparison of the strain profiles recorded during tensile tests on the 12 mm steel rebar at a stress level of 150 MPa, in the reference state and after one-month exposure in the ageing cell at 20 °C ("ageing 2" refers to the aged specimen that was turn upside down in the press)

Figure 7 gathers the strain profiles collected during tensile tests at a stress level of 150 MPa, both for the unaged rebar (reference state) and for the same rebar after one-month exposure in the aging cell at 20 °C. An additional measurement was carried out on the aged rebar after changing its direction upside down in the grips of the tensile machine, in order to verify the symmetry of the test setup (the corresponding profile is denoted “measurement after ageing 2” in the graph).

From Fig. 7, it is found that i) the strain profiles of the aged rebar are superimposed to the reference profile and ii) that the average strain level is roughly constant along the immersed and non-immersed sections of the aged rebar. This result suggests that exposure for one month in the alkaline solution at 20°C did not alter the DOFS measurements, and consequently did not induce any significant degradation of the bonded DOFS instrumentation. However, it is important to note that during aging, some leakage of the alkaline solution occurred in the ageing cell and the level of the solution was lowered by one third. Therefore, it was necessary to perform an additional test to confirm the result.

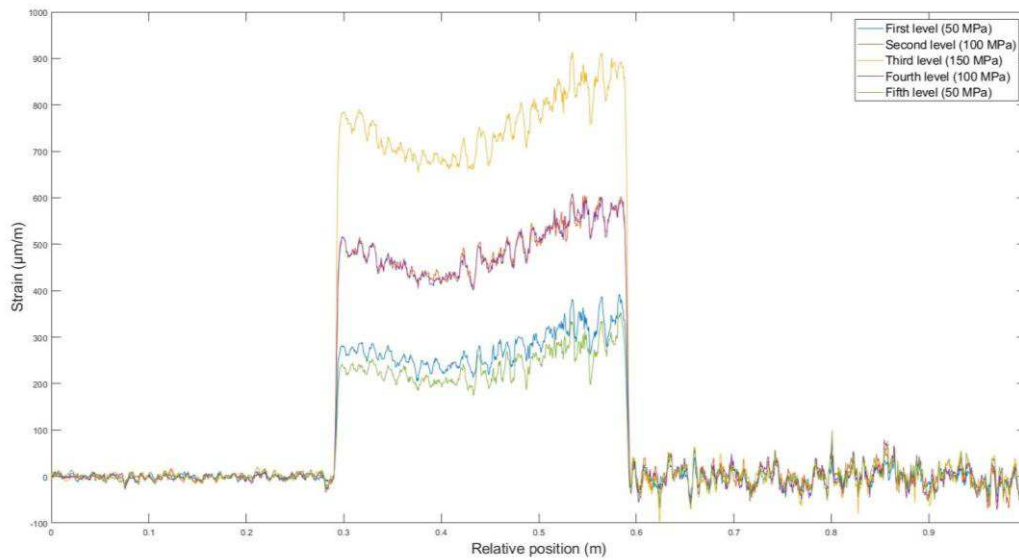
**Fig. 8.** Reference strain profiles recorded during the tensile test on the unaged instrumented steel rebar of diameter 10 mm, at the different load levels 1 to 5 (see Table 1)

Figure 8 displays the reference strain profiles recorded during the tensile test on the unaged specimen, at the same stress levels as for the previous experiment, namely 50 MPa, 100 MPa and 150 MPa (and again for increasing / decreasing load increments as reported in Table 1). At these stress levels, the average strain values are about 200  $\mu\text{m/m}$ , 400  $\mu\text{m/m}$  and 700  $\mu\text{m/m}$  respectively. One can note that the strain profiles are not flat, contrary to what was observed on the first rebar. This suggests a preexisting curvature on the present 10 mm steel rebar. This specific shape of the strain profiles will be taken into account when analyzing the experimental data after ageing.

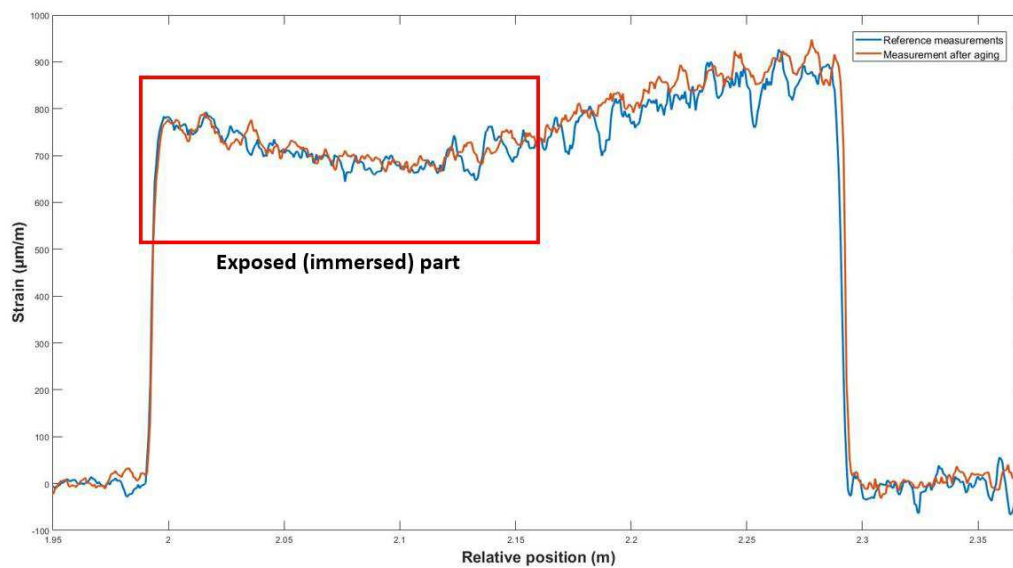
**Fig. 9.** Comparison of the strain profiles recorded during tensile tests on the 10 mm steel rebar at a stress level of 150 MPa, in the reference state and after one month exposure in the ageing cell at 60 °C

Figure 9 gathers the strain profiles collected during tensile tests at a stress level of 150 MPa, both for the unaged 10 mm rebar (reference state) and for the same rebar after one month exposure in the aging cell at 60 °C. Here again, the graph shows that the strain profiles are similar in the reference and aged states, and that the profile of the aged rebar is not modified along the section immersed in the solution. These results confirm the previous observations made on the first rebar, and do not show any significant degradation of the DOFS instrumentation after one month exposure at 60°C in the alkaline solution. However, in future work, ageing tests should be conducted over longer periods in order to confirm the reliability of the DOFS instrumentation in the long term. In addition, a complementary durability study should be carried out specifically on the epoxy adhesive used to bond the OF.
