Application of Distributed Optical Fiber Sensing Technology to the Detection and Monitoring of Internal Swelling Pathologies in Massive Concrete Blocks

Abstract: This paper presents an experimental application of Distributed Optical Fiber Sensors (DOFS) for the Structural Health Monitoring (SHM) of concrete structures affected by internal swelling pathologies. In the framework of a large research project aiming to assess the possible extension of the operating lifetime of nuclear power plants from 40 to 60 years, massive blocks were cast from reactive concrete mixtures intended to develop delayed ettringite formation and alkalisilica reaction. These blocks were subjected to specific ageing conditions to initiate and accelerate the concrete pathologies. Some of the blocks were instrumented with DOFS bonded to the surface and embedded in the concrete. Using an interrogator device based on Rayleigh backscattering and a suitable procedure to eliminate temperature effects, distributed strain measurements were then performed at different time intervals. The first results of this ongoing study made it possible to demonstrate the feasibility and effectiveness of this sensing technology fo

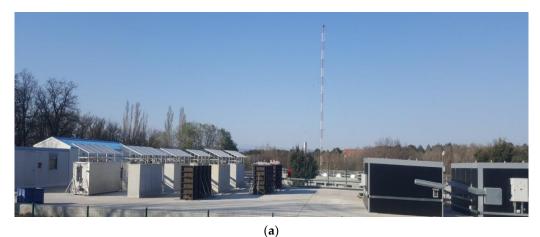
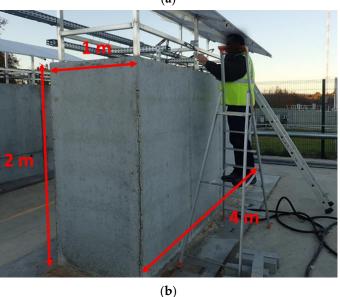
Figure 1. (a) Exposure platform for ODOBA blocks, and (b) dimensions of the blocks.

The concrete blocks of the ODOBA project are stored on a dedicated outdoor platform in Cadarache (south of France) and arranged in rows (Figure 1a). Each block measures $1 \times 2 \times 4$ m³ (Figure 1b) and weighs about 20 tons. These massive blocks are divided into three categories: Reference blocks which are not expected to develop pathologies, potentially pathological blocks subjected to external weather conditions (referred to as "natural ageing" conditions), and potentially pathological blocks subjected to experimental protocols aimed at accelerating the development of pathologies (referred to as "accelerated ageing" conditions).

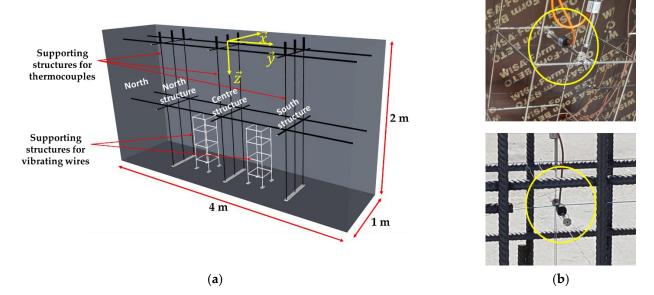
Figure 2. (a) Supporting structures for conventional sensors in NRC concrete block; (b) Installation of vibrating wires in an NRC block (top) and in an RC block (bottom).

Regarding NRC blocks, metallic frames supporting the VWs are installed at two specific locations (Figure 2a). Three VWs are attached to each frame (one VW along each direction \overrightarrow{x} , \overrightarrow{y} , and \overrightarrow{z} —see reference coordinate system in Figure 2a), allowing for strain measurements along the three directions of space at each support location.

For the RC blocks (without supporting structures), the VWs are arranged according to the same geometrical configuration but using the steel reinforcement of the block as a supporting frame (Figure 2b bottom).

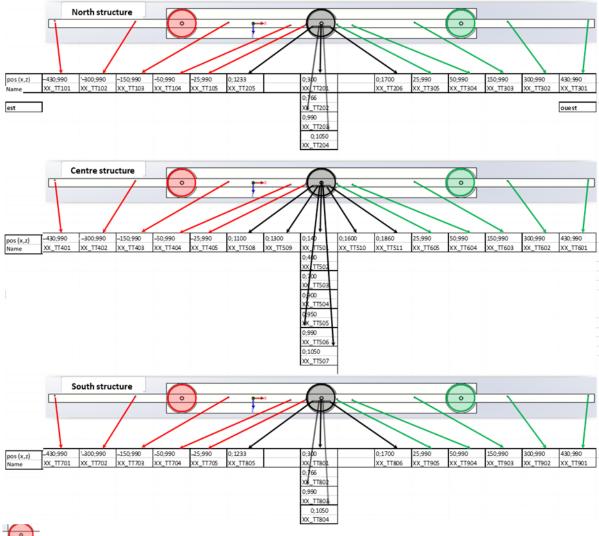
Vertical supporting bar located near the west face of the block

Vertical supporting bar located at mid-width on the block

Vertical supporting bar located near the east face of the block

Figure 3. Coordinates (in mm) of the thermocouples in an NRC concrete block considering the origin of the coordinate system at the center of the upper face of the block.

In the case of NRC blocks, these thermocouples are attached to three vertical structures, which are represented in black in Figure 2a. The thermocouples are thus arranged on three vertical (\vec{x}, \vec{z}) planes: one plane close to the north side of the block, another at the midwidth of the block, and the last plane near the south side of the block. This arrangement provides a global overview of the temperature gradients within the block. The locations of the various thermocouples on the three vertical structures are detailed in the scheme of Figure 3. The coordinates shown in Figure 3 are relative to the reference coordinate system drawn in Figure 2a (origin at the center of the upper face of the block).

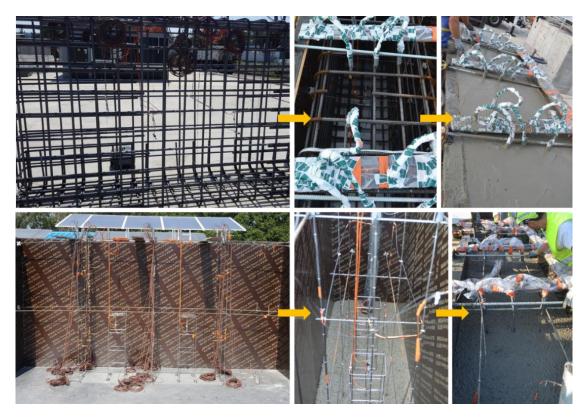
Figure 4. Construction steps of the two types of ODOBA blocks: RC blocks (top pictures) and NRC blocks (bottom pictures).

Prior to the pouring of the NRC blocks, the metallic structures intended to support the sensors (Figure 2a) were installed inside the formwork. The sensors were attached to these structures, and the last side of the formwork was then put in place. The whole formwork was finally tightened and hence ready to support the concrete weight.

For the RC blocks, the steel stirrup was assembled first. Then, the different sensors were installed at the defined locations, supported by the steel rebars. Once the sensor setup was finished, the stirrup was inserted inside the formwork. Finally, concrete was poured into the formwork.

Figure 4 illustrates the manufacturing steps for RC blocks (top pictures) and NRC blocks (bottom pictures).

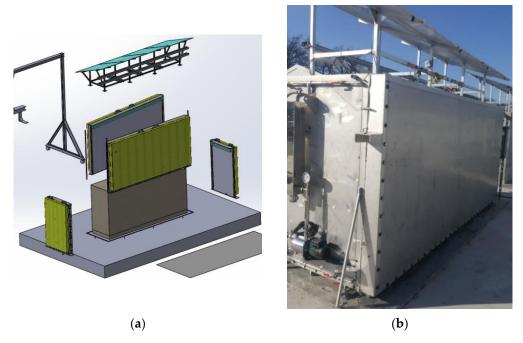
Figure 5. (a) Scheme of the pool setup used for the immersion of ODOBA blocks; (b) Picture of a pool in operation.

order to achieve this alternation of immersion/drying, the pool can be dismantled and reassembled. Indeed, as shown in Figure 5a, the four sides of the pool are easily put in place to form a watertight structure. Once filled, the pool provides a homogeneously heated water layer around the block, thanks to an integrated water circulation system (Figure 5b). In addition, an effluent treatment station allows for monitoring the quality of the water used in the pools (pH, chemical composition).

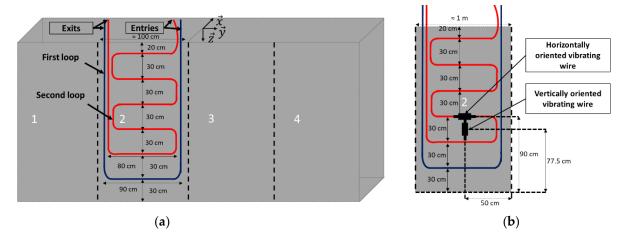
Figure 6. (a) Instrumentation scheme with bonded DOFS (b) Detail of the instrumented zone showing the two DOFS loops, and projection view of the embedded vibrating wires used for comparison.

One of the two larger sides of the block, with a surface area of 4×2 m², is first divided into four identical zones (zones 1–4, see Figure 6a). Zone 2 is dedicated to receiving the bonded DOFS. The instrumentation scheme consists of two loops of DOFS cable.

The first loop (represented in blue color in Figure 6) follows the two vertical borders of zone 2 and has a horizontal portion about 30 cm above the ground level. This loop allows for the collection of the strain profiles at the two vertical borders of the instrumented zone 2, which can then be compared with the local measurements of the vertically oriented vibrating wire (VW) located halfway between the two vertical paths of the DOFS (see Figure 6b).

A second loop (red color in Figure 6) includes several horizontal paths at different heights of the block, the lowest being about 30 cm above the ground and the highest 20 cm from the top of the block. This second loop allows for the collection of the horizontal strain profiles over the whole instrumented zone and a comparison of the recorded values with the strain measurements from the horizontally oriented VW located in the same region of the block (see Figure 6b).

The concerned VWs are embedded 50 cm away from the surface of the block. Their locations in the $(\stackrel{\rightarrow}{y},\stackrel{\rightarrow}{z})$ plane are shown in Figure 6b.

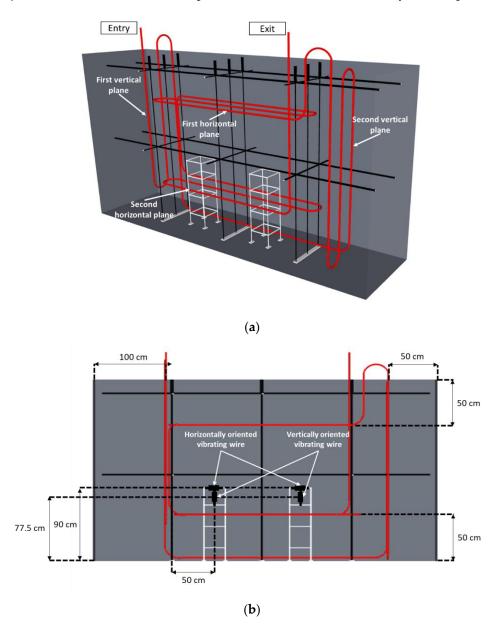
Figure 7. (a) Instrumentation scheme of NRC blocks with embedded DOFS; (b) Projection view showing the horizontal/vertical positions of the embedded DOFS and vibrating wire sensors.

As for the installation of thermocouples and VWs, the instrumentation of the NRC block with embedded DOFS was carried out prior to concrete pouring. In the first step, only three sides of the formwork were put in place to allow easy access to the operators. The fourth side of the formwork was only put in place after all the sensors were installed in their final locations. The internal loop of the DOFS follows a complex scheme presented in Figure 7a. As for the bonded configuration, and for the same reasons, the entry and exit of the DOFS cable are located on the upper side of the block. The DOFS path meanders first across a vertical plane perpendicular to the large faces of the block. In this plane, the DOFS cable is fixed to the metallic structure supporting the thermocouples. This first path allows for monitoring the vertical strain at several depths within the block, very close to the thin metal bars supporting the thermocouples. Such strain measurements will provide an overview of concrete swelling at various depths inside the block. In addition, the path of the DOFS cable also meanders across a second vertical plane (near the south face of the block), but here relatively far from the metallic structure bearing the thermocouples. Therefore, a comparison of the strain measurements carried out in these two vertical planes will allow for the detection of any influence of the metallic structures on the concrete swelling (possible restraining effect). It will also be interesting to compare DOFS data with local strain measurements from the two vertically oriented VWs (Figure 7b).

Two horizontal planes perpendicular to the large faces of the block are also instrumented with the embedded DOFS cable. The first horizontal plane (see Figure 7) is located at three-quarters of the block height. This horizontal DOFS path allows the strain to be measured in the upper part of the block where there is no VW. The second horizontal plane is located at a quarter of the block height, and hence the corresponding DOFS path provides horizontal strain profiles in the lower part of the block. A comparison can therefore be made

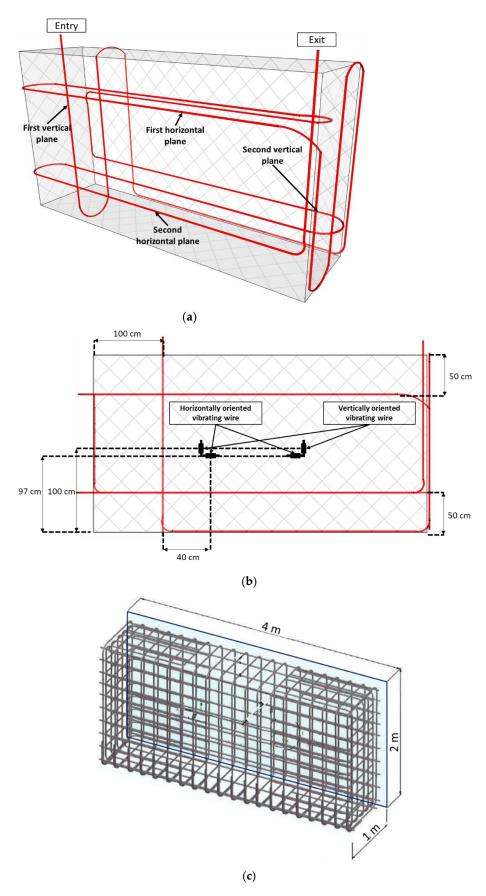
Figure 8. (a) Instrumentation scheme of RC blocks with embedded DOFS; (b) Projection view showing the horizontal/vertical positions of the embedded DOFS and vibrating wire sensors; (c) detail of the steel stirrup in RC blocks.

Unlike the previous case, the RC blocks do not contain specific metallic supports for VWs and thermocouples that could serve to fix the DOFS instrumentation. It was thus necessary to attach the DOFS cable directly to the steel stirrups and hence to adapt the internal path of the cable inside the blocks. However, the DOFS loop was still designed to pass through two vertical and two horizontal planes, as depicted in Figure 8.

Just after entering into the RC block, the DOFS cable meanders across the first vertical plane (Figure 8a). In this plane, the two descending branches of the DOFS cable are close to the steel reinforcement (see the detail of the stirrup in Figure 8c), whereas the ascending branch is distant from the steel rebars. A comparison of the strain profiles collected in these branches will thus provide relevant information about the influence of the steel reinforcement on the concrete expansion (for blocks exposed to the ageing conditions).

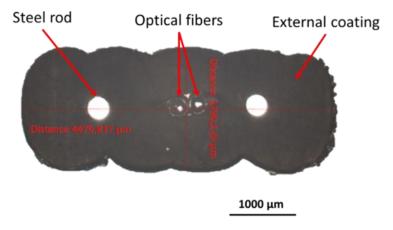
Figure 9. Cross-section of the DOFS cable, as observed by optical microscopy.

The DOFS cable considered in this study is the FutureNeuroTM FN-SILL-3 cable manufactured by Neubrex Co. Ltd. (Kobe, Japan) [26]. As illustrated in Figure 9, this cable is composed of two single-mode optical fibers (OFs) with an acrylate primary coating, two steel wires of diameter 0.3 mm, which ensure the mechanical reinforcement of the cable, and an external coating made of a soft elastomer.

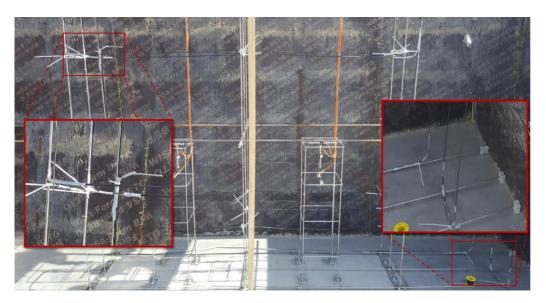
Figure 10. Instrumentation of block IA with embedded DOFS, and details of a metallic guide for curved parts (enclosed picture on the left side) and of the three metallic rods supporting the second vertical plane (enclosed picture on the right side).

The IA block was instrumented according to the scheme of NRC blocks presented in Section 3.2. In order to prevent displacements of the DOFS cable during concrete pouring, three horizontal metallic rods were added at the bottom of the formwork to support the second vertical plane of instrumentation (Cf. Figure 7). Metallic guides were also added to support the curved parts of the DOFS path in order to prevent the pinching of the cable and subsequent optical loss during interrogation. Pictures of the block instrumentation are presented in Figure 10.

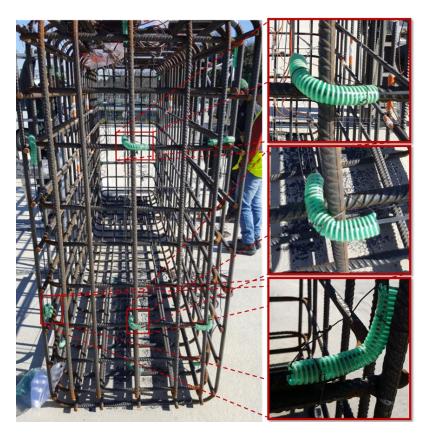
Figure 11. Instrumentation of block KB with embedded DOFS and details of cable bends around the stirrup (pictures on the right side).

of the DOFS cable around the stirrup and to avoid optical losses due to pinching, guides were again used. However, for this block, the guides consisted of plastic sheaths that ensured a bending radius greater than 4 cm. Figure 11 shows some pictures taken during the instrumentation of the KB block, including details of the cable bends (on the right side).

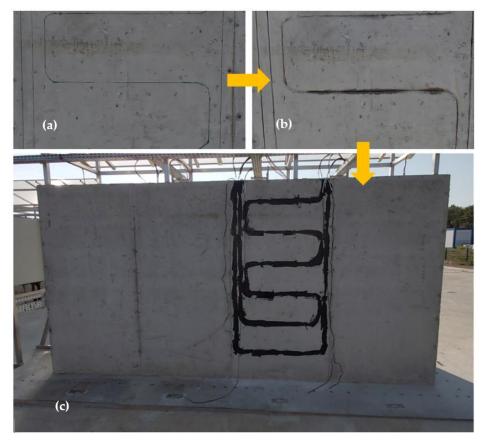
Figure 13. Installation steps of the DOFS cable at the surface of block KB. (a) Marking of the cable path at the surface of concrete (b) engraving of the groove along the path (c) insertion of the DOFS cable into the groove and application of the closing layer of X120 adhesive.

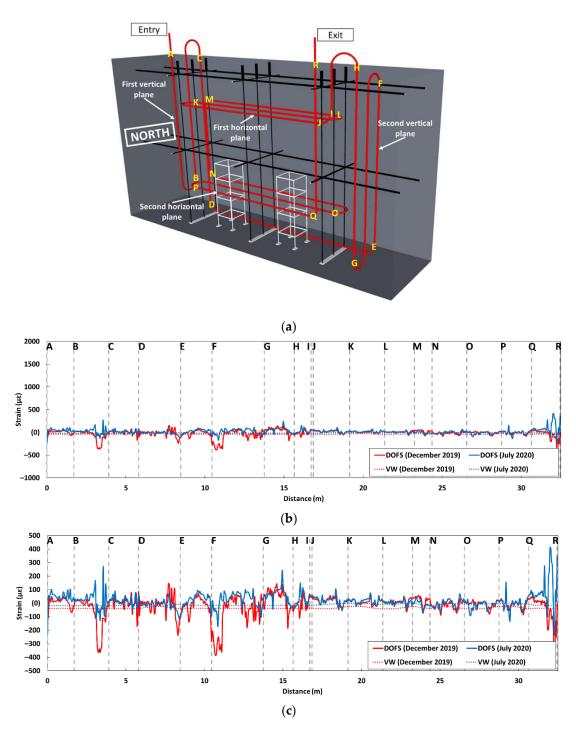
Figure 14. (a) Instrumentation scheme of the block IA with embedded DOFS, in which segments of the DOFS path are identified with alphabet letters; (b) Strain profiles along the DOFS (in solid lines) together with VW measurements (dotted lines); (c) Strain profiles at magnified y-scale.

The strain profiles at both measurement times (December 2019 and July 2020) provided continuous signals along the entire length of the embedded DOFS and included the data collected from the two vertical and the two horizontal instrumentation planes (Cf. Figure 14a). The strain values recorded by the DOFS are found to be consistent with those recorded by VWs (on each considered segment of the DOFS cable, the strain values are compared to those of the nearest VW).

Although the reference measurement was performed in the middle of summer (July 2019, see Table 1) and the first measurement in December 2019, the corresponding strain profile (solid red line in Figure 14b,c) does not evidence any contraction due to the temperature drop between these two periods. This result can be explained by the fact that the first measurement (December 2019) was taken while the IA block was in the immersion pool (wet phase of the immersion/drying cycle, at a controlled temperature), and the average temperature within the block was around 25 $^{\circ}$ C (see Appendix A). This immersion thus reduced the effect of the thermal gradient between the reference measurement (temperature

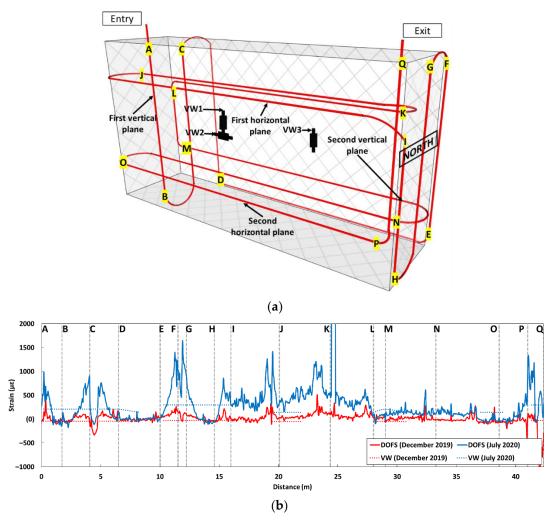
Figure 15. (a) Instrumentation scheme of the block KB with embedded DOFS, in which segments of the DOFS path are identified with alphabet letters; (b) Strain profiles along the DOFS (in solid lines) together with VW measurements (dotted lines).

Figure 15 displays the strain profiles recorded by the DOFS embedded in block KB, together with the strain values recorded by the three vibrating wires (VW1, VW2, and VW3, see Figure 15a) operational at the time of the measurements and located near the DOFS.

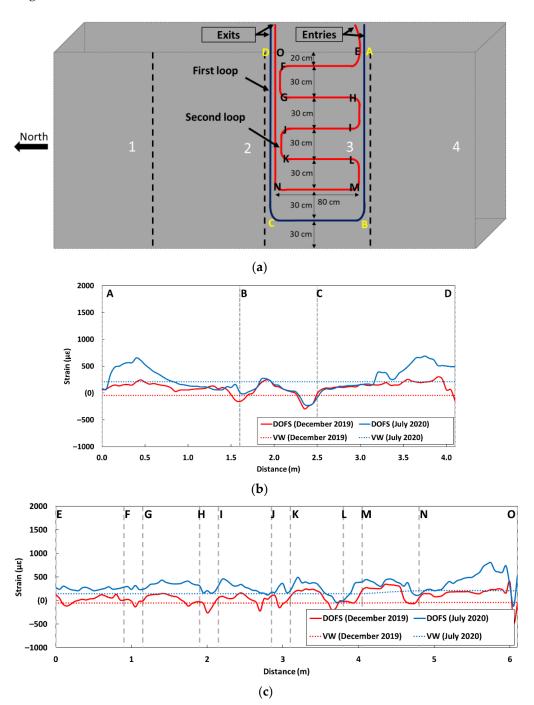
Figure 16. (a) Instrumentation scheme of the block KB with bonded DOFS, in which segments of the two DOFS loops are identified with alphabet letters; Strain profiles along the first loop (b) and the second loop (c) of the bonded DOFS cable (solid lines), together with the strain data from the nearest VWs (dotted lines).

Moreover, the profile along the second loop (see Figure 16) shows that the intensity of the strain is globally constant over the horizontal parts of the instrumented area and for all height levels.

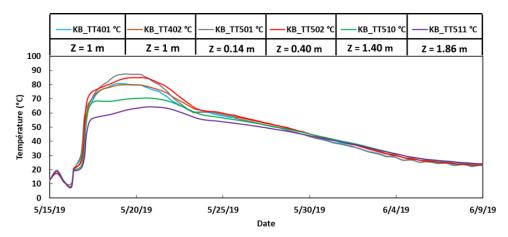
Figure 17. Temperatures recorded by selected thermocouples inside the block KB during the initial thermal treatment (z refers to the vertical position of the thermocouple, the origin of the \vec{z} axis is located at the center of the top face of the block).

In order to analyze further the previous results provided by the DOFS instrumentation, it is interesting to examine the temperatures that were recorded within the KB block during the initial thermal treatment intended to initiate the DEF. Figure 17 shows the temperature evolutions provided by several thermocouples located at different heights of the block during the 3-week thermal treatment from 15 May to 9 June 2019. From this graph, it is found that the maximum temperature reached during the heat treatment was around 80–85 °C in the upper part of the block, whereas it was much lower (around 65–70 °C) in the bottom part of the block. Considering this vertical temperature gradient at an early age, and hence the effective thermal energy gradient created [34], it could be expected that the DEF pathology would develop first in the upper part of the KB block. This is very consistent with the strain measurements provided by the embedded DOFS in July 2020, which revealed a significantly higher expansion of concrete in the upper part of the KB block, suggesting the higher kinetics of DEF in this region of the block.

Furthermore, the temperature variations between the upper and lower parts of the block were more limited at the concrete surface during the initial thermal treatment. This can be attributed to the fact that heat diffused more homogeneously at the surface through the air layer surrounding the block. The temperature values and the effective thermal energy recorded during the heat treatment were then more homogeneous and globally higher at the surface of the block compared to the core. As the swelling pathology develops in the KB block, it is thus expected that expansion will be more homogeneous at the surface than in the depth of the block.
