Application of Distributed Optical Fiber Sensing Technology to the Detection and Monitoring of Internal Swelling Pathologies in Massive Concrete Blocks

Abstract: This paper presents an experimental application of Distributed Optical Fiber Sensors (DOFS) for the Structural Health Monitoring (SHM) of concrete structures affected by internal swelling pathologies. In the framework of a large research project aiming to assess the possible extension of the operating lifetime of nuclear power plants from 40 to 60 years, massive blocks were cast from reactive concrete mixtures intended to develop delayed ettringite formation and alkali-silica reaction. These blocks were subjected to specific ageing conditions to initiate and accelerate the concrete pathologies. Some of the blocks were instrumented with DOFS bonded to the surface and embedded in the concrete. Using an interrogator device based on Rayleigh backscattering and a suitable procedure to eliminate temperature effects, distributed strain measurements were then performed at different time intervals. The first results of this ongoing study made it possible to demonstrate the feasibility and effectiveness of this sensing technology f

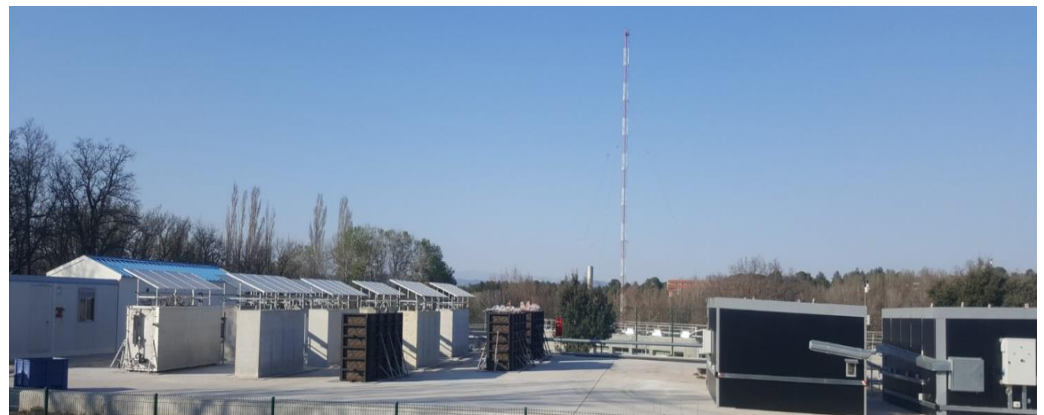
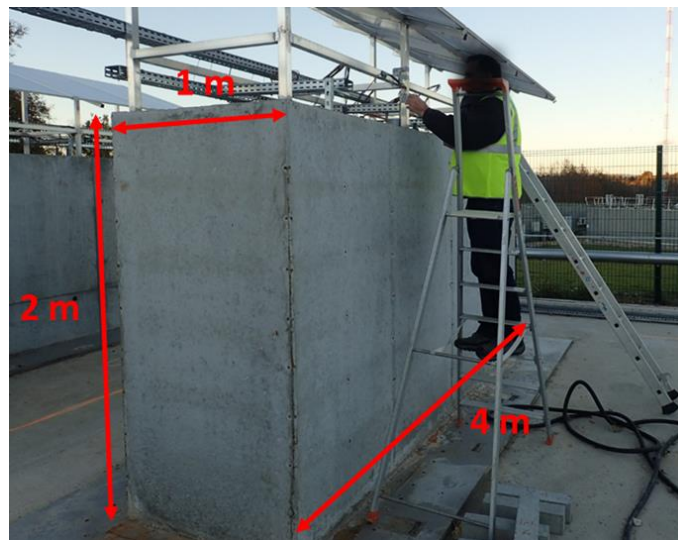
Figure 1. (a) Exposure platform for ODOBA blocks, and (b) dimensions of the blocks.

The concrete blocks of the ODOBA project are stored on a dedicated outdoor platform in Cadarache (south of France) and arranged in rows (Figure 1a). Each block measures $1 \times 2 \times 4 \text{ m}^3$ (Figure 1b) and weighs about 20 tons. These massive blocks are divided into three categories: Reference blocks which are not expected to develop pathologies, potentially pathological blocks subjected to external weather conditions (referred to as “natural ageing” conditions), and potentially pathological blocks subjected to experimental protocols aimed at accelerating the development of pathologies (referred to as “accelerated ageing” conditions).

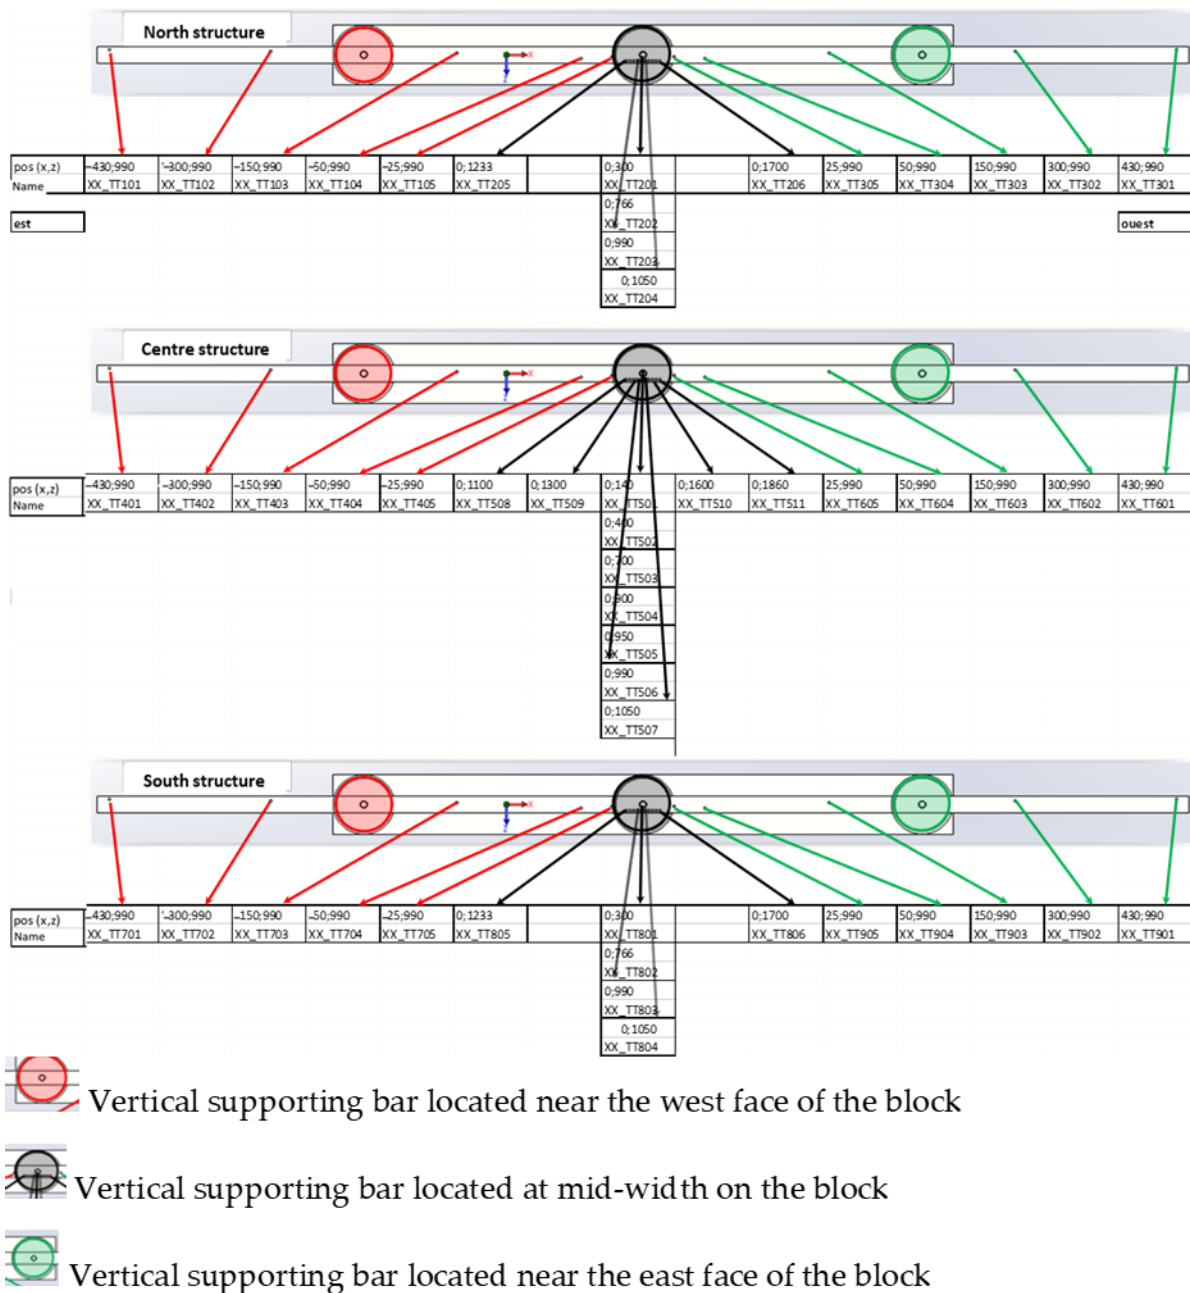
Figure 3. Coordinates (in mm) of the thermocouples in an NRC concrete block considering the origin of the coordinate system at the center of the upper face of the block.

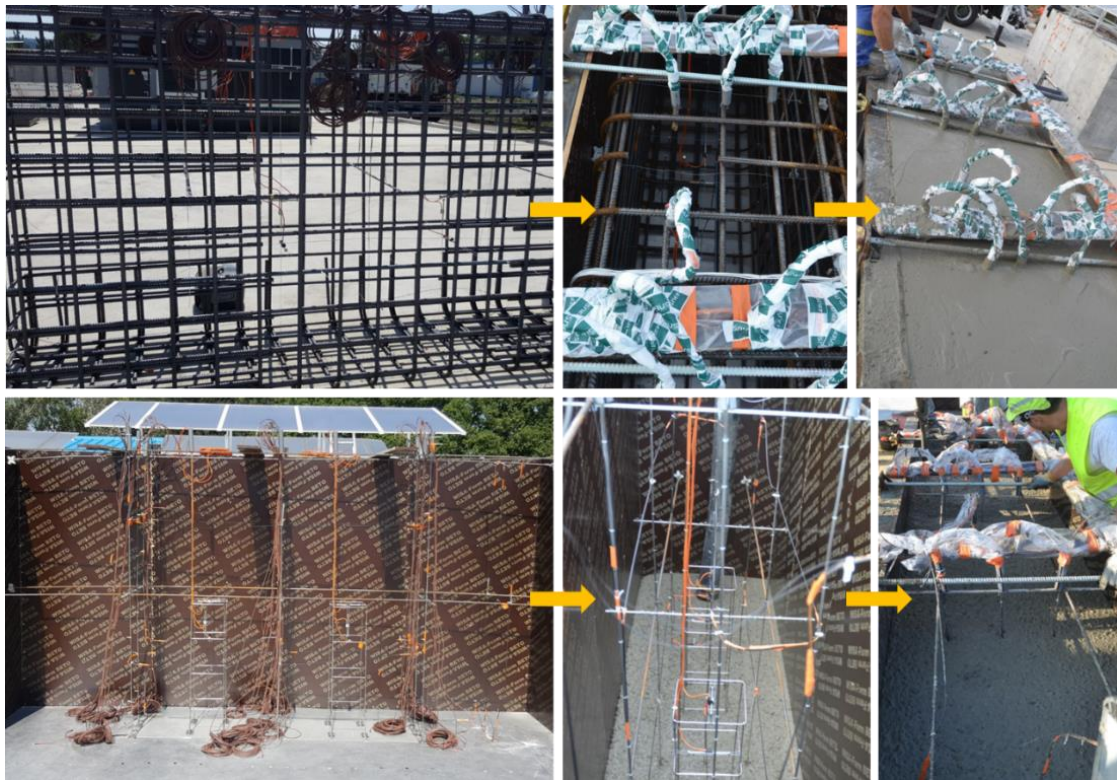
Figure 4. Construction steps of the two types of ODOBA blocks: RC blocks (top pictures) and NRC blocks (bottom pictures).

Figure 4 illustrates the manufacturing steps for RC blocks (top pictures) and NRC blocks (bottom pictures).

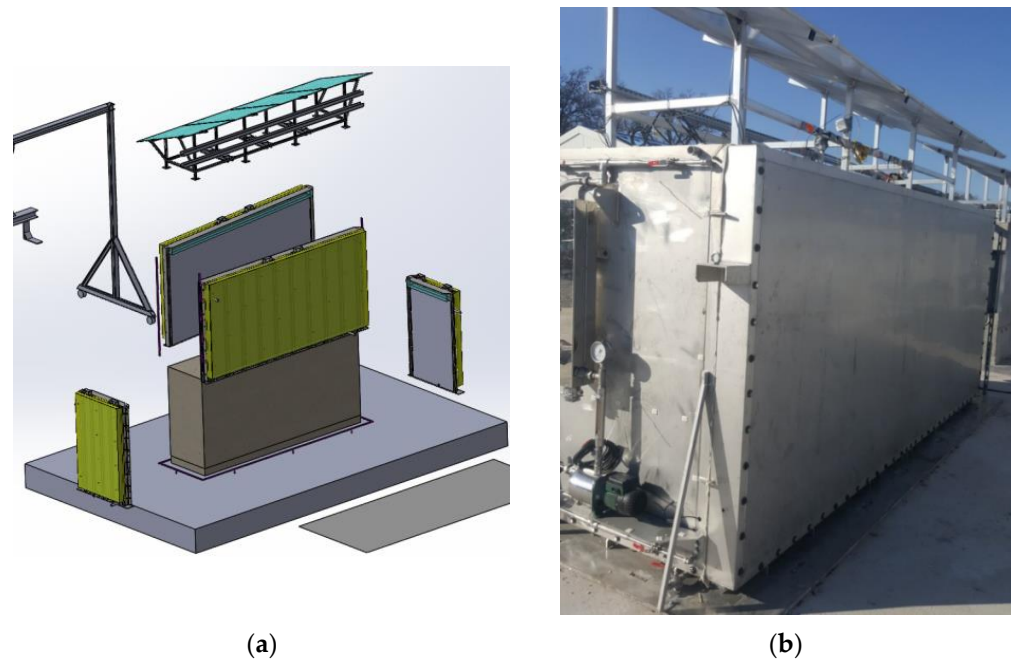
Figure 5. (a) Scheme of the pool setup used for the immersion of ODOBA blocks; (b) Picture of a pool in operation.

order to achieve this alternation of immersion/drying, the pool can be dismantled and reassembled. Indeed, as shown in Figure 5a, the four sides of the pool are easily put in place to form a watertight structure. Once filled, the pool provides a homogeneously heated water layer around the block, thanks to an integrated water circulation system (Figure 5b). In addition, an effluent treatment station allows for monitoring the quality of the water used in the pools (pH, chemical composition).

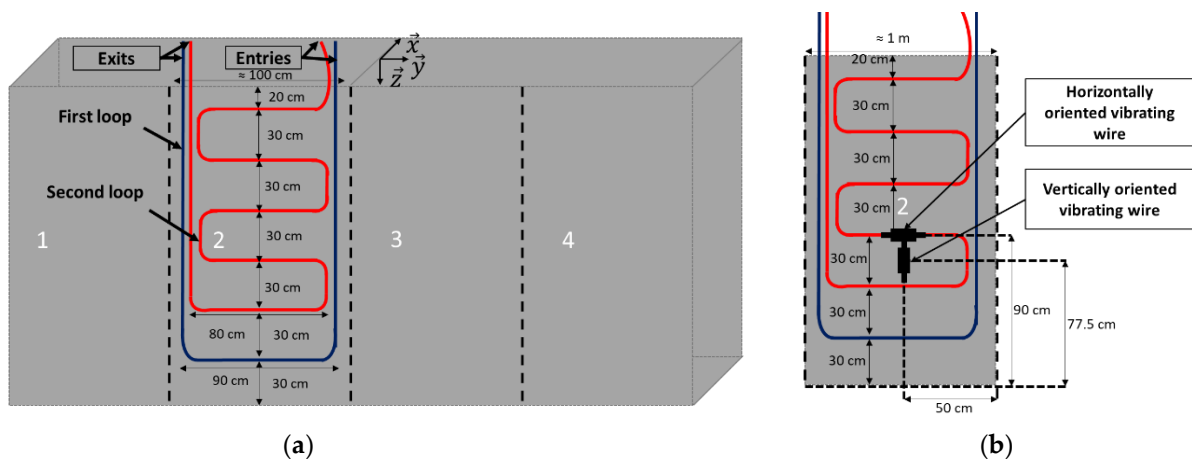
Figure 6. (a) Instrumentation scheme with bonded DOFS (b) Detail of the instrumented zone showing the two DOFS loops, and projection view of the embedded vibrating wires used for comparison.

One of the two larger sides of the block, with a surface area of $4 \times 2 \text{ m}^2$, is first divided into four identical zones (zones 1–4, see Figure 6a). Zone 2 is dedicated to receiving the bonded DOFS. The instrumentation scheme consists of two loops of DOFS cable.

The first loop (represented in blue color in Figure 6) follows the two vertical borders of zone 2 and has a horizontal portion about 30 cm above the ground level. This loop allows for the collection of the strain profiles at the two vertical borders of the instrumented zone 2, which can then be compared with the local measurements of the vertically oriented vibrating wire (VW) located halfway between the two vertical paths of the DOFS (see Figure 6b).

A second loop (red color in Figure 6) includes several horizontal paths at different heights of the block, the lowest being about 30 cm above the ground and the highest 20 cm from the top of the block. This second loop allows for the collection of the horizontal strain profiles over the whole instrumented zone and a comparison of the recorded values with the strain measurements from the horizontally oriented VW located in the same region of the block (see Figure 6b).

The concerned VWs are embedded 50 cm away from the surface of the block. Their locations in the (\vec{y}, \vec{z}) plane are shown in Figure 6b.

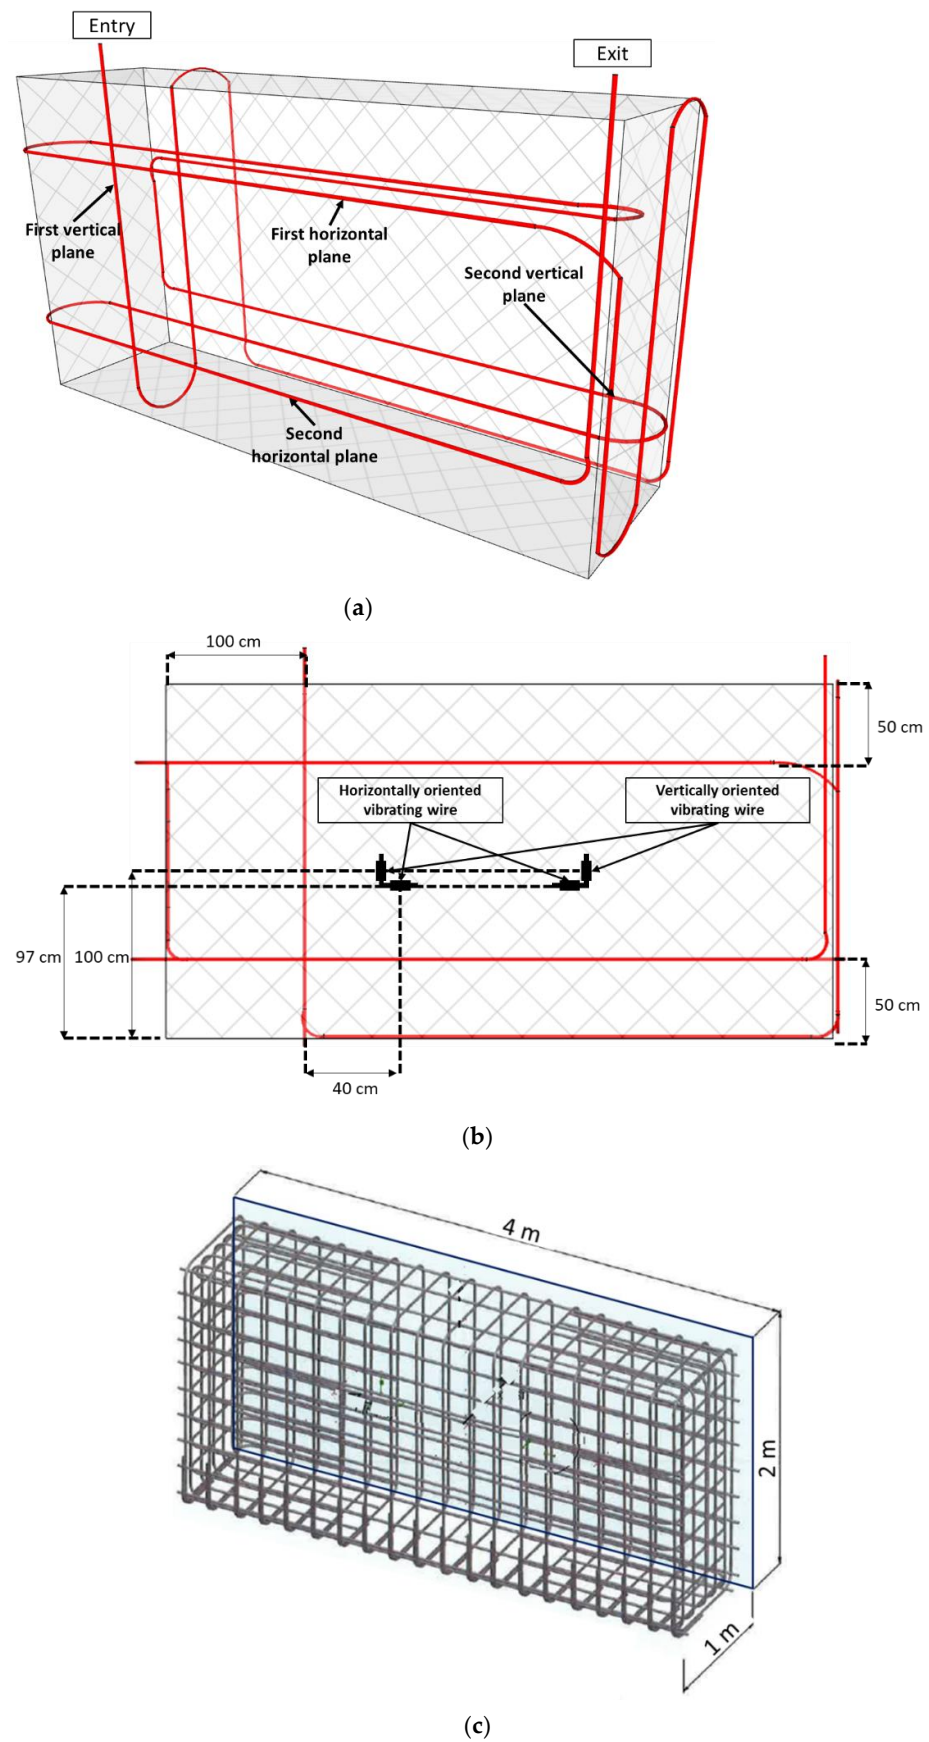
Figure 8. (a) Instrumentation scheme of RC blocks with embedded DOFS; (b) Projection view showing the horizontal/vertical positions of the embedded DOFS and vibrating wire sensors; (c) detail of the steel stirrup in RC blocks.

Unlike the previous case, the RC blocks do not contain specific metallic supports for VWs and thermocouples that could serve to fix the DOFS instrumentation. It was thus necessary to attach the DOFS cable directly to the steel stirrups and hence to adapt the internal path of the cable inside the blocks. However, the DOFS loop was still designed to pass through two vertical and two horizontal planes, as depicted in Figure 8.

Just after entering into the RC block, the DOFS cable meanders across the first vertical plane (Figure 8a). In this plane, the two descending branches of the DOFS cable are close to the steel reinforcement (see the detail of the stirrup in Figure 8c), whereas the ascending branch is distant from the steel rebars. A comparison of the strain profiles collected in these branches will thus provide relevant information about the influence of the steel reinforcement on the concrete expansion (for blocks exposed to the ageing conditions).

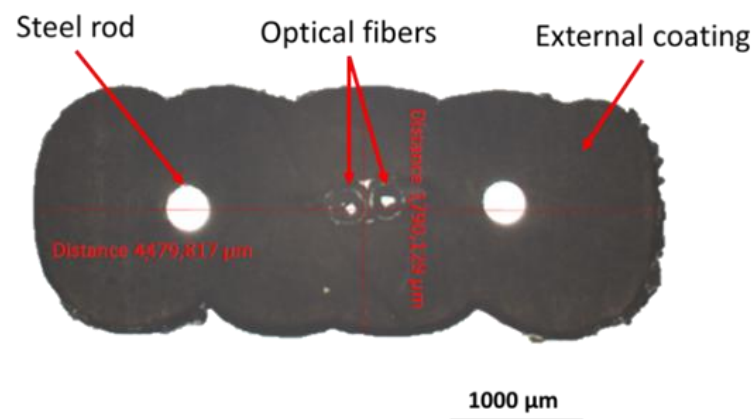
Figure 9. Cross-section of the DOFS cable, as observed by optical microscopy.

The DOFS cable considered in this study is the FutureNeuro™ FN-SILL-3 cable manufactured by Neubrex Co. Ltd. (Kobe, Japan) [26]. As illustrated in Figure 9, this cable is composed of two single-mode optical fibers (OFs) with an acrylate primary coating, two steel wires of diameter 0.3 mm, which ensure the mechanical reinforcement of the cable, and an external coating made of a soft elastomer.

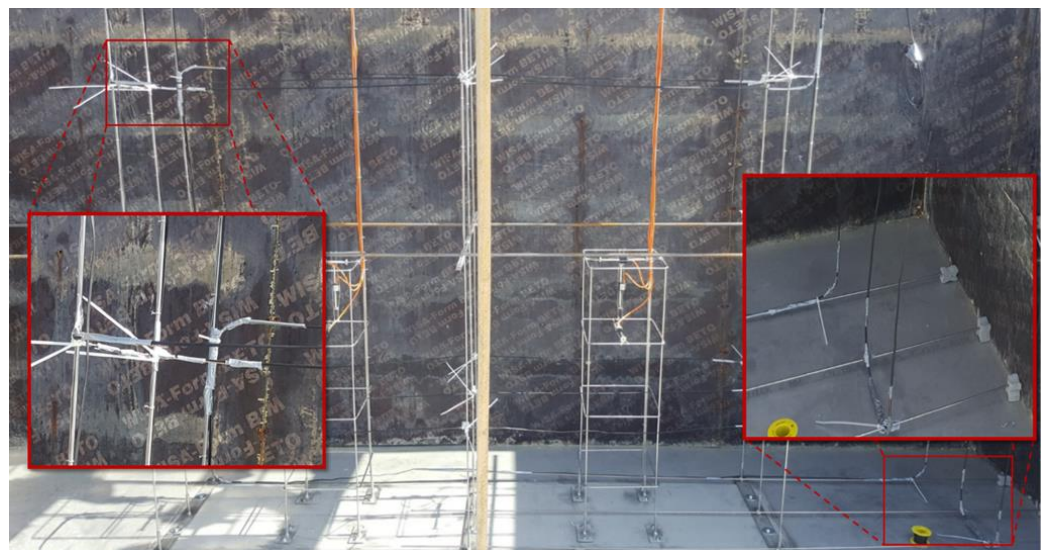
Figure 10. Instrumentation of block IA with embedded DOFS, and details of a metallic guide for curved parts (enclosed picture on the left side) and of the three metallic rods supporting the second vertical plane (enclosed picture on the right side).

The IA block was instrumented according to the scheme of NRC blocks presented in Section 3.2. In order to prevent displacements of the DOFS cable during concrete pouring, three horizontal metallic rods were added at the bottom of the formwork to support the second vertical plane of instrumentation (Cf. Figure 7). Metallic guides were also added to support the curved parts of the DOFS path in order to prevent the pinching of the cable and subsequent optical loss during interrogation. Pictures of the block instrumentation are presented in Figure 10.

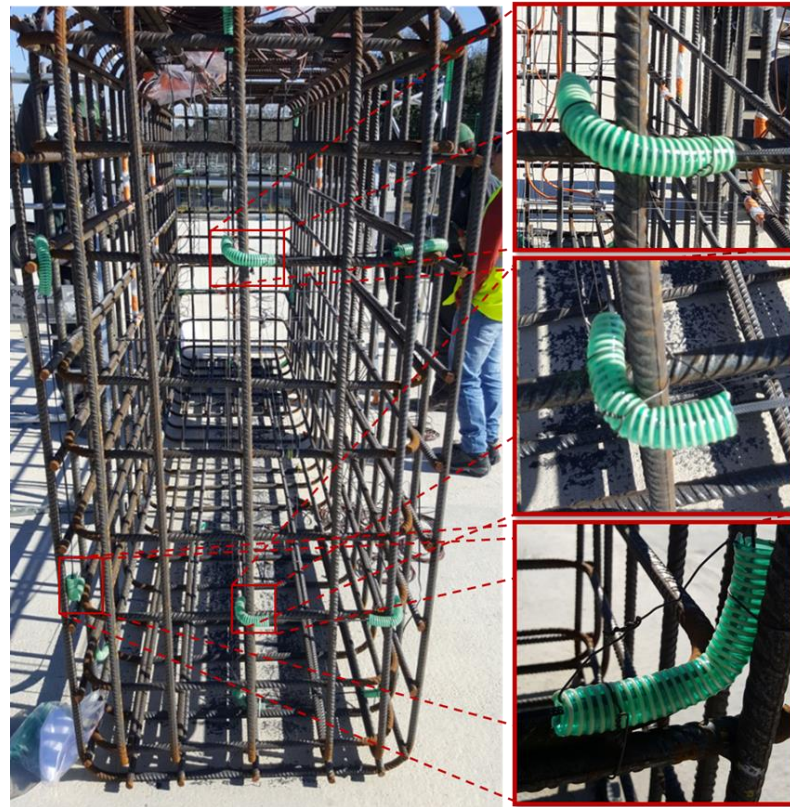
Figure 11. Instrumentation of block KB with embedded DOFS and details of cable bends around the stirrup (pictures on the right side).

of the DOFS cable around the stirrup and to avoid optical losses due to pinching, guides were again used. However, for this block, the guides consisted of plastic sheaths that ensured a bending radius greater than 4 cm. Figure 11 shows some pictures taken during the instrumentation of the KB block, including details of the cable bends (on the right side).

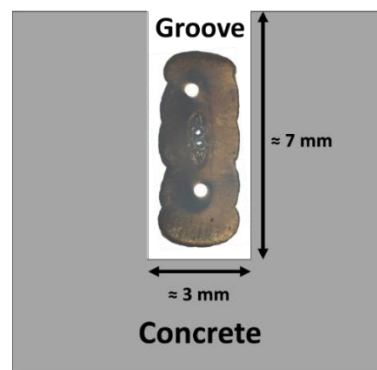
Figure 12. Positioning of the DOFS cable into the groove.

The positioning of the DOFS cable into the groove, as illustrated in Figure 12, allows for the maximization of the contact surface area between the cable and concrete and hence the adhesion at the cable/concrete interface [28,29].

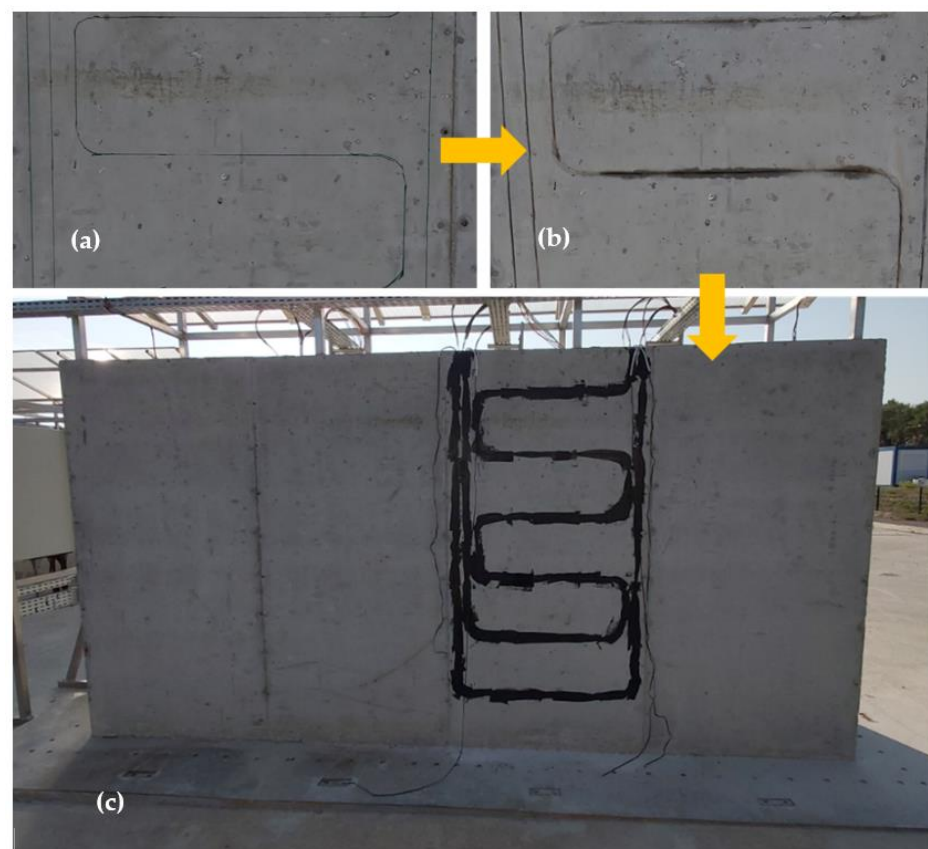
Figure 13. Installation steps of the DOFS cable at the surface of block KB. (a) Marking of the cable path at the surface of concrete (b) engraving of the groove along the path (c) insertion of the DOFS cable into the groove and application of the closing layer of X120 adhesive.

The installation steps and the final aspect of the instrumented zone are illustrated in Figure 13.

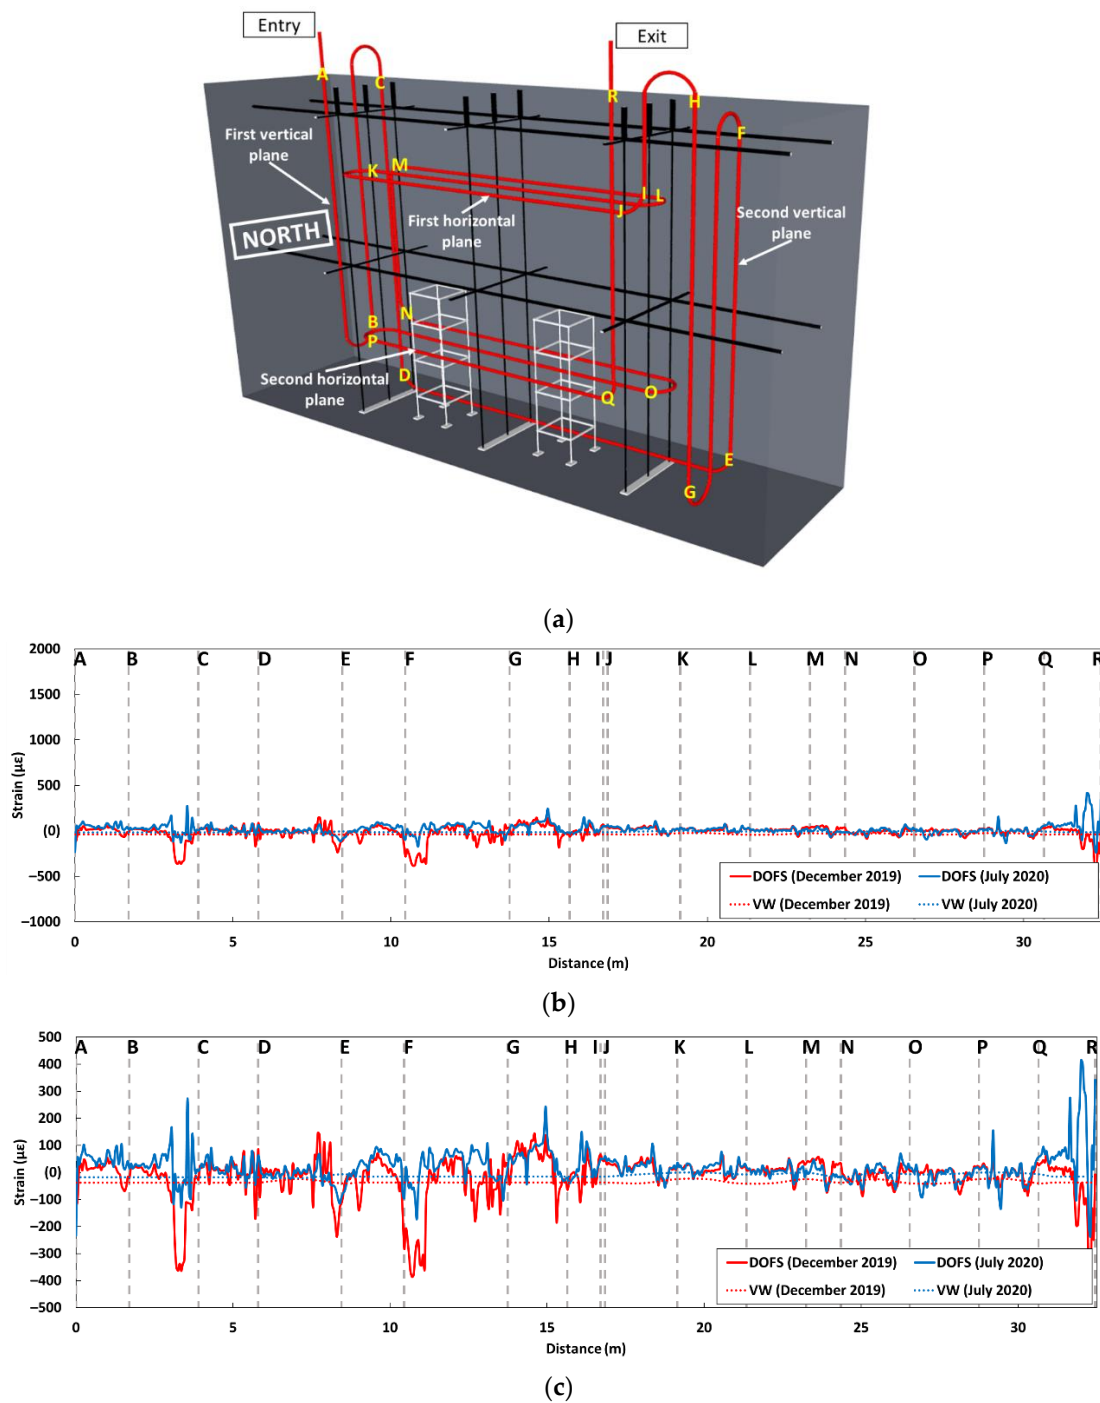
Figure 14. (a) Instrumentation scheme of the block IA with embedded DOFS, in which segments of the DOFS path are identified with alphabet letters; (b) Strain profiles along the DOFS (in solid lines) together with VW measurements (dotted lines); (c) Strain profiles at magnified y-scale.

Figure 14b displays the strain profiles using a large y-scale (ϵ -scale) that can be used in the following to compare the profiles of the two blocks IA and KB. In Figure 14c, the same profiles are displayed using a magnified scale that is more adapted to the low strain values recorded on block IA. The segments of the DOFS cable identified with letters on these profiles correspond to those previously defined in Figure 14a.

The strain profiles at both measurement times (December 2019 and July 2020) provided continuous signals along the entire length of the embedded DOFS and included the data collected from the two vertical and the two horizontal instrumentation planes (Cf. Figure 14a). The strain values recorded by the DOFS are found to be consistent with those recorded by VWs (on each considered segment of the DOFS cable, the strain values are compared to those of the nearest VW).

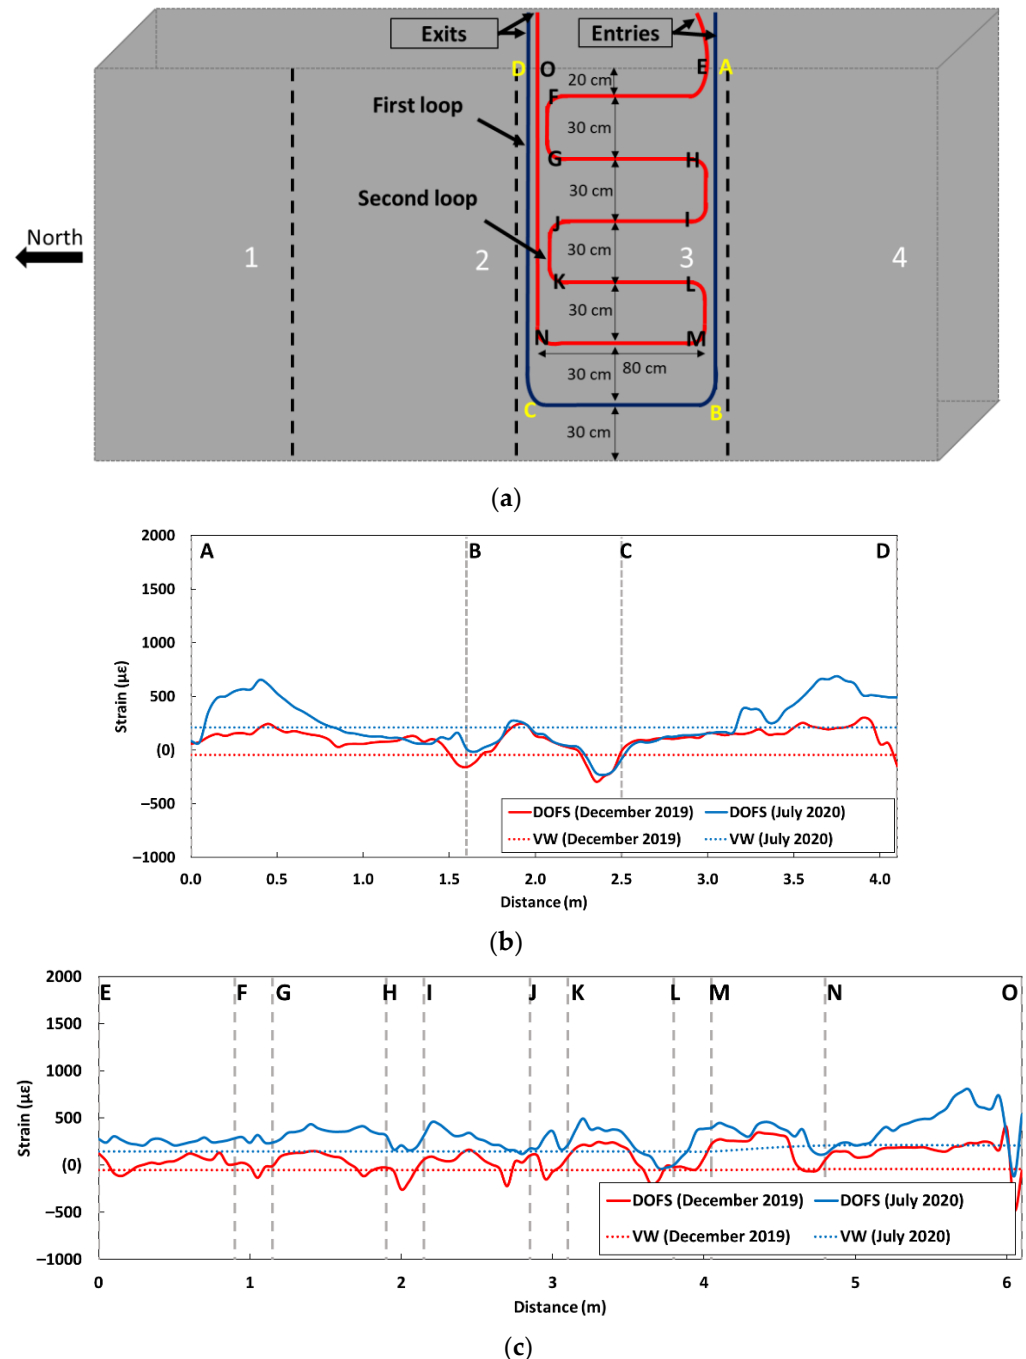
Figure 16. (a) Instrumentation scheme of the block KB with bonded DOFS, in which segments of the two DOFS loops are identified with alphabet letters; Strain profiles along the first loop (b) and the second loop (c) of the bonded DOFS cable (solid lines), together with the strain data from the nearest VWs (dotted lines).

Moreover, the profile along the second loop (see Figure 16) shows that the intensity of the strain is globally constant over the horizontal parts of the instrumented area and for all height levels.

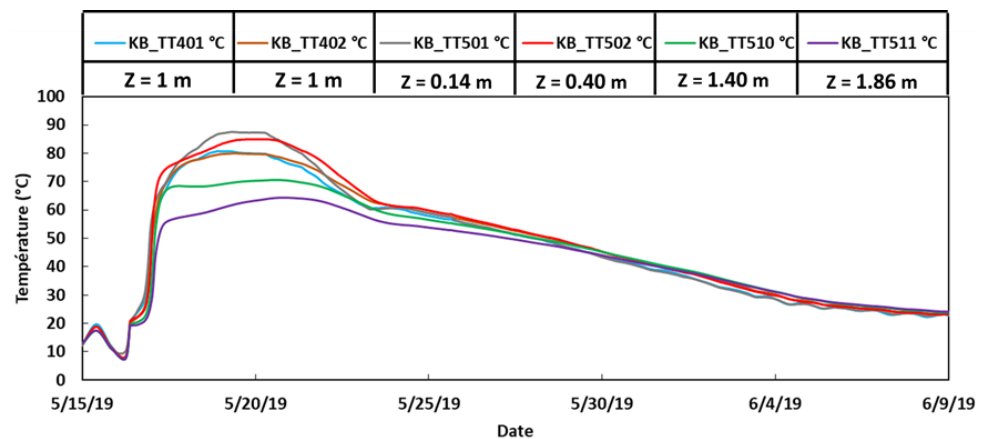
Figure 17. Temperatures recorded by selected thermocouples inside the block KB during the initial thermal treatment (z refers to the vertical position of the thermocouple, the origin of the \vec{z} axis is located at the center of the top face of the block).

In order to analyze further the previous results provided by the DOFS instrumentation, it is interesting to examine the temperatures that were recorded within the KB block during the initial thermal treatment intended to initiate the DEF. Figure 17 shows the temperature evolutions provided by several thermocouples located at different heights of the block during the 3-week thermal treatment from 15 May to 9 June 2019. From this graph, it is found that the maximum temperature reached during the heat treatment was around 80–85 °C in the upper part of the block, whereas it was much lower (around 65–70 °C) in the bottom part of the block. Considering this vertical temperature gradient at an early age, and hence the effective thermal energy gradient created [34], it could be expected that the DEF pathology would develop first in the upper part of the KB block. This is very consistent with the strain measurements provided by the embedded DOFS in July 2020, which revealed a significantly higher expansion of concrete in the upper part of the KB block, suggesting the higher kinetics of DEF in this region of the block.
