## Uncovering a 70-year-old permafrost degradation induced disaster in the Arctic, the 1952 Niiortuut landslide-tsunami in central West Greenland

# Uncovering a 70-year-old permafrost degradation induced disaster in the Arctic, the 1952 Niiortuut landslide-tsunami in central West Greenland

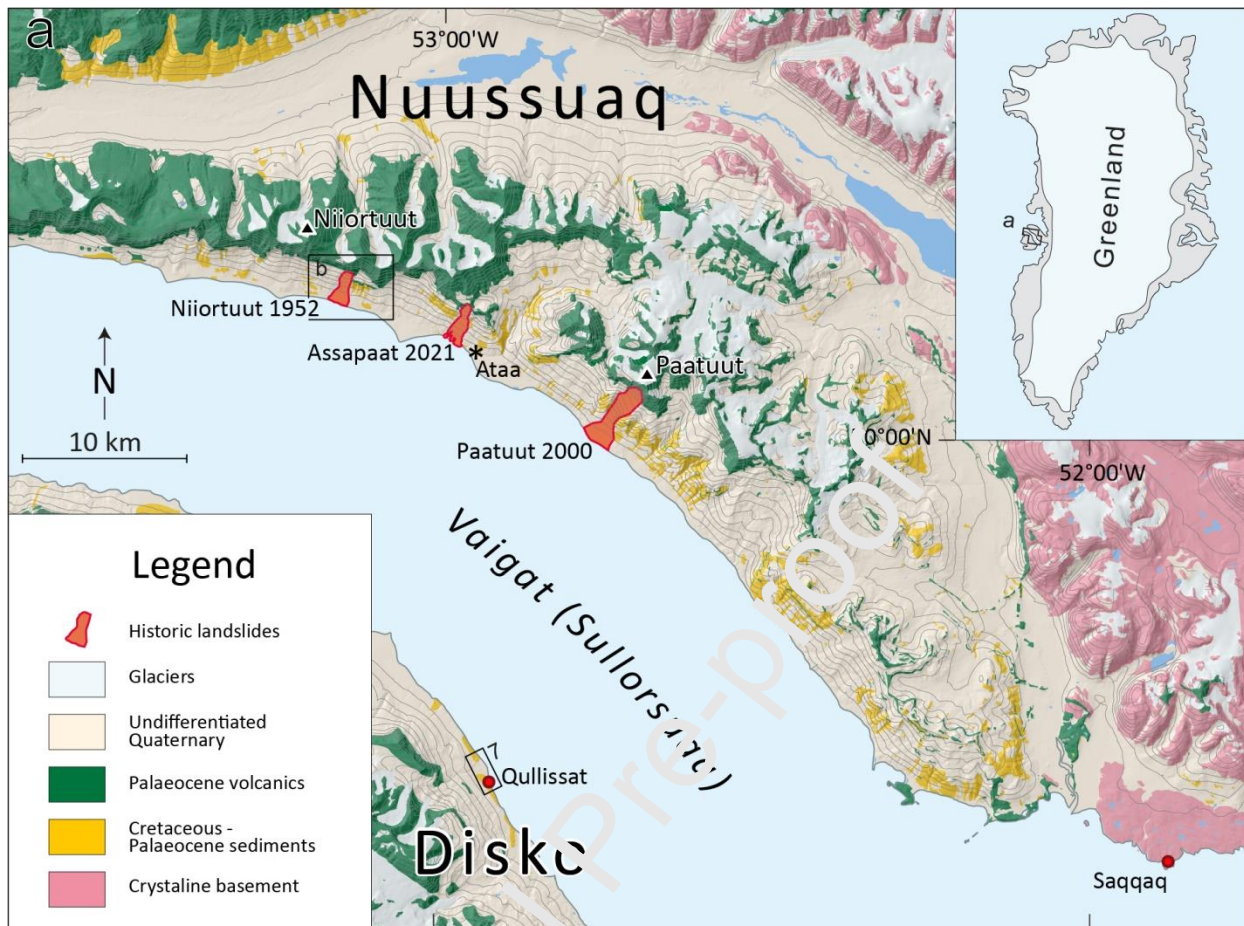
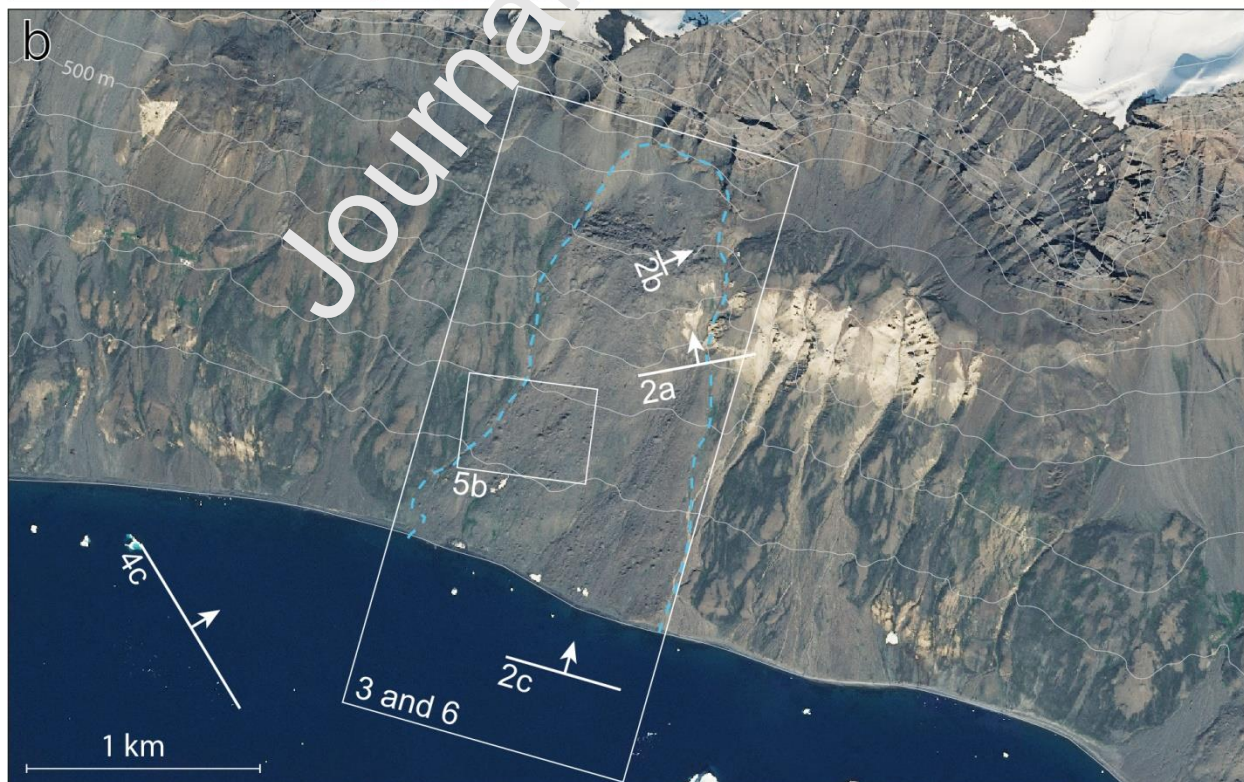
*Figure 1 (1/1 page) a) Simplified geological map of the Vaigat area based on the 1:100 000 scale geological maps from GEUS (Rosenkrantz et al., 1976; Pedersen et al., 2001, 2007). Historical landslides are shown along with place names mentioned in the text and position of Fig. 1b and Fig. 7. The estimated position of where the fisherman died is shown with a \* at Ataa. b) orthofoto of the area of the landslide from the Danish Agency for Data Supply and Infrastructure (SDFI) from 2016. The onshore part of the landslide is shown with stipled blue outline. The positions of photos in Fig. 2 and 5 are shown along with the detailed maps in Figs. 3 and 6.*

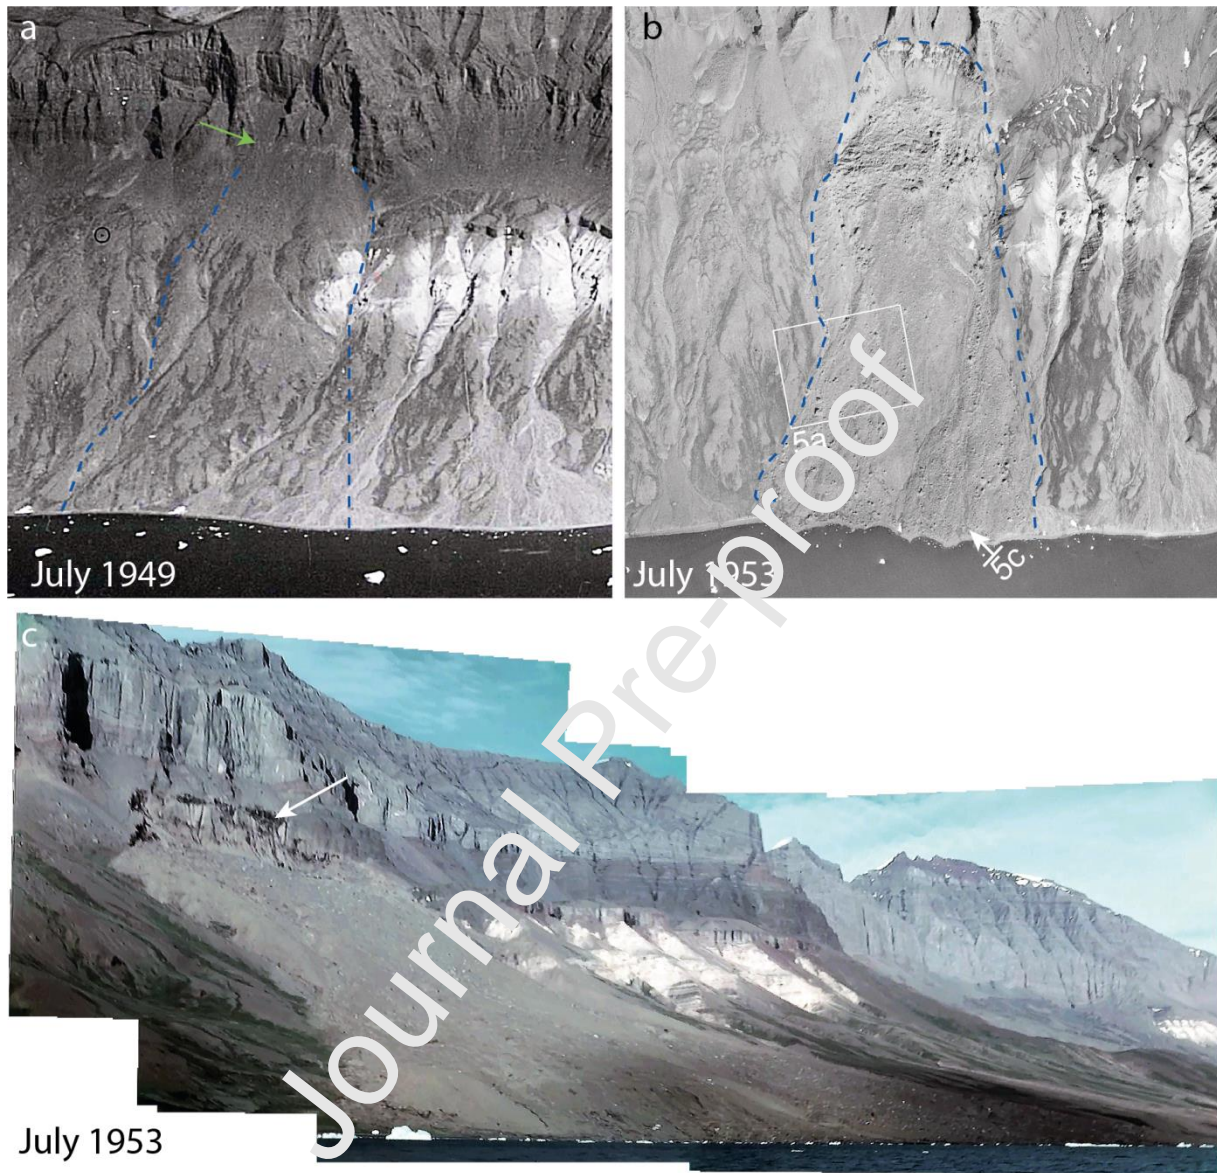
Figure 4. [two column width] Historical images. a) Extract of oblique aerial photograph recorded in July 1949 showing the coastal slope 3½ year before the landslide. Notice the light grey lineament at the top of the talus slope (green arrow) coinciding with the top of the future 1952 Niiortuut landslide. The lateral extent of the landslide is shown with blue stippled lines. b) Extract of a July 1953 1:45 000 scale aerial image (not orthorectified) from ½ a year after the landslide. Outline of the landslide is indicated with blue stippled line. Positions of photos in Fig. 5 is shown. c) Photomosaic compiled of frames from a 16 mm colour film recorded on July 29<sup>th</sup>, 1953. Notice the dark coloration in the backscarp indicated with a white arrow. Viewing direction is towards the north-east. See Fig. 1b for position.

Analysis of the oblique aerial photos from 24<sup>th</sup> July 1949 – three-and-a-half year prior to the landslide – shows a light lineament, which is an incipient backscarp in the talus slope below the 60° steep cliff (Fig. 4a). In the field, we have observed similar structures in several talus slopes on the south coast of Nuussuaq. The light lineament is 9 to 22 m long (downslope). The upper part of the slope, from 650 to 200 m had a pre slide gradient of 30° and the lower 200 m a gradient of about 15°.

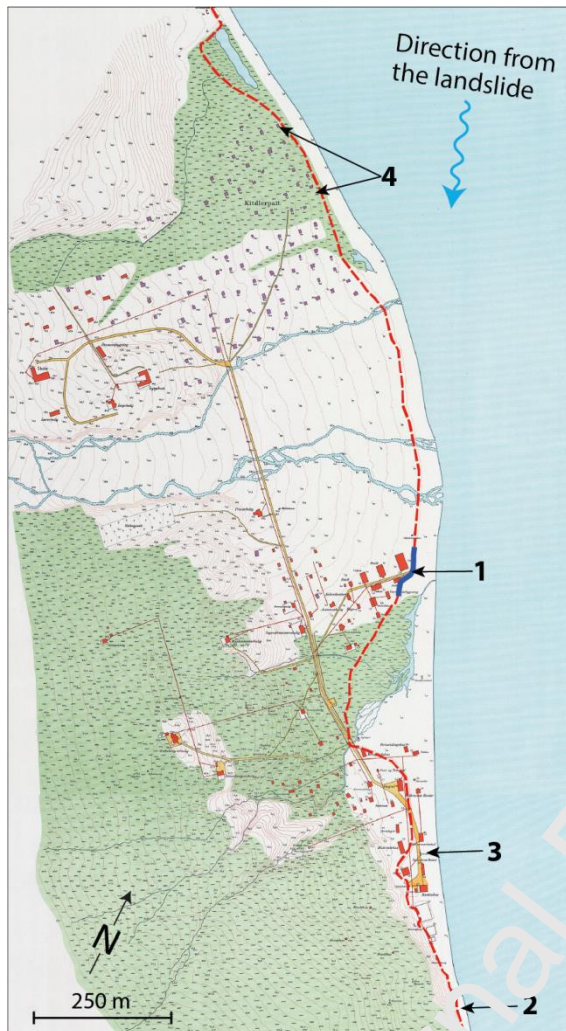
Figure 7 [single column width, text to the side or below] Observed (blue) and inferred (red) runup marked along the 2.5 m contour from the 1952 Niiortut landslide-tsunami in Qullissat. 1 shows the position of eyewitness Hans Anton Lynge, 2 the approximate position of the driver Hans Møller and 3 the position of the coal crane and power plant that was reported damaged during the tsunami. 4 marks the position of the lowermost houses in the northern part of the town that were presumably not inundated. The direction from the landslide is shown with a blue wavy arrow in the upper left corner. Background map is an extract of a topographical map of the town surveyed in 1948, published in 1950. Red polygons on the map are public buildings and purple are private houses. See Fig. 1a for location.

The tsunami's impact on the town of Qullissat is described in *Avangnâmiok*, based on eyewitness accounts of the driver Hans Møller, who was in his car on the way to the mine entrance south of town when the first wave hit (Fig. 7). According to Møller, the mass of water was enormous. The waves washed fish that seemed to be halibut up onto the road to the mine. These fish are usually found in

deep water far from the coast. Møller mentioned that there were several waves, of which the third one was the largest, powerful enough to wash up ice and debris into his car. Records of the damages to the infrastructures in the community are limited. Eyewitness Frederik (Fari) Mathiassen says that no buildings were damaged following the event, but that water entered the power plant, located at 2 m elevation above msl in the southern part of the town (Fig. 7). Unconfirmed word of mouth accounts mention that the concrete foundation of a coal crane at 1.7 m elevation above msl on the beach was damaged (Fig. 7).

Based on the above records we estimate that the tsunami runup was 2 - 2.5 m above msl in southern Qullissat. Compensating for the low tide of presumably -0.2 m gives a total runup height of 2.2 - 2.7 m here. We have not found any records of tsunami runups in northern Qullissat, where we would have expected a higher runup, as this section of the coast is more exposed towards the direction of the landslide (Fig. 7). The northern part of the town has exclusively private houses, which were located above 5 metres elevation at the time of the event. The lowermost two houses were at 3.1 m and 3.5 m above msl respectively (marked 4 in Fig. 7). We can assume that here, the wave runup was lower than 3.1 m, as damage to these houses would presumably have been reported.
