## Uncovering a 70-year-old permafrost degradation induced disaster in the Arctic, the 1952 Niiortuut landslide-tsunami in central West Greenland

# Uncovering a 70-year-old permafrost degradation induced disaster in the Arctic, the 1952 Niiortuut landslide-tsunami in central West Greenland

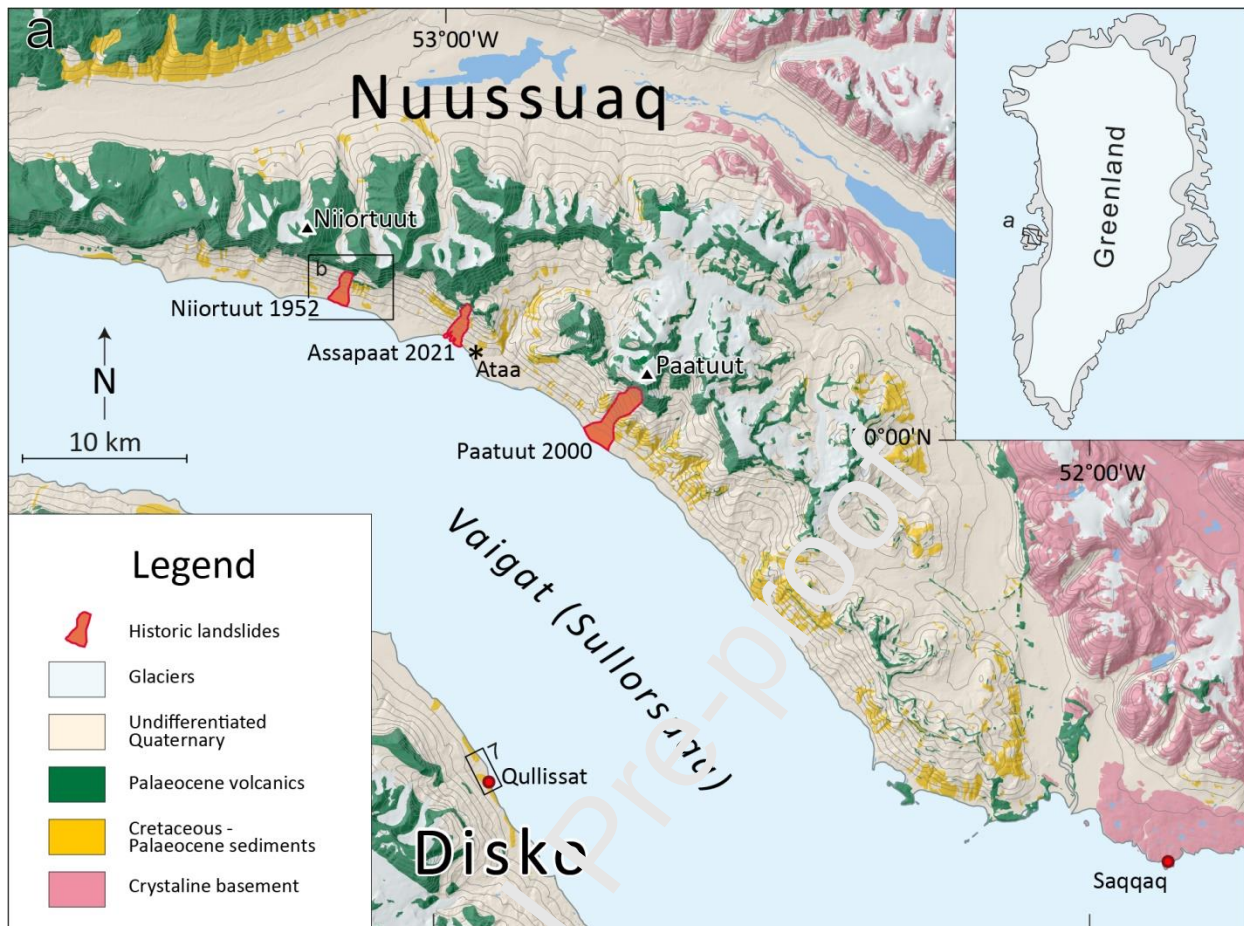
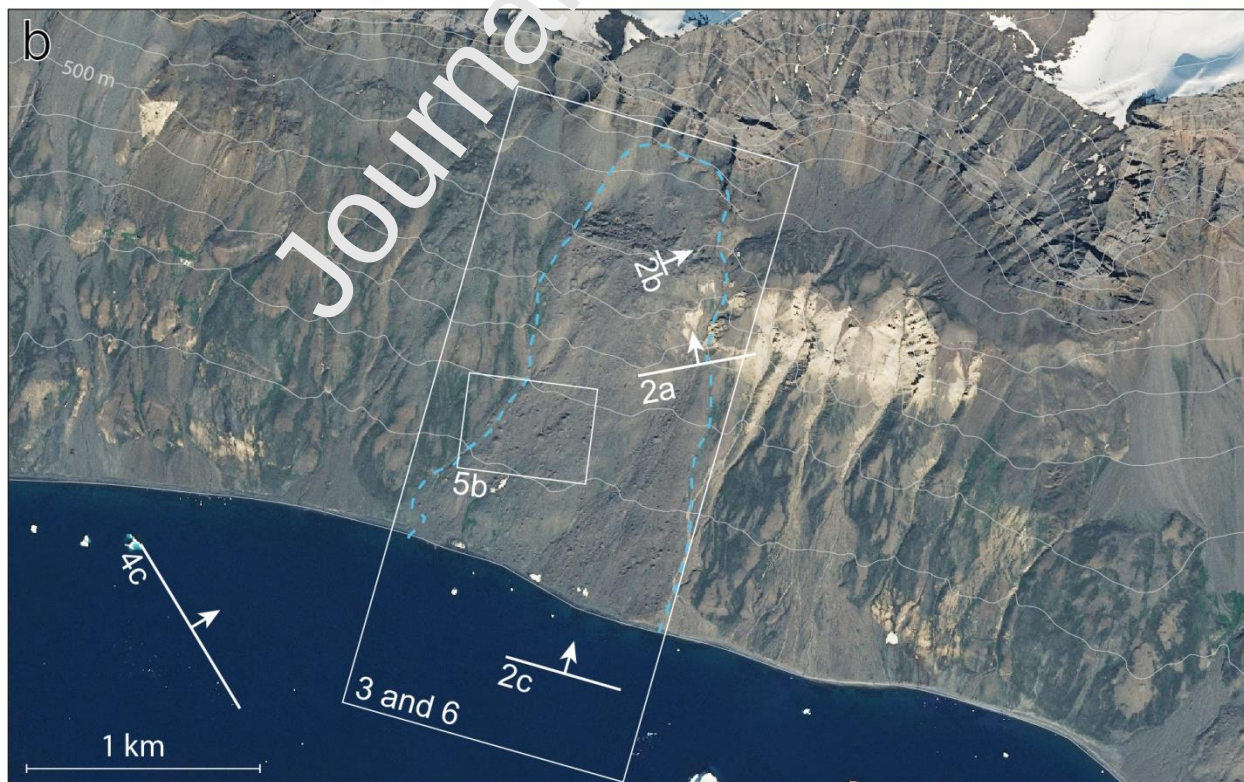
*Figure 1 (1/1 page) a) Simplified geological map of the Vaigat area based on the 1:100 000 scale geological maps from GEUS (Rosenkrantz et al., 1976; Pedersen et al., 2001, 2007). Historical landslides are shown along with place names mentioned in the text and position of Fig. 1b and Fig. 7. The estimated position of where the fisherman died is shown with a \* at Ataa. b) orthofoto of the area of the landslide from the Danish Agency for Data Supply and Infrastructure (SDFI) from 2016. The onshore part of the landslide is shown with stipled blue outline. The positions of photos in Fig. 2 and 5 are shown along with the detailed maps in Figs. 3 and 6.*

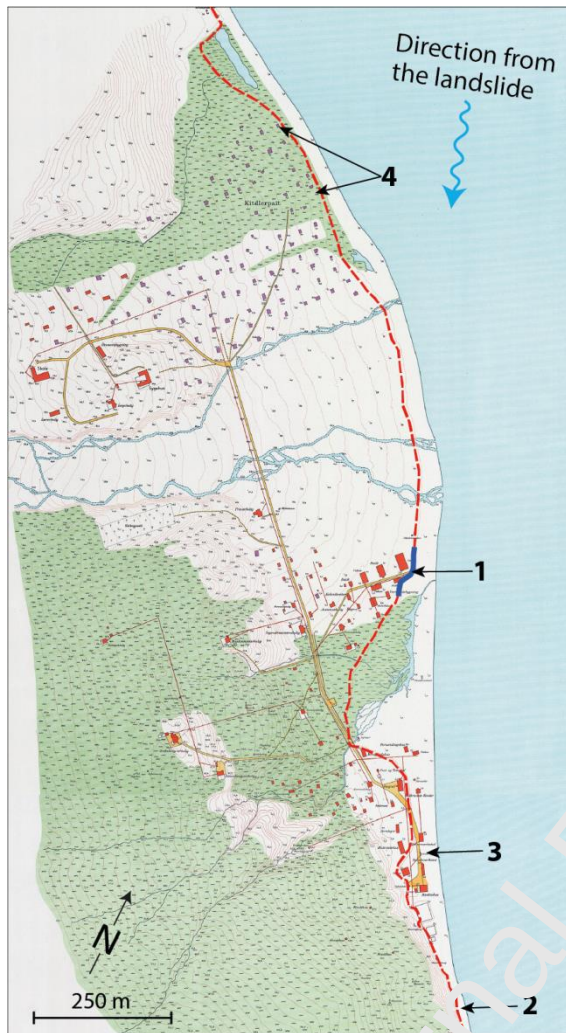
Figure 7 [single column width, text to the side or below] Observed (blue) and inferred (red) runup marked along the 2.5 m contour from the 1952 Niiortut landslide-tsunami in Qullissat. 1 shows the position of eyewitness Hans Anton Lynge, 2 the approximate position of the driver Hans Møller and 3 the position of the coal crane and power plant that was reported damaged during the tsunami. 4 marks the position of the lowermost houses in the northern part of the town that were presumably not inundated. The direction from the landslide is shown with a blue wavy arrow in the upper left corner. Background map is an extract of a topographical map of the town surveyed in 1948, published in 1950. Red polygons on the map are public buildings and purple are private houses. See Fig. 1a for location.

The tsunami's impact on the town of Qullissat is described in *Avangnâmiok*, based on eyewitness accounts of the driver Hans Møller, who was in his car on the way to the mine entrance south of town when the first wave hit (Fig. 7). According to Møller, the mass of water was enormous. The waves washed fish that seemed to be halibut up onto the road to the mine. These fish are usually found in

deep water far from the coast. Møller mentioned that there were several waves, of which the third one was the largest, powerful enough to wash up ice and debris into his car. Records of the damages to the infrastructures in the community are limited. Eyewitness Frederik (Fari) Mathiassen says that no buildings were damaged following the event, but that water entered the power plant, located at 2 m elevation above msl in the southern part of the town (Fig. 7). Unconfirmed word of mouth accounts mention that the concrete foundation of a coal crane at 1.7 m elevation above msl on the beach was damaged (Fig. 7).

Based on the above records we estimate that the tsunami runup was 2 - 2.5 m above msl in southern Qullissat. Compensating for the low tide of presumably -0.2 m gives a total runup height of 2.2 - 2.7 m here. We have not found any records of tsunami runups in northern Qullissat, where we would have expected a higher runup, as this section of the coast is more exposed towards the direction of the landslide (Fig. 7). The northern part of the town has exclusively private houses, which were located above 5 metres elevation at the time of the event. The lowermost two houses were at 3.1 m and 3.5 m above msl respectively (marked 4 in Fig. 7). We can assume that here, the wave runup was lower than 3.1 m, as damage to these houses would presumably have been reported.
