Mechanical Defects Detection on Solar Panel with Ultrasonic Guided Waves

16^{ème} Congrès Français d'Acoustique
11-15 Avril 2022, Marseille

Crack detection on solar photovoltaic module with ultrasonic guided waves

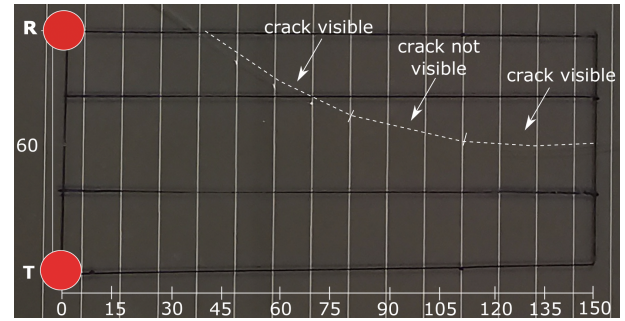
To investigate the interaction of ultrasound signals with damages within the structure, a section that contains cracks was chosen. In the selected section as shown in Figure 3, there exists a region with fine crack that is barely visible with eyes, which becomes the area of significant interest for a non-destructive evaluation. The distance between transducers was 60 mm and scanning length was 150 mm. At the position of 0 to 30 mm, there is no defect between transmitter and receiver. Between 30 mm and 75 mm there is visible crack that runs from the receiver scanning line to the middle of the investigated area. The other visible crack appears from 105 mm. However, those two visible cracks are suspected to be of one long crack, with the intermediate portion (75 mm to 105 mm) being a fine crack not detectable with visual inspection.

FIGURE 3 – Investigated area in the experiment of guided waves interaction with defects (Red T, R : transmitter and receiver starting position; scanning motion to the right; numbers are measurements in mm)

As mentioned earlier, the investigated area contains a section with fine crack not visible with visual inspection. This section (from 75 mm to 105 mm) shows high wavelet coefficient and lower phase velocity, as one can infer from Figure 8 (c) and (d). Therefore, UGW was able to detect that visually invisible crack.

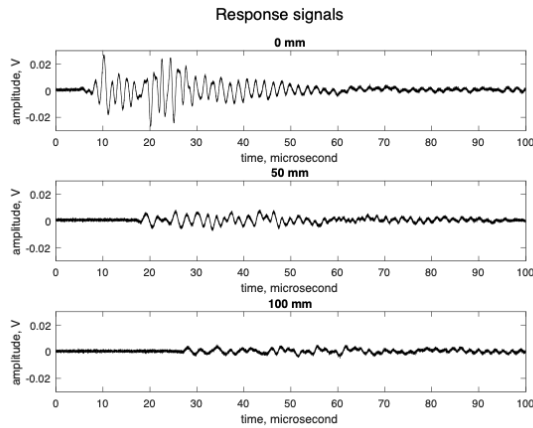
The signal in Figure 5 is a response on the receiver at a distance of 30 mm, 80 mm and 130 mm, respectively, from the transmitter. It demonstrates the change in waveform over the distance as it propagates in a dispersive medium.

FIGURE 5 – Signal waveforms at 3 points of different distance from transmitter : 30 mm, 80 mm and 130 mm

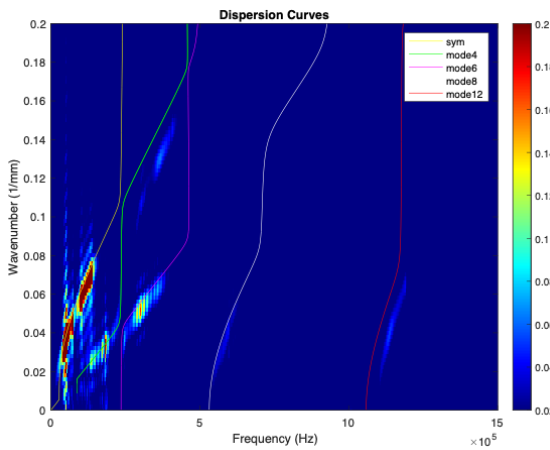
To construct dispersion curves, 2D Fourier transform technique [7] was applied to time signals of the series of equally spaced distances which, acquired from the experiment. The intensity of the Fourier spectrum, represented by the color-scaled image in Figure 6, is distributed across the plot of frequency (f) versus wavenumber (k).

Numerical simulation yields dispersion curves that are overlaid in Figure 6 as continuous curved lines, with mode numbers automatically assigned by DISPERSE software. Referring to those lines, one can identify to which modes each high intensity color scale belongs to. In addition, the curves produced by numerical simulation closely match the actual propagating modes constructed from measurement data, which means that the model satisfactorily represents the real PVM specimen.

FIGURE 6 – Dispersion curves (color scaled image : experimental results ; lines : numerical results)

Based on the hypothesis that there will be velocity changes or mode conversion upon encountering defects, the time-frequency distribution obtained from the undamaged area as depicted in Figure 7 will be different with those from defective areas. In other words, one will expect that the appearance of certain frequency can shift in time domain because of the change in velocity, if there is defect on its path. To allow observation on arrival time of a certain frequency at different points, the time series of a selected frequency in a time-frequency diagram is extracted and plotted for all position along scanning length. It creates a diagram that indicates the time of arrival of a particular frequency at every measurement position. Figure 8 (a) to (d) present the diagram for frequency of 140 kHz, 200 kHz, 300 kHz and 400 kHz. Those four frequencies are selected since they have possibilities of belonging to different modes according to the dispersion curves in Figure 6. Therefore, mode conversion can be observed if it occurs.
