# Impacts of protection decisions and actions on the morphological evolution of the Thonon-les-Bains shoreline (France, Haute-Savoie)

Véronique Maleval, Pierre-Brieuc Destombes. Impacts of protection decisions and actions on the morphological evolution of the Thonon-les-Bains shoreline (France, Haute-Savoie). *Géomorphologie : relief, processus, environnement*, 2022, 28 (1), pp.3-12. 10.4000/geomorphologie.16285 . hal-03855866

# **Impacts of protection decisions and actions on the morphological evolution of the Thonon-les-Bains shoreline (France, Haute-Savoie)**

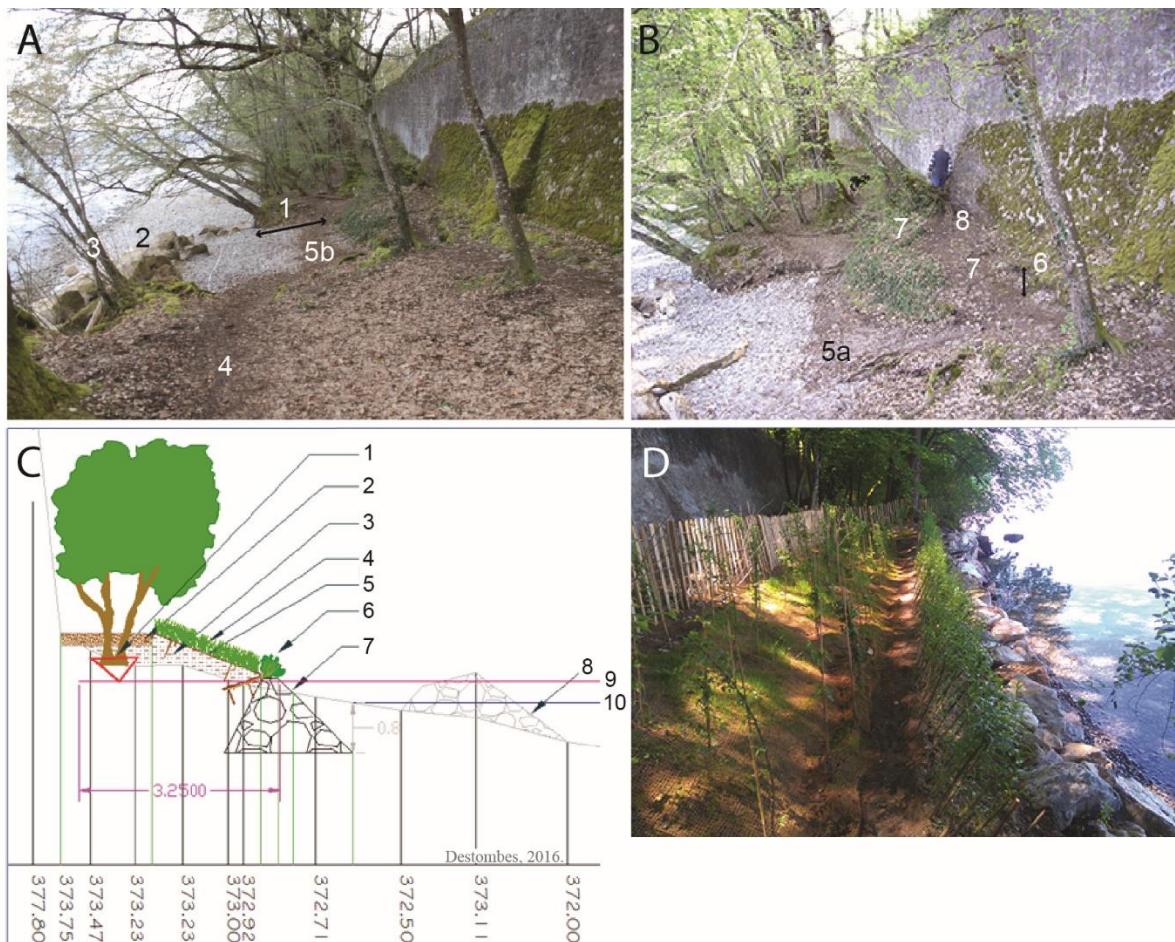
**Fig. 2 - The restored section of Ripaille**

A: photo of April 2016 (P.B. Destombes); B: photo of November 2013 (V. Maleval).

The falling tree (1) presents a protrusion of 1.7 m. Nevertheless, it would seem that the remains of the riprap structure (2), denoting an earlier shoreline, show even greater erosion; the trees located just at the back (3), protected until now, seem to corroborate this, especially as behind them a second path (4) has been trodden. This hypothesis, supported by the November 2013 photo which shows the presence of a lamina on the ground (5a) which, two and a half years later has become somewhat stripped (5b), is likely to disappear altogether. This analysis clearly shows that the development of hard protective structures without any other maintenance is not sufficient to stop erosion. Damage to the pathway can be observed by the presence of a tiny hillock (6), revealed tree roots (7) and the creation of micro-gullies (8), resulting from both footfall and water run-off.

C: technical drawing.

1. Tree in the middle of the past: felling and stump removal;
2. Compacted of 30/70 earth/stone mix down to 30 cm;
3. Infill with the compacted 70/30 earth/stone mix;
4. Planting of the

working area under geotextile sheet; 5. Biodegradable 740 gm/m<sup>2</sup> geotextile sheet including anchor staples; 6. Bed of plants and sets; 7. Rocky structure; 8. Re-use of boulders in situ; 9. Public Fluvial Domain; 10. Highest waters: 372.62 m.

D: photo of May 2017 (P.B. Destombes).

The refurbished shoreline presents a vegetalised rocky area on the surface with two tree species, grasses (70 %) and flowers (30 %), which are suitable to hydromorphic environments (willow, hedge maple, common dogwood, guelder rose, red fescue, birds foot trefoil, bladder campion, black medick, red clover, etc.). Root growth is designed to enhance the structural hold of the ensemble and, as a result of the shoreline. The pathway is located between the Ripaille wall and the wooden-slat fence which is there to direct (sometimes ill-disciplined) walkers. Certainly, ‘nothing (from grains of sand to grasses) is naturally in its place and human activity controls their life cycle (Lespez & Dufour, 2020, p. 30), but the shoreline has now been restored by renaturation.

The estate of the Château de Ripaille is separated from the shoreline by an old stone wall 1.6 km long (location in Fig. 1). Over a 17 m stretch (Fig. 1), the shoreline is severely eroded by people using the path, but also to ravine and lake erosion (Fig. 2A, B). In fact, to avoid further degradation that could lead to the wall collapsing, this section was refurbished in 2016-2017 applying eco-engineering techniques (fig. 2C). This involved combining riprap and vegetation when planting alone is not sufficient to protect and stabilise a shoreline (*Office québécois de la langue française*, 2010). These techniques have less impact on the landscape (Fig. 2D), as it provides a planted transition between the aquatic and terrestrial environments (Verniers, 1995), unlike hard landscaping which breaks the ecological continuum (EROSEE, 2006). Vegetation also protects the shoreline against wave damage (Gagnon and Gangbazo, 2007). A feasibility study was carried out by a consultancy firm (Destombes, 2016) to determine the altimeter setting and the hydraulic and morphological stresses on the structure.

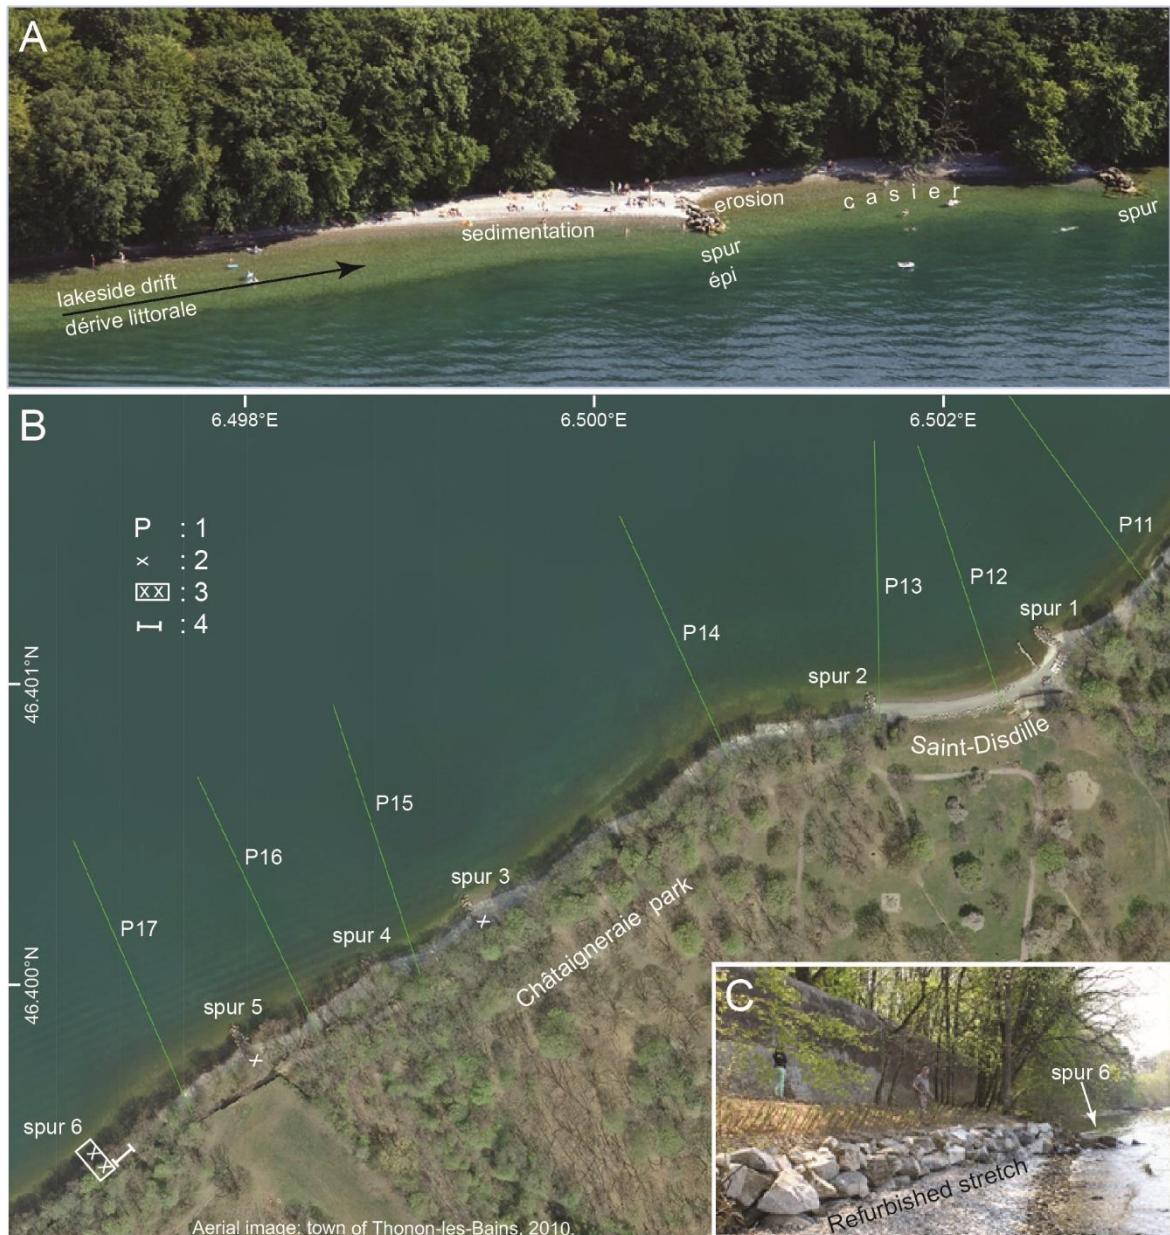
**Fig. 3 - Site of spurs removal and reinforcement**

A: photo of summer 2004 (CIPEL).

Whilst the sedimentation deposit increases the size of the beach located upstream of the spur, the downstream part, deprived of most of the sediment, has contracted.

B: aerial image.

1. Profile; 2. Removal; 3. Reinforcement; 4. Refurbished stretch. Most of the communal spurs were refurbished in the 1980s. The distance between spurs 3 and 4 is 55 m, and between 5 and 6, 68 m. The works to remove spurs 3 and 5 took 15 days in October 2018. Blocks strengthened spur 6 (L25 m x 14 m x h1.25 m) to reinforce the shoreline refurbished in 2017. The sediment

deposited upstream of the removed spur was left in place to be naturally integrated into the lakeside drift.

C: photo of October 2017 (P.B. Destombes).

Before it was reinforced using the removed spur materials, spur 6 was dilapidated through lack of maintenance.

As on many beaches, spurs were built during the 20th century to protect structures just behind the shoreline (one of the oldest is in front of the Château de Ripaille, visible on aerial images from 1927). Positioned perpendicular to the shoreline, they naturally retain sediments transported by the drift, and traps located between two spurs catch man-made sediments (fig. 3A). Once extraction at the mouth of the Dranse had ceased, Thonon municipality sought to facilitate sediment circulation by coastal drift by removing unnecessary spurs. The feasibility study (Destombes, 2018) looked at the general layout of the spurs and potential difficulties, and projected the consequences of their removal. This study focused on Châtaigneraie Park and the Ripaille wall shoreline (location in part 1. fig. 1), subject to a NE-SW drift (Maleval *et al.*, 2016), disturbed by four spurs (spurs 3 to 6). This shoreline has a micro-cliff of about 60 cm but, some years, it can be protected by the deposition of pebble strips (Maleval *et al.*, 2016). The study led to the removal of spurs 3 and 5, the materials of which ( $150 \text{ m}^3$ ) were used to reinforce spur 6 (Fig. 3B). This spur is located just downstream of the section refurbished in 2017 (fig. 3C). The purpose of the reinforcement is to provide aggradation to protect the planted vegetation while its root system develops and strengthens the shoreline.

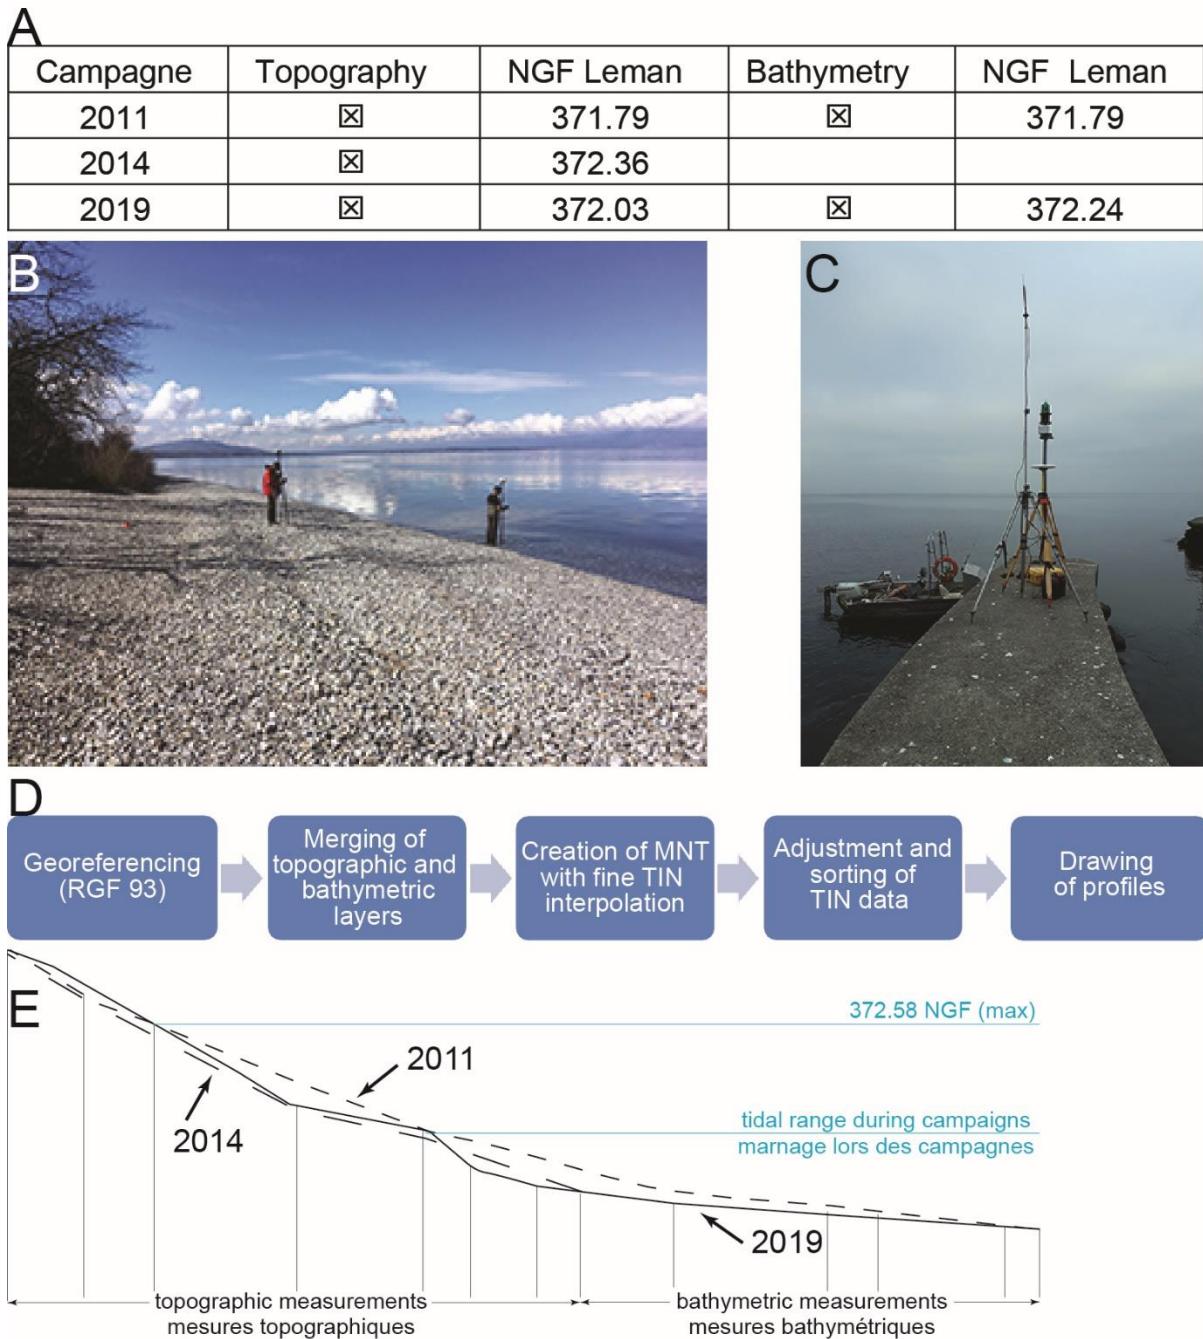
**Fig. 4 - Methodological protocol of the study**

A: tab. 1 of the characteristics of measurement campaigns; B: topographical measurements (P.B. Destombes, April 2019); C: bathymetric measurements (Bathys); D: processing of data; E: typical profile to understand the lakeside evolution: erosion and sedimentation.

The topographical profiles, with lengths between 19 m (profile 44) and 36 m (profile 42), were extended by bathymetric profiles, over 140 m on average from a boat using 3D echo-sounding (the time for the wave to come back allows depth to be interpreted). The processing of data showed the morphological tracing for each year.

Of Thonon's 8.5 km shoreline (Fig. 1), 3.8 km were studied; the rest being private and/or urbanised (e.g. the lake front of the Ripaille quay). To determine the morphological evolution of the shoreline, three measurement campaigns were undertaken: in 2011, 2014 and 2019 (fig. 4A). Topographic and bathymetric surveys were carried out on 47 transects (Maleval *et al.*, 2016) (Fig. 4B, C). All measurements (terrestrial and sublacustrine, for the three years) were georeferenced in Lambert 93 for processing in *AutoCad* and *QGis* software (Fig. 4D). The Profile comparisons made it possible to determine the speed of change of the shoreline with Lake Geneva at its fullest (372.58 NGF), and to appreciate the changes in the shape of the micro-cliffs and beaches over the years (fig. 4E).

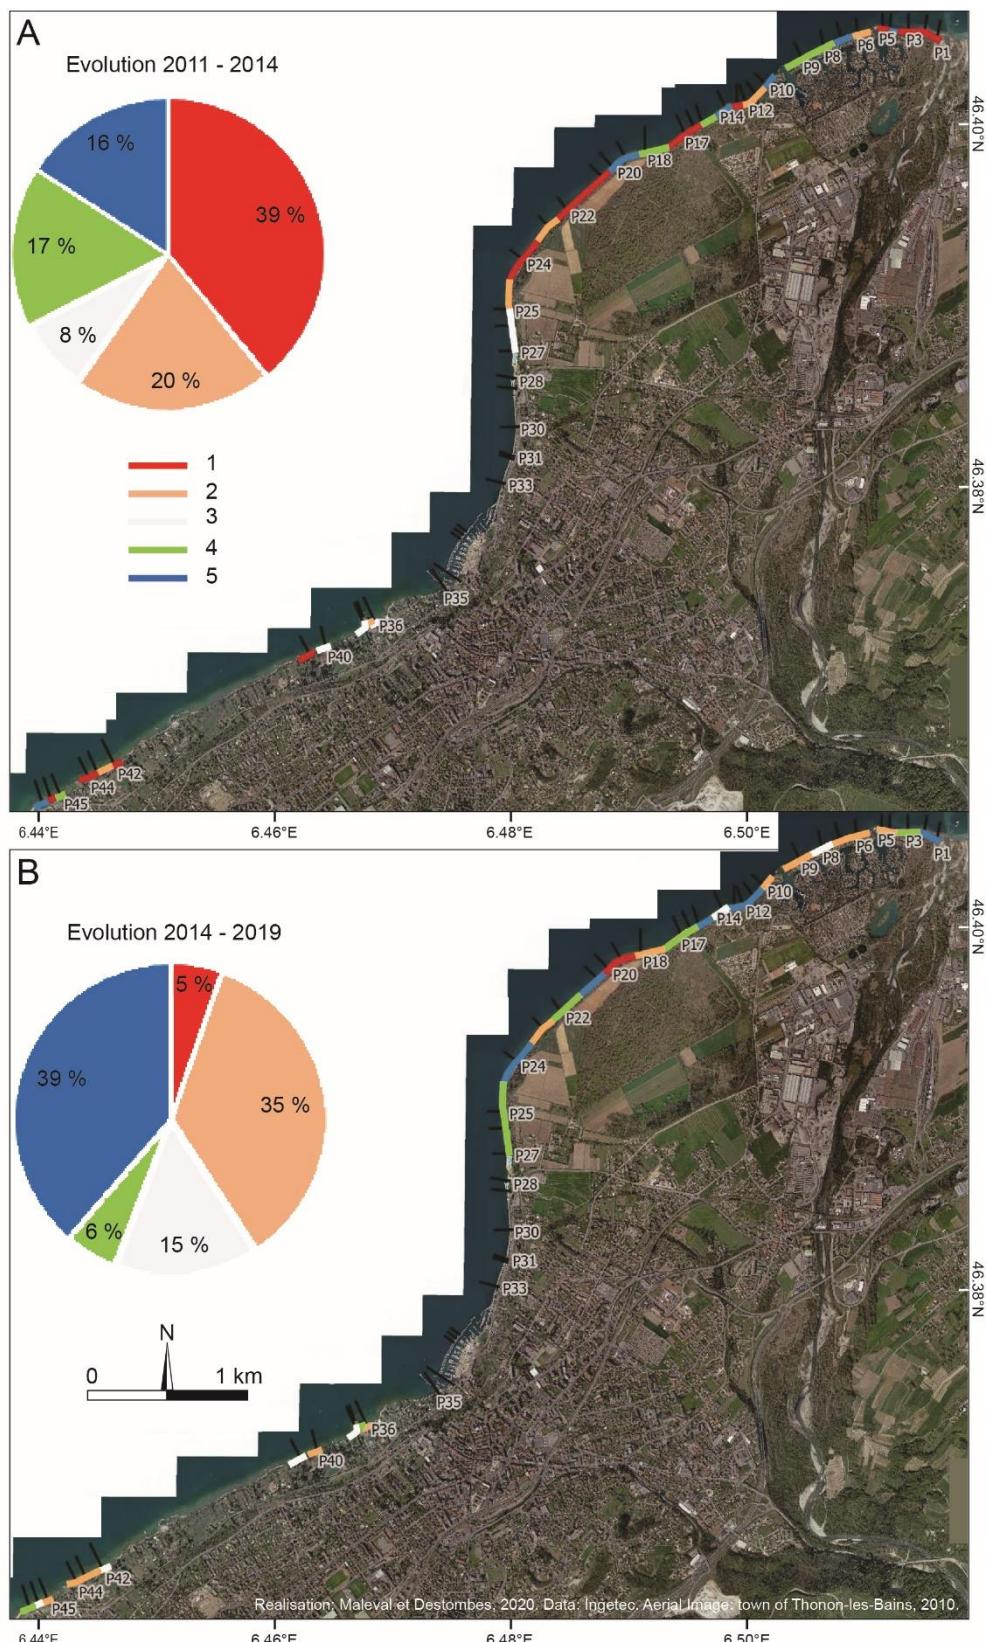
**Fig. 5 - Comparative evolution of the Thonon-les-Bains shoreline**

A: evolution 2011 – 2014; B: evolution 2014 – 2019;

1. Major retreat < -1 m; 2. Minor retreat < -0.15; 3. Non-significant evolution 0; 4. Minor sedimentation > 0.15; 5. Major sedimentation > 0.5.

The graphs of the Figure 5 show that the sections in steep decline fell from 39 % to 5 % between the two periods, a difference of 34 %.

- From a spatial point of view, the morphological evolution maps show that the sections that were in sharp decline between 2011 and 2014 (Fig. 5A) no longer existed between 2014 and 2019 (Fig. 5B). These were mainly the shoreline of the cape exposed to the wind (sectors of the Dranse, Saint-Disdille, Châtaigneraie park, along Ripaille wall and Pinède beach); these sectors have evolved with sedimentation. This evolution differs in front of Ripaille wall: two sections (P21 and P22) have grown in size and three others (P18 to P20) have gone from a period of thickening (2011 - 2014) to a period of moderate to strong erosion (2014 - 2019), resulting in an annual decline of between 0.04 and 0.44 m. This shoreline exposed to the prevailing NE winds (*bise*) is naturally prone to erosion, as can be seen by the tree root networks in front of the shoreline, exposed due to the forming of a 63 cm high micro-cliff (Maleval *et al.*, 2016). Nevertheless, this shoreline recorded the highest sedimentation according to observations of March 2014 (Maleval *et al.*, 2016), in the form of sandy strips carried by the coastal drift. The erosion mentioned after 2014 is less due to the retreat of the shoreline than to the drift's displacement of the pebble beach. This temporal morphological evolution illustrates the successive phases of shoreline erosion and sedimentation.

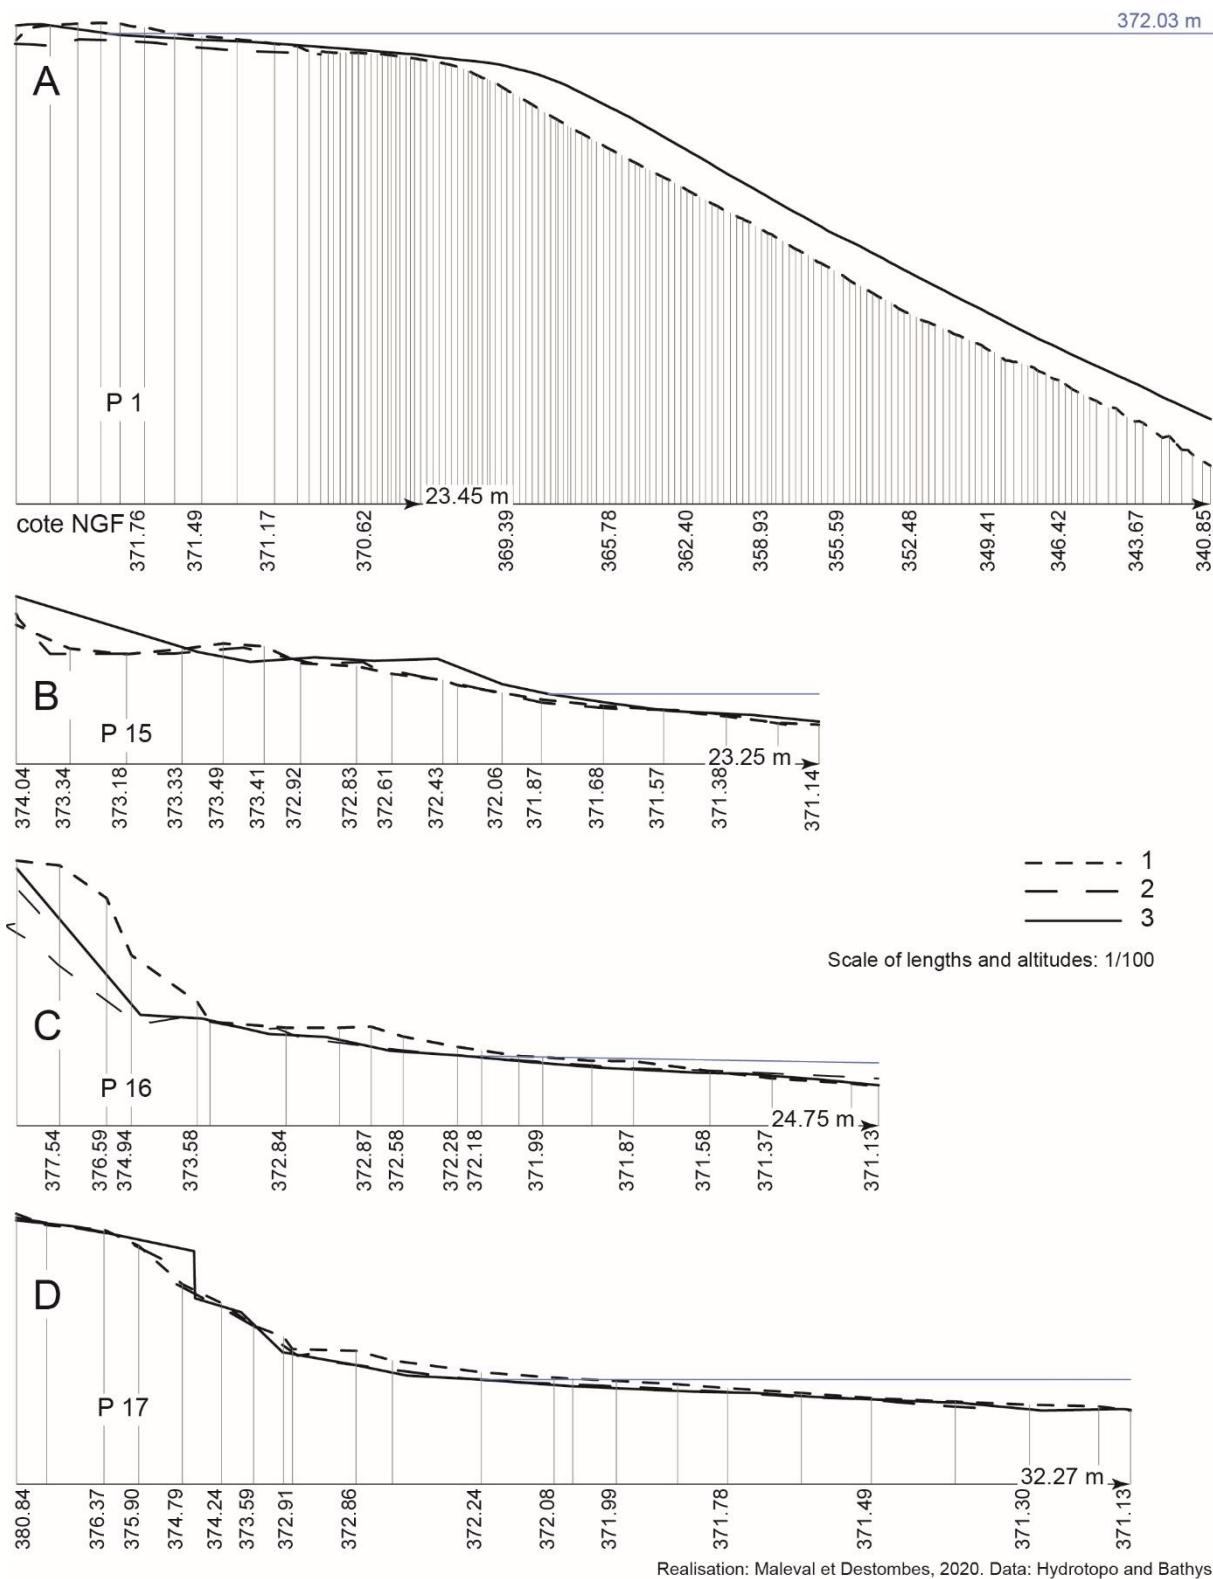
**Fig. 6 - Profiles of the Dranse delta and the Ripaille shoreline**

A: profile 1; B: profile 15; C: profile 16; D: profile 17.

1. 2011; 2. 2014; 3. 2019.

- At the mouth of the Dranse (P1), the evolution figures (Tab. 2) and the topographic and bathymetric profile (Fig. 6A) show significant sedimentation of the upper beach between 2014 and 2019 (almost 4 m per year), whereas that section was highly eroded between 2011 and 2014 (more than 6 m per year). The sub-lake aggradation modelled since 2011 is a point of interest: an average thickness of 2.88 m of sediment was observed in 2019; this deposit corresponds to a volume of 19,000 m<sup>3</sup> for an area of 190 m<sup>2</sup> around the profile (*Autocad* calculations).

- For the restored Ripaille shoreline, profiles 15 and 17 (Fig. 6B, D) show little change in the shape of the beach between 2011 and 2014, but profile 16 (Fig. 6C) shows significant beach erosion (0.76 m per year). In contrast, since 2014 the 3 profiles have evolved in the same way, characterised by sedimentation of the beach (between 0.12 and 0.38 m); however, profile 16's sedimentation had not caught up with 2011 levels by 2019. The sedimentation of P17 is in the form of pebble strips.

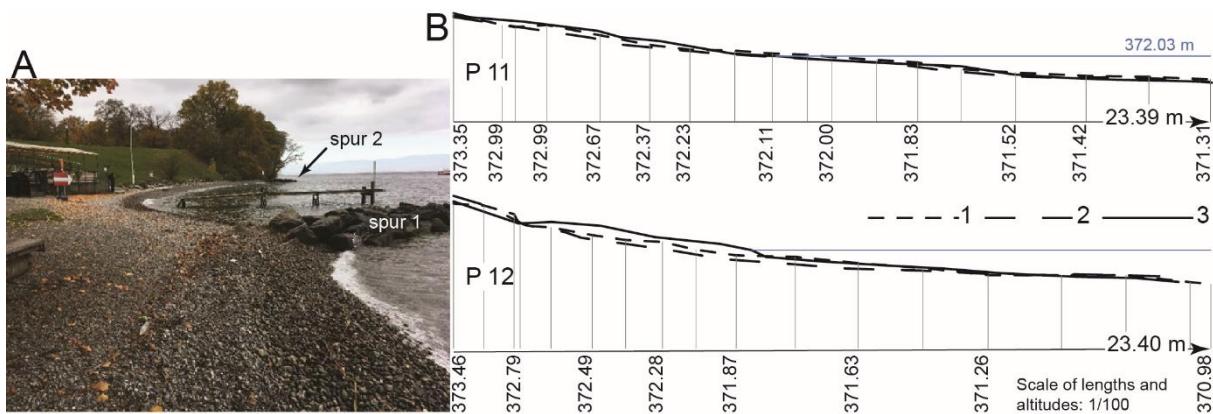
**Fig. 7 - Consider the rehabilitation of Saint-Disdille beach?**

A. photo of October 2017 (P.B. Destombes); B. profiles 11 and 12;

The removal of spur 1 should enhance the refurbished by increasing the width of the beach which today receives less sediments because of its presence.

1. 2011; 2. 2014; 3. 2019.

The renaturation strategy for the Thonon-les-Bains shoreline has begun. Once the geomorphological effects of the removal of the two spurs have been assessed, the possibility of removing the others can be assessed. Indeed, spur 4 has been kept as a precautionary measure because the spurs either side have been removed. Nevertheless, the next stage could see it disappear, especially as the trees just behind it, protruding from the shoreline, naturally play the same role (Maleval *et al.*, 2016). Removal would heighten the possibility of pebble deposition at the base of the restored section, thanks to the presence of spur 6. This is the effect anticipated with the removal of spurs 3 and 5. Indeed, since 2016 (when extraction stopped), the spurs have promoted sedimentation, according to the numerical results (table) and the topographic profiles (P15, 16 and 17): from a situation of retreat in 2011, sediment has been building up since 2014. Moreover, of the two spurs marking the limits of Saint-Disdille beach (fig. 3), spur 2 serves a real purpose, retaining the pebbles on the beach. However, if spur 1 were removed, the concave section of the beach would thicken with sediment (fig. 7A). This is a classic coastal process due to wave deflection in bays, attenuated as they are by friction on the lake bed (Touchart, 2002). The resulting increased sedimentation would widen the beach, making the riprap at the top of the beach unnecessary. This seems to be supported by the topographic profiles of the sector (Fig. 7B): the upper part of the beach, eroded between 2014 and 2019 (P12), could receive sediment carried by the drift but currently blocked by spur 1; profile 11 located just upstream of spur 1 indeed shows sedimentation gain between 2011 and 2019.
