## About the role of the hydrogen during stress corrosion cracking of a low-copper Al-Zn-Mg alloy

Loïc Oger, Eric Andrieu, Grégory Odemer, Lionel Peguet, Christine Blanc. About the role of the hydrogen during stress corrosion cracking of a low-copper Al-Zn-Mg alloy. *Journal of Alloys and Compounds*, 2022, 900, pp.163391. 10.1016/J.JALLCOM.2021.163391 . hal-03871788

**Abstract** - This study provides some clarifications about the influence of microstructural parameters on the susceptibility of low-copper Al-Zn-Mg alloy to stress corrosion cracking (SCC). Tensile tests in air were carried out on AA7046 in T4 and T4 aged at 150 °C (named 150/20) metallurgical states after pre-exposure of the specimens to a chloride solution under mechanical loading. The results showed the predominant role of the corrosion-induced hydrogen during SCC process on the loss of elongation to failure. Scanning kelvin probe force microscopy (SKPFM) measurements were performed for the T4 specimens as well as for a 530 °C heat-treated T4 specimen with a coarse-grained microstructure; this allowed the contribution of hydrogen diffusion at the grain boundaries on the hydrogen distribution to be highlighted. Th

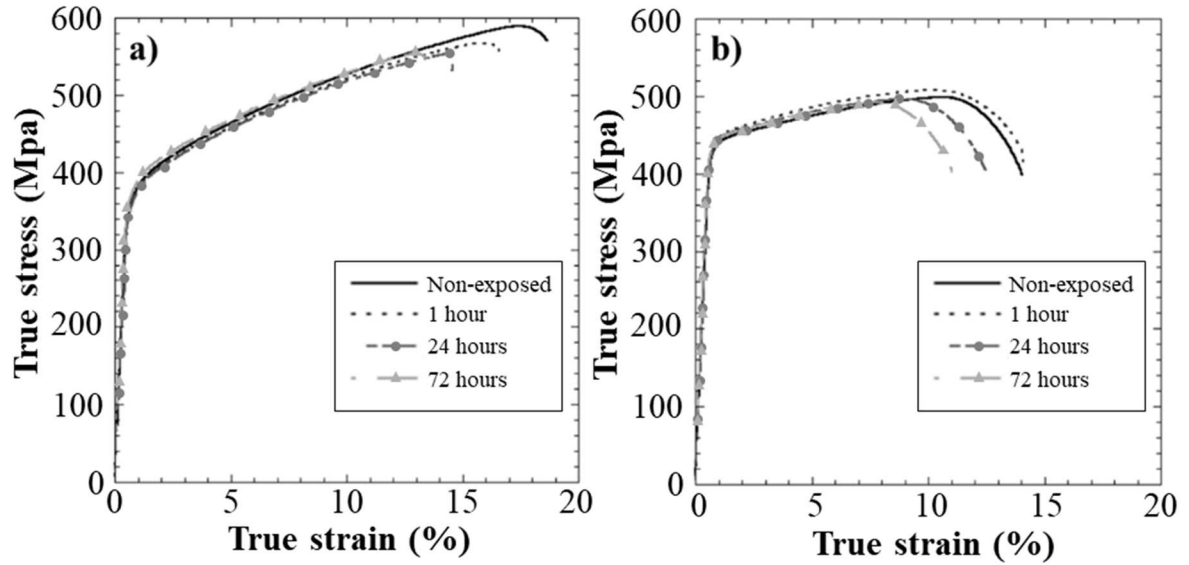
The stress vs strain curves were plotted after exposures of 1, 24 and 72 hours in 0.6 M NaCl under a  $0.8Y_{S0.2}$  loading. To make the figure easier to read, the curves obtained for 5 hours of exposure were not represented because they are similar to those obtained for 1 hour. The curves showed that the SCC pre-exposure altered the tensile properties of the alloy. Independently of the metallurgical state, no change in the elasticity domain and no decrease in the flow stress in the plasticity domain was observed. This suggested that the bearing section was not significantly affected by the corrosion defects. However, a lower elongation was obtained for all the pre-exposed samples (under sustained load) and a progressive decrease in the elongation to fracture with the duration of pre-exposure to NaCl was observed for pre-corroded samples as compared to non-exposed specimens. After 72 hours of pre-exposure, the AA7046 lost approximately 23 % in ductility in the T4 state and 15% in the 150/20 state. This suggested that the 150/20 microstructure was less susceptible to SCC than the T4 microstructure, which is consistent with existing works [7,12,28,44].

**Fig. 1.** True stress vs true strain curves of the AA7046 in T4 (a) and 150/20 (b) states for different SCC exposure durations.

Fig.1 offers a comparison of the mechanical properties of the AA7046 in T4 and 150/20 metallurgical states with and without pre-exposure to the NaCl solution. In the present study, the pre-exposure before tensile tests was always under a  $0.8Y_{S0.2}$  stress. A focus on stress vs strain curves for the non-exposed samples allowed to see the influence of the microstructural differences. An increase in YS values (from  $364\pm 7$  MPa to  $434\pm 1$  MPa) and a decrease in the elongation to failure ( $E_f$ ) (from  $18\pm 1$  % to  $13\pm 1$  %) were noticed for the 150/20 metallurgical state by comparison to the T4 samples, which was consistent with the overall literature [27,28,43].

Fig. 3 showed that a 72-hour pre-exposure in SCC conditions modified the fracture surfaces, in good agreement with the stress vs strain curves (Fig. 1). Similar results were
