## An Archaeological Account of Nyarma and its Surroundings, Ladakh

## An Archaeological Account of Nyarma and its Surroundings, Ladakh\*

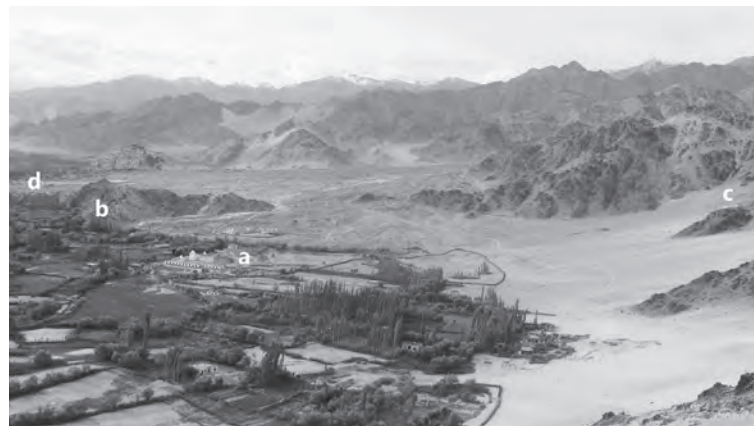
2. General view of the area of study from the south-south-east: a) main complex, b) fort, c) hill temple complex, d) Thikse-Nyarma area. The monastery of Thikse can be seen in the background (Q. Devers, 2011).

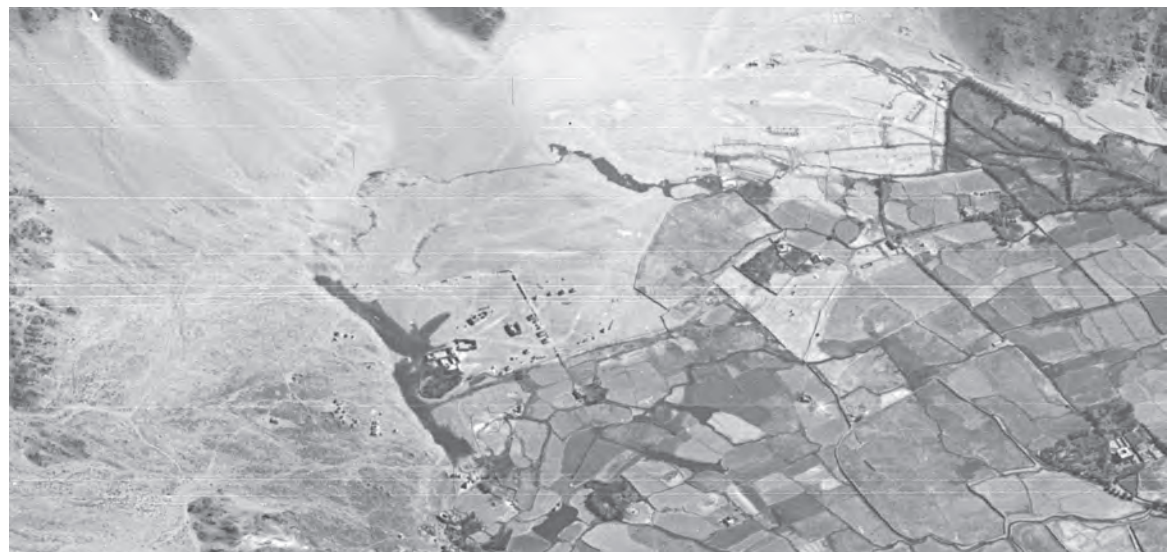
5. General view of the main complex from the south-south-east (Q. Devers, 2011).

some portions of the original enclosure on the southern and eastern edges (Figs. 5 and 6). These structures are all built with unbaked bricks, none of the walls are in stone. As the different sizes and textures of the bricks indicate (Fig. 29), these constructions were likely erected at different times.

From an archaeological perspective, important recent activity has damaged the complex, the most important being the construction of a new temple and the extraction of construction material from most of the southern and eastern part of the complex. This is carried on an industrial scale, with trucks coming on a daily basis to carry the extracted material. The size and the depth of the pit is growing every year—in 2011 it was about 50 x 70 m and over 2 m deep (on Fig. 21, a truck and the beginning of the pit on the left can be seen; the same pit is also visible on Fig. 5 on the right).

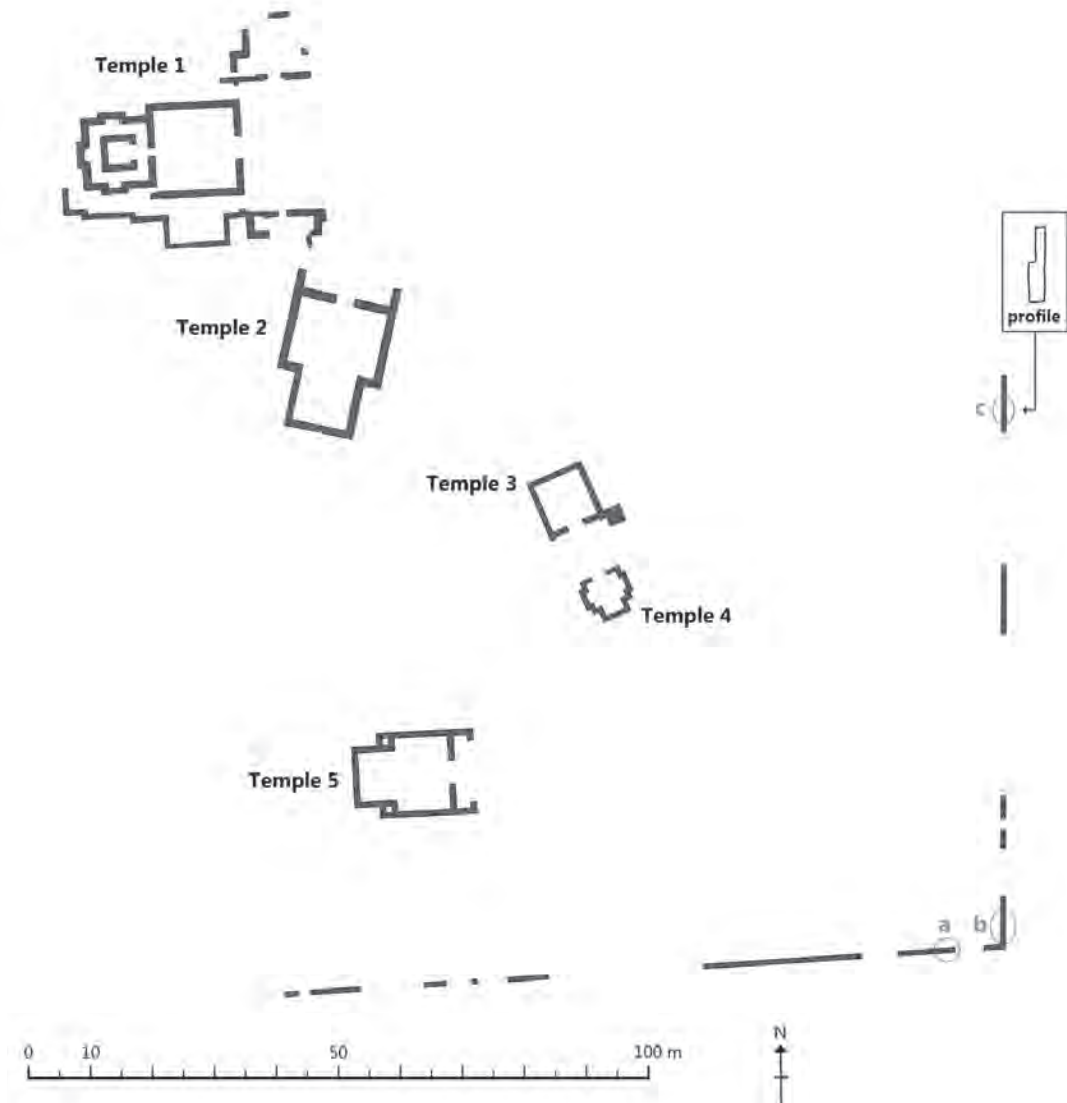
6. Plan of the main complex (Q. Devers, 2012).

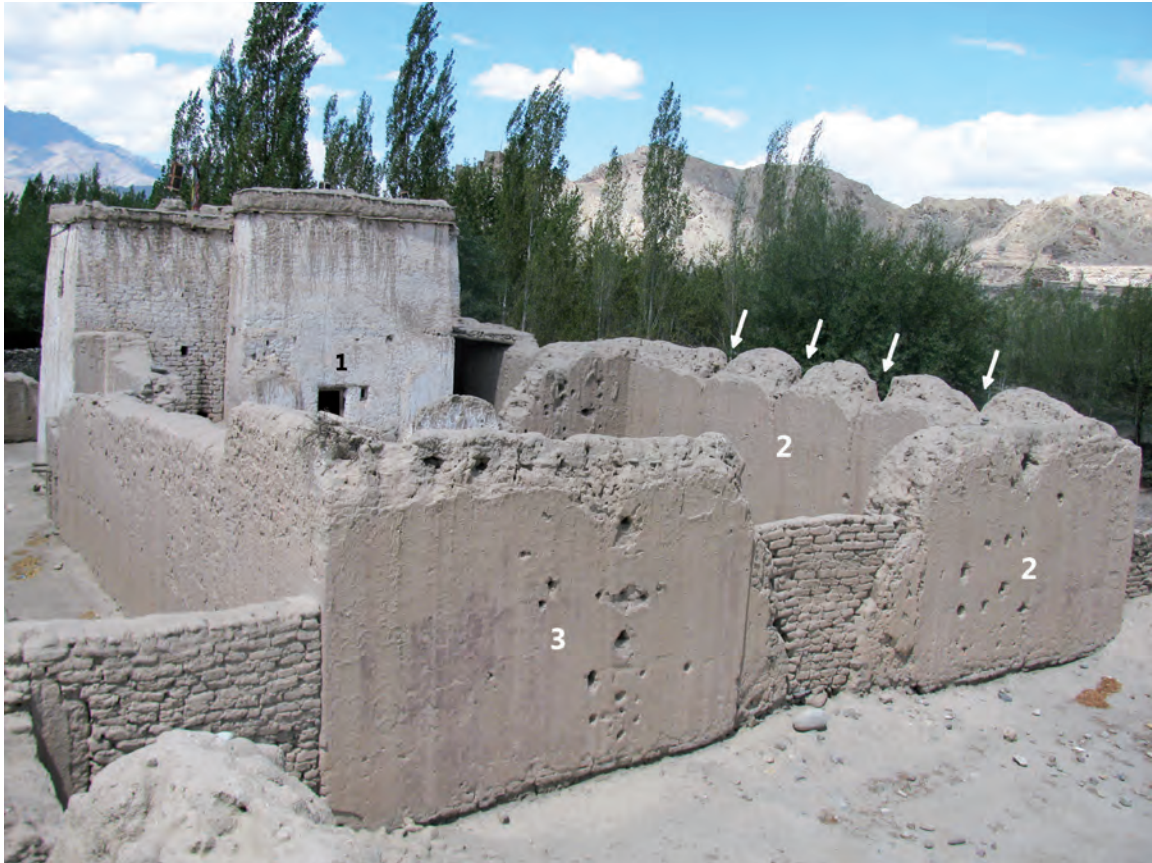
9. Assembly area of Temple 1 from south-east. Numbers indicate the walls numbers according to Fig. 8. The white arrows show the recesses where the beams used to fit on wall 2. The opposite wall has its top levelled (wall 3) (Q. Devers, 2009).

The positions of the beams that once supported the roof of the assembly area are still visible: they correspond to the vertical recesses at the top of the walls. There were four of these, about 2.5 m apart (Fig. 8: indicated by the small grey triangles in wall 2; Fig. 9: indicated by the white arrows). These can be seen only on wall 2: the upper part of wall 3 was levelled (Fig. 9).

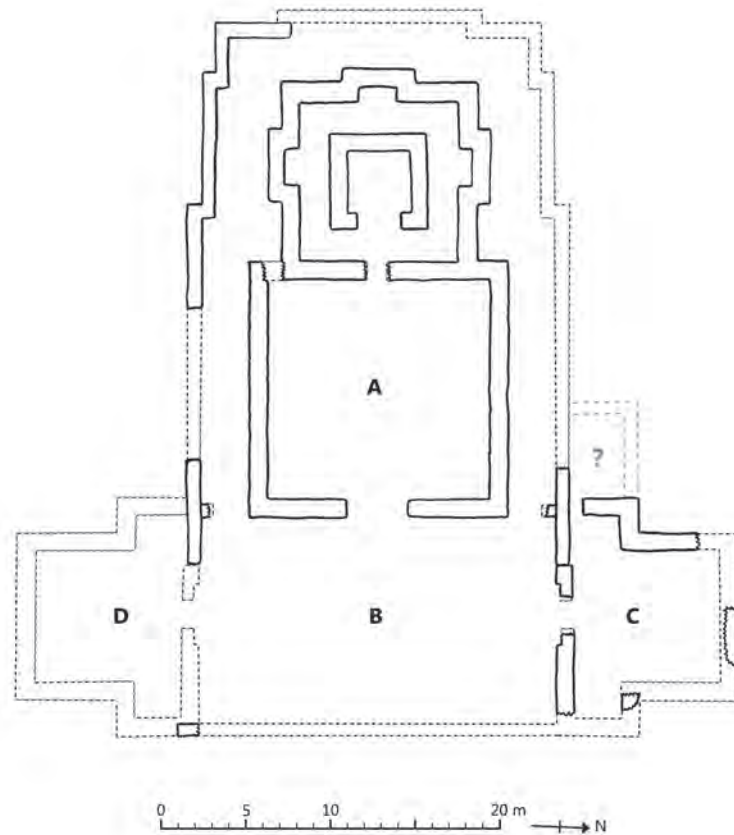
15. Temple 1: reconstruction of space B, chapel C, possible room north of chapel C and possible original chapel D (Q. Devers, 2012).

In a second phase, a development took place in front of the temple with the construction of a large space (B) along with at least one lateral chapel (C) (Fig. 8). Another chapel was likely on the other side of space B, but, as we will see, in its current state it is not from the same period as chapel C.

As there is no direct relationship between walls 12-13 on the one hand and walls 14-15-16 on the other, it is questionable to state whether the development of space B is contemporaneous with that of chapel C. But the fact that they are made from the same bricks, and that walls 12-13 use special bricks shaped with a recess in order to fit a doorframe (Fig. 13) indicates that it was designed with a door right from the beginning. As such, chapel C is likely contemporaneous with space B.

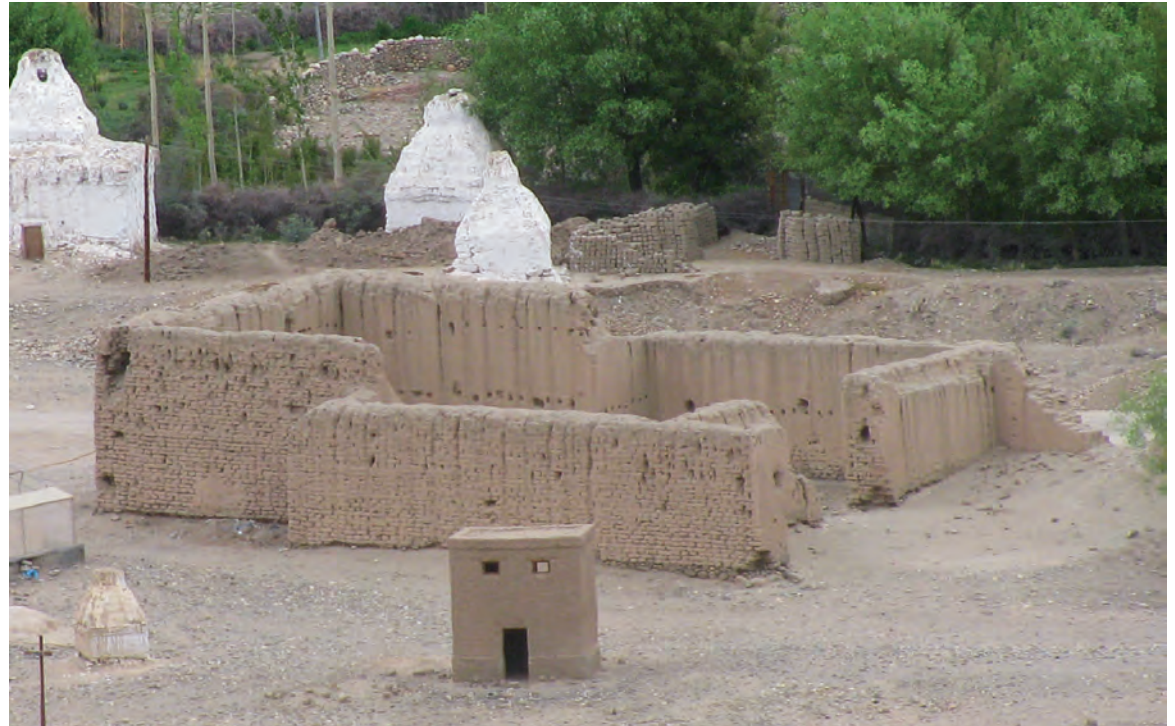
16. Temple 2 from the hill temple complex (Q. Devers, 2011).

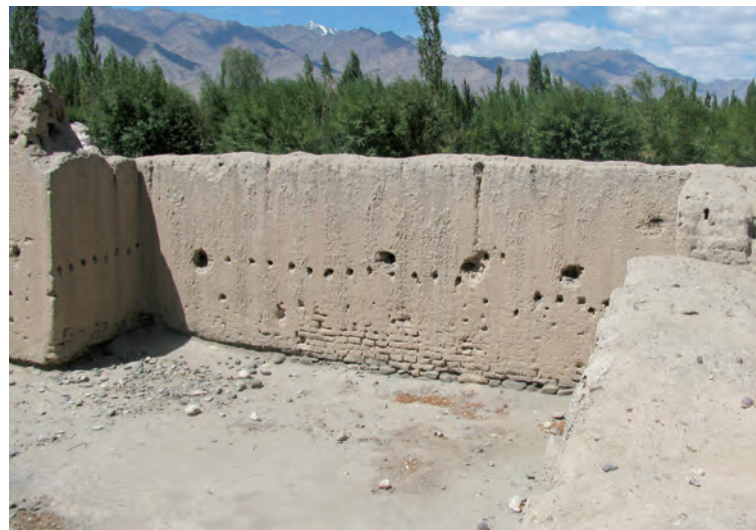
19. Temple 2: rear wall (Q. Devers, 2009).

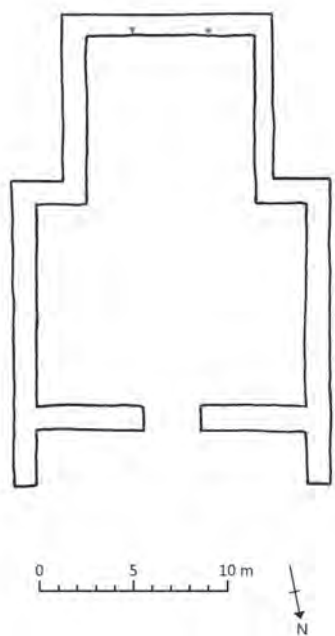
20. Plan of Temple 2 (Q. Devers, 2012).

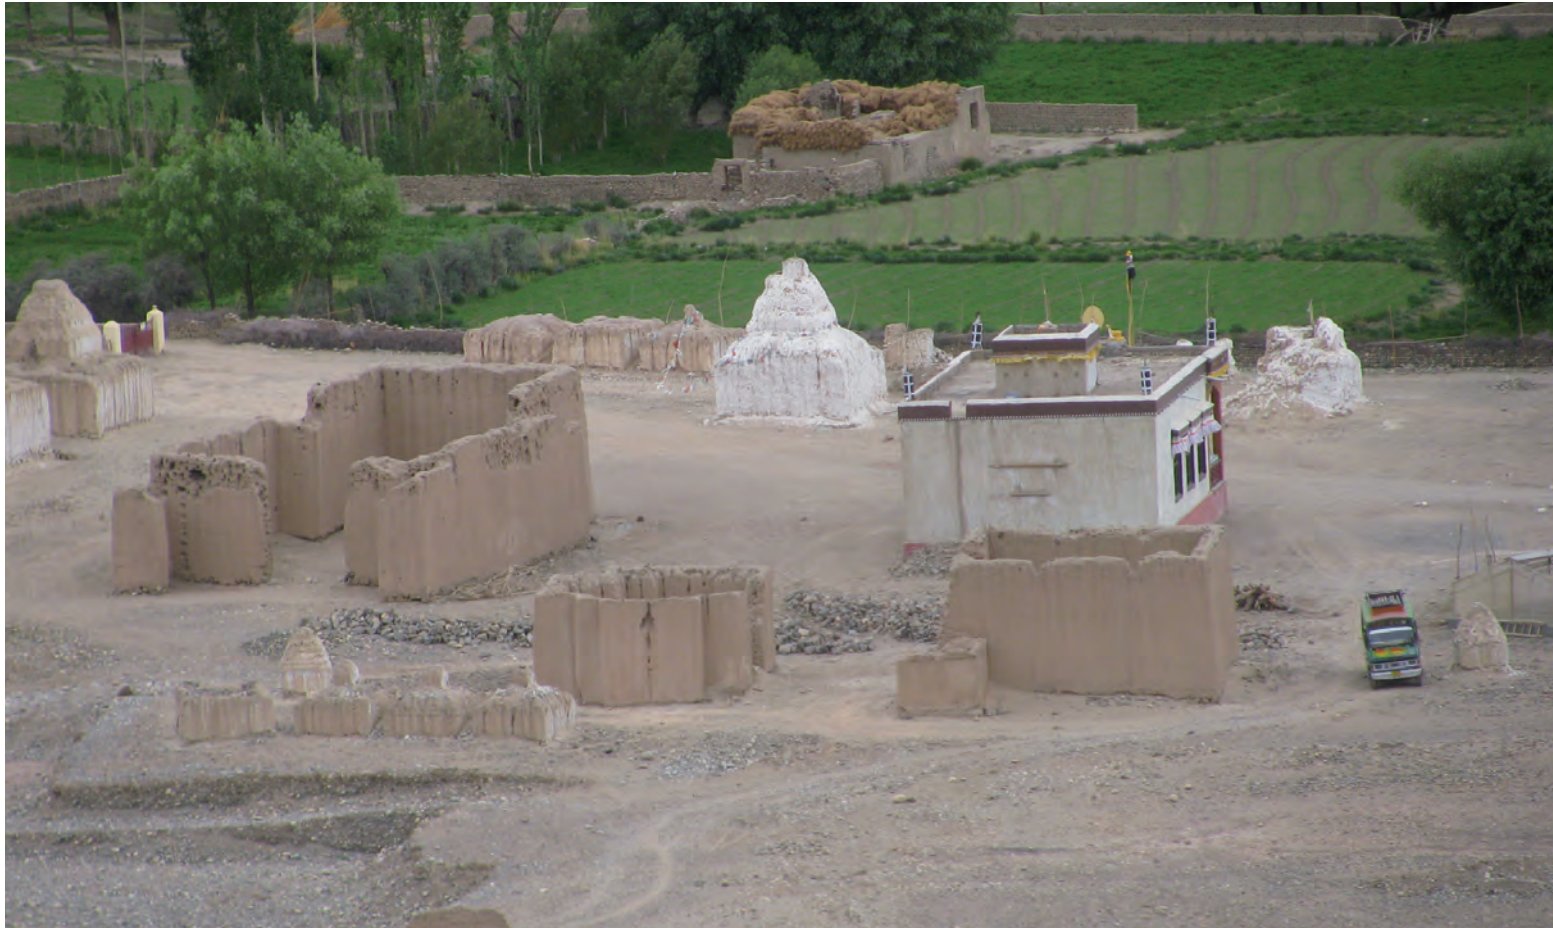
21. Temples 3 (right), Temple 4 (middle) and Temple 5 (left) from the hill temple complex (Q. Devers, 2011).

Though facing each other and looking as two coherent parts of a same whole, Temples 3 and 4 were probably not built at the same time (Fig. 21). Indeed, while Temple 3 is built with large bricks that are 45-47 x 26 x 10 cm, those of Temple 4 are 40 x 26 x 10 cm.

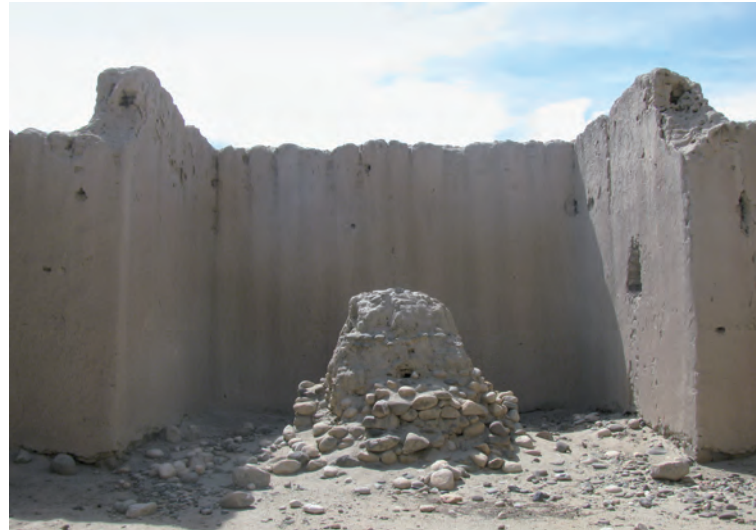
27. Porch of Temple 5 (Q. Devers, 2009).

Temple 5 is the southernmost in the complex (Fig. 21 and 26). Its walls are 90 cm thick, built with bricks that are 40–42 x 26 x 10 cm. The porch shows signs of the beams of its former roof both on the side walls and on the entrance walls. In addition, a series of vertically aligned small holes can be seen in the left corner (Fig. 27). The door jambs are straight. The roof of the assembly area was supported by two beams about 3 m apart, 2.6 m from the entrance wall and 3 m from the rear wall. The rear niche, which has walls 5.9 m high rather than 4.6 m for the assembly area, appears to have had one beam. The inner walls do not show clear signs of stucco halos or of fixation holes. The access to the two closed rooms on each side of the rear niche (A and B on Fig. 25) is open to question: the room on the right

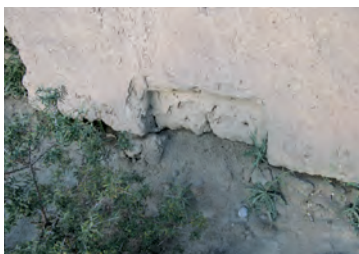
28. Enclosure: recess at the base of the wall in *b*, 0.6 m wide and 0.3 m high (Q. Devers, 2009).

In *b*, the wall has a small recess at its base, which is not due to a recent removal of bricks as its coating indicates (Fig. 28). The coat on this section, which is a little over 5 m long, does not go all the way to the top of the wall, it stops somewhere above the middle of the elevation.

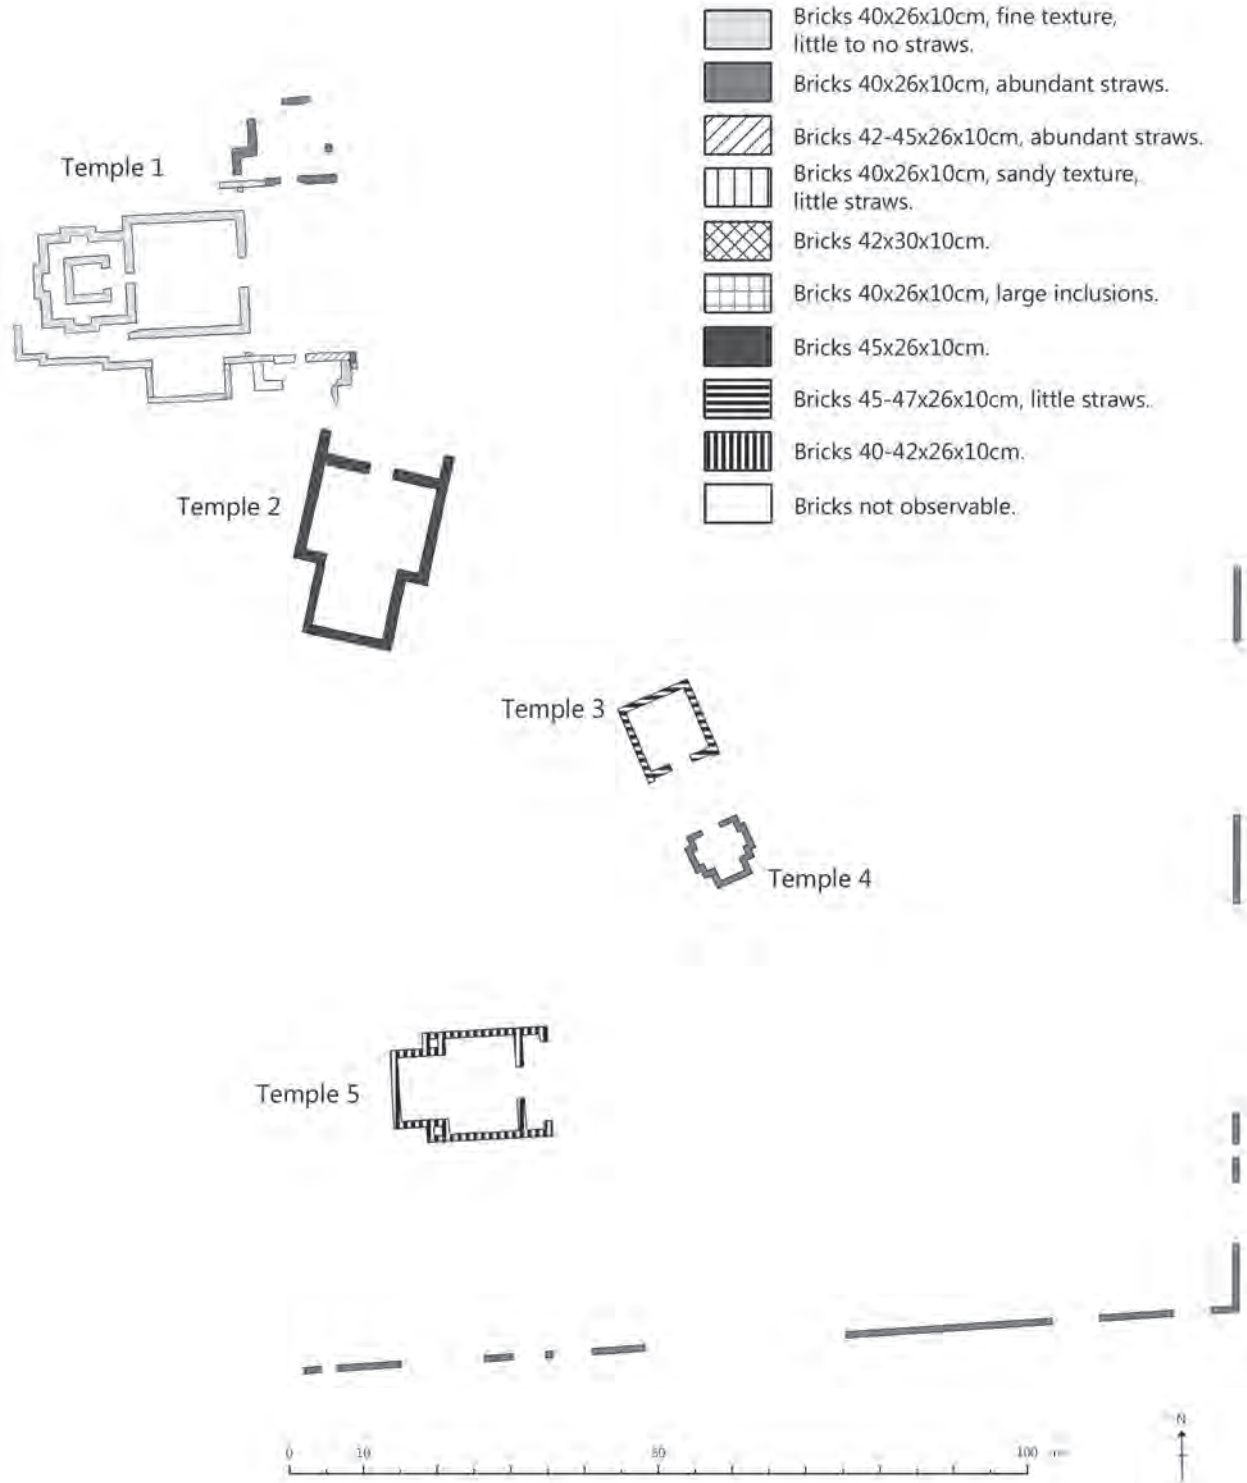
29. Walls of the main complex coloured according to their type of bricks (Q. Devers, 2012).

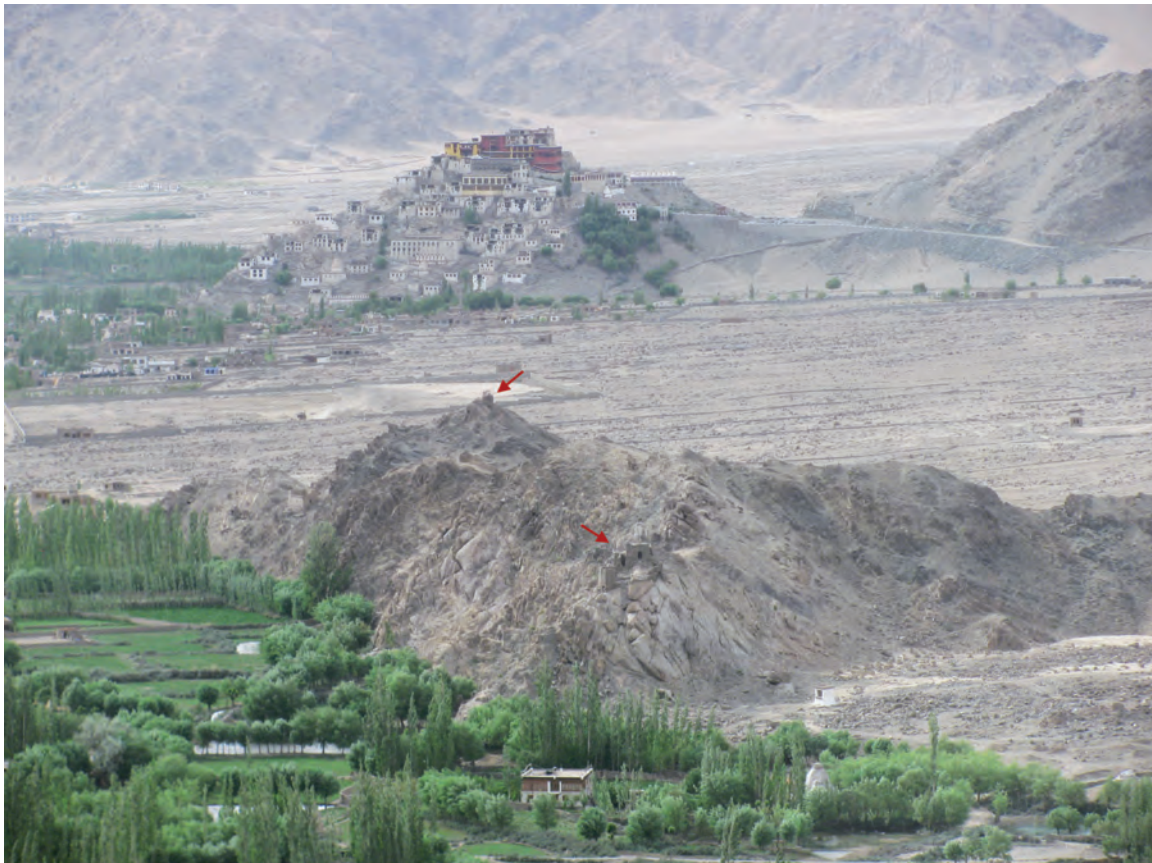
30. The fort (indicated by the red arrow in the foreground) and the small square structure at the other end of the rocky formation (indicated by the upper red arrow), with the monastery of Thikse in the background from the south-east (Q. Devers, 2011).

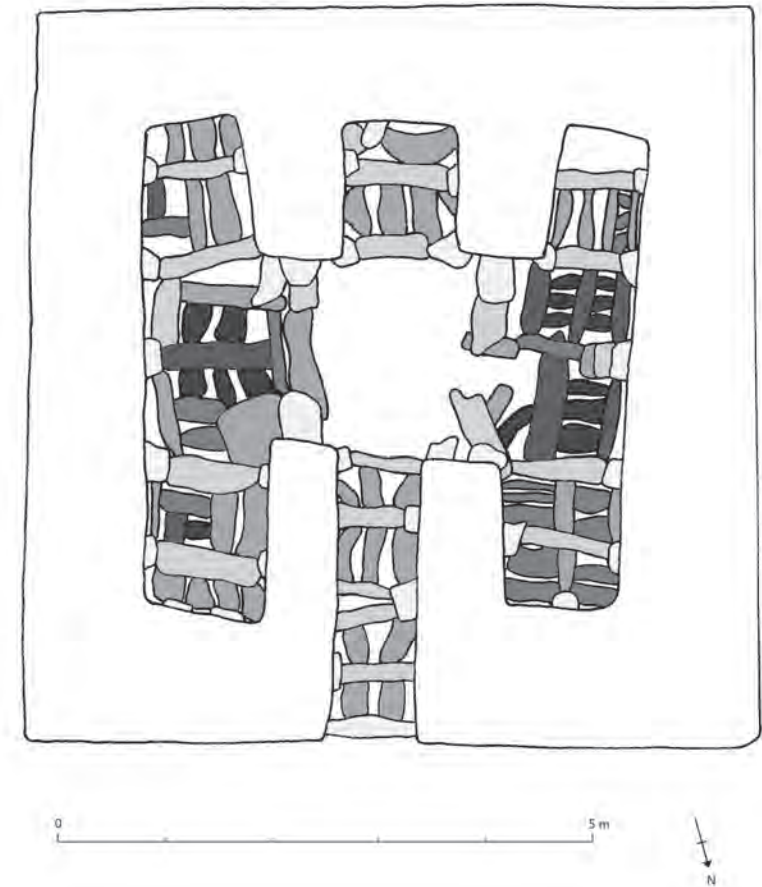
35. The three structural levels of the stone roof in the fort: corbels (light grey) support lintels (mid-grey), supporting in turn another level of lintels (dark grey) (Q. Devers, 2012).

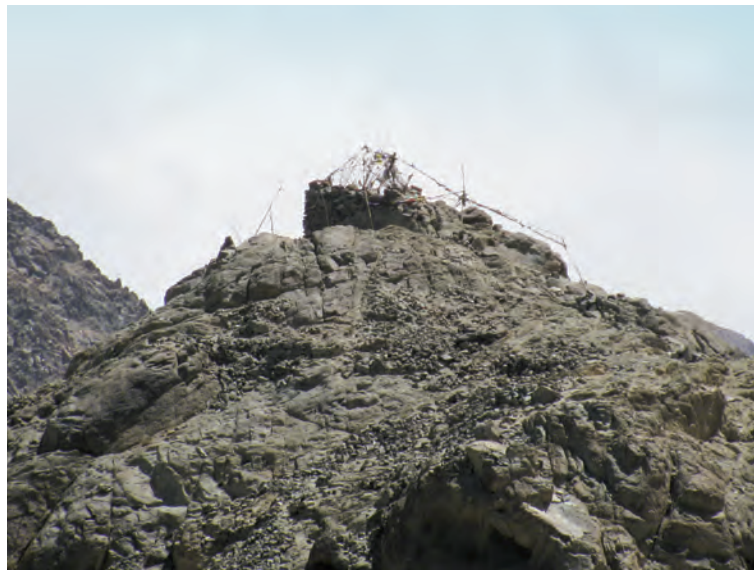
37. Small square structure at the other end of the rocky formation viewed from the north-west (Q. Devers, 2009).

At the other end of the rocky formation on which the fort stands are the ruins of a small square structure covered with prayer flags (Fig. 37). It would be hazardous to venture the nature of this ruin. One possibility is that it was a watch post linked to the fort: as there is no view downstream from there towards Thikse and Shey it could have been an intermediary watch post as the eyes of the fort.

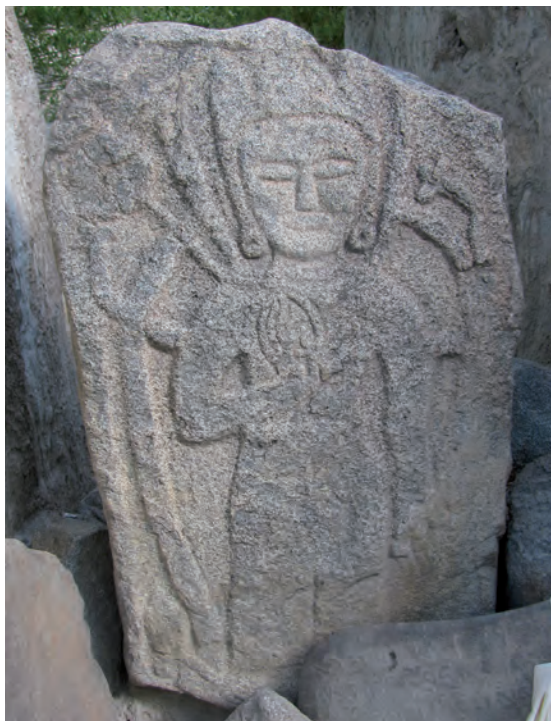
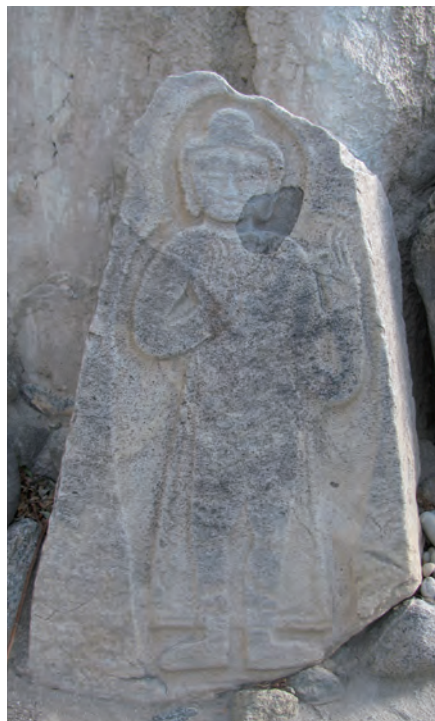
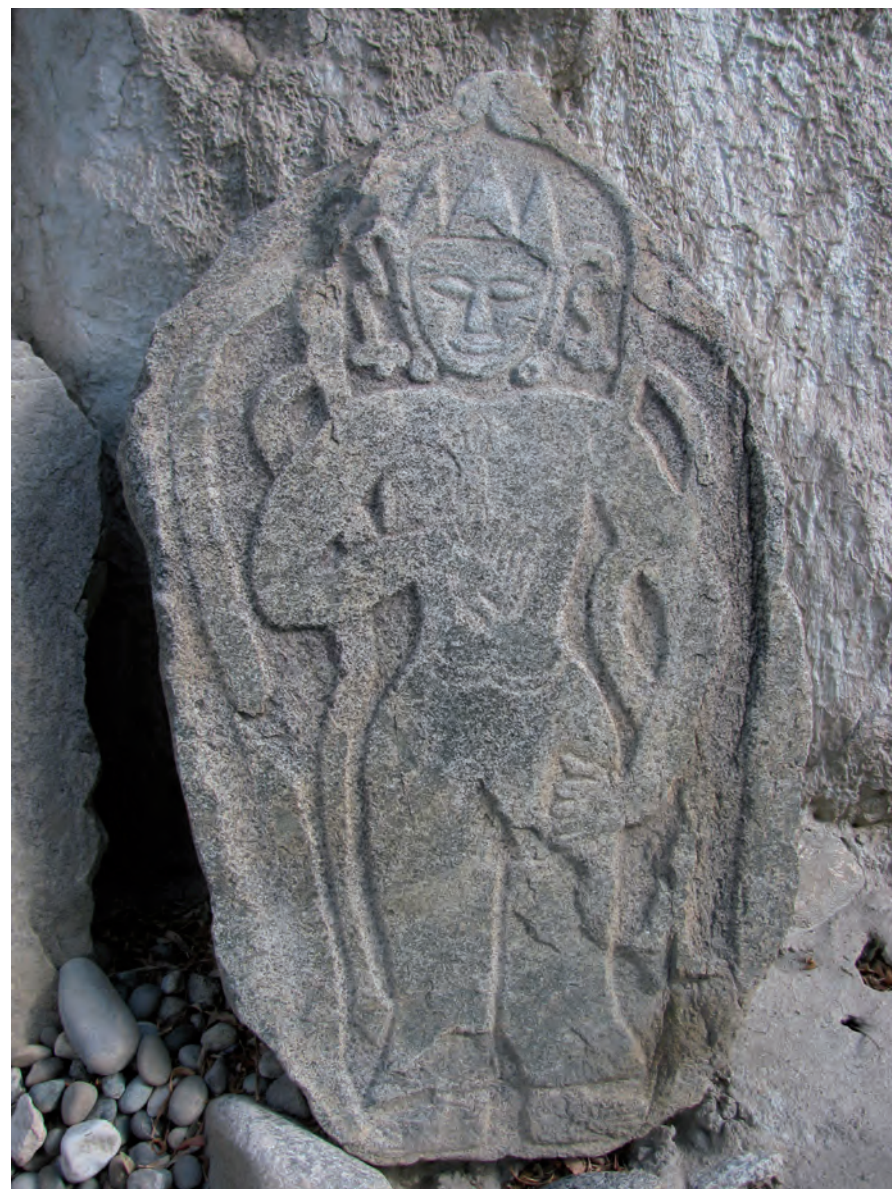
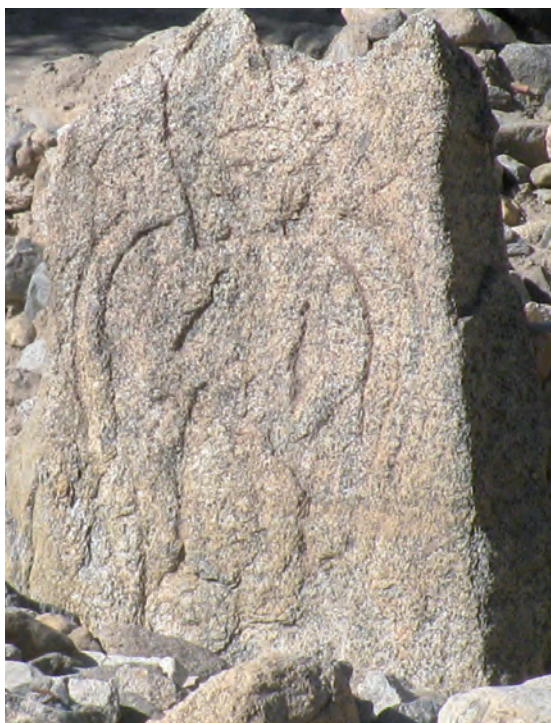
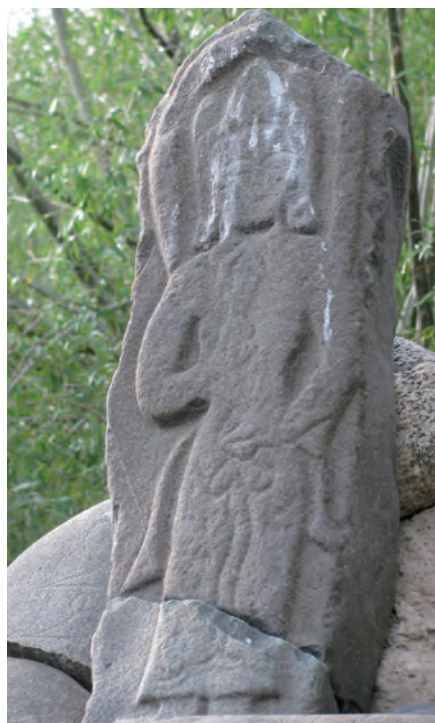
38. Stela amidst the ruins of the ancient village (a) and the three stelae against (b, c, d) and standing on (e) the *mani* wall (a: Q. Devers, 2012b; b, c, d, e: Q. Devers, 2009).

Down the hill, amidst the ruins of the former village there is a very weathered stela, while to the west, near the pond are four other stelae—three lie against a *mani* wall, one is on top of it (Fig. 38a-e; see also Fig. 3 for the location of the stelae). They are (width x height) ca. 98 x 130 cm (a), ca. 70 x 120 cm (b), ca. 68 x 113 cm (c), ca. 60 x 90 cm (d) and ca. 27 x 86cm (e).<sup>12</sup>

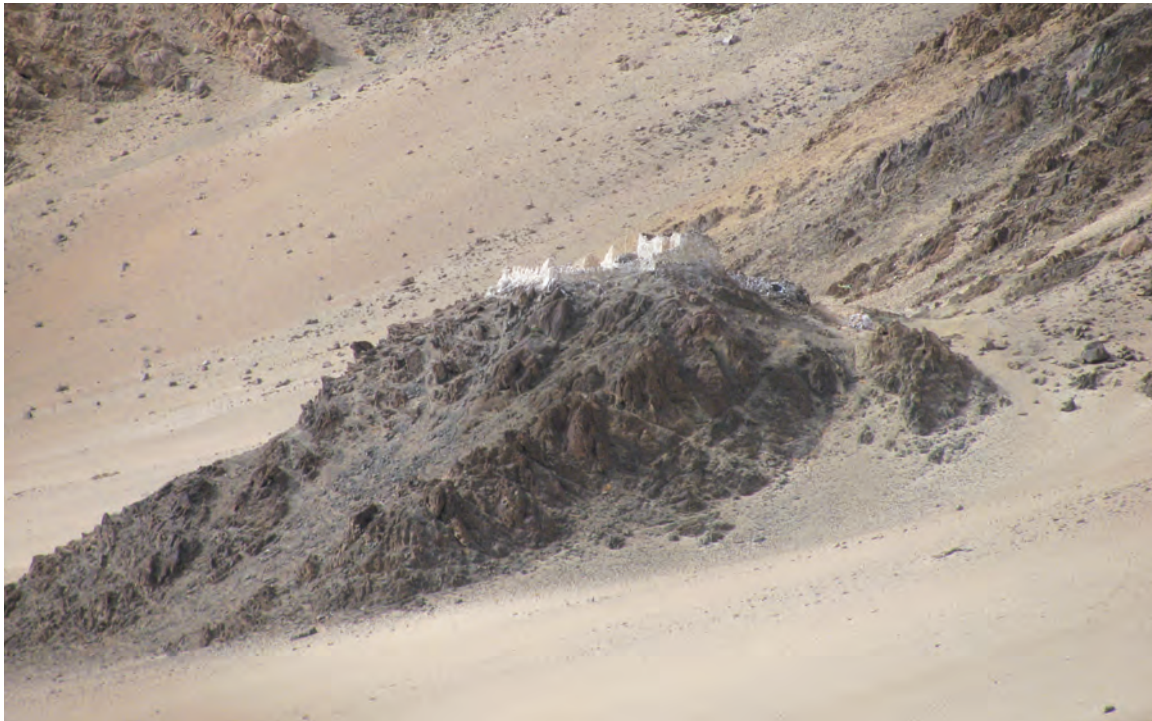
39. The hill temple complex from the south (Q. Devers, 2011).

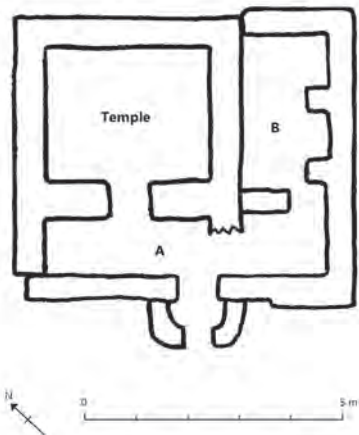
40. Sketch plan of the hill temple complex (Q. Devers, 2012).

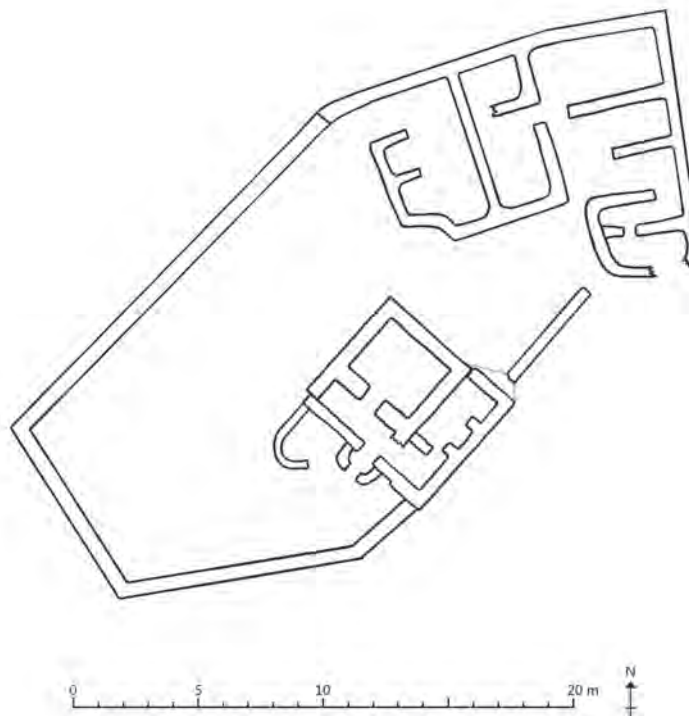
41. Plan of the hill temple (Q. Devers, 2012).

Two to three stages can be observed in the temple (Fig. 41). The first corresponds to the construction of the temple itself. It is very small, only 2.6 x 3.2 m. The door, with a stone lintel, is also very narrow, only 80 cm wide. The walls, 2.6 m high, are of stone masonry. In a second step, a wall was built around the temple on its south-eastern and south-western sides. This creates two distinct spaces, A and B. The floor of space A is at the same level as that of the temple, while the floor of space B is one level above it. The external coat of the temple in B was either removed or never existed. Finally, in what seems to be a third step, an additional structure was built at the entrance with two walls protruding from the building, reducing the doorway to only 60 cm in width.

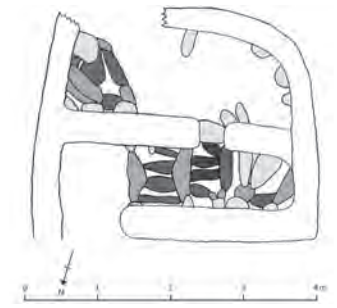
43. Plan of one of the room's stone roof: the corbels and the lintels are viewed from underneath, looking up (Q. Devers, 2012).

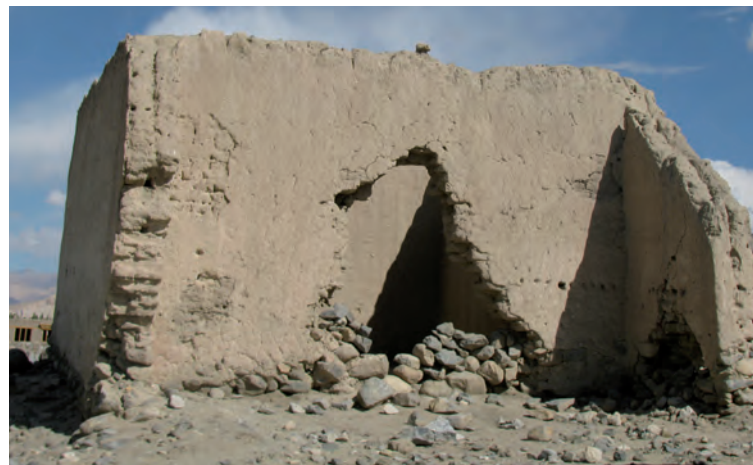
45. Thikse-Nyarma: Temple 1 from the south (Q. Devers, 2009).

This stands immediately after the rocky formation (Fig. 44 and 45). Built of some of the longest bricks I have measured in Ladakh—52 x 22 x 10 cm—its walls are quite thin compared with those of the main complex: they are only one brick thick, i.e. 55 cm when adding the thickness of the mud coat.<sup>14</sup> They are 4.9 m high. The shape of the door jambs is not visible, both having deteriorated. The right half of the porch is marked with a line of small holes on the entrance and side wall (Fig. 44). The roof of the temple was supported by one main beam in the middle of the side walls. There are still stones in the recesses into which the timber used to fit, protecting the bricks from the pressure it created. These stones show the width of the former

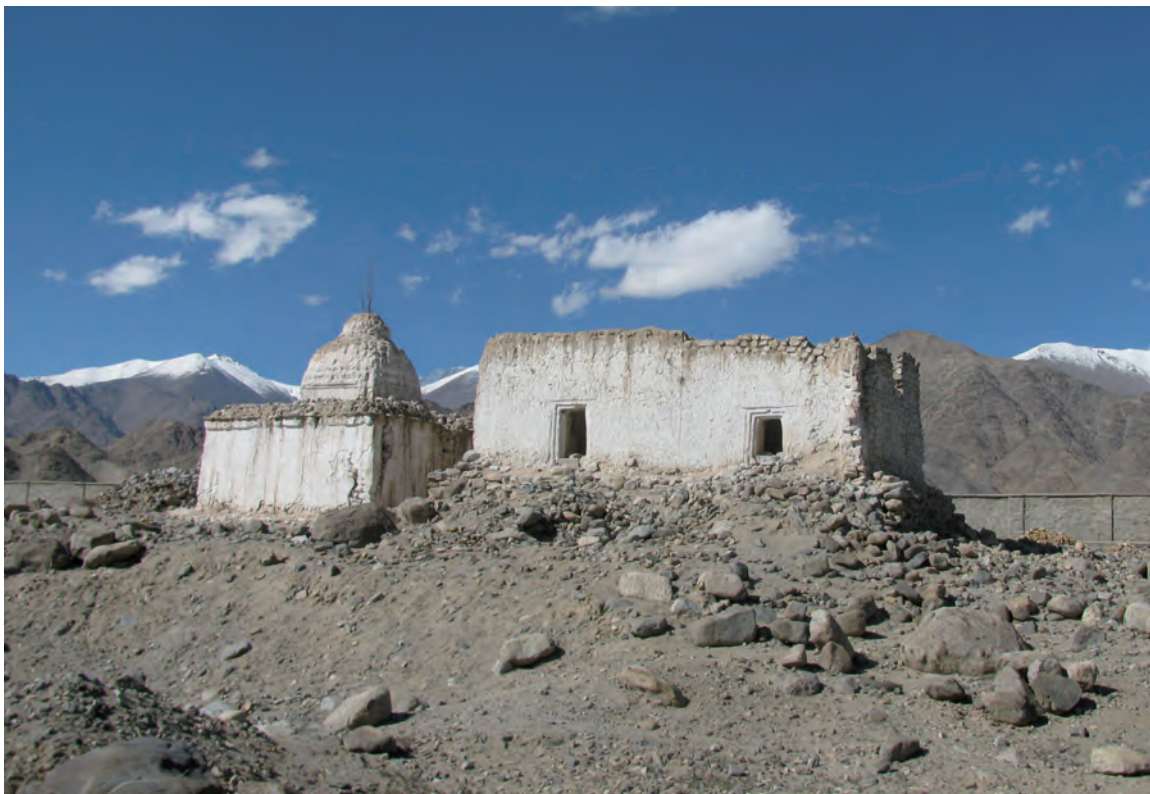
46. Thikse-Nyarma: Temple 2 and Temple 3 from the south-south-west (Q. Devers, 2010).

About 180 m further north-west of these *mchod rten* are the ruins of two temples side by side. Built on a raised platform—1.3 m at its highest point—they are both made in stone masonry (Figs. 46 and 47).

Temple 2 is the least well preserved; its walls are falling to pieces. Due to their degradation, their thickness is now variable, from 50 cm to 70 cm, for a height of 2.2 m. Except for the front façade, the walls do not have an external mud coat. Its door is very narrow and low—only 55 cm wide and 1.15 m high. Its frame is decorated with four successive recesses, the outermost of which is T-shaped (Fig. 47[a]). Its intact mud coat conceals the material used for the lintel of the door. Only one small porch wall protrudes on the right: made of bricks, it is possibly a later addition. However, from the side one can see one long stone sticking out from the masonry to penetrate into the bricks: this may be an indication that although it is made of brick it is contemporaneous with the temple (Figs. 48 and 49).

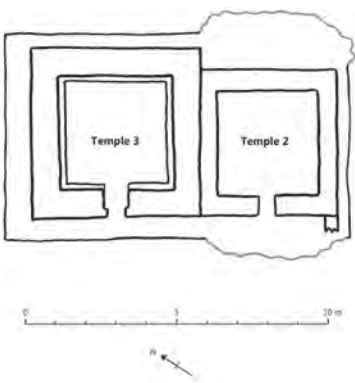
47. Thikse-Nyarma: door of Temple 2 (a) and 3 (b) (Q. Devers, 2010).

Temple 3 is coated both inside and outside. It has the particularity of having an additional inner brick wall built against the outer stone wall. This brick wall is a later addition, as the internal coat of the stone wall shows. The inner brick-wall is only 21 cm thick, made of bricks that are 40 x 20 x 8 cm. It has the marks of the single beam that used to support the roof. The stone walls are 90 cm thick and 2.8 m high. The door is also very small, though a little bigger than that of Temple 2: it is 75 cm wide and 1.25 m high. The door frame is decorated in a similar way, with four successive recesses and a T-shaped outer one (Fig. 47[b]). Similarly, its intact coat makes it impossible to see which material has been used for the lintel.

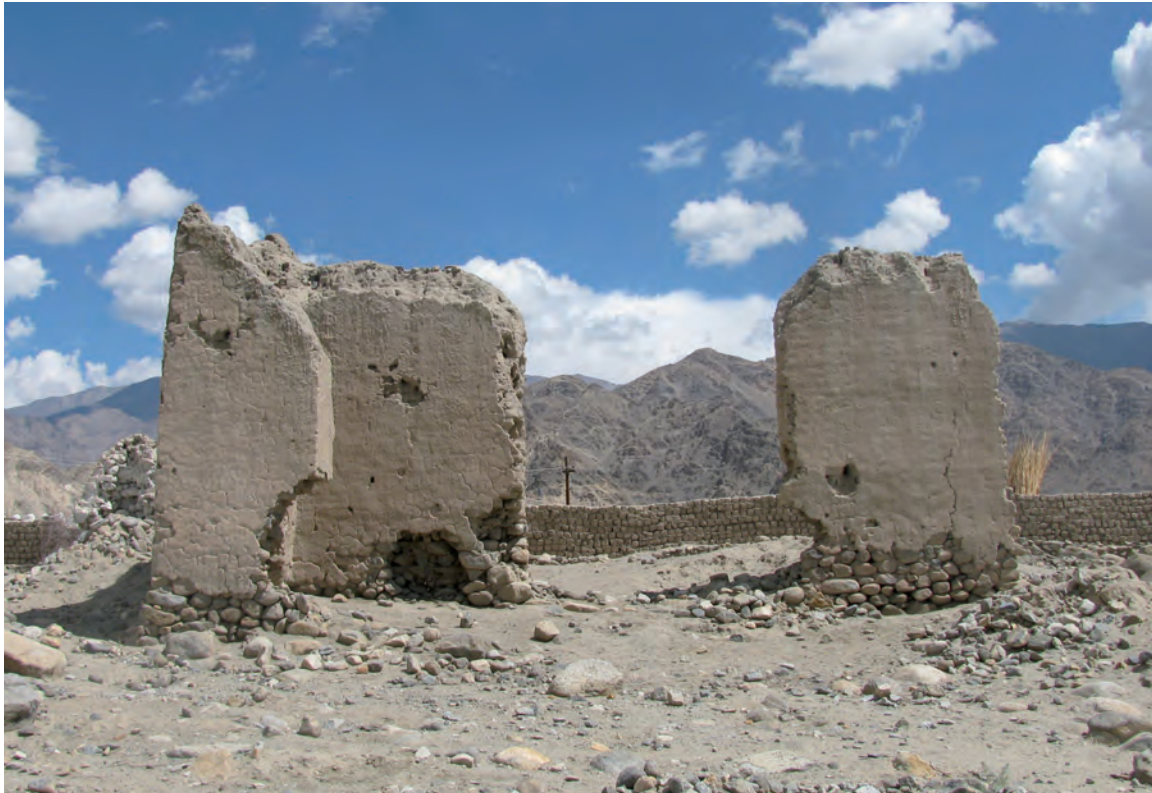
51. Thikse-Nyarma: Temple 4 from the south-west (Q. Devers, 2009).

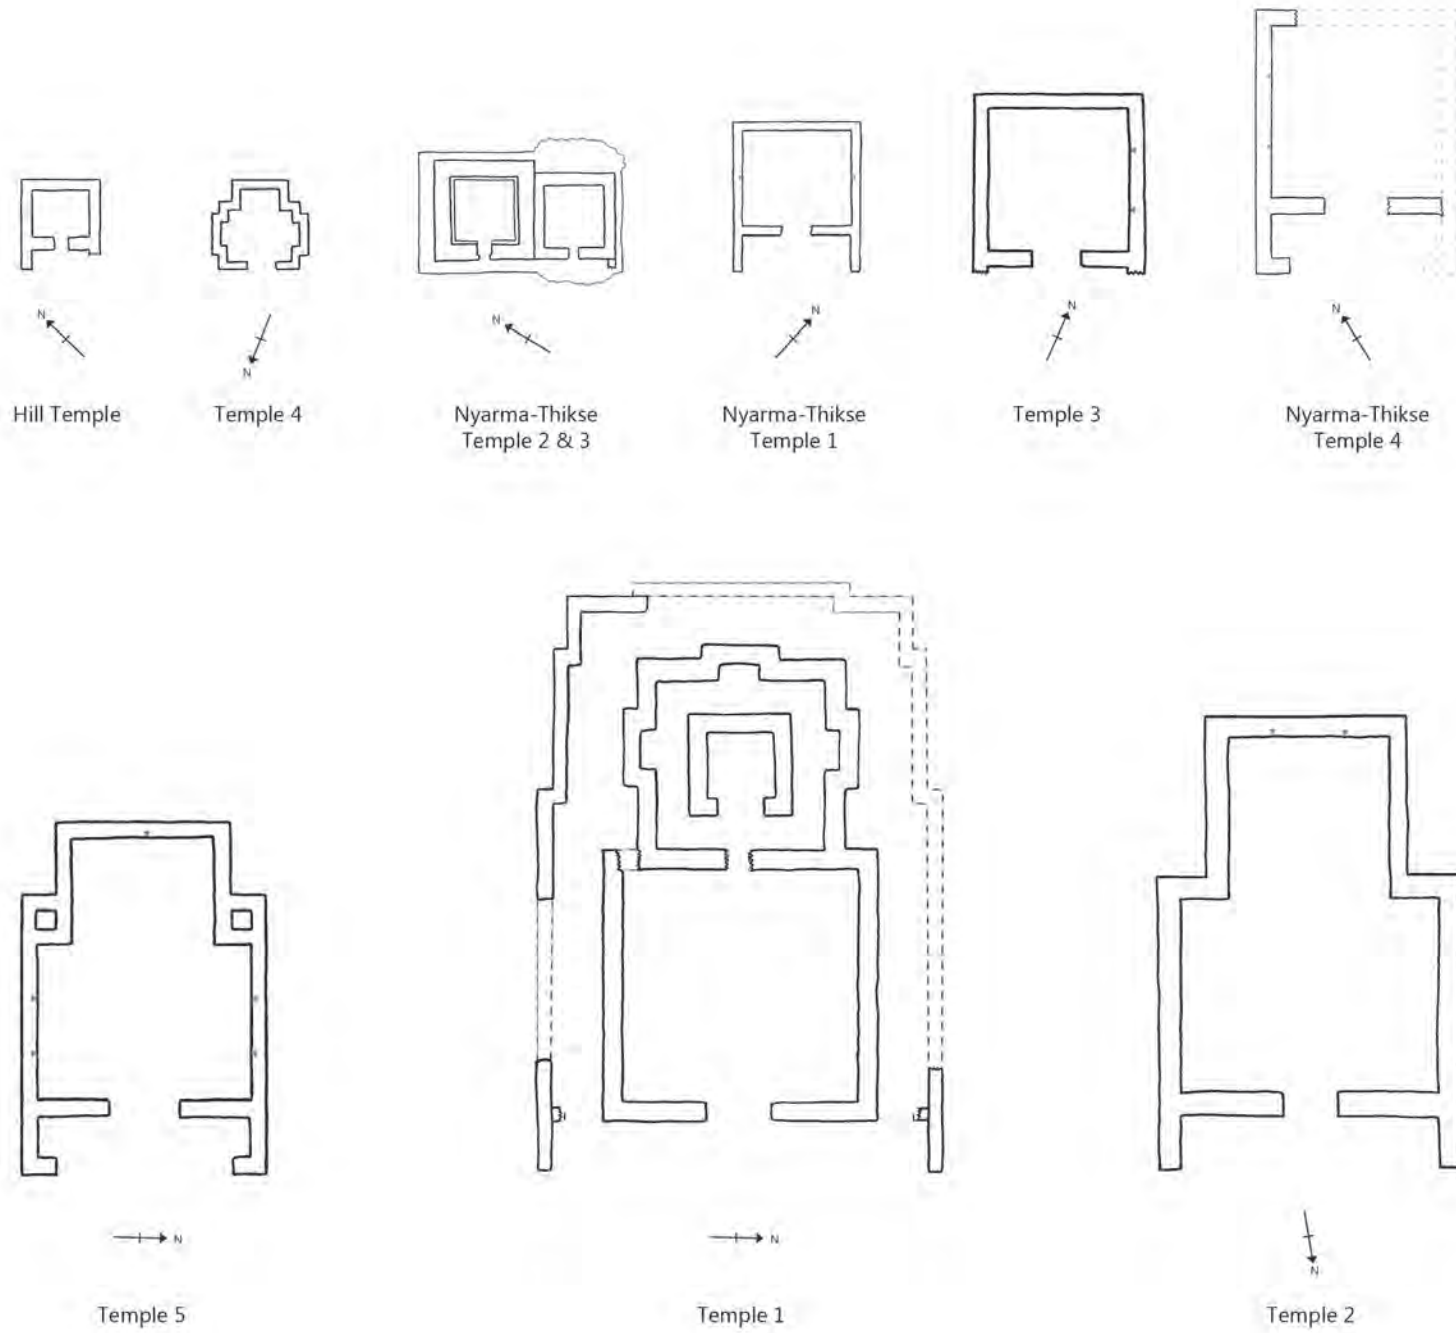
53. Comparison of the different temples (Q. Devers, 2012).
