INFRARED THERMOGRAPHY OF FRACTURE OF CONCRETE AND ROCK

M.P. LUONG

ABSTRACT

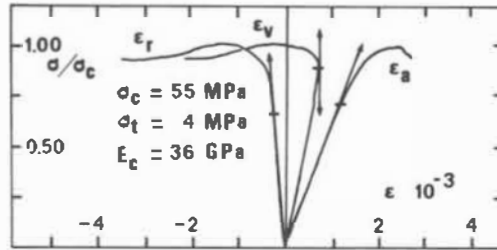
Fig. 1. Axial (ϵ_a), radial (ϵ_r) and volumetric (ϵ_v) strains of a concrete specimen subjected to a uniaxial unconfined compression.

The figure 1 presents a monotonic uniaxial compression test on a two years old concrete specimen.

The volume change detected by strain gages in transverse and longitudinal directions of the cylindrical specimen is seen to be highly relevant in characterizing the deformation of concrete under loads. It may be attributed to (1) elastic variations of minerals, (2) or to dilatancy due to growing microcracking.

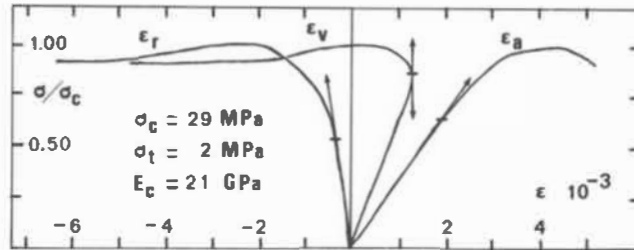
Fig. 2. Uniaxial unconfined compression on a cylindrical specimen of rock salt.

The figure 2 describes the response of a cylindrical specimen of rock salt under uniaxial unconfined compression.

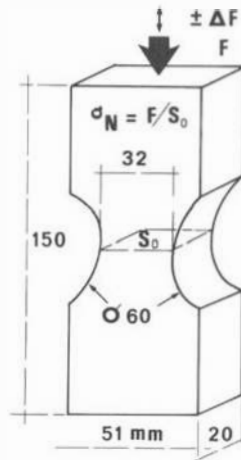
Fig. 3. Geometry and dimensions of the specimen.

The parameter investigated in this test is heat generation due to the energy dissipated by the concrete which has been excited beyond the stable reversible domain. A vibratory loading at 100 Hz on the specimen subjected to a given static compression (figure 3) exhibits in a nondestructive manner the irreversible plastic strain concentrations around gaps or cracks generated by stresses exceeding locally the stability limit of the material. The contribution of the plasticity term is revealed by the rapid evolution of heat dissipation once the stable reversible domain has been exceeded.

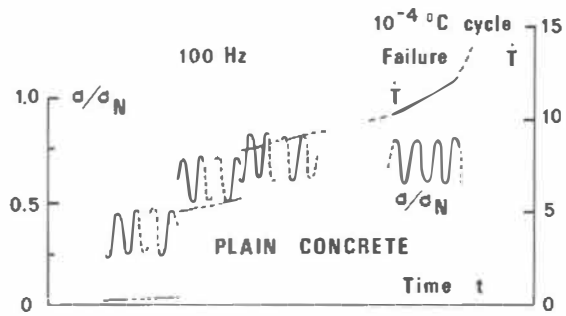
Fig. 4. Vibratory excitation on a concrete specimen subjected to various static uniaxial compression and evolution of the growth rate of heat on the warmest point.

The figures 4, 5 and 6, 7 show the different stages of heat dissipation describing the process of unstable crack propagation which occurs in specimens of plain concrete and natural rock salt.

The growth rate of heat on the warmest point enables the detection and the location of the onset of specimen failure.

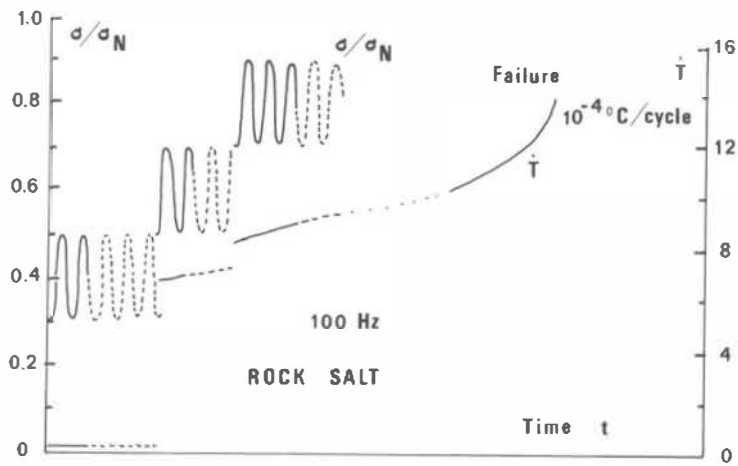
Fig. 5. Vibratory excitation on a rock salt specimen subjected to various static unconfined compression and evolution of the growth rate of heat at the warmest point.

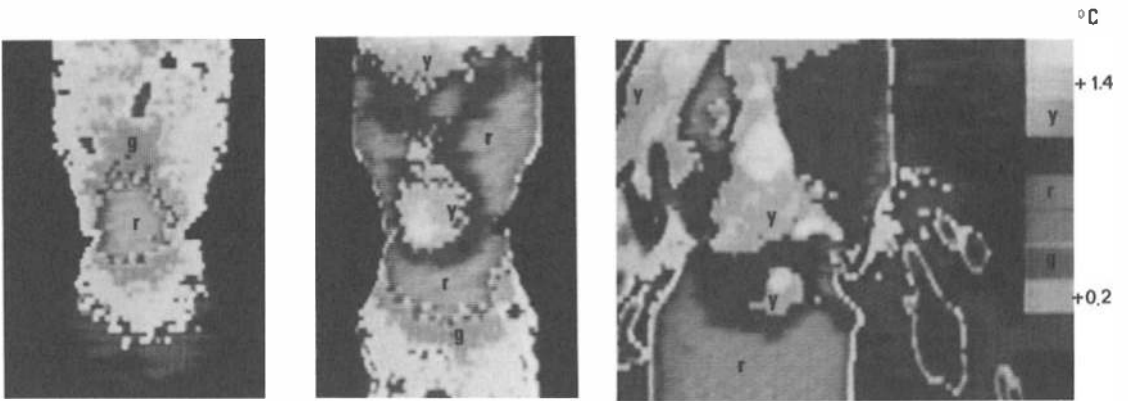
Fig. 6. Thermograms of a plain concrete specimen evidencing the process of unstable failure.

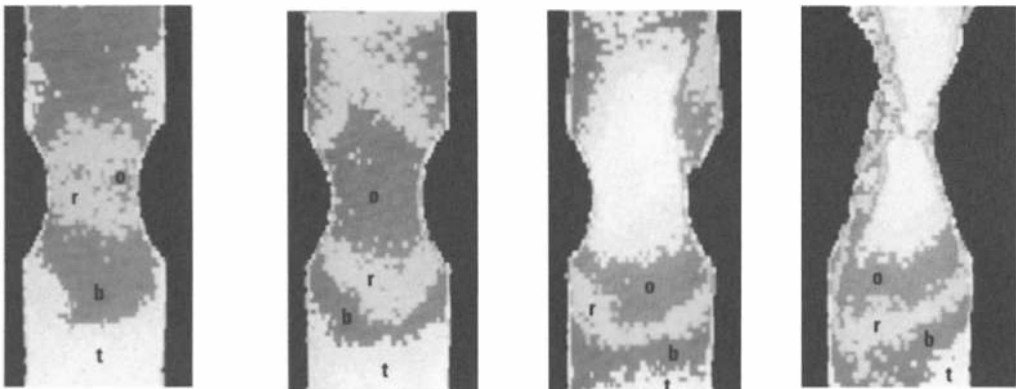
Fig. 7. Heat dissipation describing the process of unstable failure in rock salt specimen.

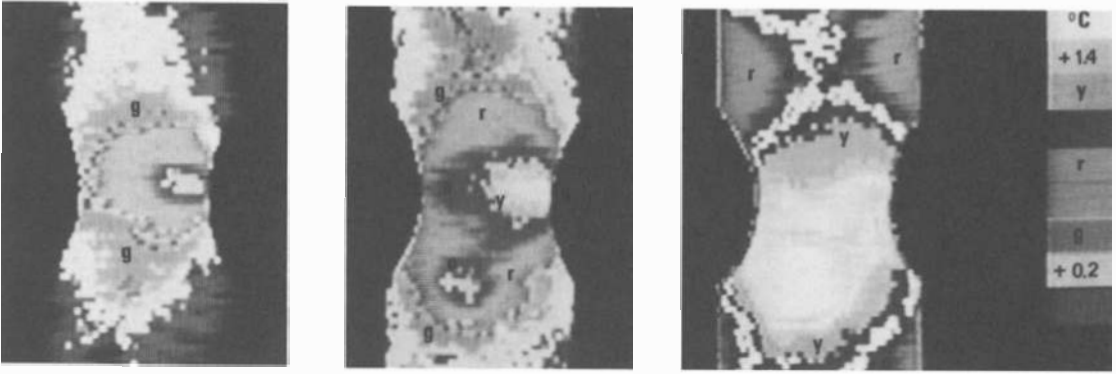
Fig. 8. Flaw coalescence mechanism occurring during concrete failure.

The figures 8 and 9 record respectively the flaw coalescence mechanism in concrete and rock salt.

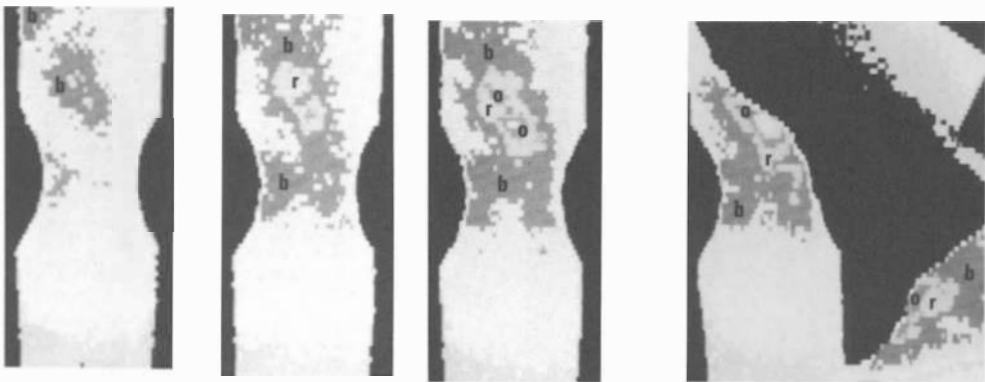
Fig. 9. Flaw coalescence achieving the progressive failure of rock salt specimen.

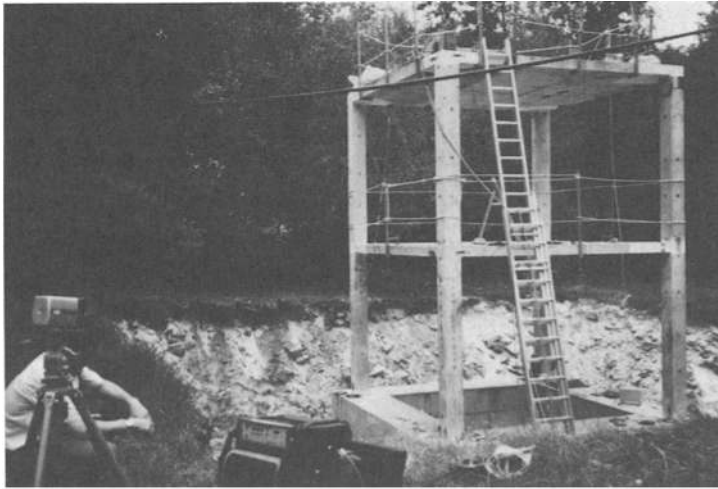
Fig. 10. Experimental concrete structure under seismic type loading generated by a rotating mass excitator on its top.

Figure 10 describes an experimental reinforced concrete building frame, intended for earthquake resistance studies. The most severe likely earthquake can be survived if the members are sufficiently ductile to absorb and dissipate seismic energy by inelastic deformations. It is recognized that the connections present adequate ductility in order to undergo large inelastic deformations with little decrease in strength. Under seismic loading, simulated by a rotating mass exciter placed on the top of the building, plastic hinges form progressively at the column bases where heat dissipation can be observed by infrared thermography.

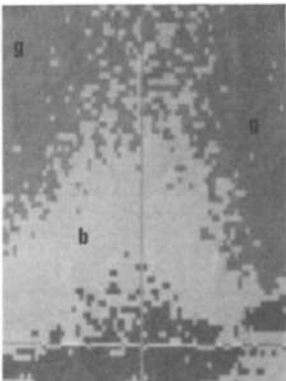
Fig. 11. Thermogram of the base of a column before the start of the excitation

Figure 11, 12 and 13 show the progressive evolution of heat dissipation at a column base before crack line is visible.

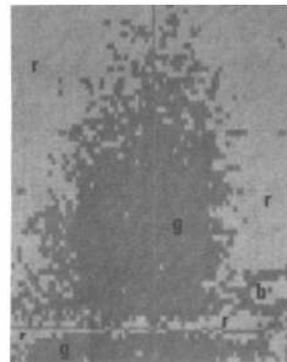
Fig. 13. Thermogram at the same location recorded before cracks are visible.
