## Detection, localization, and quantification of corrosion damage using Lamb Waves for the structural health monitoring of aluminum aeronautics structures

Julie Liegey, William Briand, Marc Rebillat, Mohamed El May, Olivier Devos,  
Nazih Mechbal

Julie Liegey, William Briand, Marc Rebillat, Mohamed El May, Olivier Devos, et al.. Detection, localization, and quantification of corrosion damage using Lamb Waves for the structural health monitoring of aluminum aeronautics structures. EWSHM2022 ( European Workshop on Structural Health Monitoring), Jul 2022, Palerme, Italy. hal-03991136

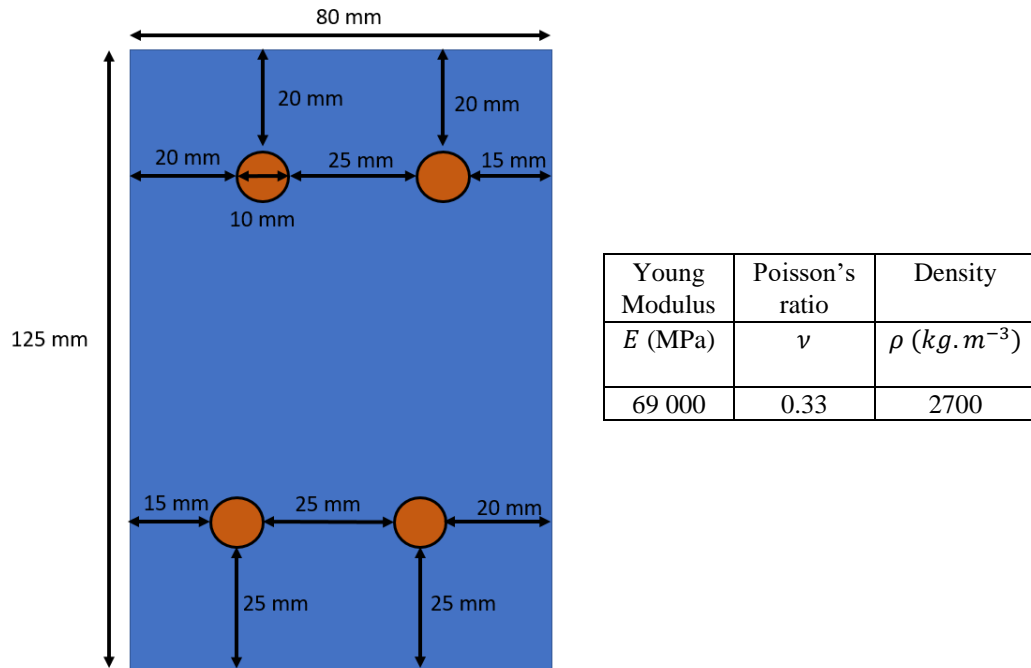
Figure 1 : [Left] Dimensions of the aluminum plate studied within the COQTEL project with the piezoelectric elements position (orange circles). [Right] Material's properties of 2024 aluminum

In this section, details about the experimental setup are presented. The material used is 2024 Aluminum alloy with the material properties provided in Figure 1 by the company Rescoll<sup>1</sup>. The studied aluminum plates dimensions are  $125 \times 80$  mm and 2 mm of thickness (see Figure 2a).

Four piezoelectric transducers were bonded to the aluminum plates and positioned strategically (not symmetric to the center to avoid recording reflected signals) as shown in Figure 1.

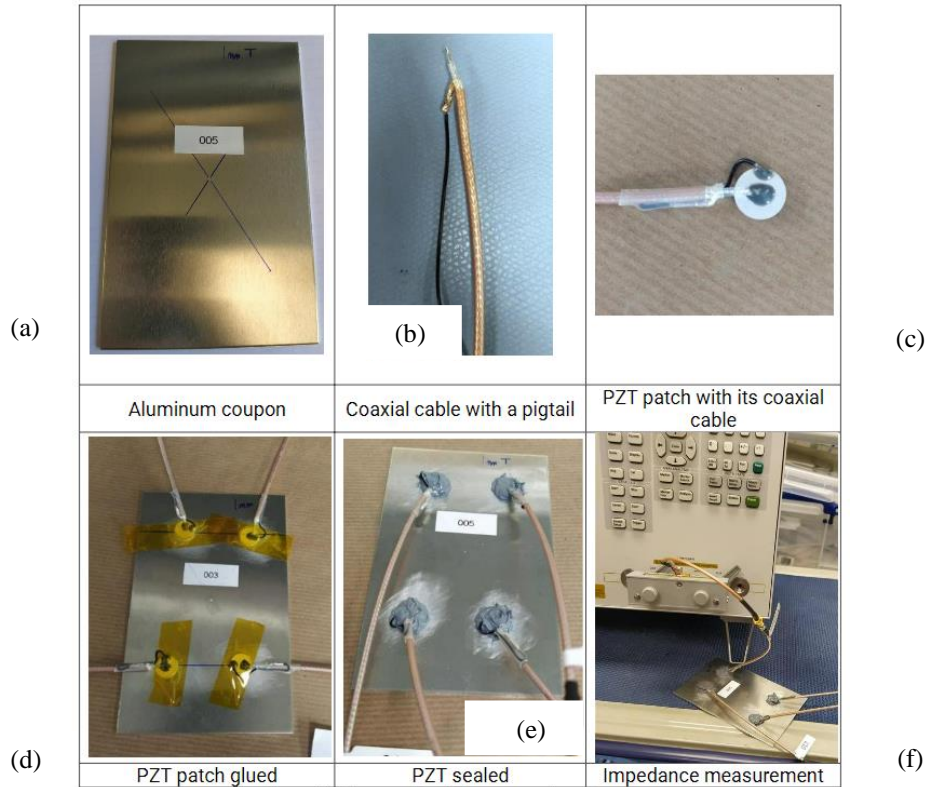
Figure 2 : Experiment set up with PWAS and aluminum plate

The chosen piezoelectric transducers are made up of NCE51 material provided by Noliac and have a 5mm radius allowing them to measure a target frequency bandwidth contained between 50 kHz and 400 kHz using a sampling frequency of 2 MHz. These piezoelectric elements have been bonded on the aluminum coupons by Cedrat Technologies<sup>2</sup>. They are 1mm thick because such thickness allows them to catch more energy than larger thicknesses (like 2 or 3 mm) and not to be too brittle. A coaxial cable of length 150 mm (see Figure 2b and 2c) has been brazed directly on each element in order to optimize the signal to noise ratio. The piezoelectric elements are then bonded to the plate and made waterproof using a specific coating (see Figure 2d&e).

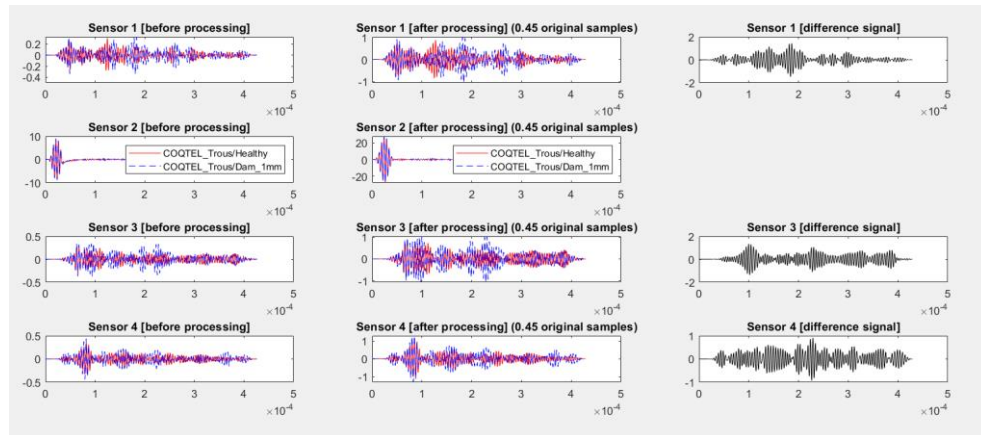
Figure 4 : Signals from plate with 1mm defect at 200kHz and with the piezoelectric element number 2 used as an actuator. On the left column, the signals are raw. In the middle one, the denoised and time aligned reference and current signals are presented. On the right one, the difference signals (*i.e.* the differences between the healthy and damaged signals) are shown.

To exploit the recorded Lamb wave data, signals from the damaged plate are compared to the healthy ones. For example, below are shown the signals received and processed from the plate with the 1mm damage and at 200kHz with the piezoelectric element number 2 being active. On the left column, the signals are raw. In the middle one, the denoised and time aligned reference and current signals are presented. On the right one, the difference signals (*i.e.* the differences between the healthy and damaged signals) are shown.

Given the received signals, a clear difference between the signal associated to corrosion damage and the healthy one can be seen. The hole of 1mm radius and 1mm of depth is thus clearly detectable using Lamb waves and this is also true for the smaller holes. The detection step is thus correctly achieved using Lamb waves.

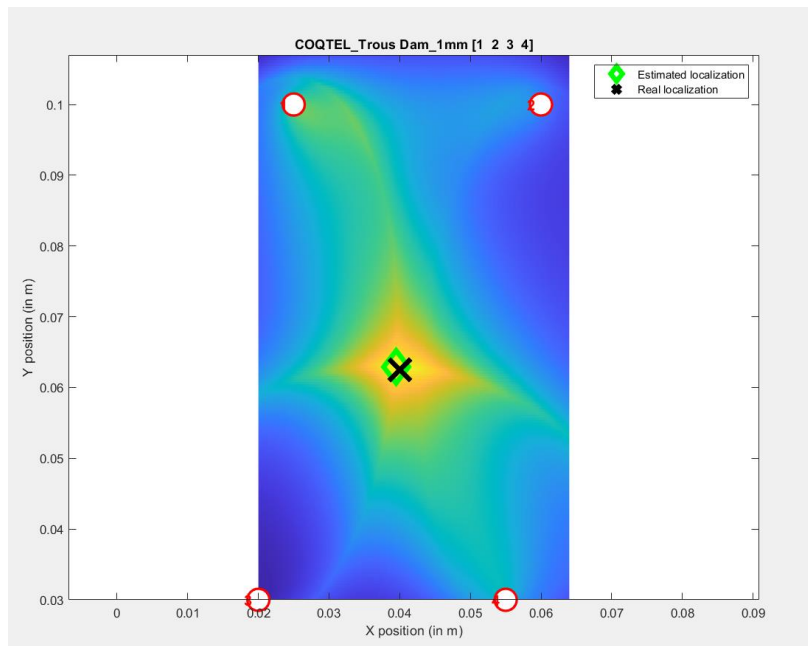
Figure 5 : Damage localization results for the damage of 1mm at 200kHz

To localize the damage, the ponderated ToA method mentioned earlier is used and pictured below. The time of flight corresponds to the time taken by the wave packet to travel from an actuator to a sensor along a given path. It is a feature extracted from the scattered signal that is used for damage localization purposes as it contains information related with damage position. More precisely, the ToA method ponderated using the CC damage index is used. It means that when adding up the ellipse corresponding to each path, they are weighted by the CC value corresponding to each path. In practice, ellipses having a high DI value count more than the one with a lower CC value in the final imaging results. Like the rest of the graphs shown before, the example of the plate with 1mm hole defect is displayed and the frequency sent by the piezoelectric 2 is 200kHz. As the picture below illustrates, the estimated localization damage (green diamond) is very close, if not superimposed, to the real localization of the damage (black "x"). This algorithm also provided correct localization results for the other damage sizes thus validating its effectiveness for corrosion-like damage monitoring.

To quantify the damage, the IPP damage quantification method was used as mentioned earlier. This method consists in computing a damage localization map and in extracting from this map the area above a given threshold (the yellow points in the above figure). When the damage size is increasing, this area is also very likely to increase and thus provide a reliable cue to damage size quantification. A polynomial regression between the area size and the actual damage size then allows to extrapolate to unknown damage sizes. A figure representing the estimated damage size versus the actual damage size is plotted. Only small damage sizes have been used for learning purposes and then the

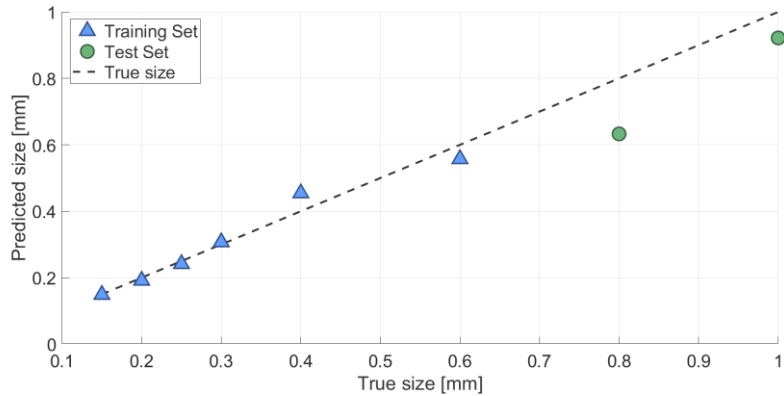
Figure 6 : Example of damage size quantification achieved by the IPP approach. The IPP algorithm has been trained on blue triangle and predicts sizes corresponding to green circles.

ability of the algorithm to extrapolate to larger damage sizes have been assessed. Points close to the diagonal line indicated correct damage size quantification. Learning points are shown in blue and prediction points in green. This example illustrates the fact that such algorithm is able to quantify correctly the size of corrosion-like damages.
