Elisabeth Marie Victoire, Véronique Bouteiller, Myriam Bouichou, Mirah Rakarabo, Victor da Silva, et al.. Concrete of tomorrow: corrosion performances in marine environment.. Concrete Solutions 2022 - the 8th International Conference on Concrete Repair, Durability and Concrete Technology, Jul 2022, Leeds, United Kingdom. 7 p., photos, graph., bibliogr. hal-04018305

# Concrete of tomorrow: corrosion performances in marine environment

Within the frame of the French national project PERDUB [1], an intensive series of studies mixing lab scale, natural ageing and durability modelling was launched in 2015. The aims of the project are multiple. One of these is to provide innovative concrete mix designs to improve durability performances and lower carbon footprint. Another one is to characterize the performances of these concretes, especially against carbonation and chloride ingress. For the latest, a vast database of performances is being produced at the lab scale in combination with life cycle modelling. A last part of the project is dedicated to the evaluation of the performances of 11 of the concrete mixes designed against corrosion induced by natural carbonation or exposure to marin

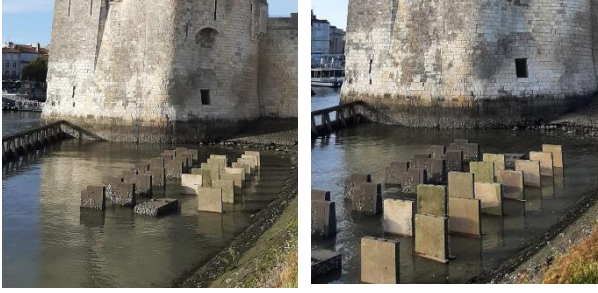
**Fig. 9.** During the tide's descent, the bottom of the walls remains a longer time immersed.

Another phenomenon can be observed on the potential maps, which exhibit an electronegative gradient from the top to the bottom of the walls on both faces, but clearer with the lowest concrete cover (RL10 and HA10, Fig. 6). The explanation could come from the duration of the tide's descent on the one hand, as the bottom of the walls stays wet a longer time (Fig. 8). On the other hand, when the tidal coefficient is low, the walls are not totally immersed (Fig. 9), which means that the top of the walls remains in the open air and can dry, while the bottom is totally under water.

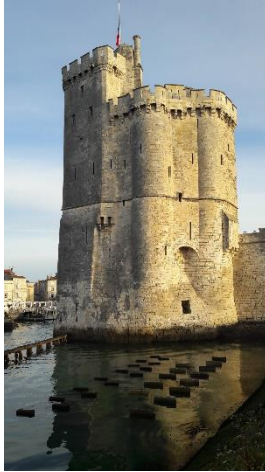
**Fig. 10.** At high tide of low coefficient, the top of the walls remains in the open air.
