Concrete of tomorrow: corrosion performances in marine environment.

Elisabeth Marie Victoire, Véronique Bouteiller, Myriam Bouichou, Mirah Rakarabo, Victor da Silva, et al.. Concrete of tomorrow: corrosion performances in marine environment.. Concrete Solutions 2022 - the 8th International Conference on Concrete Repair, Durability and Concrete Technology, Jul 2022, Leeds, United Kingdom. 7 p., photos, graph., bibliogr. hal-04018305

Concrete of tomorrow: corrosion performances in marine environment

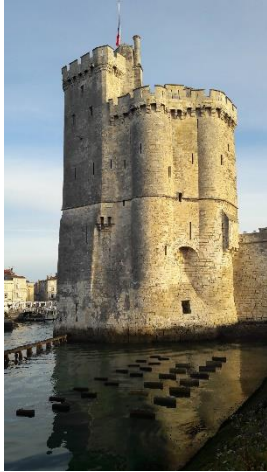
Fig. 10. At high tide of low coefficient, the top of the walls remains in the open air.

Another phenomenon can be observed on the potential maps, which exhibit an electronegative gradient from the top to the bottom of the walls on both faces, but clearer with the lowest concrete cover (RL10 and HA10, Fig. 6). The explanation could come from the duration of the tide's descent on the one hand, as the bottom of the walls stays wet a longer time (Fig. 8). On the other hand, when the tidal coefficient is low, the walls are not totally immersed (Fig. 9), which means that the top of the walls remains in the open air and can dry, while the bottom is totally under water.
