## Reassessing the seismic hazard in the Cusco area, Peru: New contribution coming from an archaeoseismological survey on Inca remains

## **Reassessing the seismic hazard in the Cusco area, Peru: New contribution coming from an archaeoseismological survey on Inca remains**

Archaeoseismology; Inca architecture; Earthquake damage; Seismic hazard; Heritage; Cusco

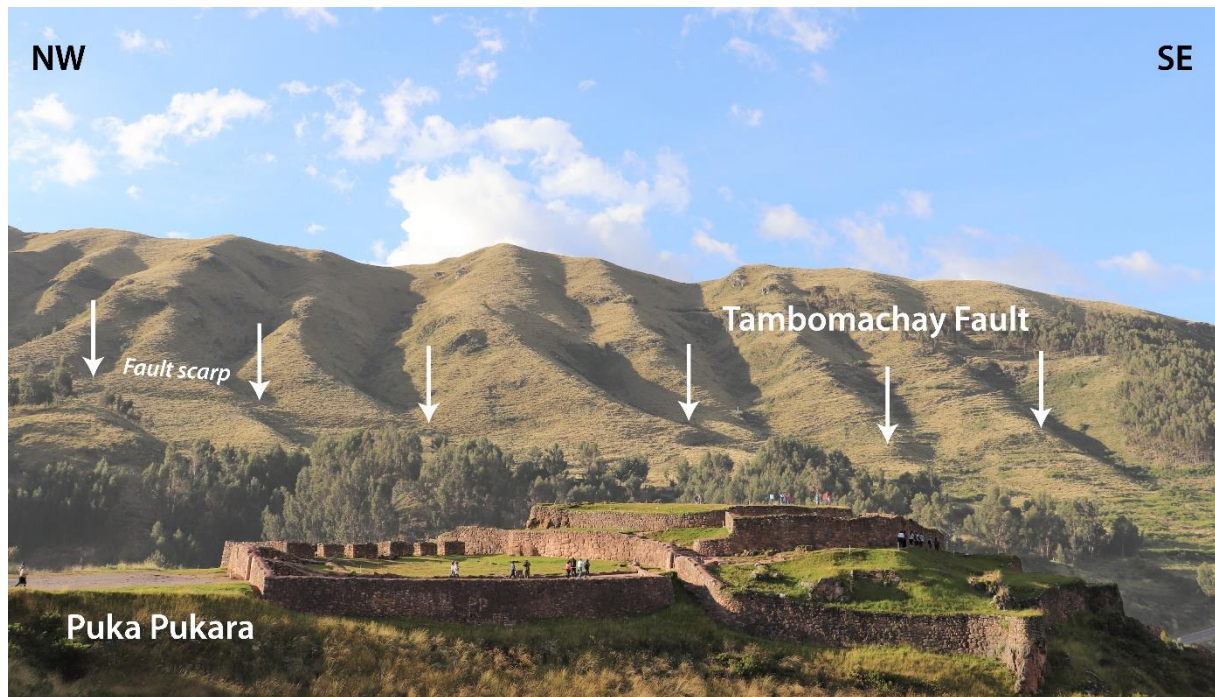
**Fig.2** View of the Tambomachay Fault from the Puka Pukara site.
