Results from InSight Robotic Arm Activities

M. Golombek, T. Hudson, P. Bailey, N. Balabanska, E. Marteau, et al.. Results from InSight Robotic Arm Activities. *Space Science Reviews*, 2023, 219 (3), pp.20. 10.1007/s11214-023-00964-0. hal-04066274

Abstract

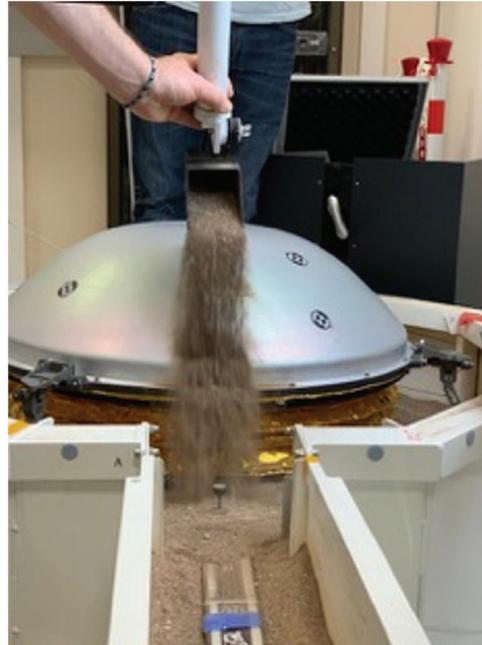
Fig. 9 Dump test on the WTS and SEIS tether in CNES testbed, using a hand-held three dimensional model scoop. Note the ball on the post of the pinning mass of the tether upon which soil is being dumped

scoop onto the tether. There were two techniques for dumping soil on the tether. The first poured soil directly on the tether. The second poured the soil on the dome of the WTS so it slid off onto the tether close to the WTS. Dumping soil on the WTS was carried out to reduce the chance of soil pushing against the WTS skirt and potentially breaking its seal with the ground.

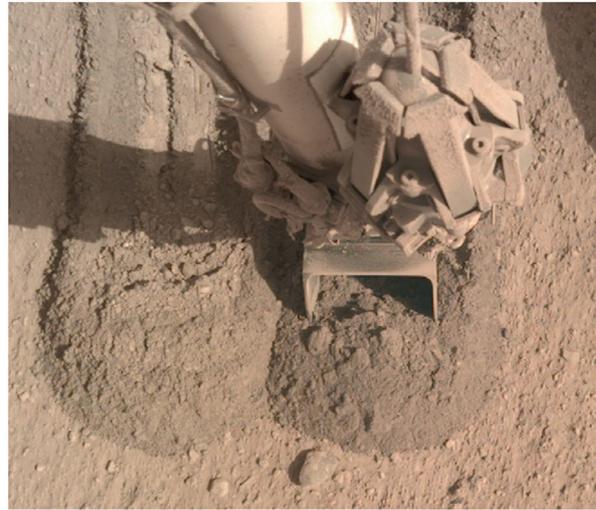
Fig. 11 IDC images showing (a) excavating soil into the scoop, and (b) the scoop filled with soil on sol 816. Note clods of soil in the scoop. (a) IDC image D000M0816_668978122EDR_F0000_0900M4. (b) IDC image D000M0816_allowbreak 668978338EDR_F0000_0901M2

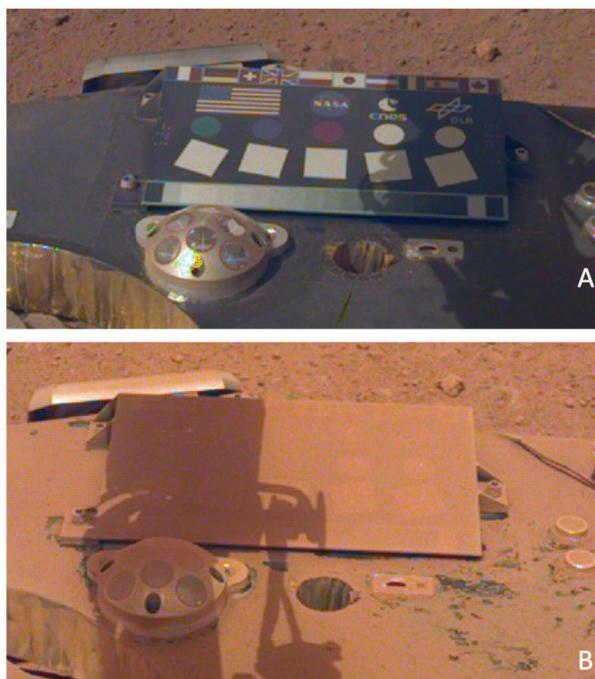
Fig. 19 IDC images of the calibration target on sol 12 (A) and sol 1238 (B) showing the accumulation of dust over the mission that almost completely obscured it

Changes in the rate of power decay can be most closely correlated to the amount of dust present in the local atmosphere, which controls the rate at which dust falls into the arrays. Observations indicate that the greater the amount of dust in the local atmosphere, the higher the rate of decay of the dust factor with significant drops after sols 50, 550, 710, 1110, and 1250 (Figs. 16 and 17). The amount of dust on the spacecraft has increased through time. Figure 18 shows spacecraft selfies obtained on sols 10 and 1211. The deck and solar arrays are almost completely obscured by sol 1211, which corresponds to the 90% drop in power over that time. Close up IDC images of the calibration target obtained on sol 12 and 1238 shows the targets are almost completely obscured by dust at the later sol (Fig. 19).

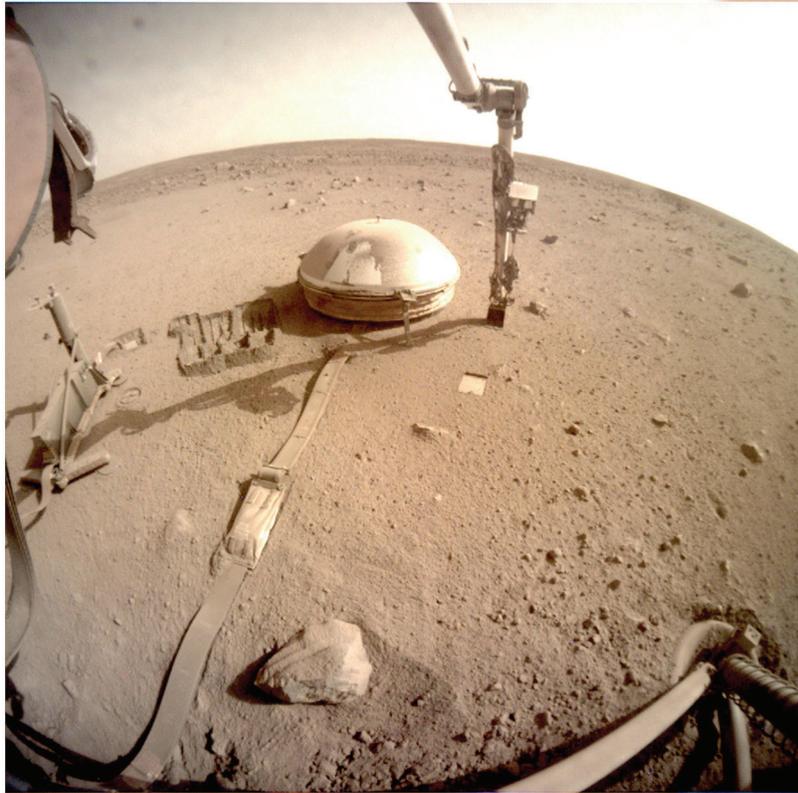
Fig. 26 ICC image on sol 1170 showing the IDA performing the second elastic properties experiment by repeatedly pushing on the ground resulting in a tilt recorded by SEIS. Rectangular smooth patch closer to the lander is the imprint of the back of the scoop from the indentation experiment and the first elastic properties experiment. Note the scrapes in the soil between SEIS and HP³ showing the surface after tether burial (soil on top of tether near the WTS) and six of the solar array cleaning experiments. Rectangular smooth patch to the left (east) of the scrapes is where the back of the scoop tamped down the soil over the buried mole, with the HP³ SSA nearby (Sect. 7). Note how dusty the SEIS tether and HP³ (and spacecraft) are

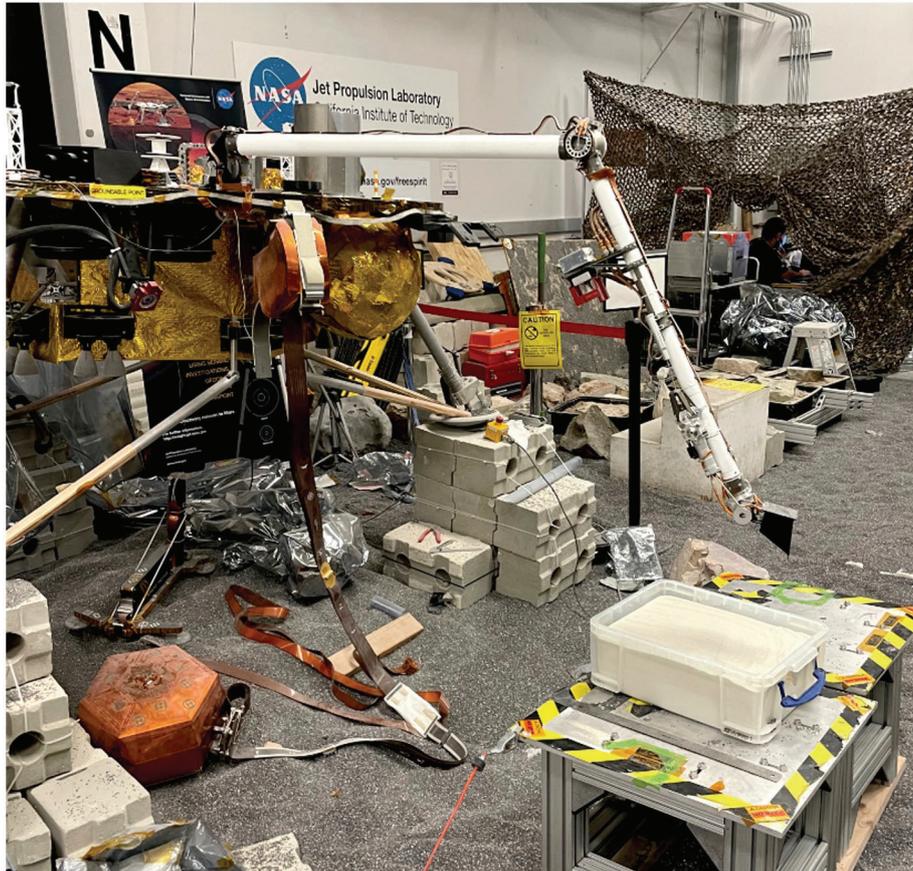
Fig. 27 Picture of the engineering model lander, robotic arm, and scoop in the JPL testbed. Note the container of simulant below the arm as well as the SEIS and HP³ models on the surface to the left. The IDC is on the forearm of the IDA and the ICC is mounted beneath the deck to the left (with red around the lens). Note the lander feet were placed on cinder blocks to enable end to end testing of arm activities that assisted the HP³ mole and interacted with the surface

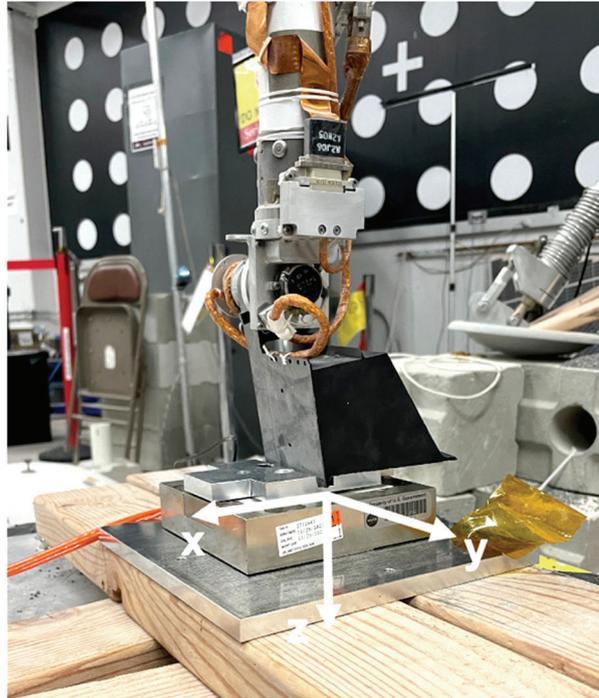
(Keysight DAQ34972a). A top plate is mounted on the load cell and designed with a groove to fit the scoop when pushing with its tip or flat bottom. The load cell is also bolted to a base plate that remains parallel to the top plate. Figure 28 shows the IDA scoop pressing with its flat bottom on the multi-axis load cell setup. Tests were run at three different locations to match those done at Mars near the HP³ hole, at the Indentation and first Elastic Properties location, and at the second Elastic Properties location. Near HP³, the scoop external loads are measured for both the flat and tip pushes.
