Results from InSight Robotic Arm Activities

M. Golombek, T. Hudson, P. Bailey, N. Balabanska, E. Marteau, et al.. Results from InSight Robotic Arm Activities. *Space Science Reviews*, 2023, 219 (3), pp.20. 10.1007/s11214-023-00964-0. hal-04066274

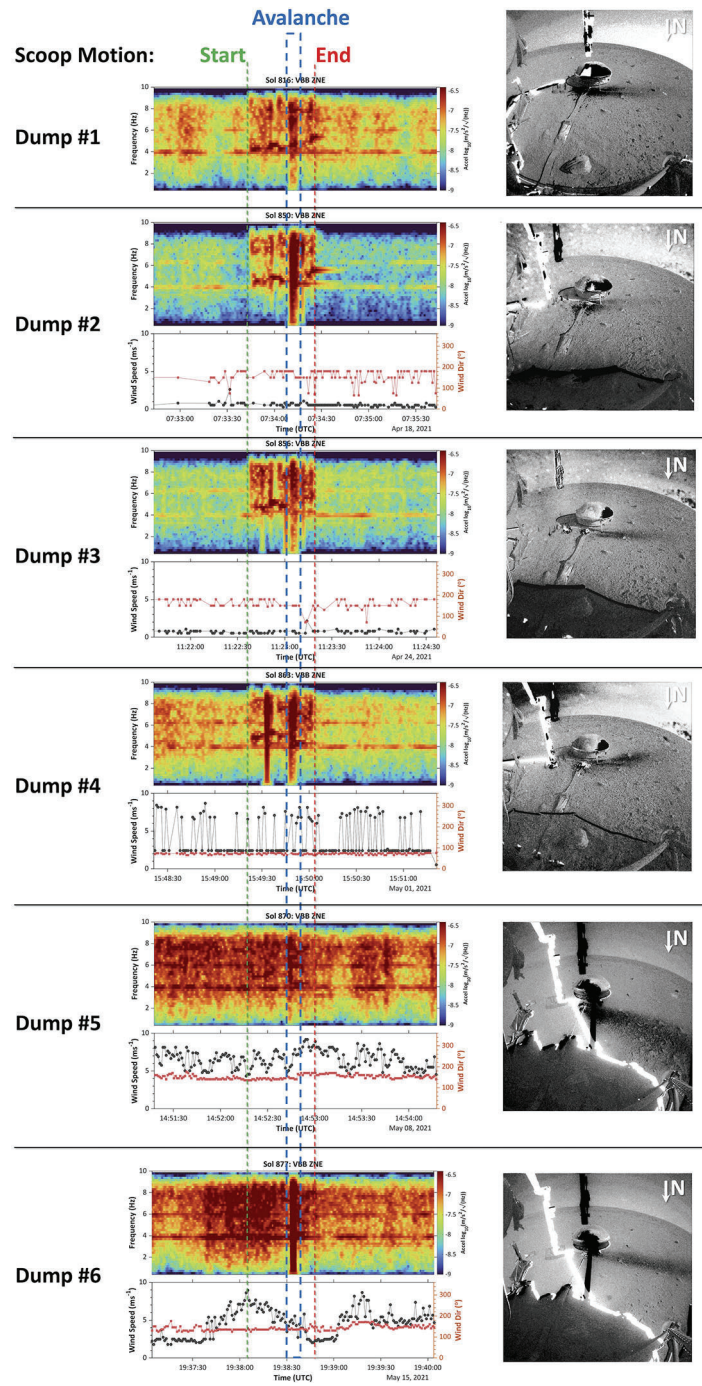
Fig. 15 Summary of six tether burial dumps showing SEIS acceleration frequency response with the start, end and main avalanche indicated, wind speed and direction, and before-after differenced ICC images showing darker areas of the pile and dispersed soil

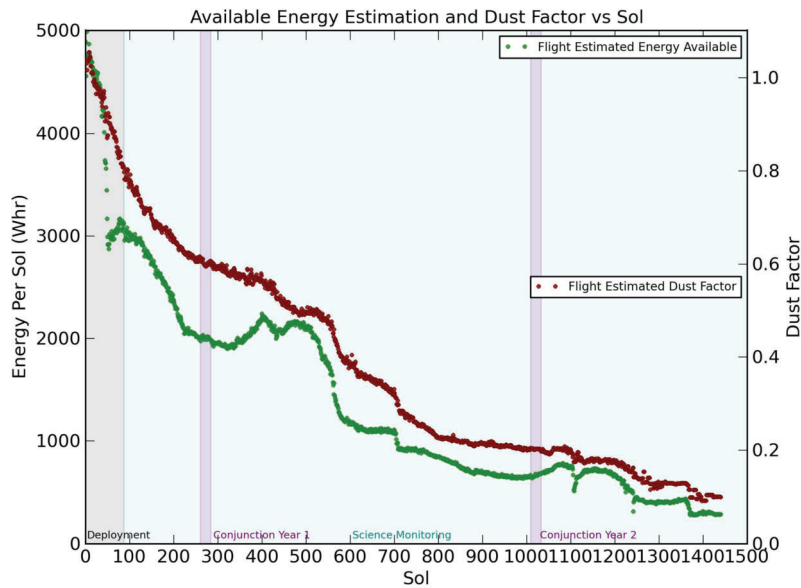
Fig. 16 Plot of energy generated per sol (green) and the dust factor (red) versus time (sol) of the InSight lander. Power decreased exponentially and the dust factor worsened by $\sim 90\%$ in the roughly 2 Mars years of the mission (1442 sols). Increased rates of change in dust factor (and power production) correlate with periods of higher atmospheric opacity associated with dust storms

The dust accumulation on the InSight arrays was essentially unremitting (Lorenz et al. 2021a), with only one or two detectable cleanings of the order of 1% (e.g., Figs. 16). This is in stark contrast to the quasi-regular 30% cleaning events seen on Spirit and Opportunity’s solar panels (Stella and Herman 2010), and on optical sensors on Curiosity (Vicente-Retortillo et al. 2018; Lorenz et al. 2021b). One speculation has been that stronger back-ground winds cause shear that suppresses the formation of the largest, most intense vortices which are responsible for the majority of dust lifting. This is supported by the increase in power law slope of the vortex pressure drop (a measure of intensity) in the InSight population measured by the meteorology instruments compared with other missions (e.g., Banfield et al. 2020), and in the character of the dust devil tracks at InSight compared with Gusev. These are both narrower (suggesting an absence of large vortices) and straighter (suggesting advection dominated by background winds) (e.g., Spiga et al. 2021; Chatain et al. 2021) in contrast with the cycloidal, meandering tracks often seen at Gusev.

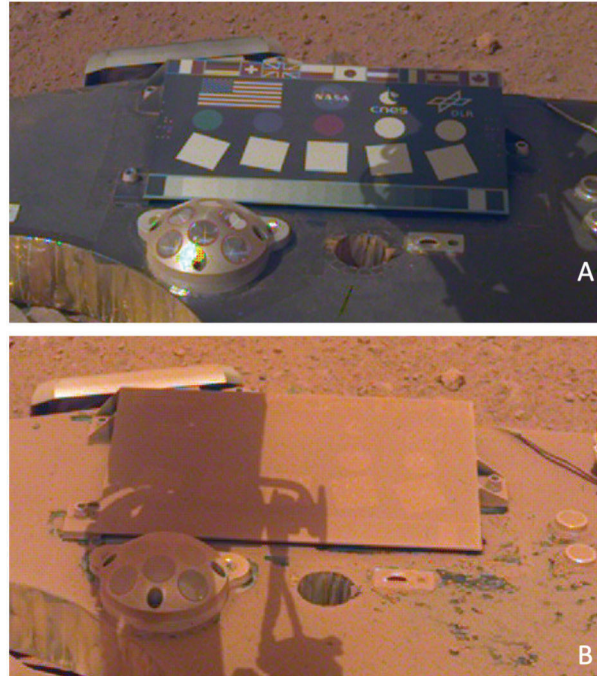
Fig. 19 IDC images of the calibration target on sol 12 (A) and sol 1238 (B) showing the accumulation of dust over the mission that almost completely obscured it

Changes in the rate of power decay can be most closely correlated to the amount of dust present in the local atmosphere, which controls the rate at which dust falls into the arrays. Observations indicate that the greater the amount of dust in the local atmosphere, the higher the rate of decay of the dust factor with significant drops after sols 50, 550, 710, 1110, and 1250 (Figs. 16 and 17). The amount of dust on the spacecraft has increased through time. Figure 18 show spacecraft selfies obtained on sols 10 and 1211. The deck and solar arrays are almost completely obscured by sol 1211, which corresponds to the 90% drop in power over that time. Close up IDC images of the calibration target obtained on sol 12 and 1238 shows the targets are almost completely obscured by dust at the later sol (Fig. 19).

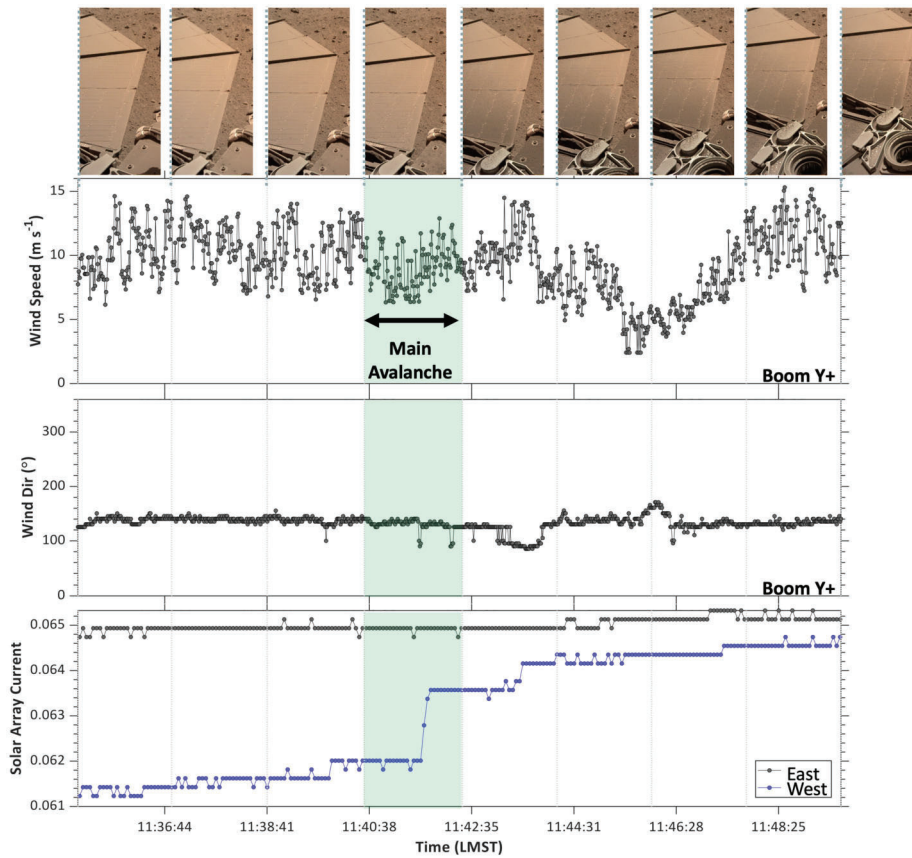
Fig. 23 Progressive IDC images of northwestern edge of the lander and the southeastern edge of the western solar array during the arm motion and dump of soil along with wind speed and direction from the TWINS +Y sensor and the detrended solar array current on both panels. The main avalanche from the scoop occurred between 11:40 and 11:42 LMST on sol 884 and resulted in a 3% increase in solar array current for the west array
