Results from InSight Robotic Arm Activities

M. Golombek, T. Hudson, P. Bailey, N. Balabanska, E. Marteau, et al.. Results from InSight Robotic Arm Activities. *Space Science Reviews*, 2023, 219 (3), pp.20. 10.1007/s11214-023-00964-0. hal-04066274

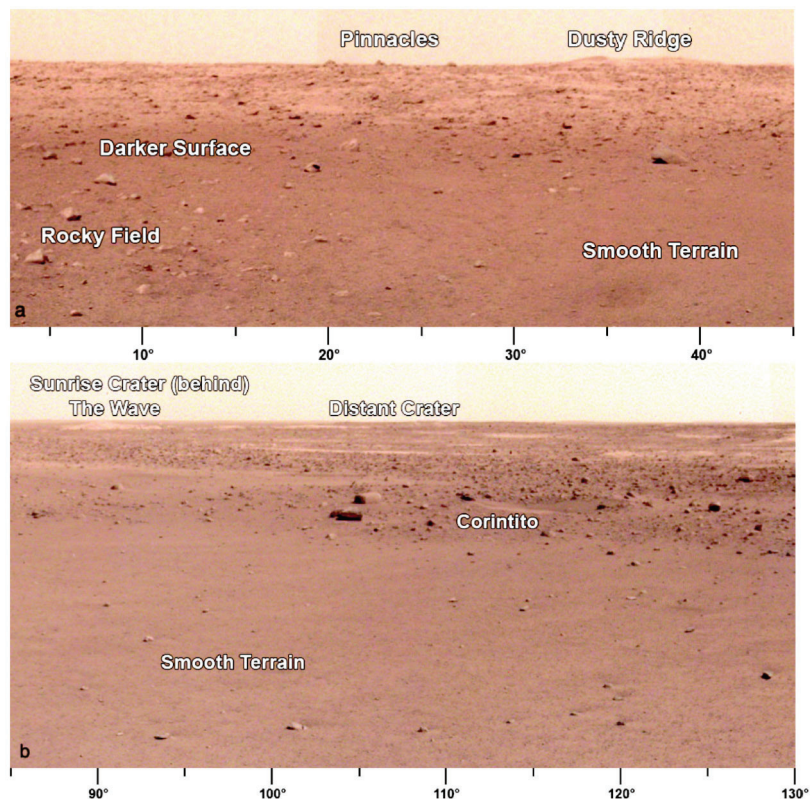
Fig. 7 Portion of a panorama around the InSight lander. a) Area to the north-northeast of the lander (azimuths below image) shows a darker surface, where dust was removed within 20 m of the lander. Rockier surface is to the west (Rocky field), and smooth terrain of Homestead hollow is to the east. The Pinnacles rocks and Dusty Ridge (a bright eolian bedform) on the southern edge of a degraded impact crater, are located about 50 m north of the lander. b) East-southeast (azimuths below image) of the lander shows smooth terrain to the edge of Homestead hollow and rougher and rockier terrain beyond. The Corinto secondary crater (Corintito) is on the edge of the hollow and <2.5 Ma (Golombek et al. 2020a). Circular soil filled depressions (hollows) are in the distance, and bright eolian bedforms (The Wave) and Sunrise crater rim are on the horizon about 400 m away. The rim of Distant crater, a larger (460 m diameter), relatively fresh crater to the east-southeast is ~2.4 km away

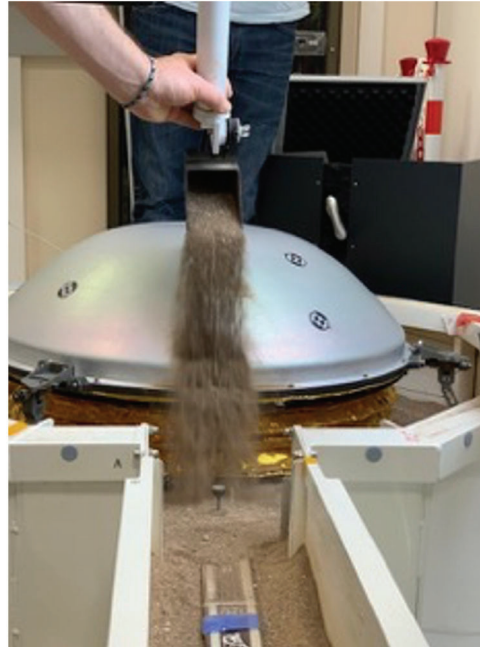
Fig. 9 Dump test on the WTS and SEIS tether in CNES testbed, using a hand-held three dimensional model scoop. Note the ball on the post of the pinning mass of the tether upon which soil is being dumped

scoop onto the tether. There were two techniques for dumping soil on the tether. The first poured soil directly on the tether. The second poured the soil on the dome of the WTS so it slid off onto the tether close to the WTS. Dumping soil on the WTS was carried out to reduce the chance of soil pushing against the WTS skirt and potentially breaking its seal with the ground.

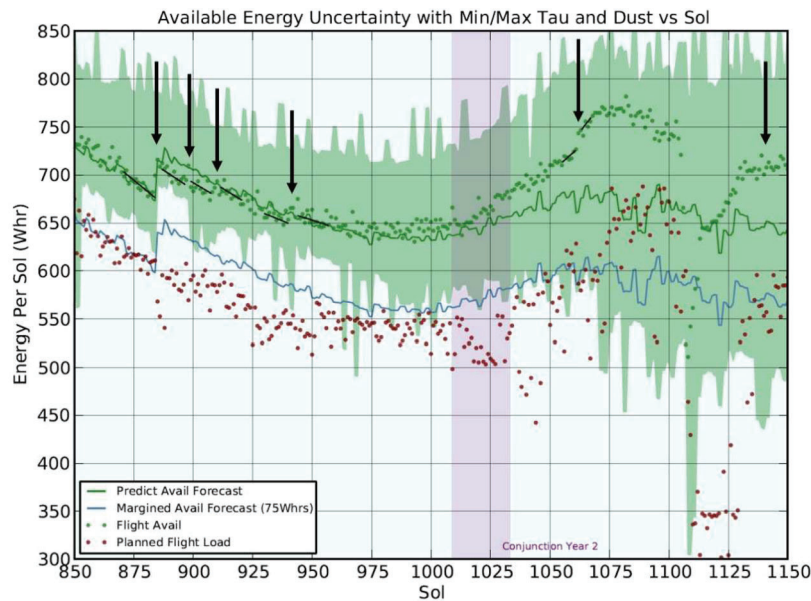
Fig. 17 Plot of InSight energy from sol 850 to sol 1150 with the first six solar array cleaning experiments marked (black arrows). The energy low centered around sol 975 is near aphelion and conjunction (in purple) when the spacecraft was out of communication with Earth. The green shaded region is the power expected bounded by maximum and minimum atmospheric opacity based on the compilation of previously measured and extrapolated tau developed for InSight (Lisano and Bernard 2014). The green dots are the energy per sol produced by the solar cells. The green line is the modeled energy produced by the spacecraft. The red dots are the energy per sol planned to be used by the spacecraft. The blue line is the modeled margined energy provided to the operations team for planning and is 75 W hrs below the modeled energy. Black lines show trends in energy per sol on either side of the first five solar array cleaning events to emphasize the jumps in energy. The largest increases occur from the first and fifth cleaning experiments. More modest increases occur at the others

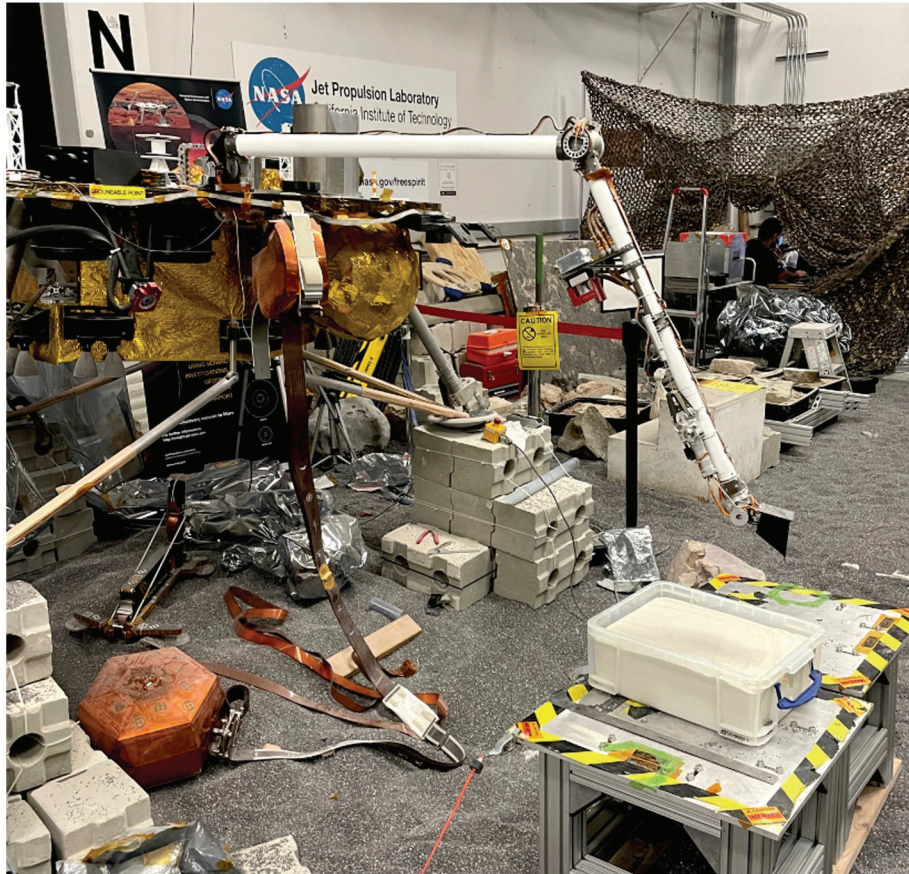
Fig. 27 Picture of the engineering model lander, robotic arm, and scoop in the JPL testbed. Note the container of simulant below the arm as well as the SEIS and HP³ models on the surface to the left. The IDC is on the forearm of the IDA and the ICC is mounted beneath the deck to the left (with red around the lens). Note the lander feet were placed on cinder blocks to enable end to end testing of arm activities that assisted the HP³ mole and interacted with the surface
