A new accelerated salt weathering test by RILEM TC 271-ASC: preliminary round robin validation

B. Lubelli · A. M. Aguilar · K. Beck · T. De Kock · J. Desarnaud ·
E. Franzoni · D. Gulotta · I. Ioannou · A. Kamat · B. Menendez ·
I. Rörig-Dalgaard · E. Sassoni

Received: 12 July 2022 / Accepted: 18 October 2022 / Published online: 15 November 2022
© The Author(s) 2022

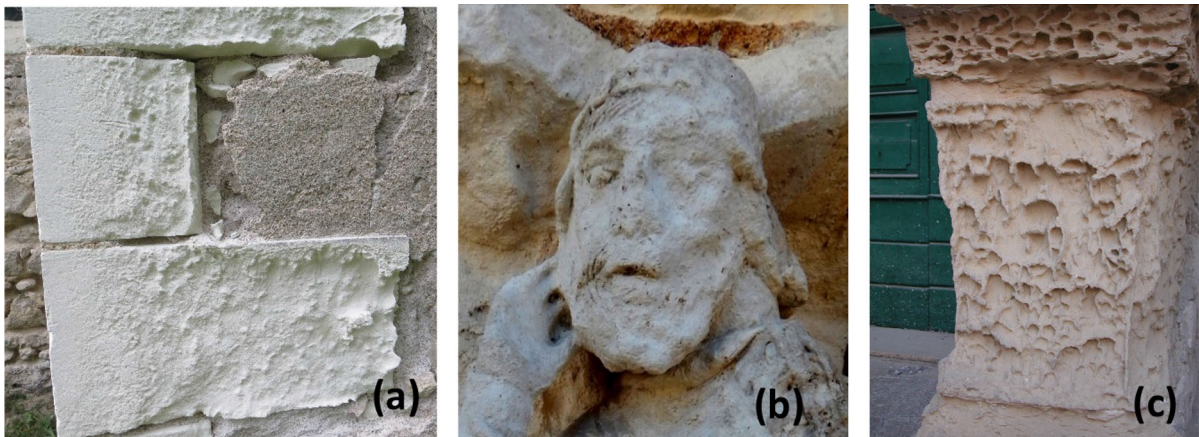
Fig. 2 Decay patterns in the presence of salts in some of the selected substrates; **a** powdering in Tuffeau, chapel of Maurepas, Chambord (F) (photo, courtesy of Kevin Beck); **b** powdering and scaling in Migné stone, Notre-Dame-la-

Grande, Poitiers (F) (photo, courtesy of Veronique Verges-Belmin); **c** Alveolization and powdering in Lecce stone, Church of S. M. del Carmelo, Nardo' (I); (photo, courtesy of Rob van Hees)

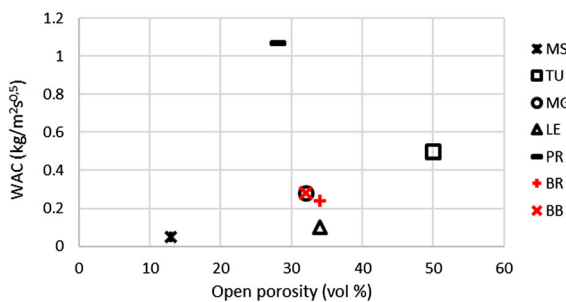
Fig. 3 Open porosity and Water Absorption Coefficient (WAC) of the selected substrates

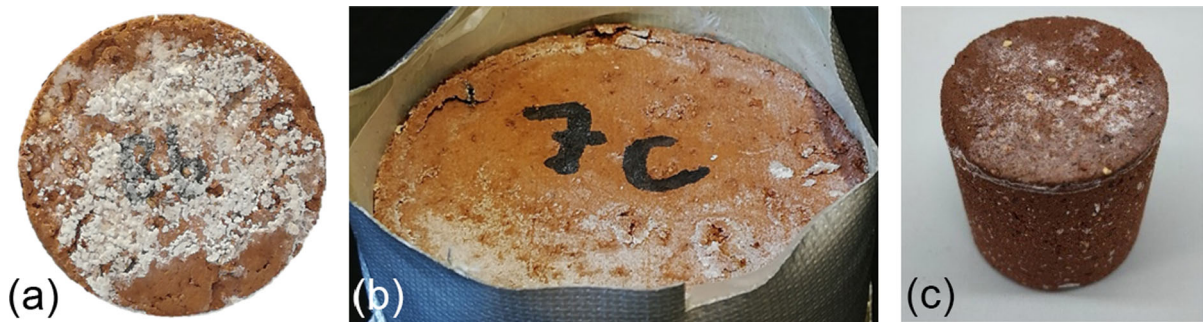
Fig. 10 **a** Decay and salt crust on Red brick specimens contaminated with 5 wt% Na_2SO_4 at the end of the test, after brushing off the evaporation surface; **b** surface of Red brick specimen contaminated with 1 wt% Na_2SO_4 , at the end of the

test, before brushing off the evaporation surface **c** decay in Red brick specimen contaminated with 5 wt% Na_2SO_4 , at the end of the test, before brushing off the evaporation surface

Red brick specimens contaminated with Na_2SO_4 exhibited no efflorescence at the end of the accumulation phase. In the propagation phase, a thin layer of efflorescence appeared on a large part of the surface, both in the case of 1 wt% and 5 wt% salt contamination (Fig. 10a). However, the mass loss due to the propagation phase found at the three laboratories involved in the testing of this substrate was different. In two laboratories, no damage was observed (Fig. 10b), while in another laboratory damage in the form of powdering and crumbling was observed and material loss was recorded (Fig. 10c); the material loss was higher in the case of the higher salt concentration (Fig. 4).

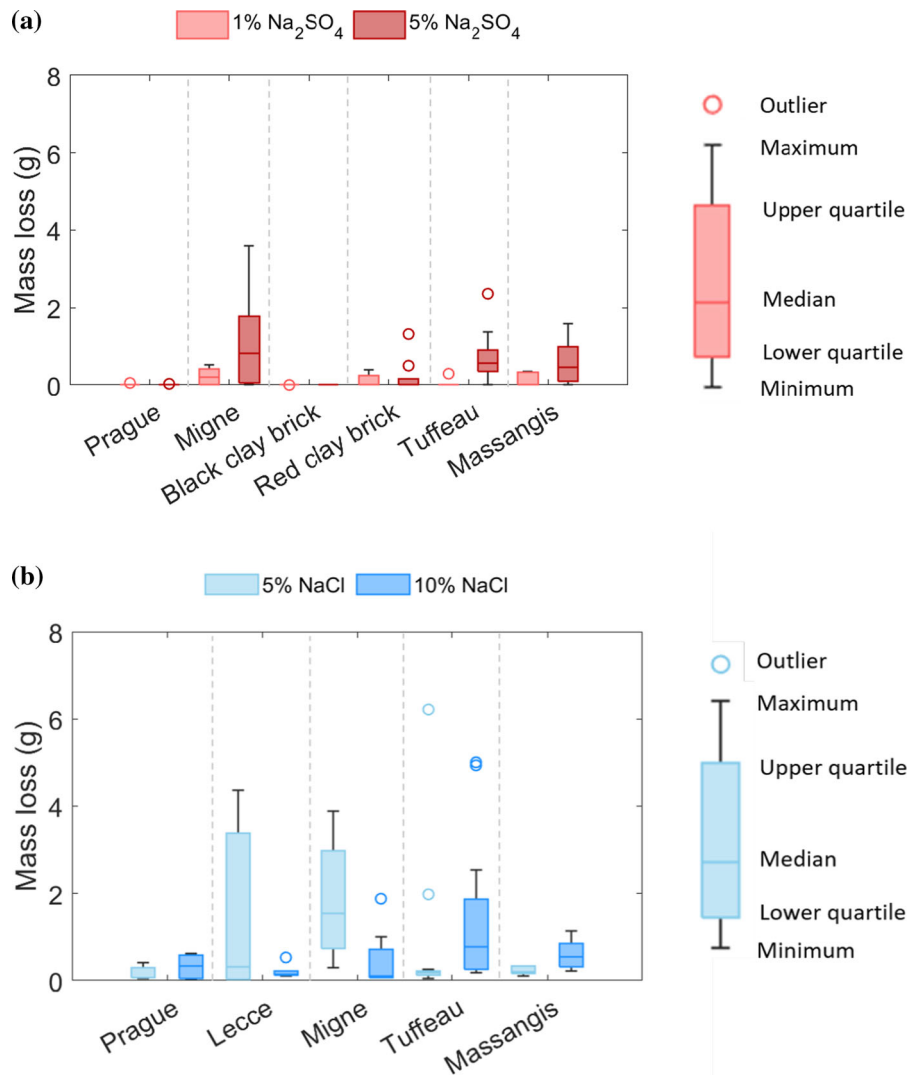
Fig. 12 Material loss measured at the end of the test at the different labs on the tested substrates contaminated with Na₂SO₄ (a) and NaCl (b)

Figure 12 reports the damage type and the material loss observed at the different labs. In general, the reproducibility of the results in the case of sodium sulphate contaminated specimens is quite good. In the case of sodium chloride contaminated specimens, a larger variation is observed: this is probably due both to the more complex procedure, which increases the chances of small differences in conditions between labs, and the occurrence of cracks parallel to the evaporation surface, leading to spalling at different moments of the test, depending on the intrinsic variability between specimens of the same type.
