Damage control of the masonry infills in RC frames under cyclic loads: a full-scale test study and numerical analyses

Qiwang Su, Gaochuang Cai, Meree Hani, Amir Si Larbi, Konstantinos Daniel Tsavdaridis

Qiwang Su, Gaochuang Cai, Meree Hani, Amir Si Larbi, Konstantinos Daniel Tsavdaridis. Damage control of the masonry infills in RC frames under cyclic loads: a full-scale test study and numerical analyses. *Bulletin of Earthquake Engineering*, 2022, 21 (2), pp.1017-1045. <10.1007/s10518-022-01565-y>. <hal-04092564>

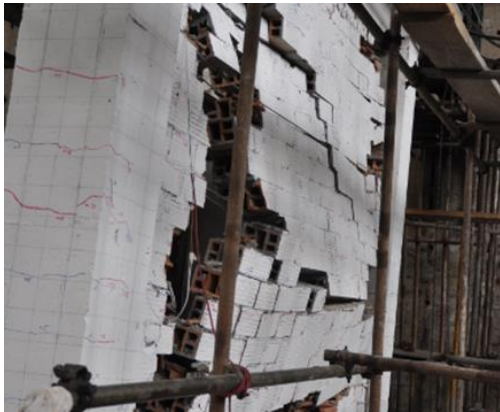
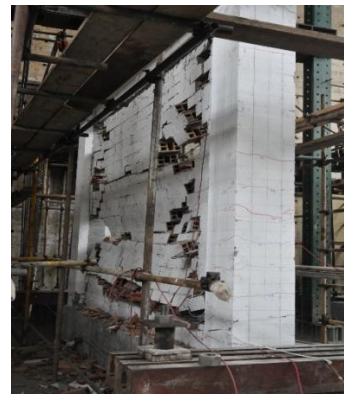
Figure 4 Damage of Specimen 1 at $R=4.0\%$

(a) front view of wall collapse

(b) back view of wall collapse

207 As shown in Figures 4 to 6, the treatment methods in the walls present a significant
 208 influence on the seismic performance of infilled RC frames. For Specimen 1, when the drift
 209 ratio was 0.25%, several cracks were observed, including diagonal and horizontal cracks on
 210 both sides of the wall, transverse cracks in the middle of the frame columns, and the diagonal
 211 zone at the ends of the frame beam (upper beam, same as below). When R reached 0.5%,

212 new cracks appeared inside the frame columns and were roughly distributed on the infilled
213 wall. The previous cracks at the ends of the beam extended to the beam edges and the beam-
214 column joint zones. While R was 1.0%, several cracks were observed in the mortar in the
215 middle of the wall and the zones of the connection rebars. Some connecting steel bars were
216 exposed and the mortar layer is completely peeled off. The mortar on the wall's middle sides
217 fell off and the upper connection bars were slightly bent outside when R reached 1.5%, and
218 several bricks were crushed and fell off on both sides of the wall at the same time. When R
219 was 2.0%, the cracks in the columns developed significantly, while the connecting rebars
220 were bent seriously and the bricks continually fell off from $R=2.5\%$. After R exceeded 3.0%,
221 the wall top was separated from the upper beam bottom, and more connecting bars were

222 exposed. Before $R=3.50\%$, the wall subsidence occurred in the specimen middle, and more
223 bricks were crushed and more connecting rebars were seriously bent. At $R=4.00\%$, the
224 infilled wall collapsed almost completely, as shown in Figure 4 (a), making the wall exhibit
225 a similar structural behavior to a bare RC frame.

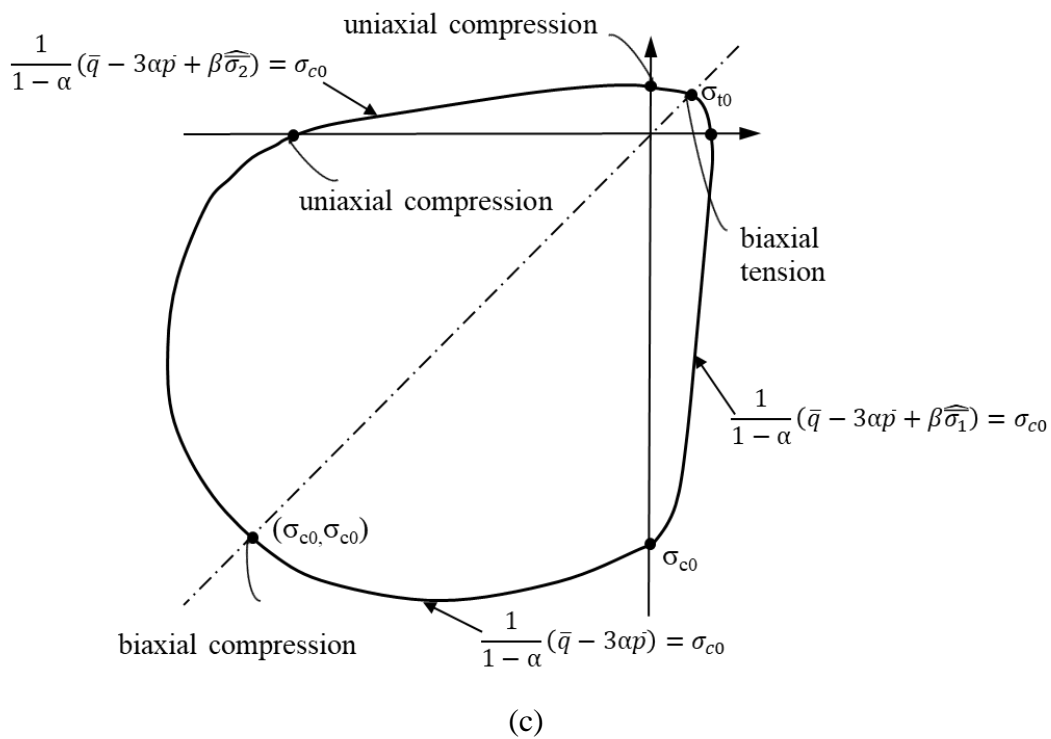
Figure 13 (a) Deviatoric cross-section of failure surface (b) hyperbolic surface of plastic potential in the meridional plane (c) constitutive model of concrete under biaxial stress

416 Besides, the concrete model used a Drucker-Prager strength hypothesis modified by
 417 Lubliner [41], and Lee and Fenves [42]. For this, the failure surface in the deviatoric cross-
 418 section was determined by Parameter K_c . It is always greater than 0.5, and the deviatoric
 419 cross-section of the failure surface becomes a circle (as Drucker-Prager strength hypothesis)
 420 when K_c is 1.0. The study used the original CDP model recommend value assuming K_c as
 421 $2/3$ [43]. For this value, the shape is similar to the strength index (a combination of three
 422 mutually tangent ellipses) formulated by William and Warnke [44], which is a theoretical-
 423 experimental index based on tri-axial stress test results, as shown in Figure 13 (a). In addition,
 424 the plastic is adjusted by eccentricity (plastic potential eccentricity) in the CDP model, which
 425 was taken as 0.1 referring to the literature, which means the surface in the meridional plane

426 becomes a straight line[39]. As shown in Figure 13 (b), the dilation angle in the CDP model
 427 was interpreted as a concrete internal friction angle, which was assumed as 36° according to
 428 the literature [39]. Besides, the viscosity parameter, μ , was ignored in Abaqus/Explicit
 429 analysis and was set as 0.0 [44]. Figure 13 (c) shows the constitutive behavior of the concrete
 430 materials under biaxial stress. Here, the ratio of the strength in the biaxial to the strength in
 431 the uniaxial σ_{b0}/σ_{c0} (f_{b0}/f_{c0}) was taken as 1.16 [44].

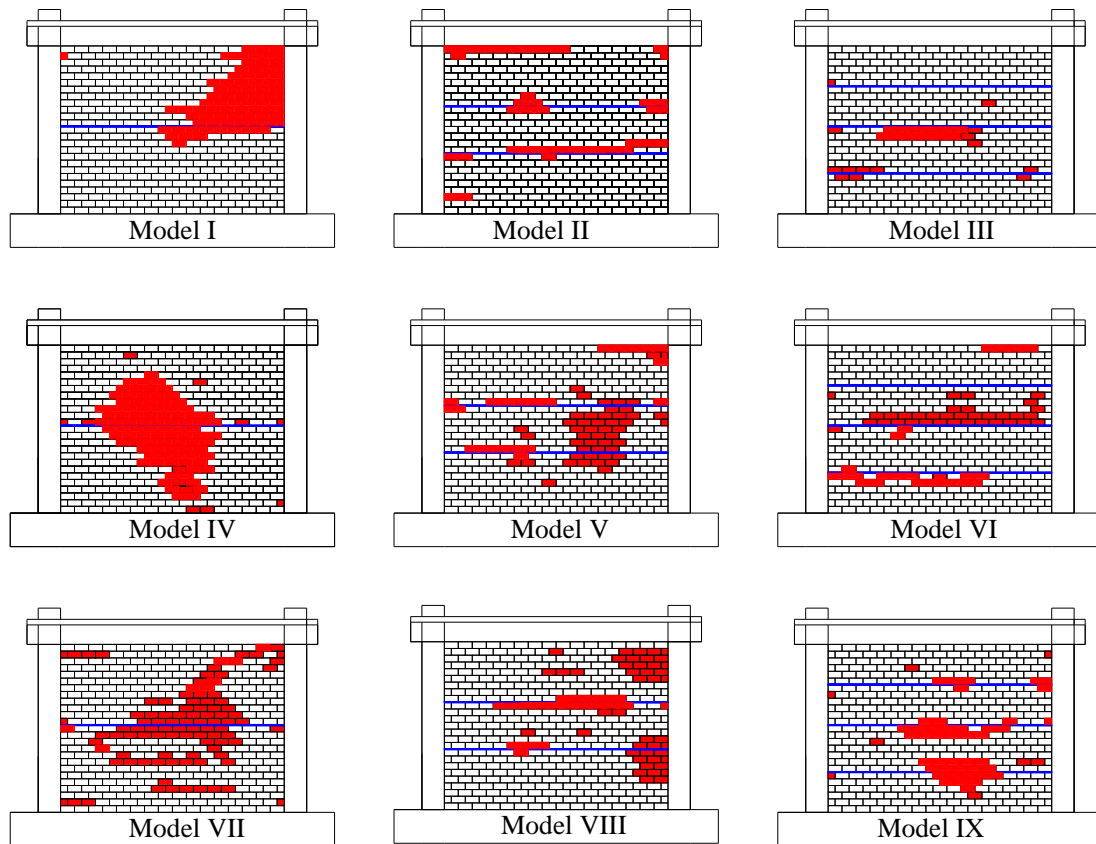
Figure 17 Damages and collapse of the simulated specimens (Model II= Specimen 2)

515 Figure 17 shows damaged areas for all tested and numerical specimens, while Table 6
 516 lists a summary of the main results including the maximum load and corresponding
 517 displacement, the initial stiffness, and the failure modes of the frames. The results show that
 518 the failure modes of the filled walls change from DC or CC mode to SS mode when the
 519 sliding layers are applied inside. This was also verified by the experimental results in the
 520 study and the literature [28]. Here, Specimen R1 (RC frame 0% in [28]) in previous research,
 521 a fully infilled frame without openings similar to Specimen 1, was applied here for a
 522 comparative study. The difference from Specimen 1 was that the connecting rebars were not
 523 full length and only had a length of 700mm. The failure mode of Specimen R1 was DC+CC
 524 mode, because (1) the length of connecting steel rebars was insufficient and (2) the strength

525 of the filled wall was low. The masonry units in the central zone of the wall were first
 526 destroyed under reversed cyclic lateral loads. The damaged area increased and extended to
 527 the diagonal zones of the frame finally to form DC+CC failure mode. However, Specimen 2
 528 and other specimens used more than one sliding layer, the filled wall was divided into
 529 multiple parts by the layers which then weakened the diagonal strut effect in the whole
 530 infilled wall. This led to the frame being damaged with the SS failure mode. The results listed
 531 in Table 6 show that the main model of the frames with sliding layers is SS failure mode,
 532 especially when the number of layers increases. The DC mode and CC mode disappeared
 533 when the number of layers was large. Moreover, the smaller the friction coefficient of sliding
 534 layers was, the easier this effect changed.

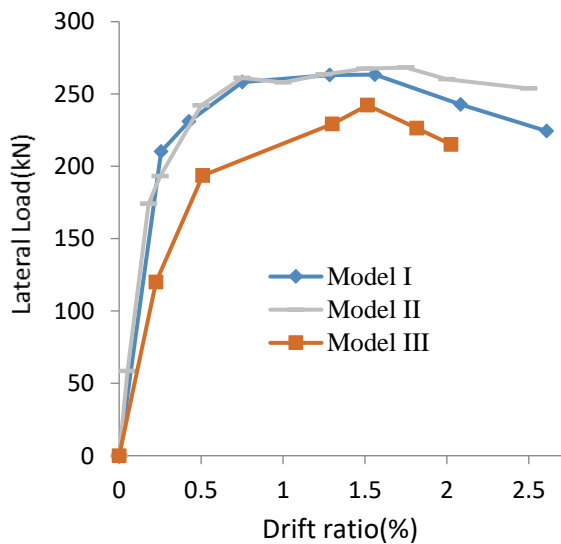
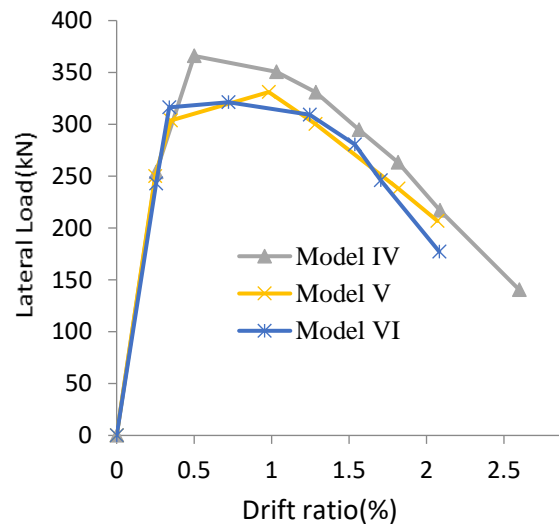
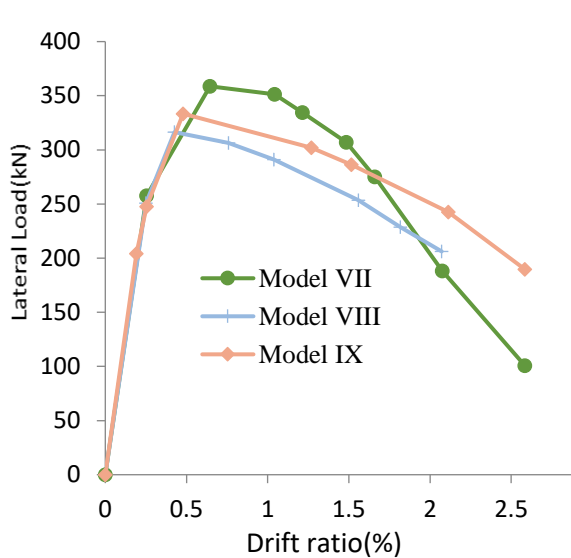
Figure 18 Effect of the spacing of layers in the frames

(a) Specimens with SBS layers

(b) Specimens with steel plates

(c) Specimens with BFRP laminates

(d) All specimens

When a SBS layer is paved in the infills (Model I), the diagonal strut effect is interrupted at the sliding layer. When the number of sliding layers increases, the strut effect gradually disappears, and the damage to the infilled wall is concentrated at the sliding layer or the connection between the sliding layer and the column, indicating that SBS sliding layers weaken the strut effect resulting in a significant reduction in the in-plane damage of infilled wall. Figure 18 (a) shows a comparison of the load-displacement curves of the specimens with a different number of SBS layers. The specimens using one and two SBS layers presented a similar behavior until $R=1.5\%$, but the specimen with three layers possessed a much lower capacity than the others. From the point of view of reducing in-plane damage

557 On the other hand, all specimens using steel plates possessed the same early linear
 558 behavior at the early stage until their ultimate loads, and then the lateral stiffness of the frames
 559 began to decrease. This is mainly due to the high coefficient of friction of the sliding layers.
 560 The increasing number of layers of steel plate did not lead to a decrease in the capacity of the
 561 frames, on the contrary, using more SBS layers can increase the slippage between the layers
 562 and wall, which then resulted in a degradation in the peak loads. Therefore, as shown in
 563 Figure 18 (b), the number of layers has a negative influence on the peak loads of the frames
 564 but made the frames present a similar post-peak behavior to the model specimens. A similar
 565 result was confirmed in the specimens with BFRP laminate (see Figure 18 (c)). Because the
 566 BFRP layers are non-ductility materials with a large slippage, the load-carrying capacity of

567 the frames with BFRP laminate layers is reduced significantly. The stiffness of the frames
 568 significantly decreased after peak load, especially for the frames with fewer laminate layers.
 569 However, the stiffness of the BFRP specimens decreased with an increasing number of
 570 sliding layers, similar to the cases using steel plates, which also is similar to previous research
 571 [49] [50]. Figure 18 (d) presents the load-displacement behavior of all specimens, indicating
 572 that the load-carrying capacity of the frames with SBS layers is much smaller than that of the
 573 other frames.

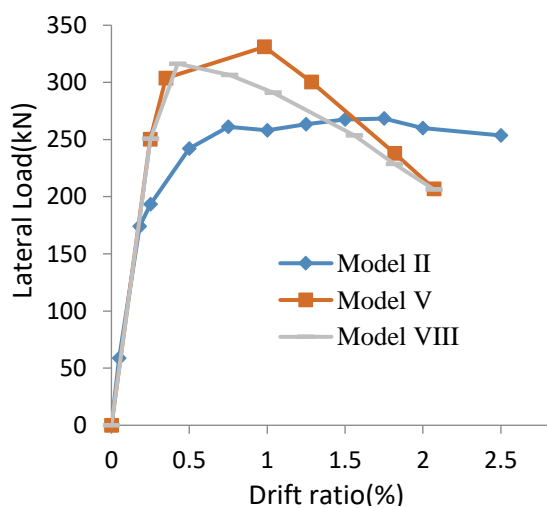
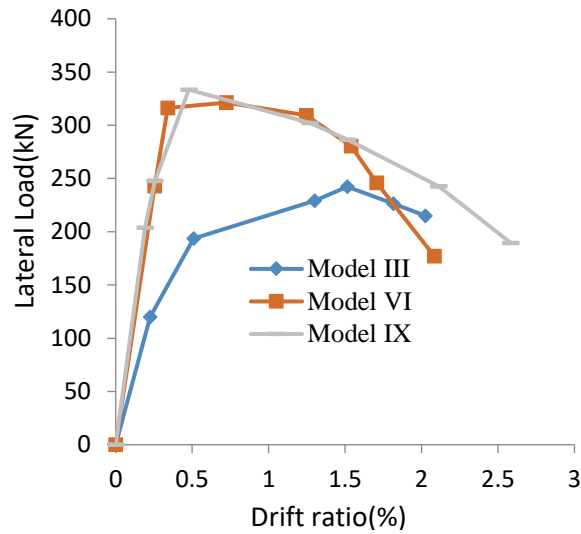
(a) $L_s=1500$ mm, one layer

(b) $L_s=1000$ mm, two layers

(c) $L_s=750$ mm, three layers

583 **Figure 19 Effect of the materials of sliding layers on infilled walls**

576 Figures 19 (a) to (c) show the load-displacement skeleton curves of the specimens
 577 with the same layer spacing but different sliding layer materials. When using the same layers
 578 of steel plate or BFRP laminate, the load-displacement behavior of the frames was the same,
 579 including initial elastic behavior, load-carrying capacity, and post-peak behavior. Due to the
 580 coefficient of friction of SBS layers, the use of the layers significantly reduced the ultimate
 581 load and accelerated the degradation of the load at post-peak. But the specimens using SBS
 582 layers can still present similar initial stiffness to the other specimens.
