Damage control of the masonry infills in RC frames under cyclic loads: a full-scale test study and numerical analyses

Qiwang Su, Gaochuang Cai, Meree Hani, Amir Si Larbi, Konstantinos Daniel Tsavdaridis

1 **Damage control of the masonry infills in RC frames** 2 **under cyclic loads: A full-scale test study and numerical** 3 **analyses**

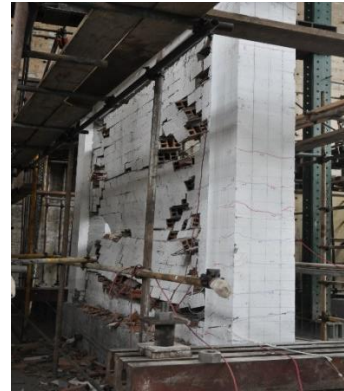
Figure 4 Damage of Specimen 1 at $R=4.0\%$

(a) front view of wall collapse

(b) back view of wall collapse

207 As shown in Figures 4 to 6, the treatment methods in the walls present a significant
 208 influence on the seismic performance of infilled RC frames. For Specimen 1, when the drift
 209 ratio was 0.25%, several cracks were observed, including diagonal and horizontal cracks on
 210 both sides of the wall, transverse cracks in the middle of the frame columns, and the diagonal
 211 zone at the ends of the frame beam (upper beam, same as below). When R reached 0.5%,

212 new cracks appeared inside the frame columns and were roughly distributed on the infilled
 213 wall. The previous cracks at the ends of the beam extended to the beam edges and the beam-
 214 column joint zones. While R was 1.0%, several cracks were observed in the mortar in the
 215 middle of the wall and the zones of the connection rebars. Some connecting steel bars were
 216 exposed and the mortar layer is completely peeled off. The mortar on the wall's middle sides
 217 fell off and the upper connection bars were slightly bent outside when R reached 1.5%, and
 218 several bricks were crushed and fell off on both sides of the wall at the same time. When R
 219 was 2.0%, the cracks in the columns developed significantly, while the connecting rebars
 220 were bent seriously and the bricks continually fell off from $R=2.5\%$. After R exceeded 3.0%,
 221 the wall top was separated from the upper beam bottom, and more connecting bars were

222 exposed. Before $R=3.50\%$, the wall subsidence occurred in the specimen middle, and more
 223 bricks were crushed and more connecting rebars were seriously bent. At $R=4.00\%$, the
 224 infilled wall collapsed almost completely, as shown in Figure 4 (a), making the wall exhibit
 225 a similar structural behavior to a bare RC frame.
