Revealing the iron skeleton of Notre-Dame de Paris. Methodologies and issues of archaeological and analytical investigations following the blaze

Maxime L'Héritier, Aurélia Azéma, Delphine Syvilay, Delphine Neff, Ivan Guillot, Emmanuelle Delque-Količ, Thibault Creacheadec, Philippe Dillmann

Revealing the iron skeleton of Notre-Dame de Paris. Methodologies and issues of archaeological and analytical investigations following the blaze.

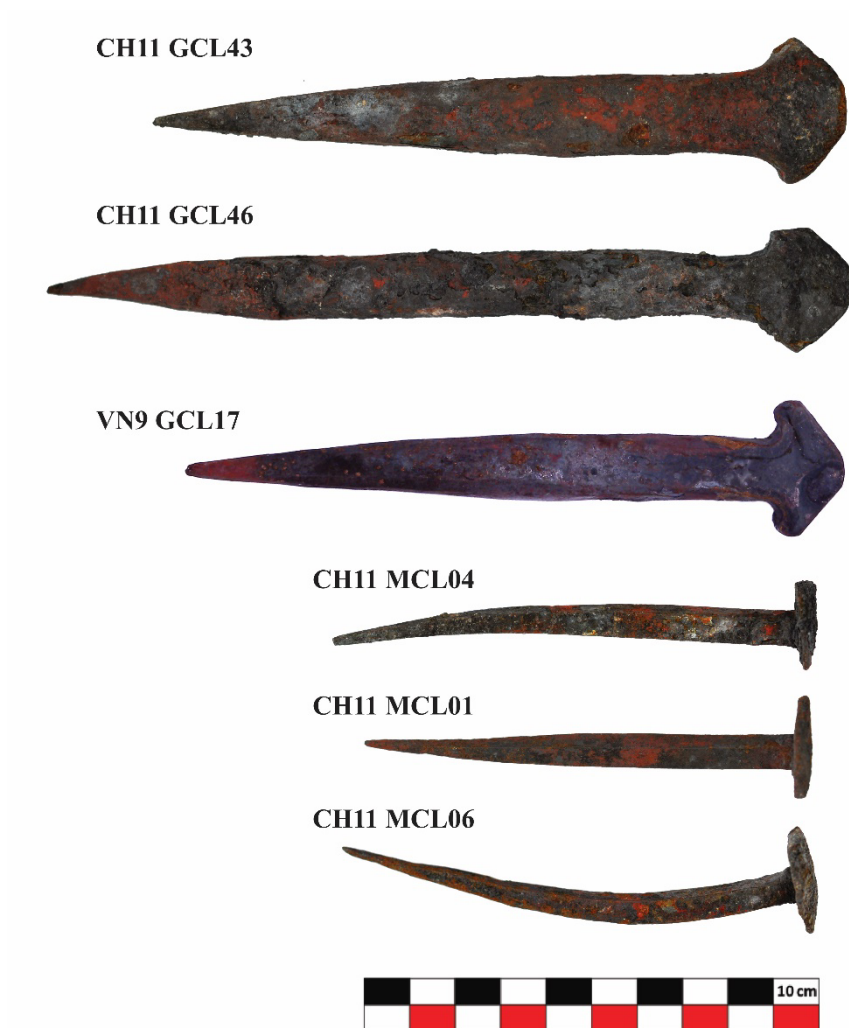
Figure 4: Different types of forged nails found in the excavation of the vaults debris.

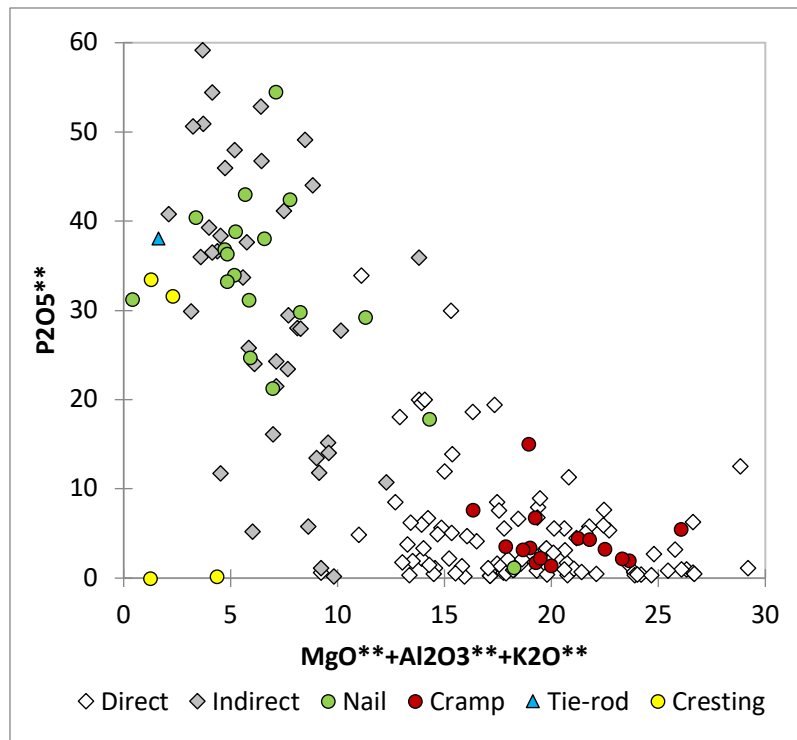
Figure 8: Discrimination of iron reduction processes using slag inclusion composition [30]. Each dot represents one object determined by its slag inclusions average weighted contents. ** refers to the compound average weighted content reported to iron. Grey and white dots constitute a corpus of reference for bloomery and finery iron. Coloured dots are the objects analysed within this study.

The first results on major element composition show a clear distinction between the metallurgical processes used to produce the metal according to the type of sample (figure 8). On the one hand, all the iron cramps (tribunes, nave chapels and upper walls) are made of bloomery iron, which is the only process existing in Europe at the building time of Notre-Dame. This suggests that they are compatible with the medieval construction phases of the building [36,37]. Although their precise dating still has to be performed, because the bloomery process remains in use relatively later in some parts of Europe [38,39], this primary result is an important clue towards the use of iron in the initial design of the monument. On the other hand, all forged nails but two are distinctively located in the finery iron area, meaning that they were forged from iron produced in blast furnaces, consequently later than the initial building time, regardless of their size and typology. Therefore, we can conclude that all iron reinforcements of the framework were undertaken in late restorations phases after the middle of the 15th century when this iron production. Even the nails coming from the framework wooden pathway, which was so far presumably associated with the 13th century construction phases [40], seem to be much later and highlight a modern construction (or restauration) of this ensemble. Only one nail (and maybe a second one located in the undetermined zone) can surely be associated with the more ancient bloomery process (CH14 MCL 03 & VN9 GCL 17). Such a feature still has to be explained. Radiocarbon dating of some of these nails was carried out to understand if they can represent an undocumented former restauration phase or is rather an evidence of iron recycling (see §4.3). Lastly, two different groups can be highlighted within the tie-rods and cresting implemented in the 19th century. Those (tie-rod + 2 cresting) with inclusions containing high iron oxide silica, calcium and phosphorus contents (in average FeO = 50-75 %, SiO₂ = 5-15%, P₂O₄ = 10-15%, CaO = 10-16 %) are typical of 19th century ferrous alloys, despite the restauration by Mouton in the 2000's, suggesting a reuse of the former cresting. On the other hand, the two cresting elements that Fonquernie had restored display very small slag inclusion with silica and MnS particles as well as an homogeneous carbon distribution in the metallic matrix which is typical of modern steels refined by means of a converter from the end of the 19th century, rather indicating an absence of reuse. The results are in accordance with the conclusion of their historical and typological study [41].
