Revealing the iron skeleton of Notre-Dame de Paris. Methodologies and issues of archaeological and analytical investigations following the blaze

Revealing the iron skeleton of Notre-Dame de Paris. Methodologies and issues of archaeological and analytical investigations following the blaze.

Keywords: Iron armatures, Gothic construction, Dating, Metallography, Tensile tests

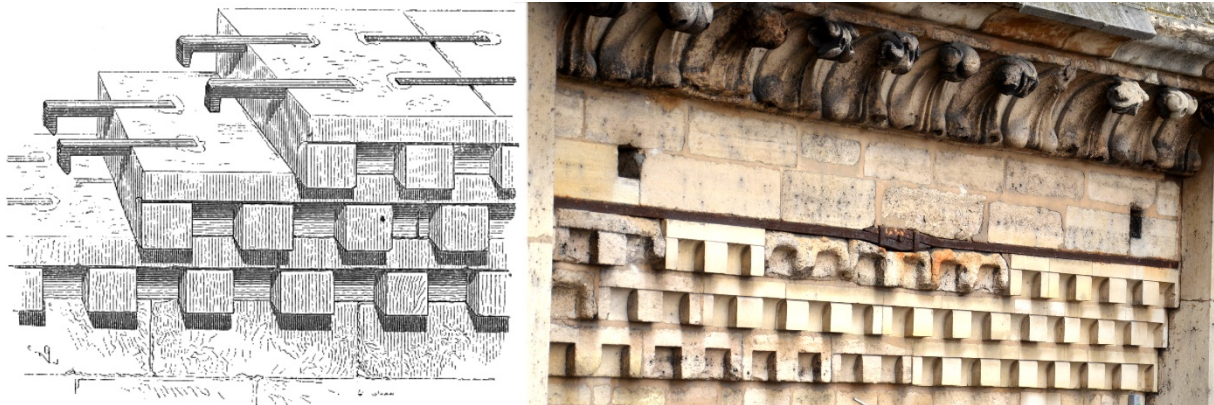
Figure 1 : (a) Rows of cramps in the chequered cornice of the choir as described by Viollet-le-Duc in his Dictionary of Architecture. (b) Reinforcement of the same part of the building by iron chains in the 19th c. by Lassus.

« La grande corniche à damiers qui couronne le chœur de la cathédrale de Paris, et qui dut être posée vers 1195, se compose de trois assises de pierre dure formant parpaing, dont les morceaux sont tous réunis ensemble par deux rangs de crampons, ainsi que l'indique la [figure 1.a]. Cela constituait, au sommet de l'édifice, au-dessus des voûtes, un puissant chaînage... » (tome 2, article "chaînage")¹

Moreover, the records of the work of the Historical Documents Commission for the year 1846 report that Lassus adopted a new method of chaining of this part of Notre-Dame cathedral using large sections chains consolidating the two upper courses [14]. This system is still visible from the outside surrounding the top of the chevet. Despite their possible importance to the structure of the building, these 19th century elements were so far never studied (figure 1).

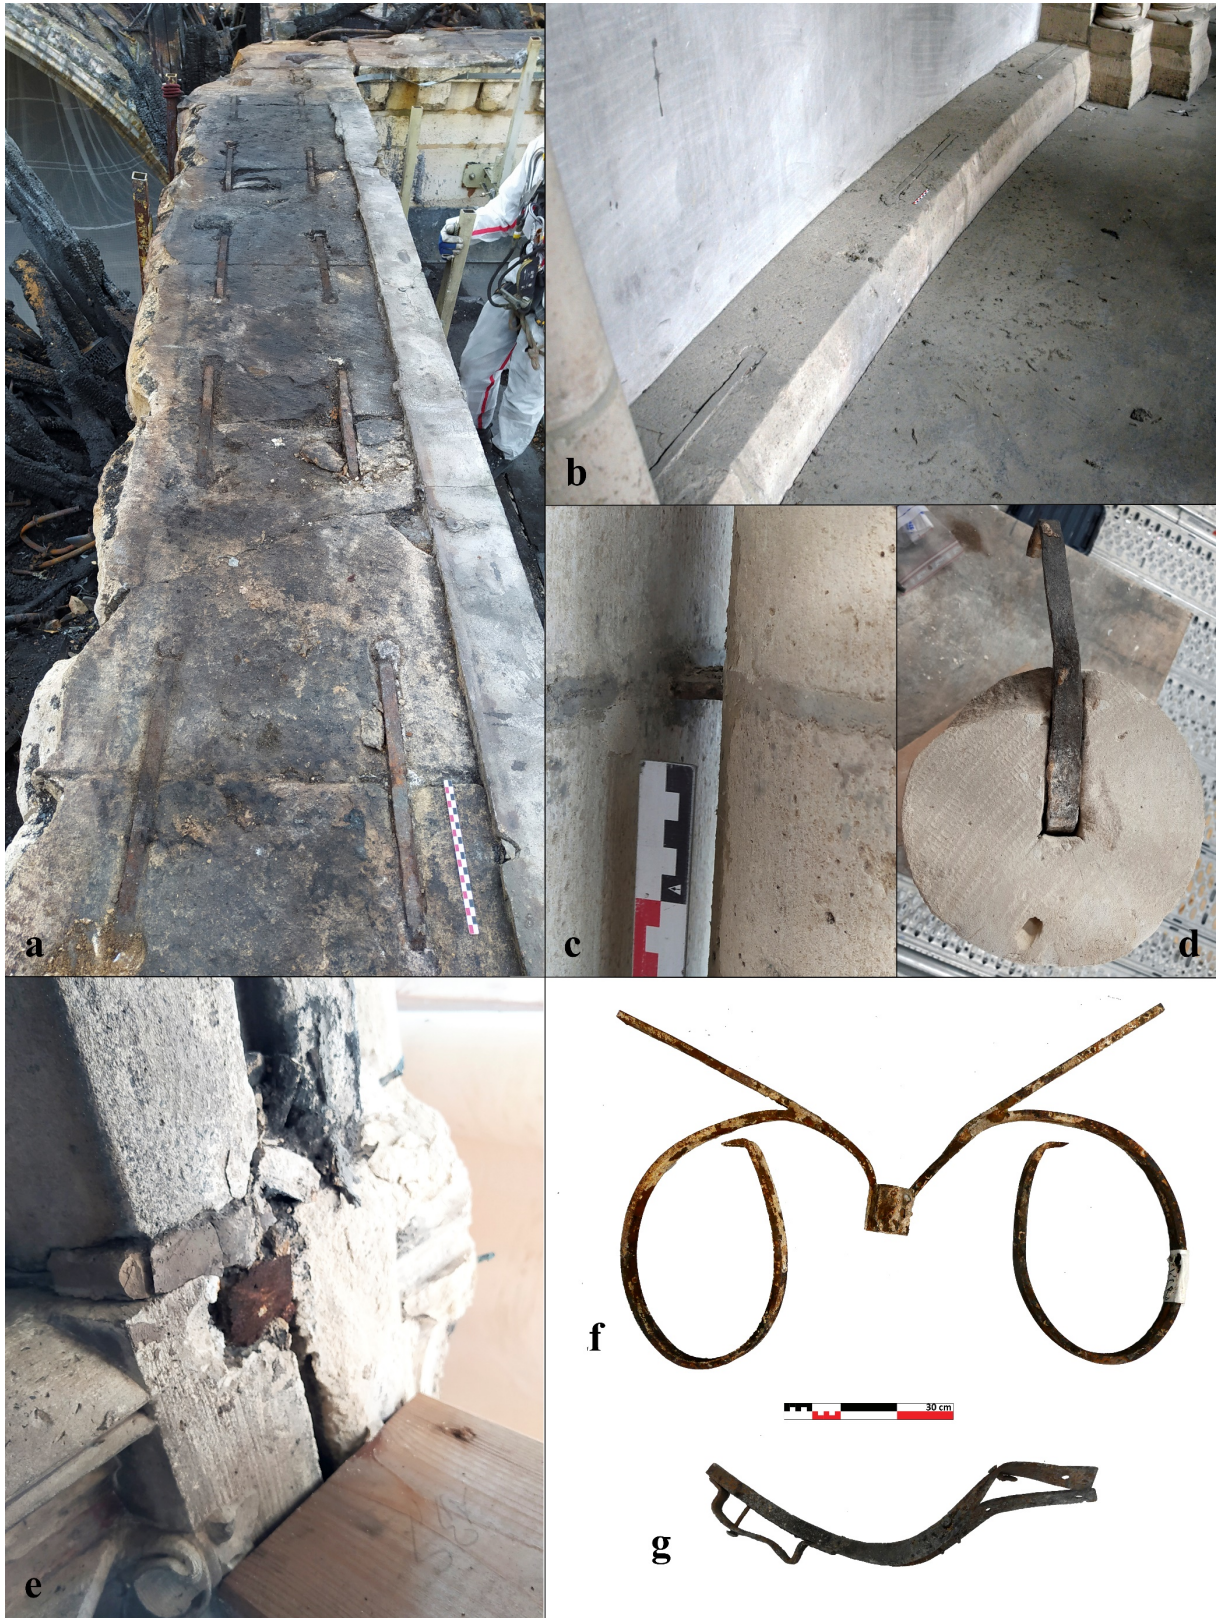
Figure 2 : Iron armatures in Notre-Dame de Paris. (a) Cramps discovered on the top of the upper walls (b) cramps in the tribunes (c) & (d) cramps attaching monolithic column blocs to the piers in the nave (e) ancient iron bars remains in the upper bays (f) iron armature of lead cresting (g) iron armature of spire lead decoration

The result of these prospections and excavation shows that iron armatures were used at different levels in Notre-Dame's structure and correspond to different construction phases from the medieval parts of the building to the 19th century restorations and adjunctions (figure 2).

First, the builders used a great number of cramps in Notre-Dame's masonry as soon as the tribunes' level and up to the upper walls (figure 2 a & b). Viollet-le-Duc describes the presence of cramps in the chequered cornice of the choir yet other cramps were revealed on the top of the eaves-bearing walls, right below the burnt framework (figure 3). All these reinforcements (tribunes, cornice and upper walls) are made of two rows of 40 to 50 cm long cramps (60 to 70 including both legs), sometimes on several courses. Smaller cramps (25 cm) are also implemented to attach the monolithic columns blocks decorating the chapels' walls: each of the three 8 m high column circling each pier is made of two to three en delit blocks of stone, whose upper part is joined to the wall using such cramps (figure 2 c & d). The same feature is used for the piers situated in between the inner and outer aisles with blocks up to 4 m high and only about 16 cm in diameter. These series of cramps seem to have different functions: attaching fragile slender en delit columns to the masonry, reinforcing the upper walls maybe due to the framework thrusts and maybe providing a provisional buttressing to the great arcades in the outer aisles. A more extensive discussion on their role is presented elsewhere [16].

Many iron armatures were found in the excavation of the vestiges of the framework. Most are machined bolted rods that could have been integrated in the 18th or most probably 19th centuries works. Other pegs and nails were however hand-forged. A corpus of forged nails and brads (headless nails used for roofing) of different sizes (from about 1 cm long to more than 30 cm) was isolated for study (figure 4). Their typology and repartition in the vaults allowed to identify bigger nails used in the framework and smaller (10-15 cm long and 15-25 g heavy) nails used in its suspended wooden pathway. Lastly, many iron pieces were integrated in the 19th century construction and restauration works to sustain lead ornaments. They are particularly numerous at the top of the roof for the cresting made of cast lead elements attached on an iron armature shaped in the form of leaves (figure 2 f and figure 3). Built by Viollet-le-Duc in the 19th centuries, it was strongly restored during different renovation phases in the 20th century: the choir and southern transepts by Fonquernie in the late 1970's and 1980's and the northern transept by Mouton in the end of the 2000's. Many decorations from the spire also use such iron armatures (figure 2 g).

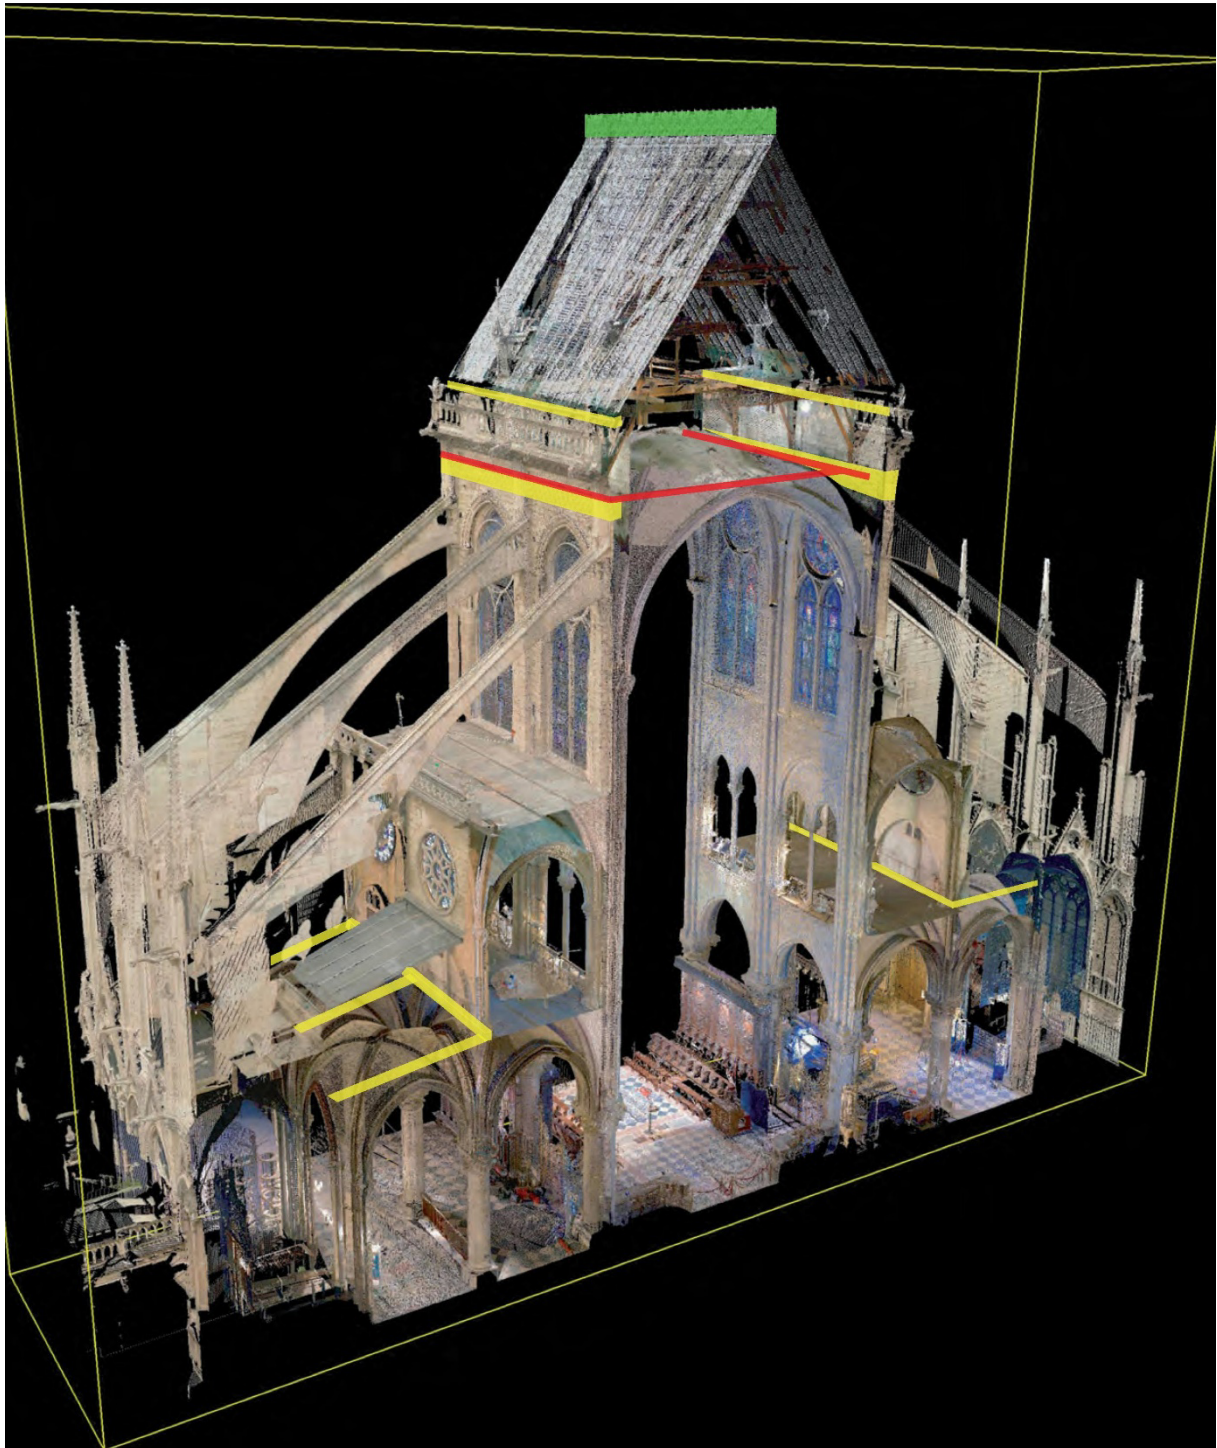
Figure 3: Situation of some armatures in the choir of Notre-Dame (series of cramps in yellow, cresting in blue, tie-rods in red).

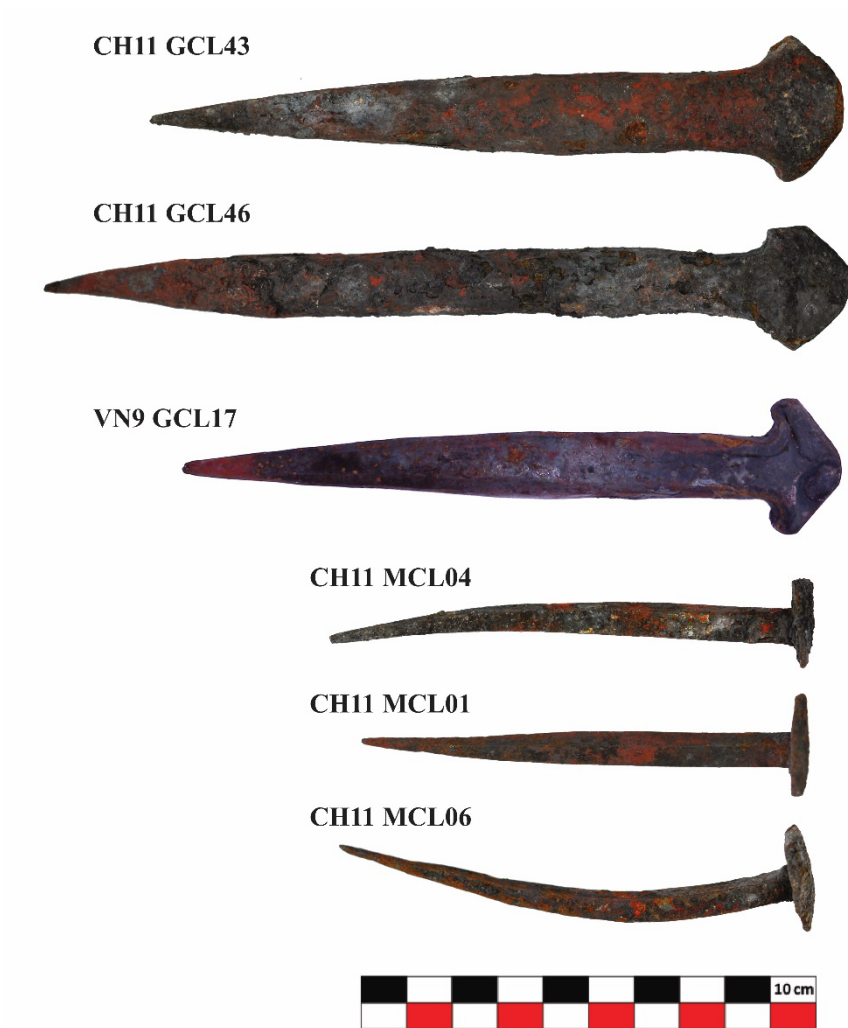
Figure 4: Different types of forged nails found in the excavation of the vaults debris.

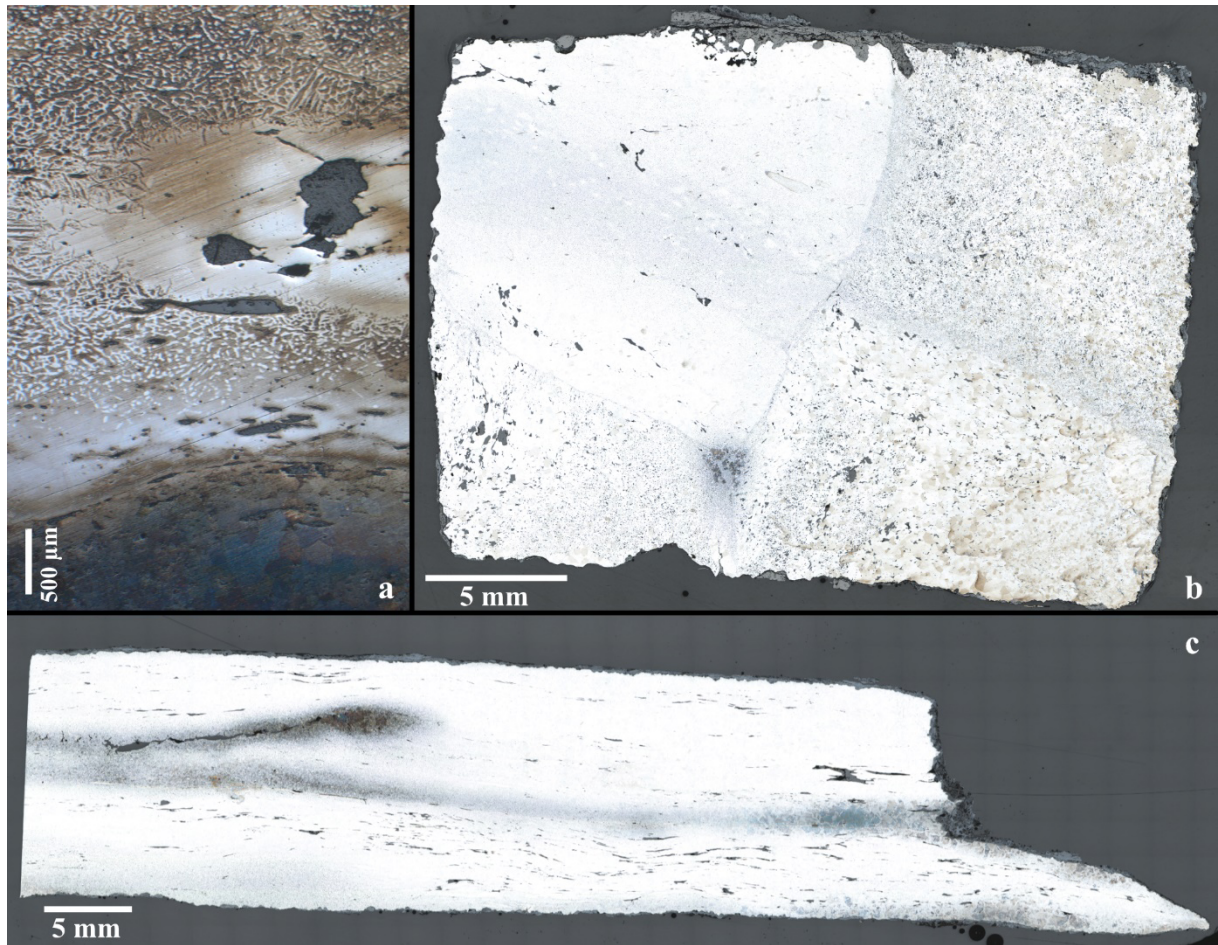
Figure 5: Micrography of some of the studied iron samples. (a) Oberhoffer etching showing microscopic and macroscopic variation of phosphorus content (b) AGR VN2, Nital etching, showing welding lines separating zones with different slag inclusion size and content in a globally ferritic matrix (c) AGR TRIB 01 Nital etching, showing a ferritic structure with embedded slag inclusion and a carburised band (0,4 to 0,7 %C)

Metallographic examinations reveal that most structures are highly ferritic regardless of the armature type (figure 5). Only a few cramps are slightly carburized but none can be considered as steel as they never exceed 0.3 %C in average. On the other hand, two nails are made of homogeneous steel close to the eutectoid with about 0.5-0.7 % C in average. The slag inclusion proportion in the matrix (in average 2-3 % and sometimes up to 10%) is comparable to previous studies on pre-modern construction iron [19,20]. Phosphorus is also present in most samples. Nital etching reveals the presence of ghost structures in more than half the studied samples and Oberhoffer's etching performed shows its heterogeneous distribution at a microscopic and macroscopic scale (figure 5) [21]. Let us recall that high levels of phosphorus create iron embrittlement [22]. Finally, many welds were observed especially in the cramps (figure 5 b), which seem to have been regularly forged by the assembly of several metal pieces. The tensile tests provide the mechanical characteristics of these alloys.

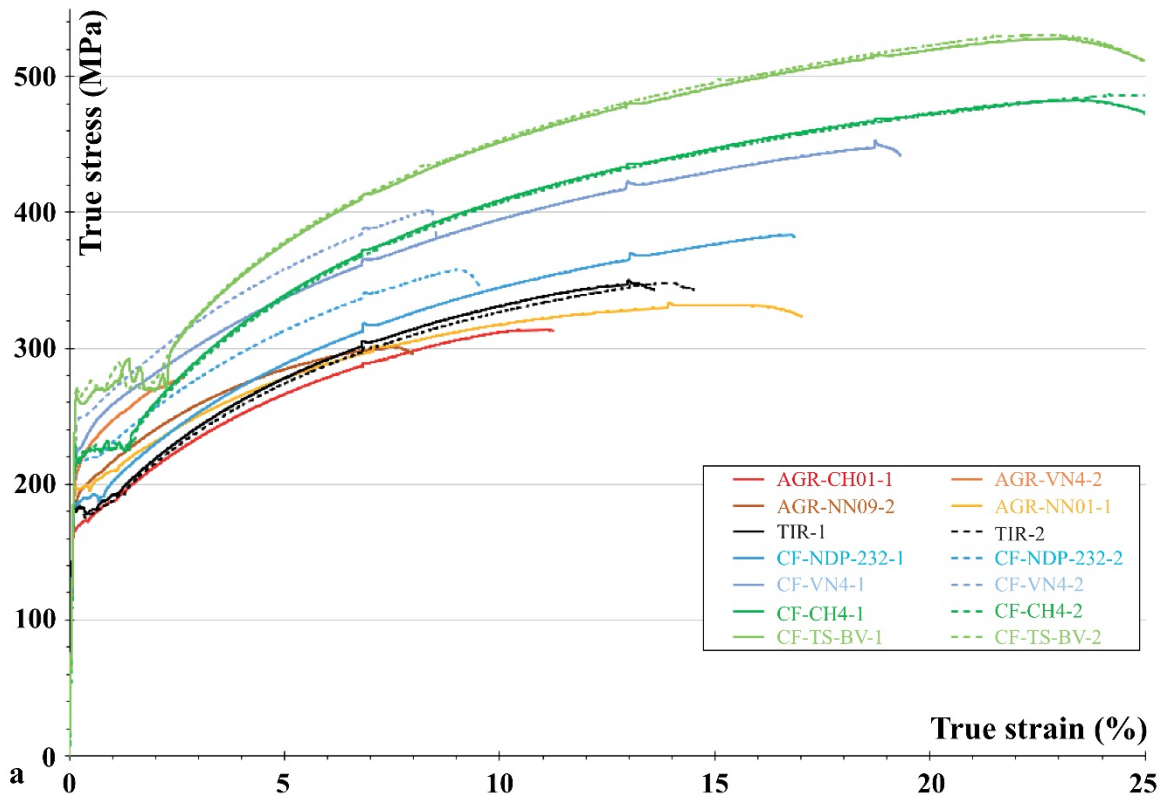
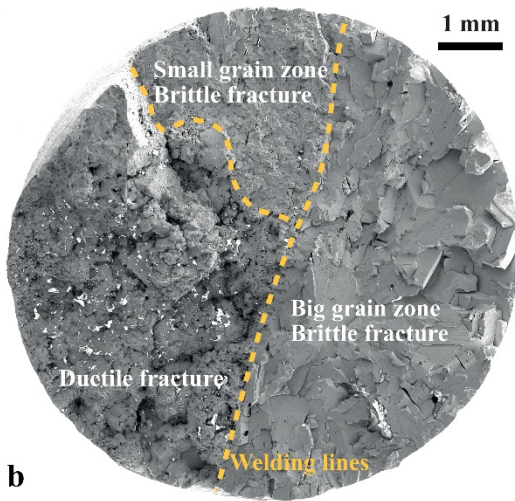
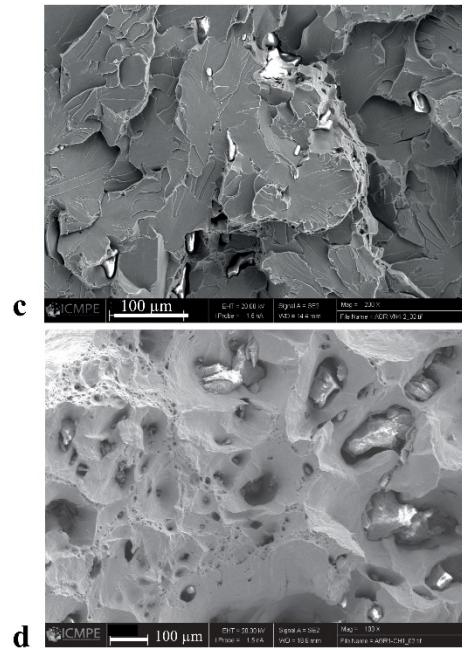
Fracture surface AGR-VN4

Figure 6: Tensile tests on Notre-Dame samples. (a) Tensile true stress/true strain curves of reinforcements. (b) Fracture examination of AGR-VN4 showing different behaviour on each side of the welding lines. (c) transgranular brittle fracture by cleavage (d) ductile fracture with slag inclusion inside the dimple

Tensile tests were performed on cylindrical specimens with 8 mm diameter and 64 mm gauge length according to the protocol published by L'Héritier et al. [19]. They were done on an MTS machine with 100 kN capacity controlled by an extensometer with 50 mm gage length and a full range of 10%. All tests were performed at room temperature (300 K) until failure with a constant strain rate of $1.3 \times 10^{-4} \text{ sec}^{-1}$. Young's modulus is comprised between 185 and 215 GPa for all samples, quite well corresponding to that of iron and mild steels [23]. However, other characteristics show a great heterogeneity from one sample to another and sometimes even for two samples of the same object (figure 6 a). The elongation goes from 2,5% to 25% and tensile strength from 280 to 530 MPa revealing characteristics way below those of modern steels. Fractures are usually ductile with slag inclusion inside the dimple, yet some samples present brittle transgranular fracture and brittle intergranular fracture, due to the presence of phosphorus (figure 6 b, c, d). The significant presence of phosphorus, the presence of many non-metallic inclusions, sometimes millimetre-sized, and the numerous welds, more or less well executed, explain the very poor quality of the metal used in the cathedral of Notre-Dame de Paris at the time of its construction and during the restoration work carried out in the middle of the 19th century by Viollet-le-Duc. The relatively modest mechanical properties of the iron and steel used in these periods are not unique to Notre-Dame de Paris and can be found in all the buildings studied earlier in medieval and early modern France (see figure 7) [19] and Italy [24–26]. Only the modern carbon cresting installed in the 20th century have mechanical properties, admittedly among the weakest in the multitude of contemporary steels, but normal for this type of steel in terms of its composition, production and shaping. Finally, no observation revealed any impact of fire on the microstructure and mechanical properties of the various reinforcements studied. These armatures can therefore be reused in full knowledge of these characteristics, provided that they would only work in the elastic domain.

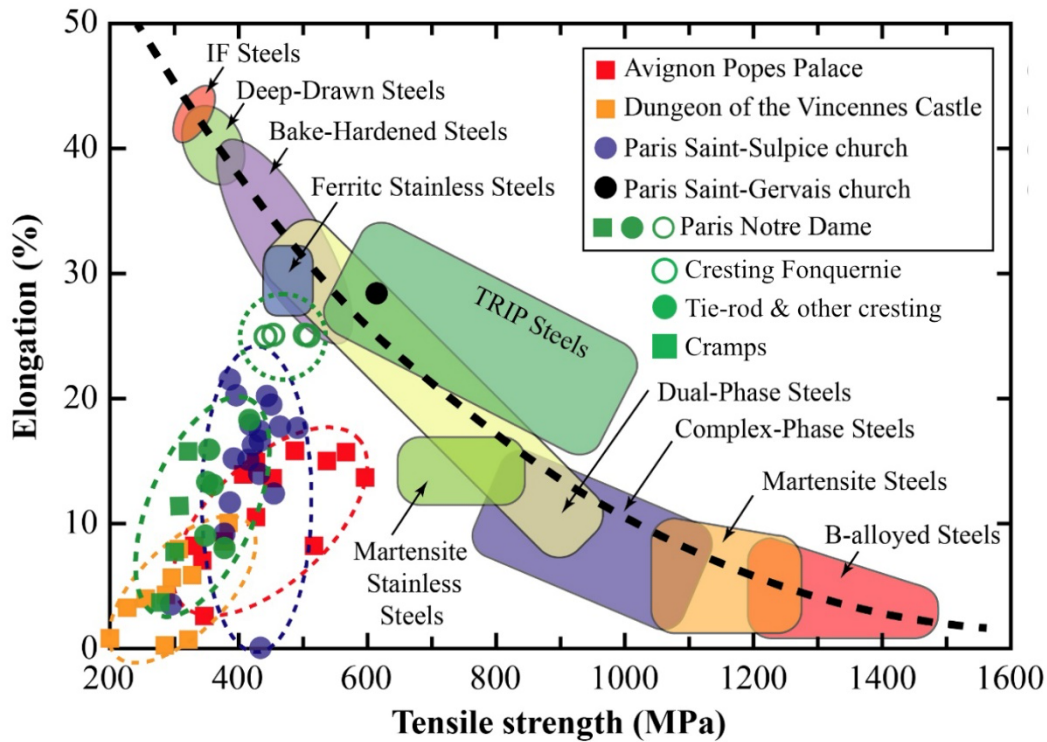
Figure 7: Mechanical characteristics of Notre-Dame ferrous reinforcements compared to modern steels and other medieval and modern construction iron on the Ashby Map [27]

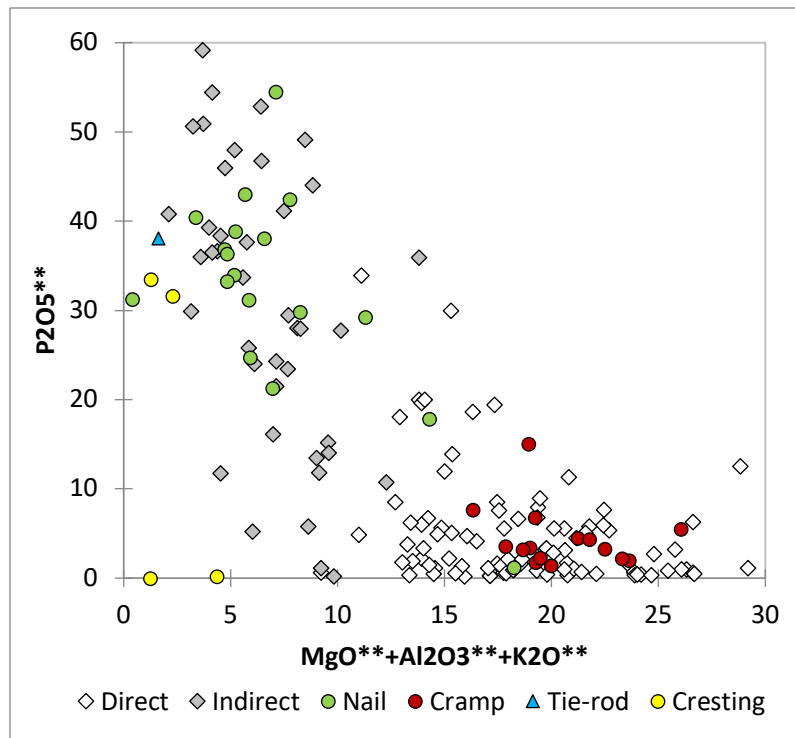
Figure 8: Discrimination of iron reduction processes using slag inclusion composition [30]. Each dot represents one object determined by its slag inclusions average weighted contents. ** refers to the compound average weighted content reported to iron. Grey and white dots constitute a corpus of reference for bloomery and finery iron. Coloured dots are the objects analysed within this study.

The first results on major element composition show a clear distinction between the metallurgical processes used to produce the metal according to the type of sample (figure 8). On the one hand, all the iron cramps (tribunes, nave chapels and upper walls) are made of bloomery iron, which is the only process existing in Europe at the building time of Notre-Dame. This suggests that they are compatible with the medieval construction phases of the building [36,37]. Although their precise dating still has to be performed, because the bloomery process remains in use relatively later in some parts of Europe [38,39], this primary result is an important clue towards the use of iron in the initial design of the monument. On the other hand, all forged nails but two are distinctively located in the finery iron area, meaning that they were forged from iron produced in blast furnaces, consequently later than the initial building time, regardless of their size and typology. Therefore, we can conclude that all iron reinforcements of the framework were undertaken in late restorations phases after the middle of the 15th century when this iron production. Even the nails coming from the framework wooden pathway, which was so far presumably associated with the 13th century construction phases [40], seem to be much later and highlight a modern construction (or restauration) of this ensemble. Only one nail (and maybe a second one located in the undetermined zone) can surely be associated with the more ancient bloomery process (CH14 MCL 03 & VN9 GCL 17). Such a feature still has to be explained. Radiocarbon dating of some of these nails was carried out to understand if they can represent an undocumented former restauration phase or is rather an evidence of iron recycling (see §4.3). Lastly, two different groups can be highlighted within the tie-rods and cresting implemented in the 19th century. Those (tie-rod + 2 cresting) with inclusions containing high iron oxide silica, calcium and phosphorus contents (in average FeO = 50-75 %, SiO₂ = 5-15%, P₂O₄ = 10-15%, CaO = 10-16 %) are typical of 19th century ferrous alloys, despite the restauration by Mouton in the 2000's, suggesting a reuse of the former cresting. On the other hand, the two cresting elements that Fonquernie had restored display very small slag inclusion with silica and MnS particles as well as an homogeneous carbon distribution in the metallic matrix which is typical of modern steels refined by means of a converter from the end of the 19th century, rather indicating an absence of reuse. The results are in accordance with the conclusion of their historical and typological study [41].

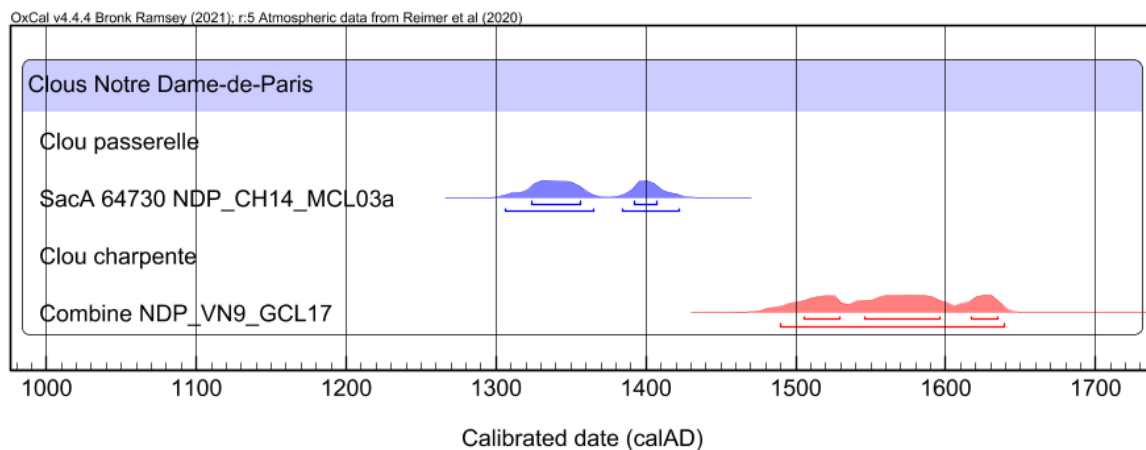
Figure 9: Radiocarbon dating of the framework nails CH14 MCL03 (wooden pathway, choir) and VN9 GCL17 (framework, nave). "The radiocarbon result were calibrated with the OxCal 4.4 software [47] using the IntCal20 calibration curve [48]

When they contain some steely parts, ferrous alloys can indeed be dated using radiocarbon dating according to the method developed by Leroy et al 2015 [46]. Actually, the carbon is coming from the smelting stage during which charcoal is used for the reduction. The process occurs at high temperature (about 1300°C) and a part of the carbon from the charcoal diffuses into the metal, creating these carburised zones. The carbon is sampled within these carburized zone, a iron-carbon alloy (up to 0,8 % C for eutectoid steels). Several iron artefacts among all the armatures sampled at Notre-Dame are sufficiently carburized and were dated: 2 cramps from the tribunes, erected in the middle of the 12th c., 4 cramps of the upper walls probably built in the beginning of the 13th c. and 2 nails of the

framework, one made of steel and both identified as made from bloomery process iron (see above). These dating contribute to a better understanding of the implementation of iron at the different stages of Notre-Dame's construction, highlighting the use of iron as early as the middle of the 12th c. construction campaigns [16]. Notre-Dame is now the earliest monument using such iron armatures, almost 40 years before Chartres and Bourges [3,4,46], thus considerably renewing our apprehension of medieval construction techniques. Secondly, they also allow dating the reinforcement of the upper walls to link them with the dates obtained on the framework and later on the mortars. Crossing all these data will provide a better understanding of the monument's chronology. The results obtained on the two nails are presented here (figure 9). The smaller iron nail of the suspended wooden pathway in the choir was dated from the 14th century (1306-1422 AD). Let us recall that all other studied small nails are made of iron from finery and likely to be associated to later works, thus suggesting evidence of reuse. The bigger nail of the nave made of steel is dated from the 16th century (1475-1642 AD). There is however no recollection of major works to the framework before 1681. Do both dating rather indicate recycling practices? Alternatively, could they document unknown consolidations phases of the framework? Other dating on big nails and smaller finery nails should be performed to confirm these first tendencies. The precise role of these big nails still has to be explored through the analysis of the wooden vestiges of the framework, now available for study.
