Response of riparian vegetation to the restoration of lateral connectivity: the case of the dismantling of old groyne fields on the Rhône River

Philippe Janssen, Hervé Piégay, André Evette

Philippe Janssen, Hervé Piégay, André Evette. Response of riparian vegetation to the restoration of lateral connectivity: the case of the dismantling of old groyne fields on the Rhône River. First International Conference on Riparian Ecosystems Science and Management, Apr 2022, Bratislava, Slovakia. hal-04145887

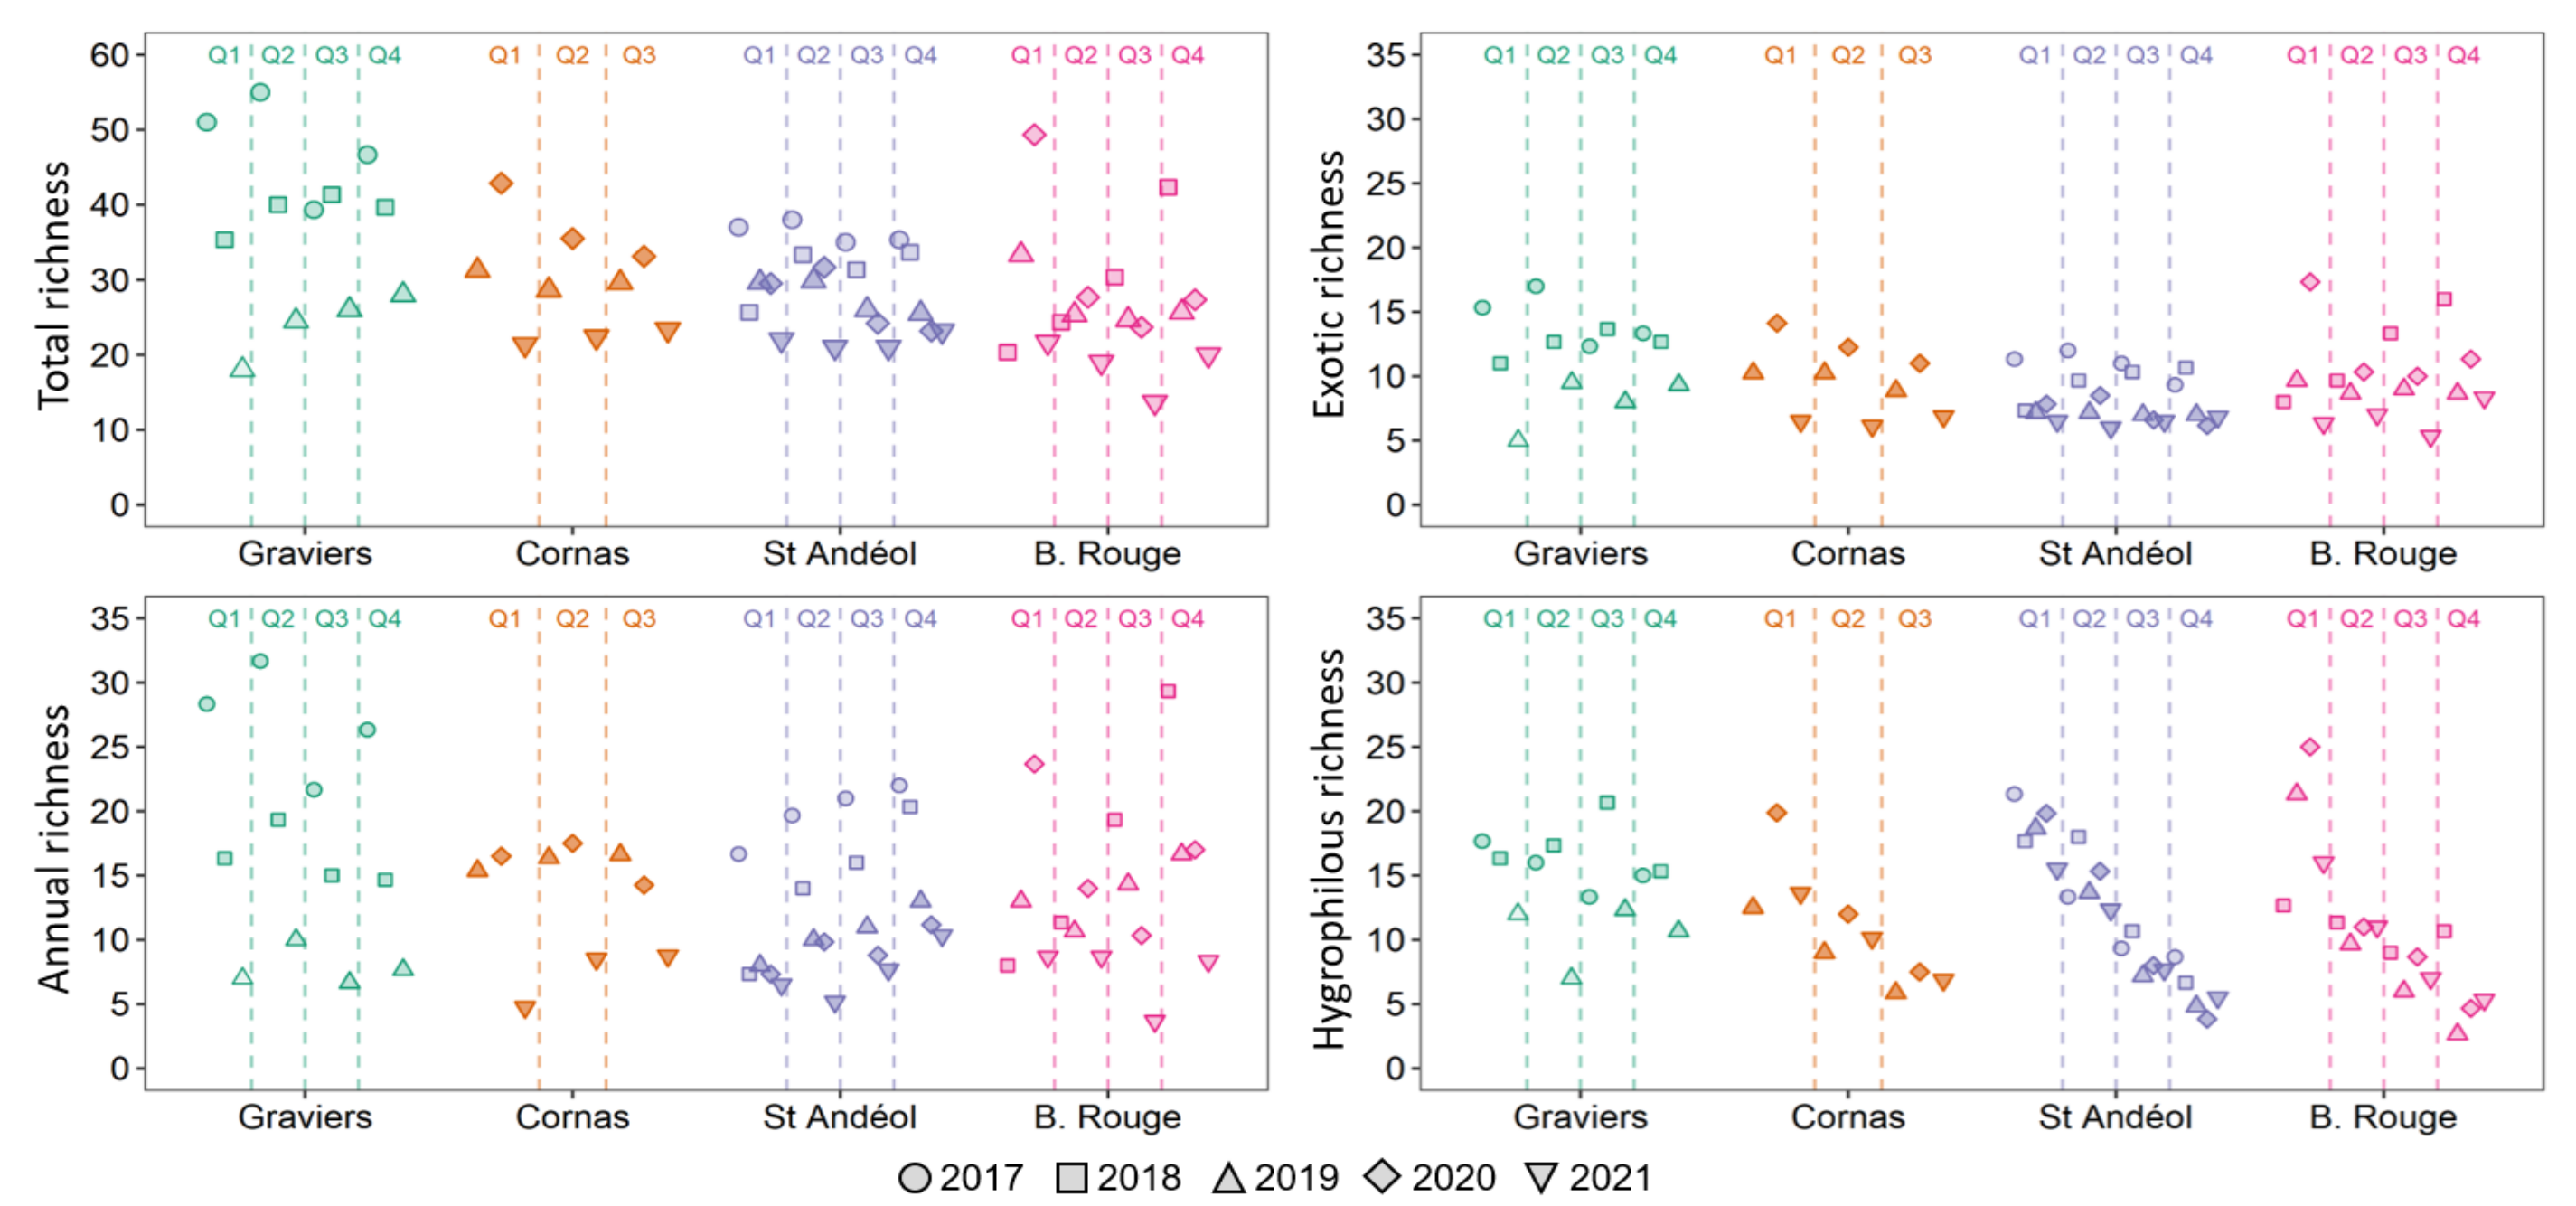
Variations in mean species richness for each site and year, depending on the position of the quadrat along the flooding gradient

Restored sites were quickly recolonized by many riparian plants, with an average of 33 species per quadrat (minimum = 16, maximum = 66) but high variation between years:

- Many annual species from the soil seed bank initially colonized the recreated surfaces (*Artemisia annua*, *Chenopodium album*, *Echinochloa crus-galli*) and then declined due to the establishment of perennial species (*Phalaris arundinacea*, *Phragmites australis*);
- Secondary succession has benefited several exotic species (*Ambrosia artemisiifolia*, *Cyperus eragrostis*, *Artemisia verlotiorum*) that tend to decline over time;
- Variations in hygrophilous species richness, depending on the position of the quadrat, illustrate the progressive structuring of riparian communities along the flood gradient;
- The strong decrease in species richness in 2021, mainly annuals species, reflects the response of communities to the July five-year flood of the Rhône.

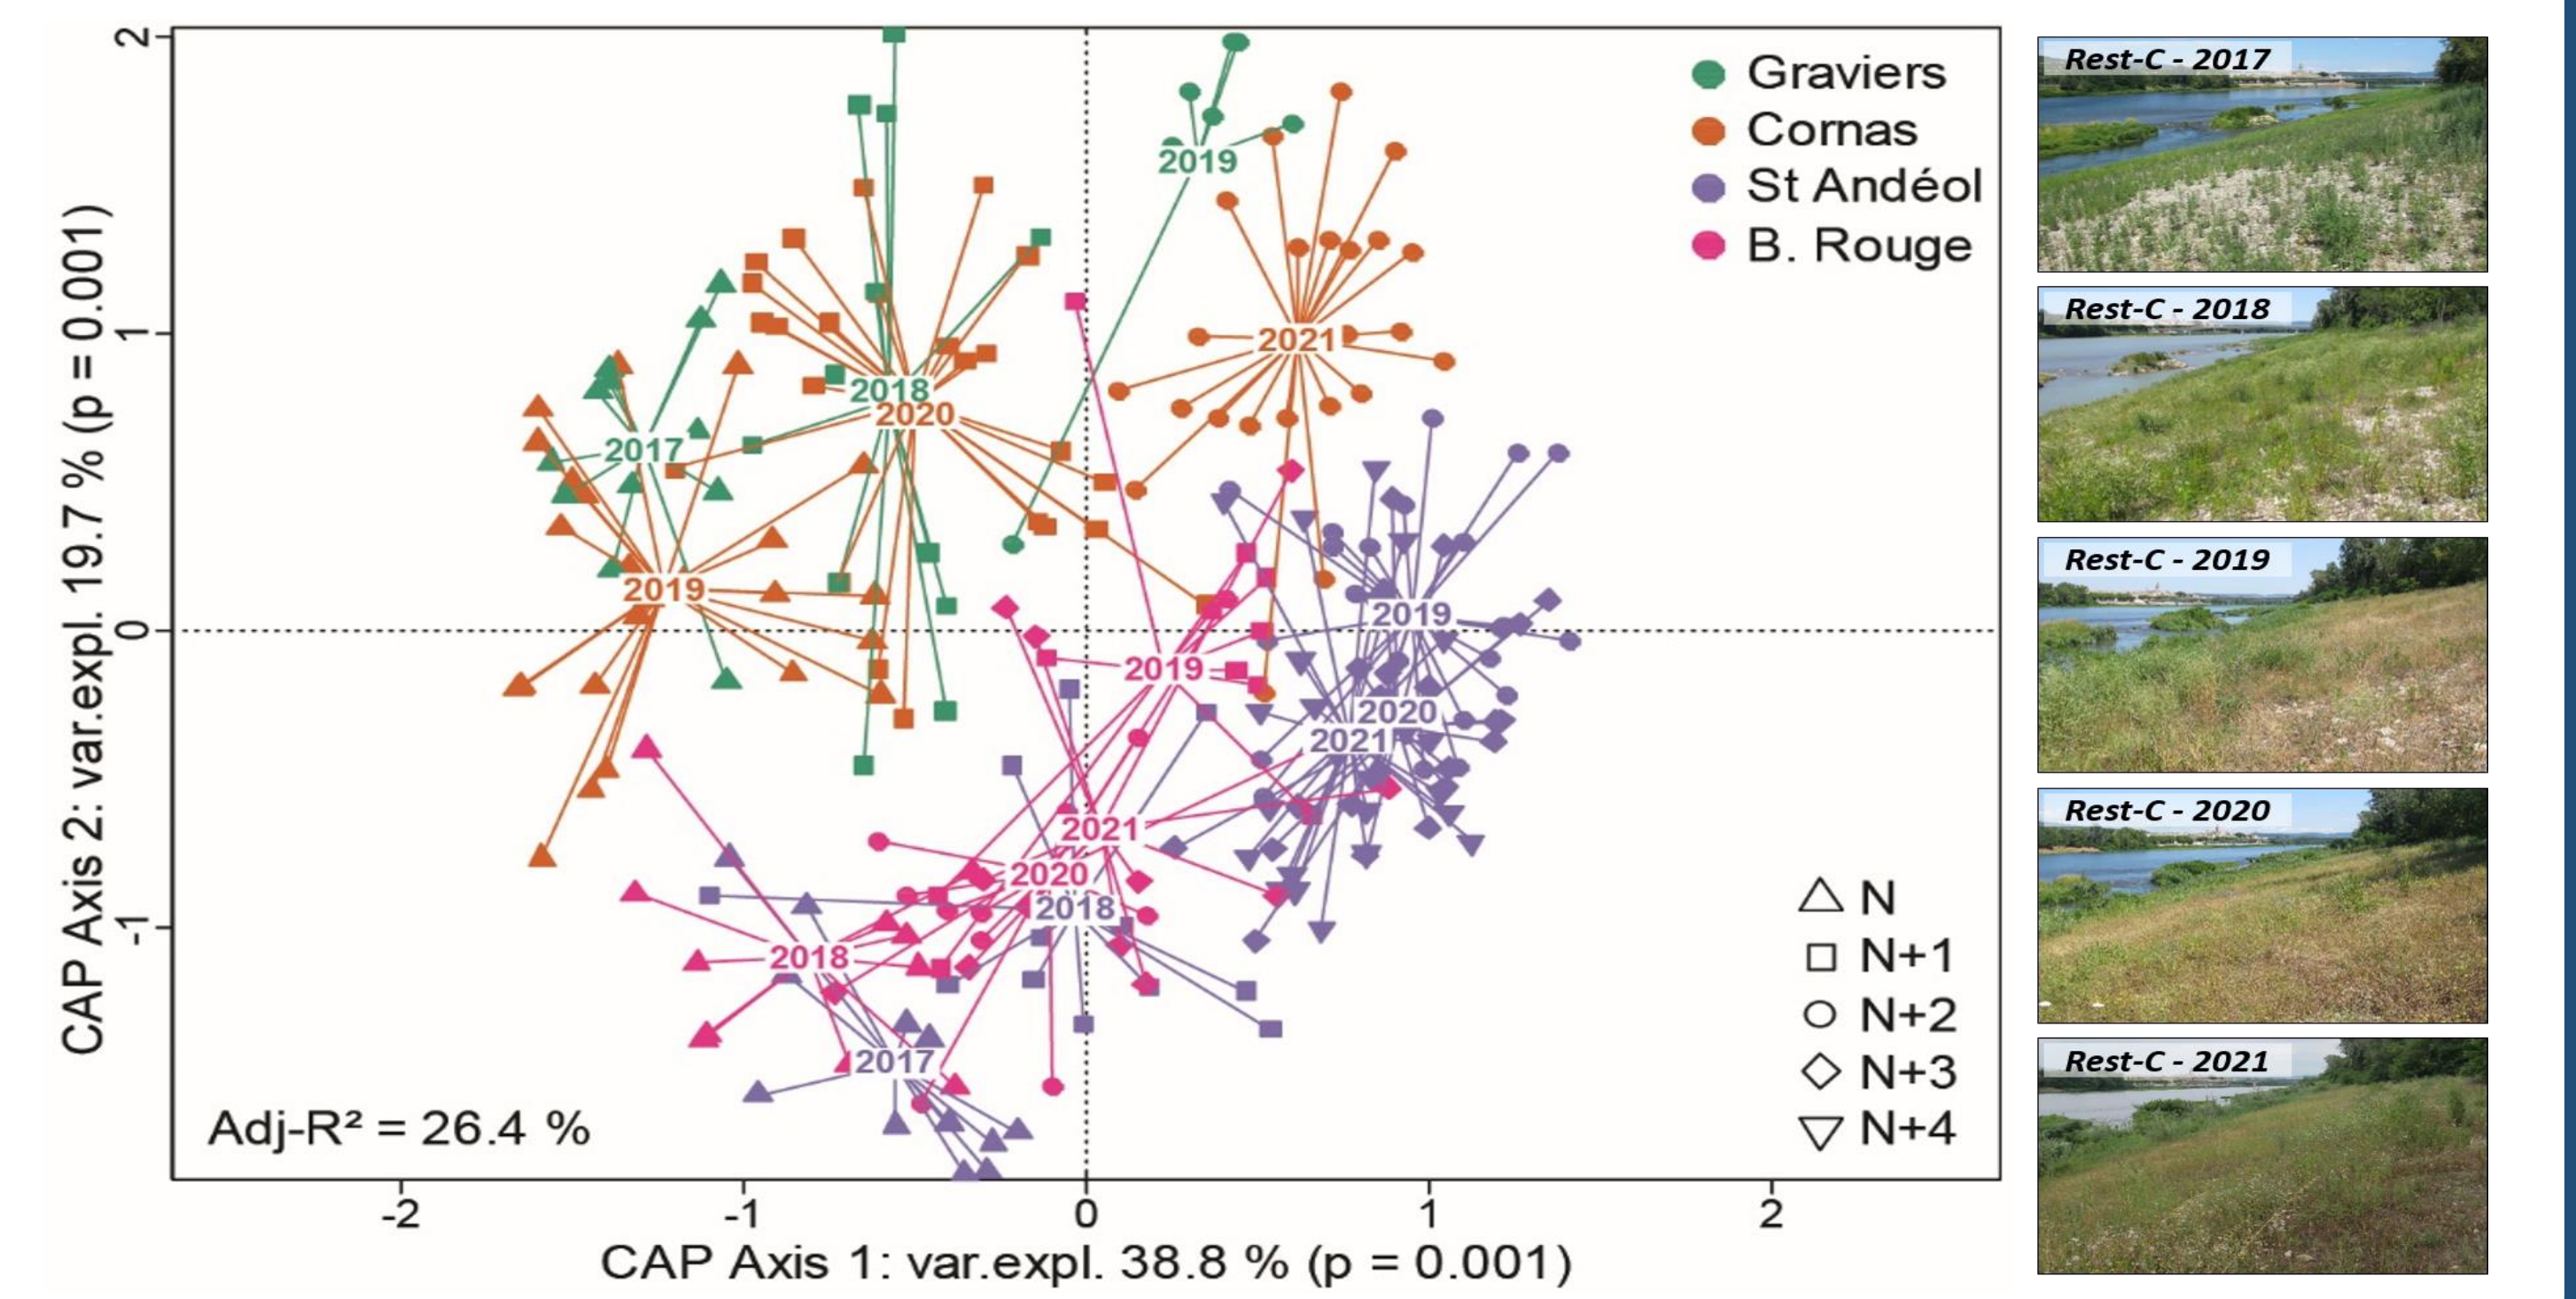
Canonical analysis of principal coordinates testing changes in species composition for each site as a function of time since completion

Changes in species composition between years reveal consistency in the successional trajectories followed by riparian communities between the 4 restored sites:

- The first axis is related to the time spent since the works and shows that the composition varies in the same direction despite a lag in the dismantling of the sites;
- The second axis is related to the position along the river corridor, with a clear structuring of communities between the northern and southern sites;
- At the St Andéol site, community dynamics stabilize after three years, suggesting an equilibrium between the species and the recreated environmental conditions;
- At the Banc Rouge site, a regressive succession occurred between 2019 and 2020, reflecting community response to plowing operations conducted by Rhône managers.
