# Assessing Maintenance Techniques to Restore the Hydraulic Function of Permeable Pavements

### Assessing Maintenance Techniques to Restore the Hydraulic Function of Permeable Pavements

Ryan J. Winston<sup>1</sup>, Ian M. Simpson<sup>2</sup>, Michael Brooker<sup>3</sup>

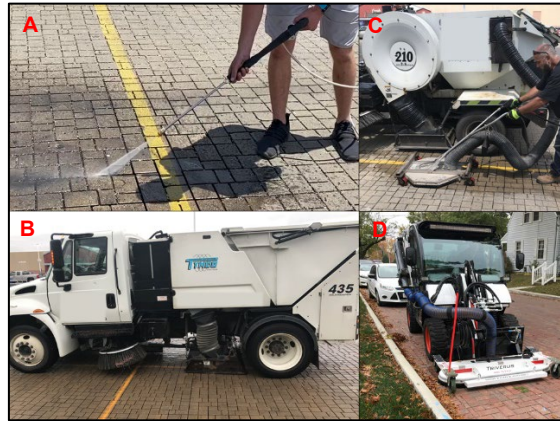
Figure 1: Examples of maintenance techniques testing in this research: pressure washer (A), Rejuvenater (B), Regenerative air street sweeper (C), Machine Cleaning Vehicle (D).

Maintenance techniques were trialed on five PICP systems which were moderately to heavily clogged in the greater Columbus, Ohio, USA, metropolitan area; four were permeable residential streets while one was in a commercial parking lot. These techniques included a pressure washer, the Rejuvenater, the MCV, regenerative air street sweepers, and a pressure washer and the Rejuvenater in series (Figure 1). The Rejuvenater is a walk behind purpose-built permeable pavement maintenance device with a 0.6-meter-wide deck equipped with a rotating, high-pressure nozzles. This deck was attached to a Model 210® Tymco regenerative air street sweeper to remove dislodged debris (Figure 1). A regenerative air street sweeper maintained all five PICP systems at regularly schedule intervals and with varying number of passes. Visual inspection of debris removal from the joint spaces was used to determine the number of passes at each PICP. The MCV is a modified Bobcat® Toolcat 5600 (Figure 1) with a rotating pressure washer and built in suction line to remove the debris / water mixture from the pavement.

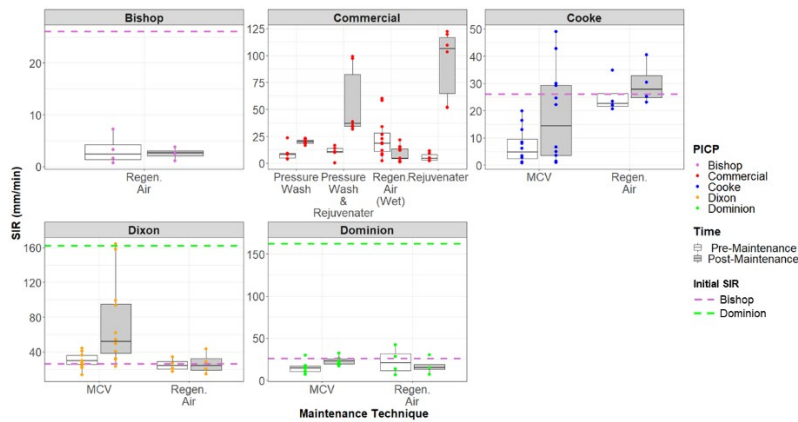
Figure 2: Boxplots of pre- and post-maintenance surface infiltration rates (SIRs) for various maintenance techniques (e.g., pressure washing, regenerative air sweeping performed during dry weather [“Regen. Air”] and wet weather [“Regen Air (Wet)”], Machine Cleaning Vehicle [MCV], and the Rejuvenater). Horizontal lines correspond to median initial SIRs at the Bishop and Dominion PICPs.

Observed improvements in SIR were highly varied among the PICP maintenance techniques tested (Figure 2). Median percent changes in SIR were -28, 67, 149, 505, and 1075% for the regenerative air street sweeper, MCV, pressure washer, pressure washer and Rejuvenater in series, and Rejuvenater, respectively. The most effective techniques were those which employed a high-power pressure washer and suction in combination. These were able to loosen accumulated debris in the joint space and subsequently remove it from the PICP. The Rejuvenater was the most effective of the maintenance practices tested, perhaps because of its slow operational speed (walk-behind), which provided more time for removal of debris via pressure washing and suction.

Regenerative air street sweeping performed at the Commercial PICP was negatively affected by rainfall during maintenance (Figure 2); the percent change in SIR for this maintenance technique was significantly different when it was performed during dry versus wet weather conditions. It improved SIRs on moderately clogged PICP in residential streets by a median of 11 percent when antecedent dry period was greater than 24 hrs (i.e., dry conditions). However, during wet weather the regenerative air street sweeper caused clogging material to consolidate into a mat-like network in the joint spaces, thereby reducing post-maintenance SIRs by a median of 59 percent.
