11<sup>e</sup> Conférence internationale

LYON 2023

# Assessing Maintenance Techniques to Restore the Hydraulic Function of Permeable Pavements

Ryan Winston, Ian Simpson, & Andrew Tirpak

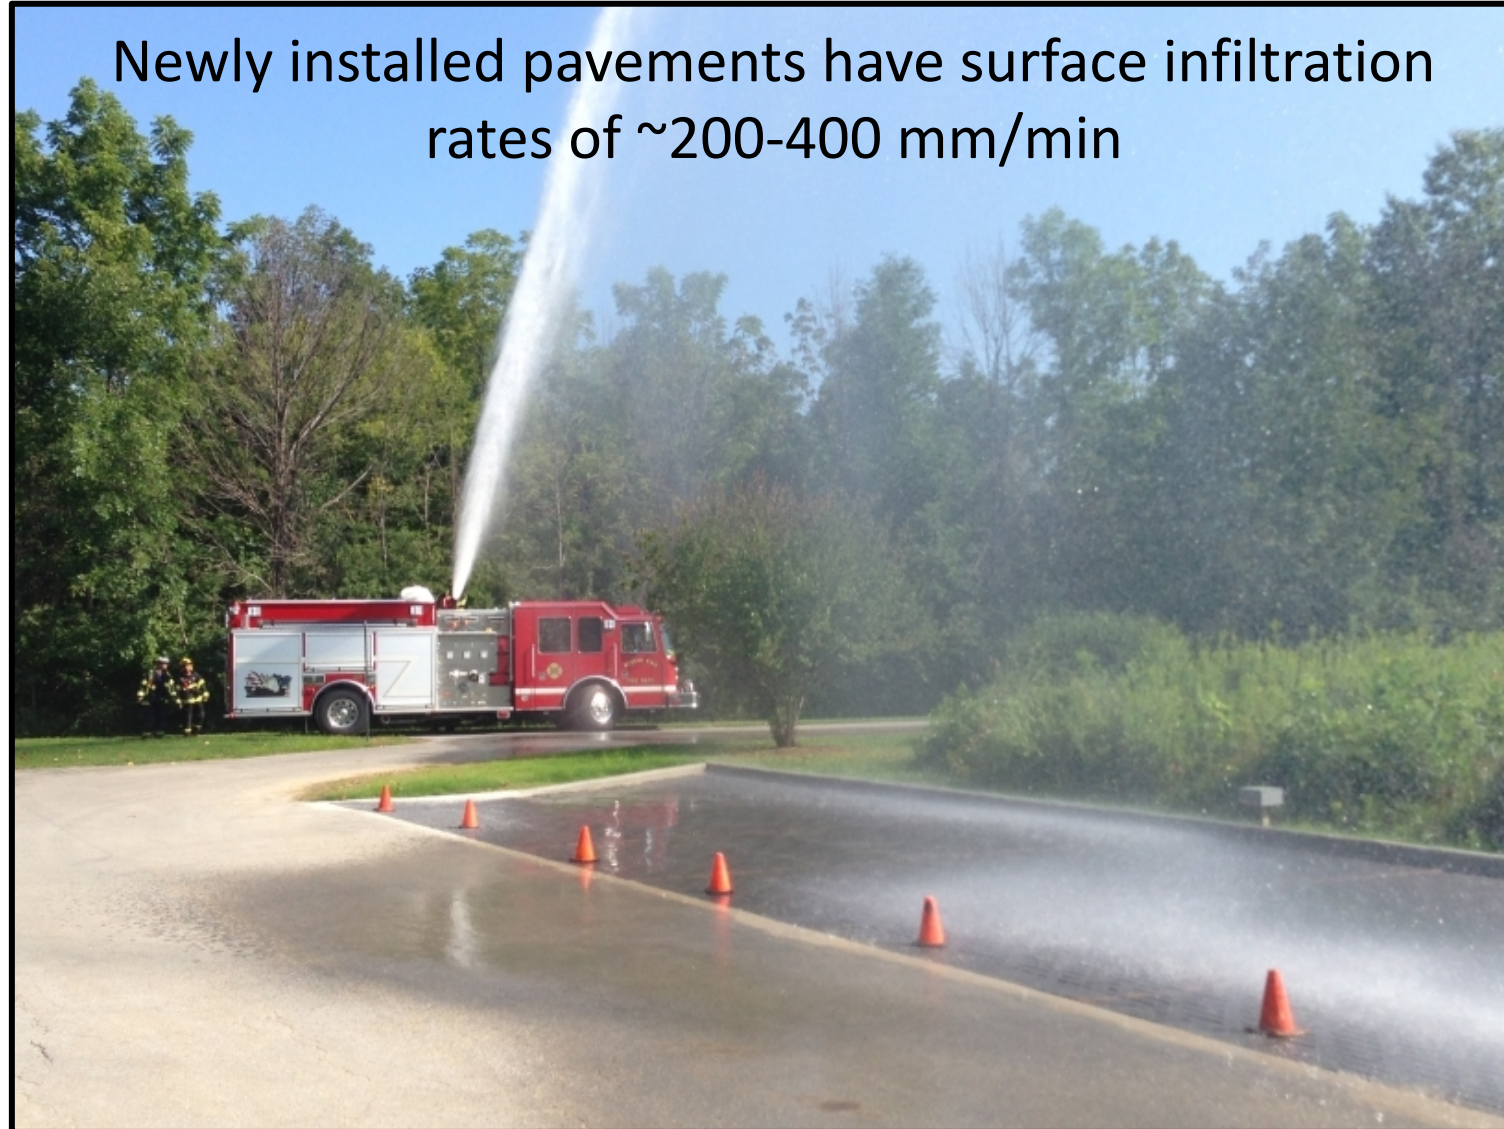
Newly installed pavements have surface infiltration rates of  $\sim 200\text{-}400$  mm/min

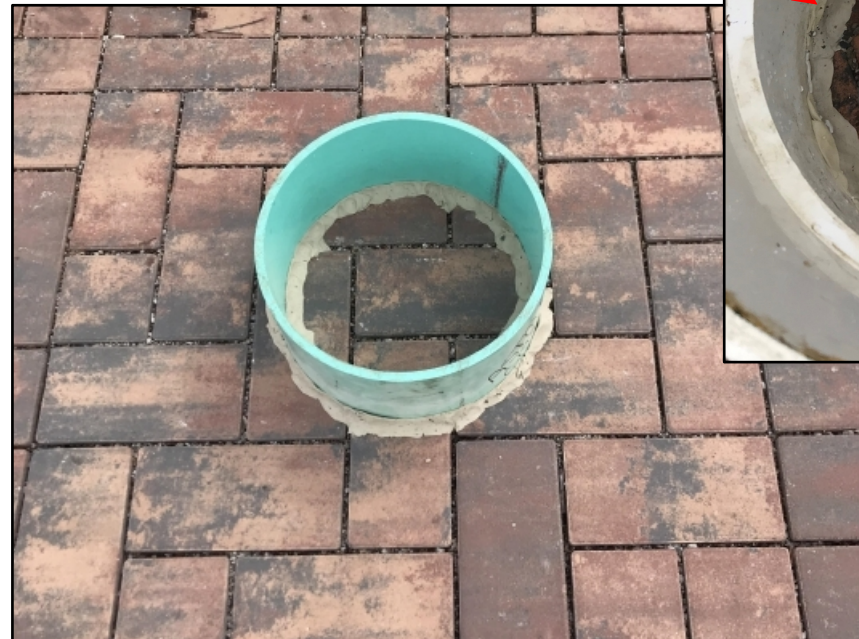
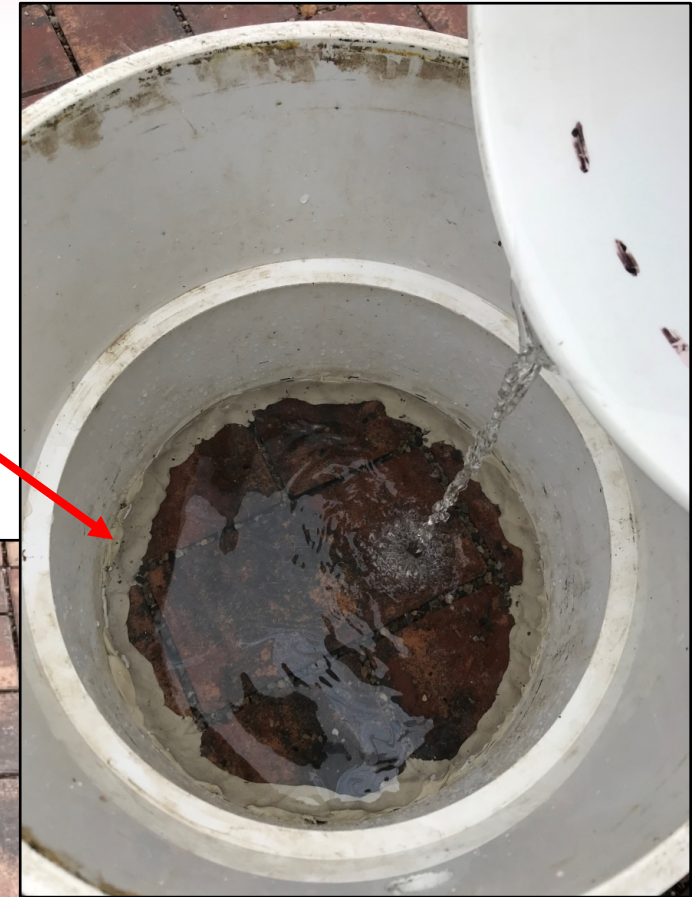
- Five permeable interlocking concrete pavements (PICPs)
  - Measured surface infiltration rate (SIR) immediately before and after maintenance
- $SIR = \text{total depth of water poured through the infiltrometer} / \text{time}$  (mm/min)

Max head of 1.5 cm

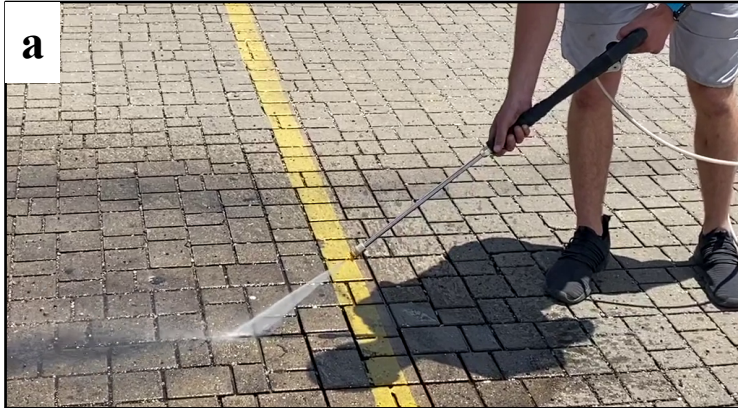
a) Pressure washer (P)

a) 45° angle, 290 kPa

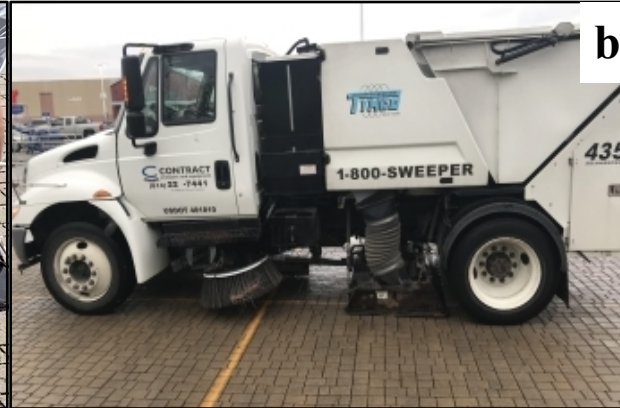
b) Regenerative air street sweeper

- Blower + vacuum

- Tymco 435/600

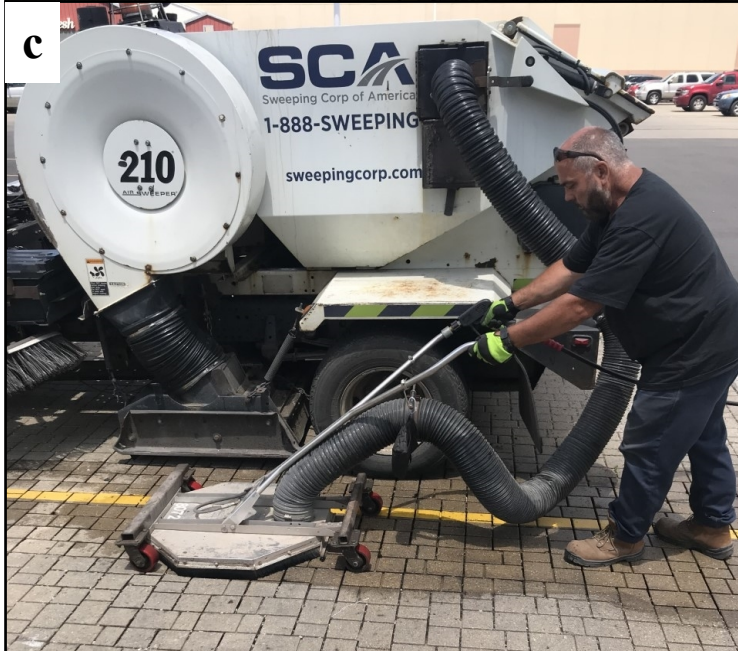
c) Rejuvenater (RJ)

- Vacuum + rotating pressure washer nozzles

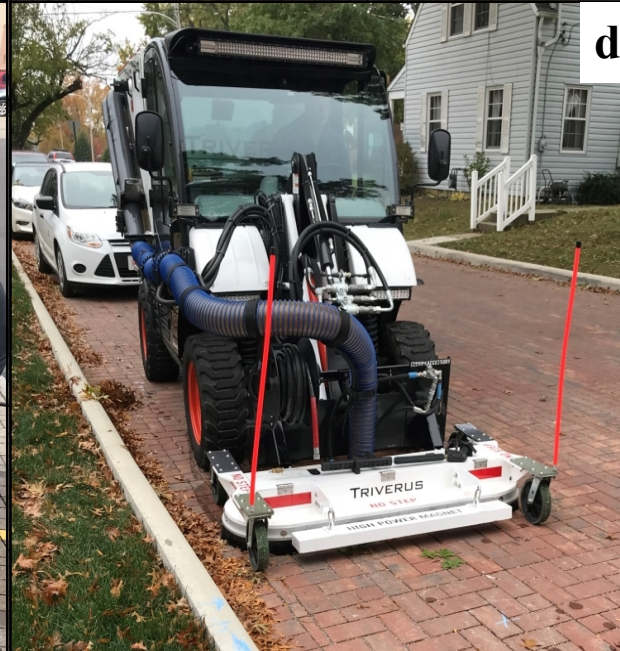
d) Machine Cleaning Vehicle (MCV)

- Vacuum + rotating pressure washer nozzles

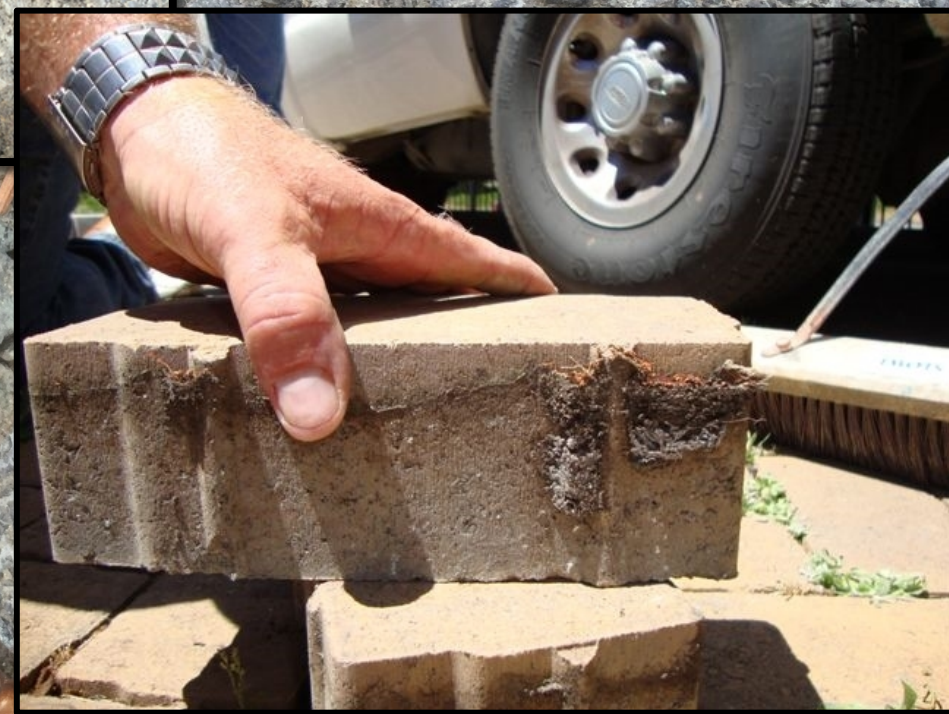
At what depth does  
clogging occur in the  
pavement?

This slide courtesy Bill Selbig, Upper Midwest  
Water Science Center, USGS

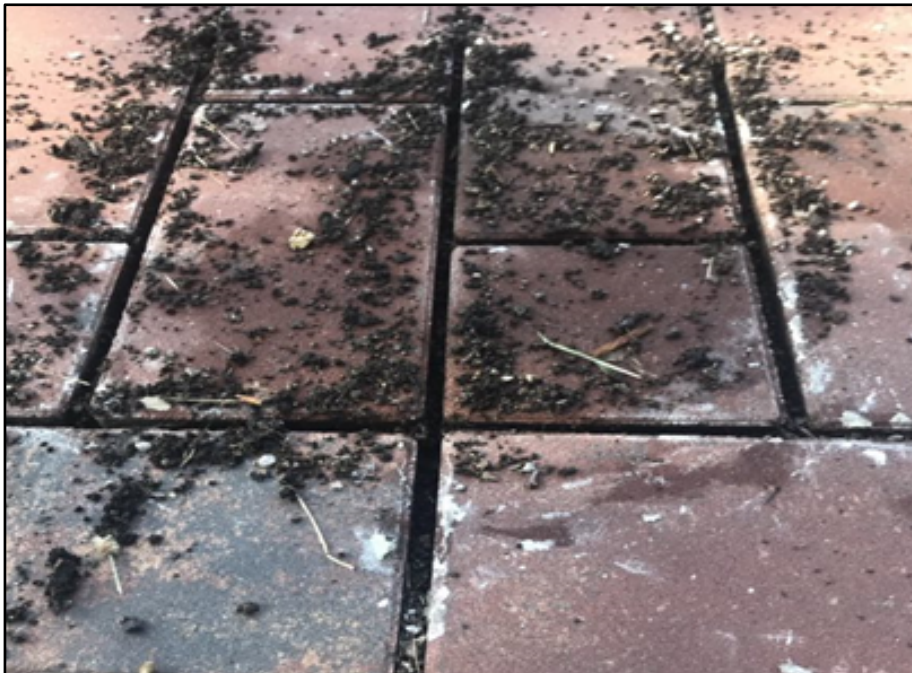
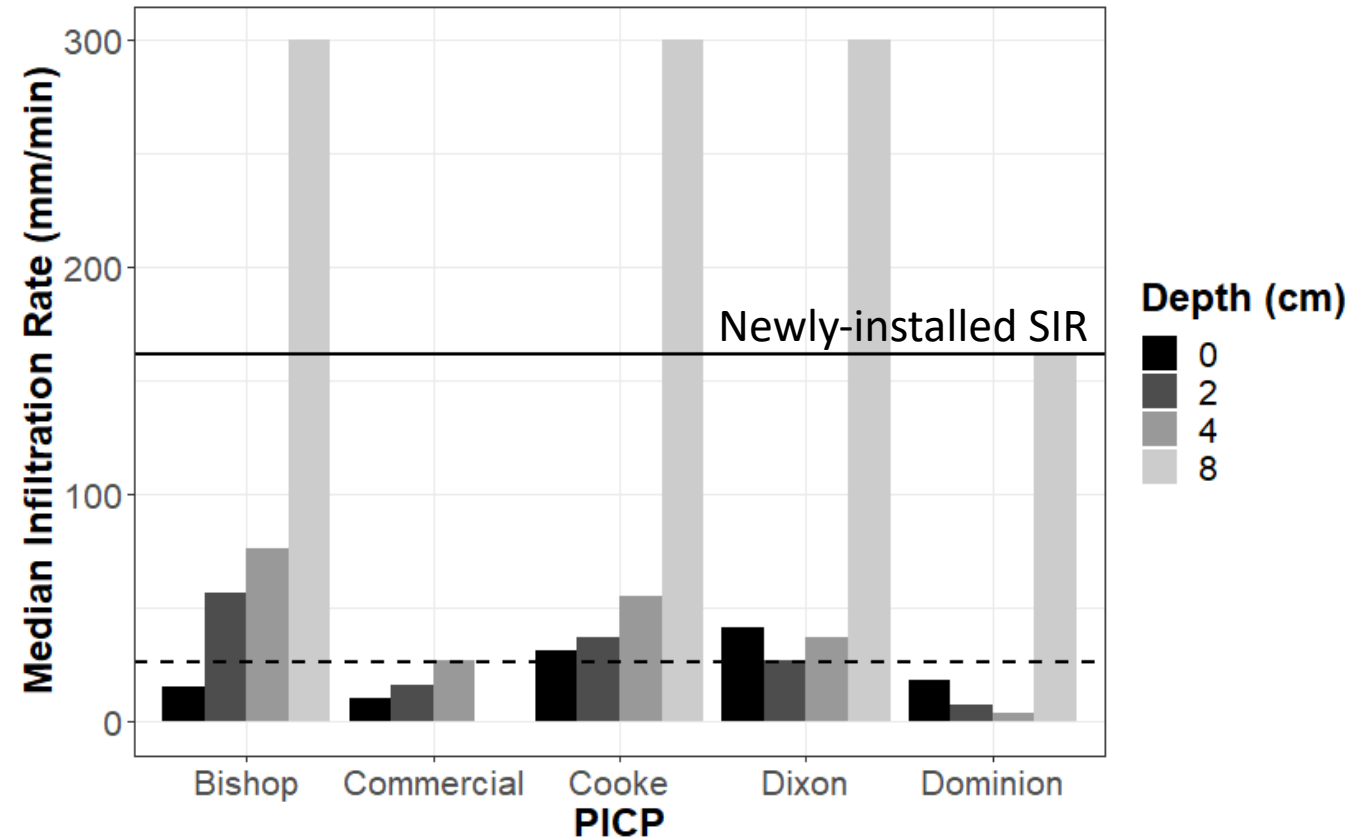
# How Deep Does it Clog?

- Manually removed all joint material in increments of 2 cm
- Repeated SIR testing after subsequent removal of joint material

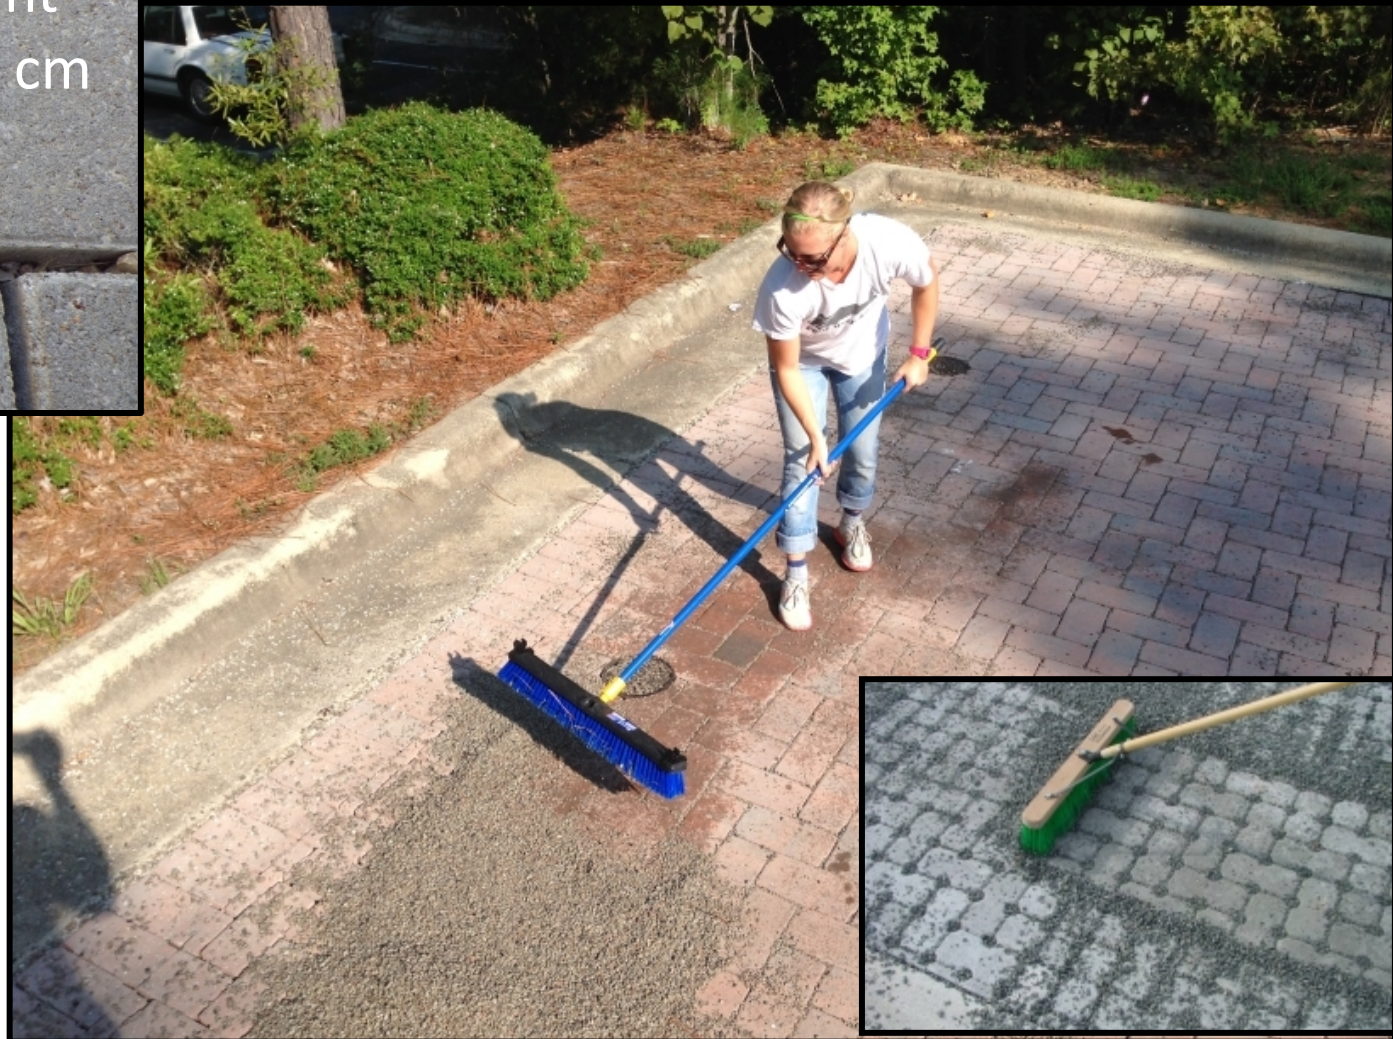
# Following PICP Maintenance, Must Refill Gaps with Gravel

Recommend limiting joint material removal to 2-5 cm below the pavement

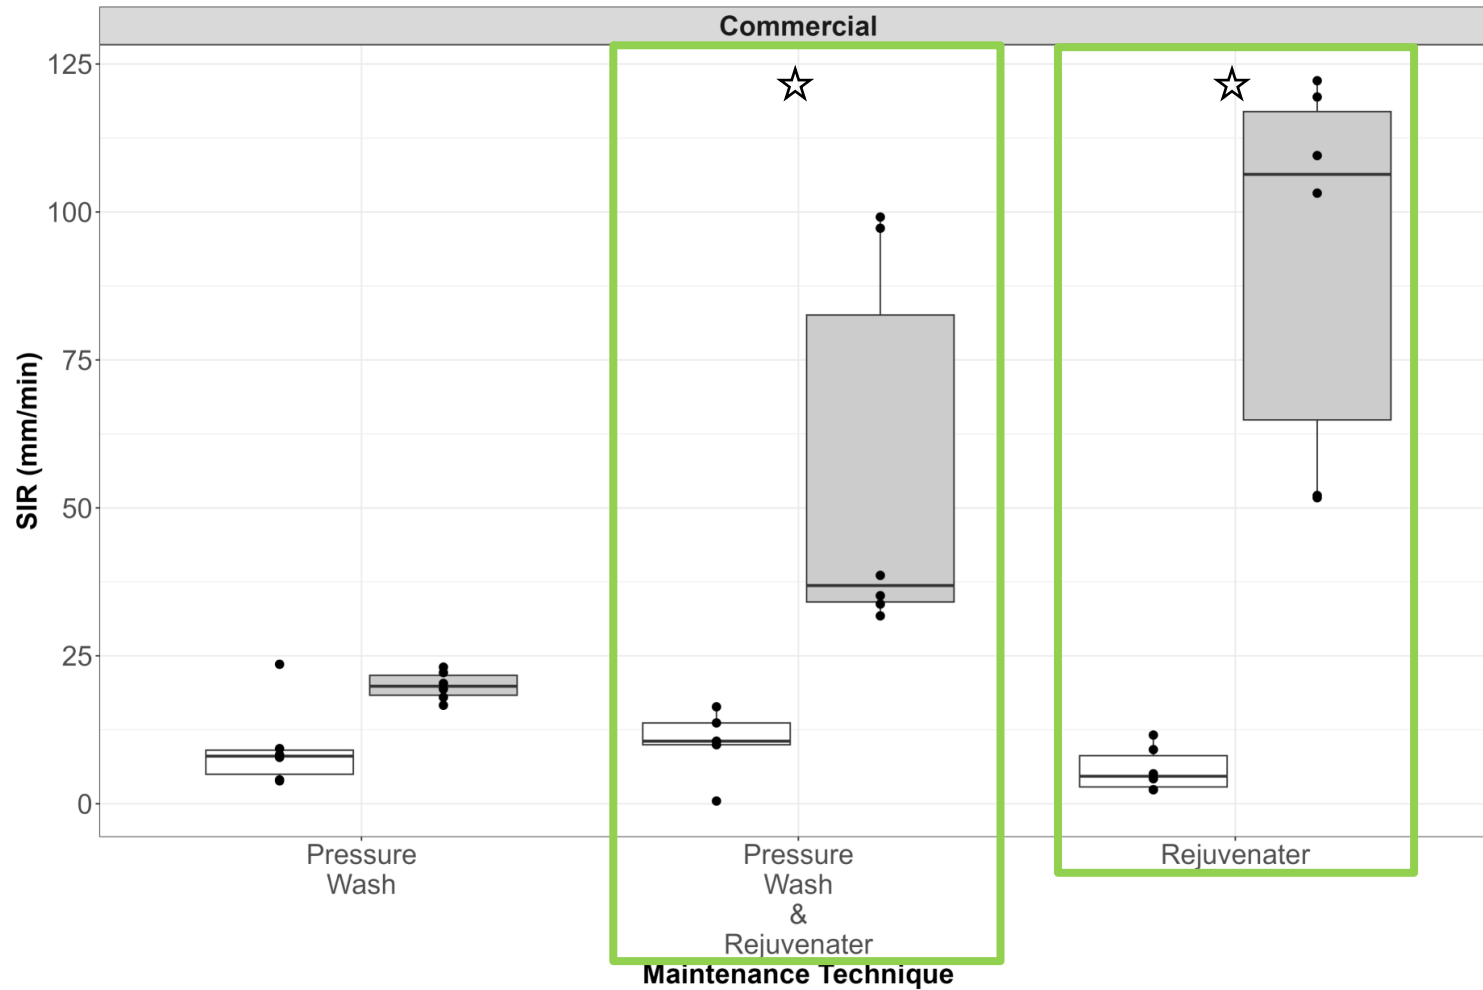
# Results: Pressure Wash & Rejuvenater

Pre-Maintenance  
 Post-Maintenance

- Wetting prior to additional maintenance hinders SIR recovery

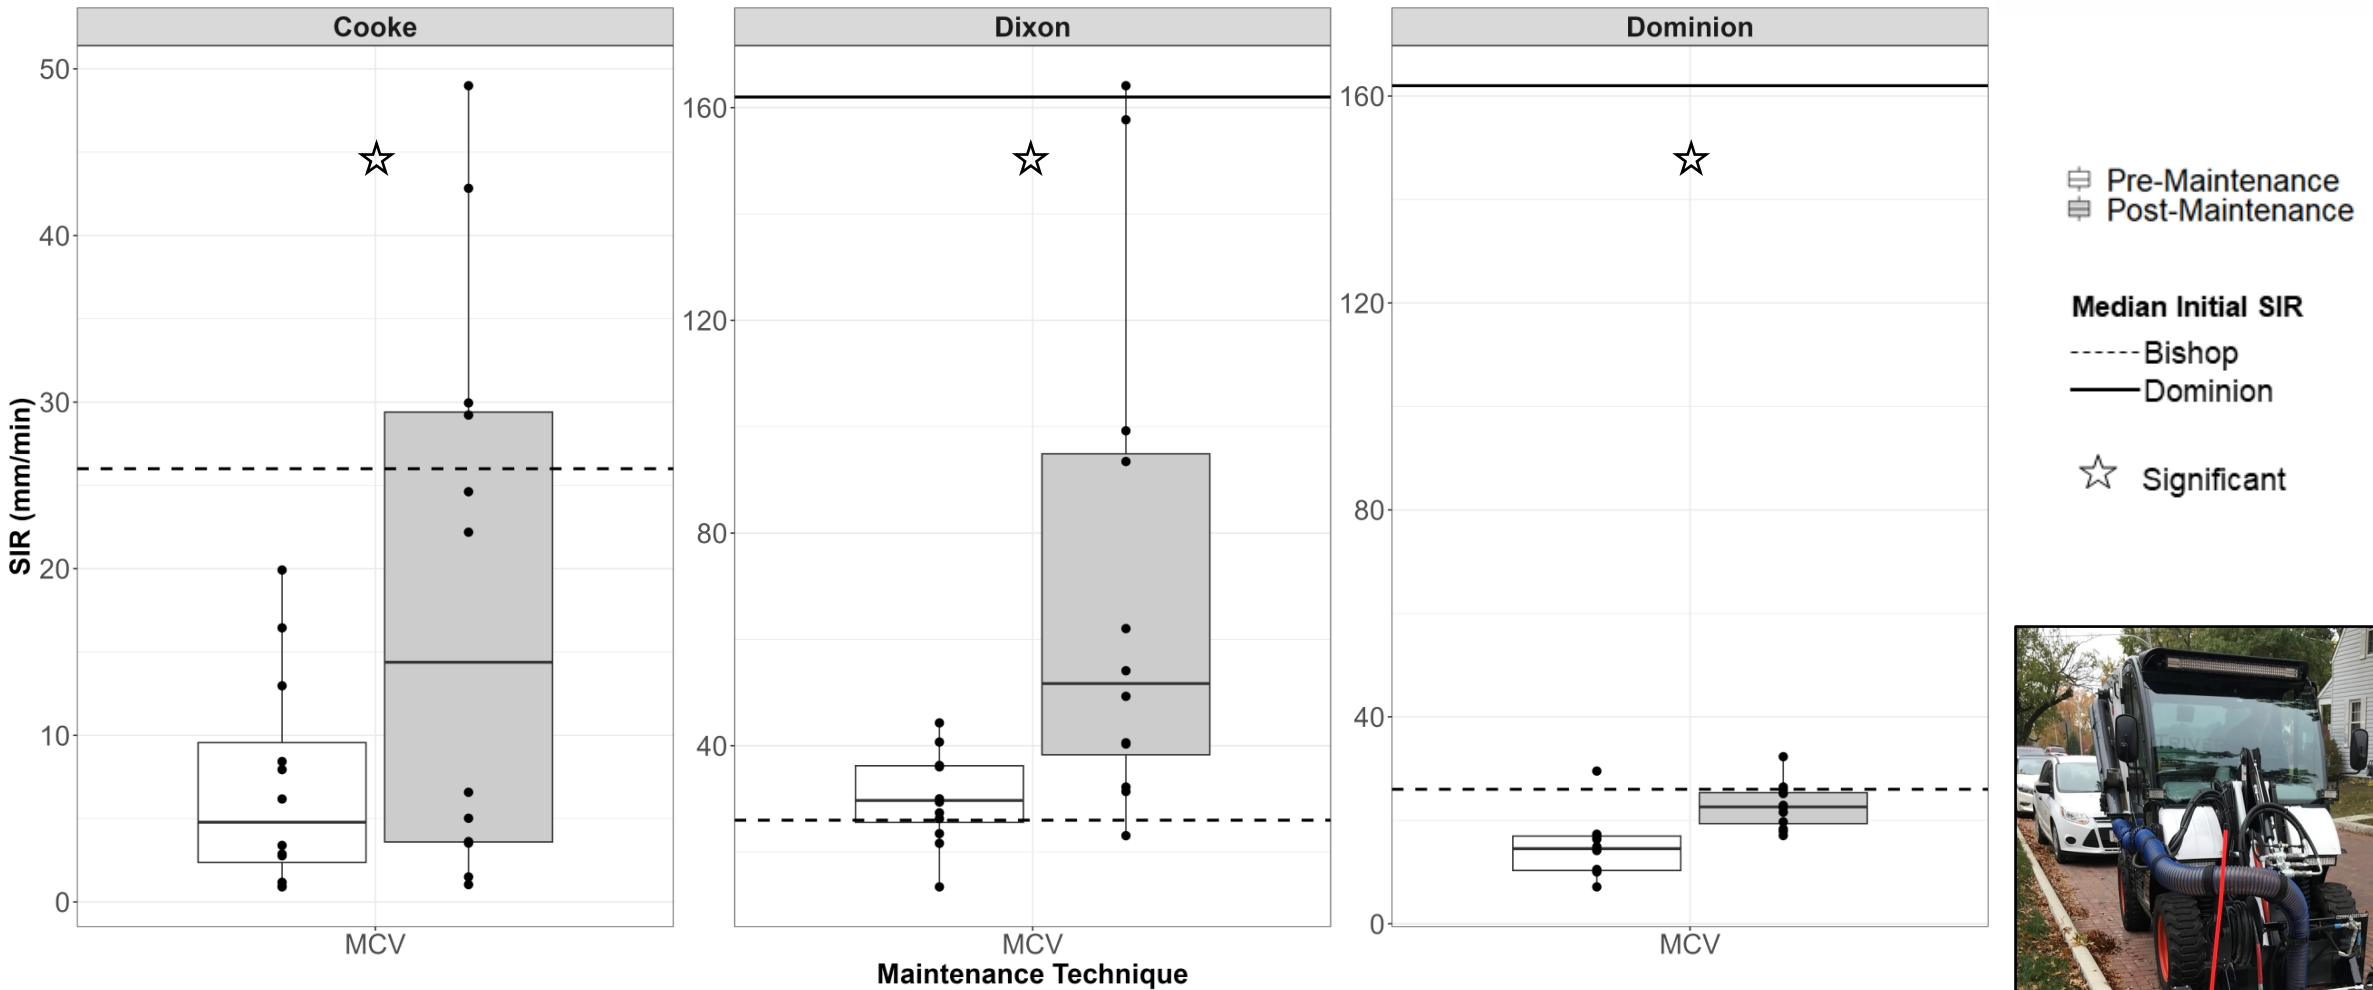
# Results: MCV

- Median SIRs improved from 15 to 26 mm/min improvements varied by site
- Tended to work better at sites with less clogging

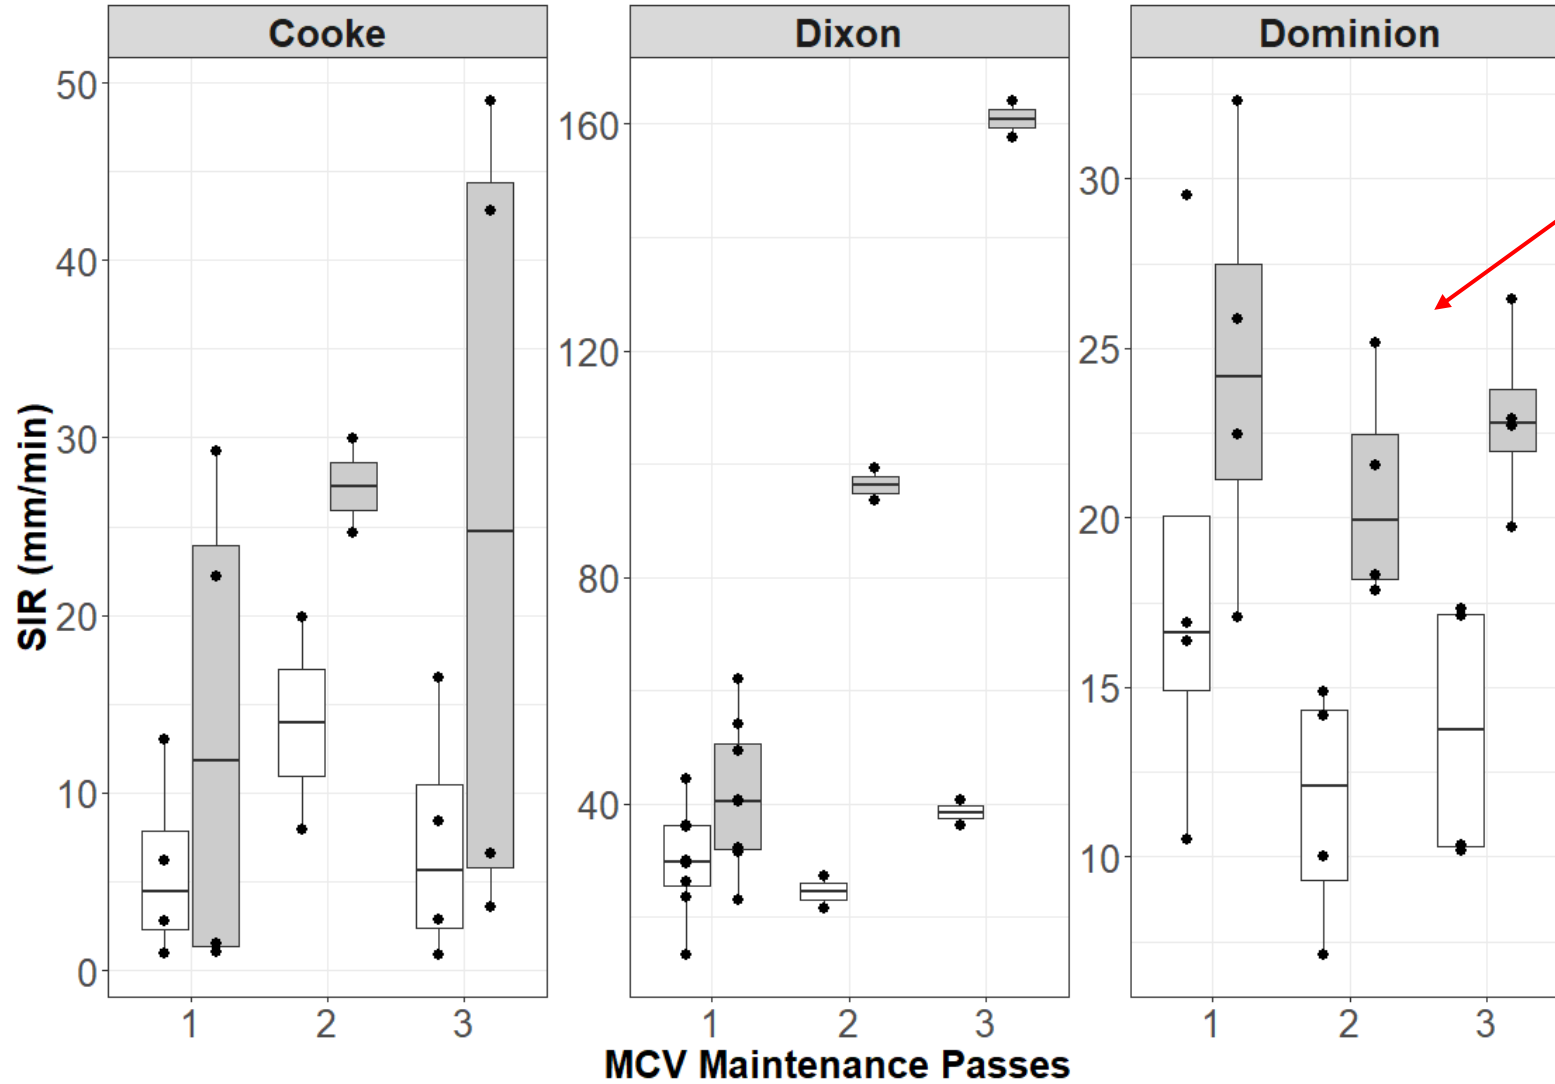
# Number of Passes with MCV

Most of clogging material >4 cm into pavement profile

- Pre-Maintenance
- Post-Maintenance
