Conservation of the earthen architectural assets at Pepy I necropolis archaeological site: how to adapt to climate change?

CONSERVATION OF THE EARTHEN ARCHITECTURAL ASSETS AT PEPEY I NECROPOLIS ARCHAEOLOGICAL SITE: HOW TO ADAPT TO CLIMATE CHANGE?

THIERRY JOFFROY

XAVIER HÉNAFF

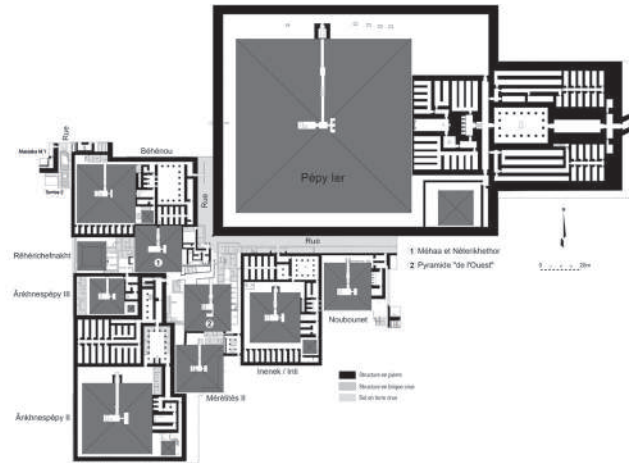
Figure 1: General plan of the Pepy I necropolis.
© MafS, X. Hénaff

In terms of organization, the funerary complex dedicated to the king (pyramid and funerary temple) is delimited by a large 4m wide enclosure (1st circle)⁴. A 5 m wide street runs around the enclosure. This street serves all the funerary complexes of the royal family (royal wives and children) which are estab-

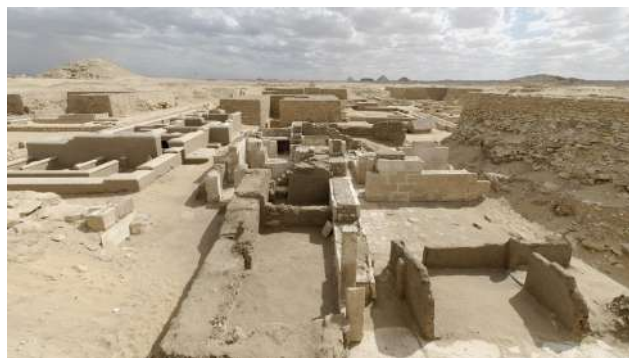
Figure 2: Funerary complex of Queen *Méhaa* and her son *Hornetjerikhet* (right), and the anonymous “Pyramide de l'Ouest” (left); use of massive brick walls and mixed constructions.

tures faced with limestone. To illustrate these cases, we can cite as examples the complex of Queen *Méhaa* and her son Prince *Hornetjerikhet* (Fig. 2) and Tomb No. 2 (excavated in 2022), the main parts of which are made of bricks, with the outer walls covered with limestone “slabs”.

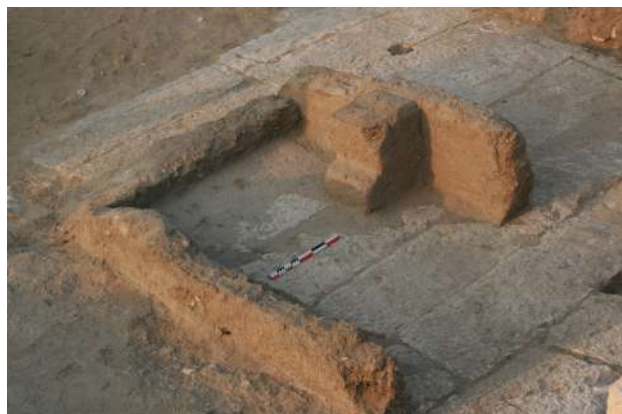
Figure 3: Queen *Behenou*’s complex: small mudbrick building discovered north of the pyramid. Construction of one to two bricks thick covered in places with a gypsum coating.

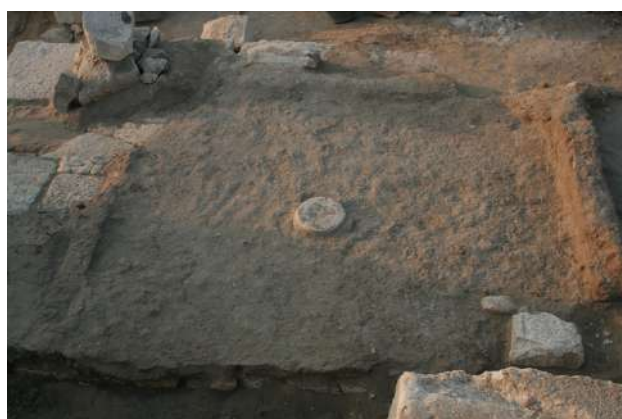
Figure 4: Queen *Behenou*’s complex: small mudbrick building erected in the courtyard north of the pyramid. An earthen floor was laid on a pre-existing pavement.

Many of the buildings described above contain earthen plaster which is sometimes covered with a layer of gypsum. The floors are also very often covered with a layer of earth mixed with small pebbles and/or cobbles⁵. These were used in the construction of the streets and the setting of the floors of the buildings’ rooms, even when the latter were laid on limestone paving (Fig. 4).

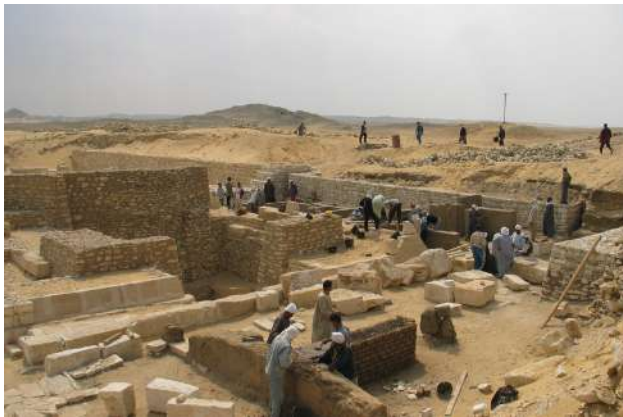
Method A: partial reconstruction of the walls with identical mud bricks made with local materials; the earth as well as the straw and degreasing agent (limestone chips and pebble fragments) are taken from the silt at the nearby village.

Method B: covering the faces of the structures with earthen plaster made according to traditional methods; a particular aspect (such as traces of smoothing) must make them easily distinguishable from the original elements.

Figure 5: Conservation works on the mudbrick structures (methods A and B).

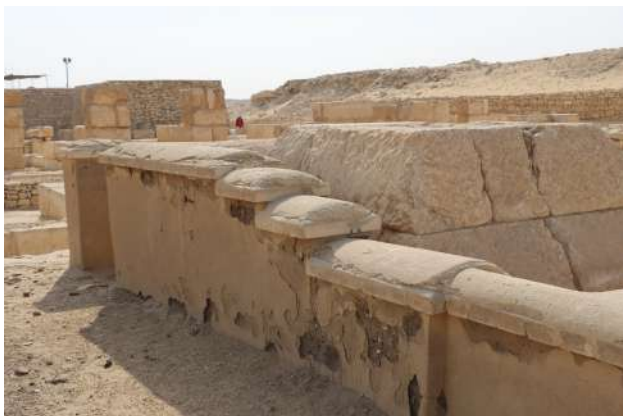
Figure 6: The conservation works (method C) did not prove efficient during the 2020 rains.

In combination with methods A and B, method C effectively protects the tops of the walls, and the overflow pushes the run-off beyond the wall. Unfortunately, the Antiquities Service has often reminded us of the lack of aestheticism of this choice, which we have therefore had to replace as best we could for several years. This represents a great deal of work for the Mission, as this method had become systematic in covering all brick walls since the 1990s. Over time, there is a natural tendency for the “caps” to fall off, resulting in infiltrations between the disjointed bricks, causing cracks in the heart of the walls and the plaster to detach. The main consequence is that the walls “open up” following vertical cracks to the base.

At the top of the walls: the flat shapes lead to the formation of gullies, the extent of which varies greatly depending on the shape and surface of the rainwater collection area. The joints between the bricks, especially those positioned as a stretcher, are areas of weakness. Concrete protective caps (method C) that had already been criticized for their poor aesthetics by the Egyptian authorities have also proved insufficient, if not leading to specific types of erosion, just underneath them (Fig. 6).

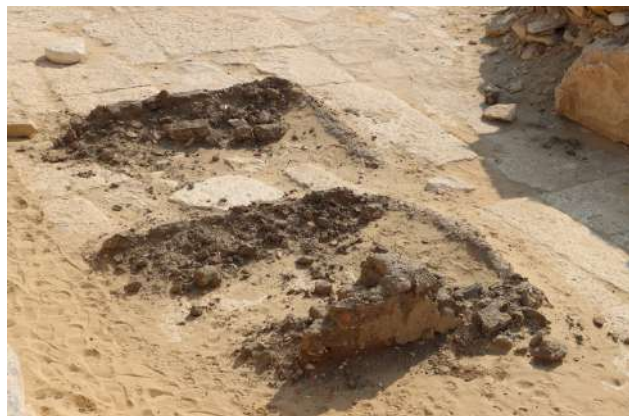
At the bases of the walls: erosion in the form of “destructive furrows” exists in zones prone to runoff and / or water stagnation. These instances of erosion are very important where damp is retained by sand or powdery earth deposits on the surrounding ground. Wall (and floor) configurations on stone slabs are also very unfavourable (Fig. 7).

Figure 7: The small structure (see Figure 4) built right above stone slabs suffered badly in 2020.

An unfortunate but clear pattern at the Pepy I necropolis is that when heavy rains occur, the capacity of mud structures built on stone flooring systems around the main buildings (pyramids or mastaba) to cope with the water is very limited. Several structures that had withstood several years without problems were seriously affected during the 2020 heavy rains, to the point that it is now difficult to restore them except by rebuilding them as they were documented when brought to light. This limited reconstruction is ethically possible, but there is also the opportunity to propose a reconstruction using more resistant materials, at least for the first one or two rows of bricks, which are most at risk. The way to do that is known as stabilization (DOAT *et al.*, 1979), though how to undertake it to create and use mud bricks with compatible aspects / colors requires experimentation. To that end, a first series of sam-

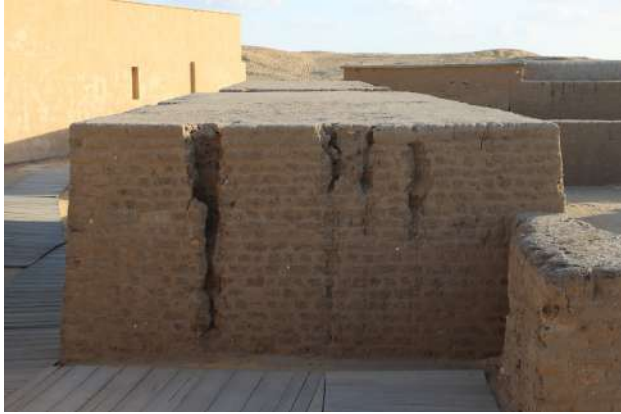
On the walls themselves, the phenomena observed starts at the surface of the wall which has the initial potential to absorb the first drops of water. When the surface is saturated, there is a continuity of absorption inside the structure (possibly including through micro cracks), but this is also when the water accumulating at the surface starts to flow. That process always starts at the top of the wall as it is more exposed, though if the rain is accompanied by wind, then the exposed elevations can be prone to a similar phenomenon. The main issue, then, is that the water accumulating on the top surface of the wall finds a way to flow down to the vertical surfaces. How this happens depends on the regularity of the top surface, but it is clear that even if the top of the wall is flat, it is never flat enough to ensure that the flow of water is equally distributed. That issue leads to the creation of concentrated flows which, if the rainfall lasts long enough, results in the erosion of the vertical faces of the walls in the form of gullies. An important point here is that the thicker the wall, the more water is collected, and thus the deeper is the gully formation (Fig. 8).

Figure 8: Gullies formed on a recently partially reconstructed entry pylon of one of the tombs of the New Kingdom necropolis at Saqqara.

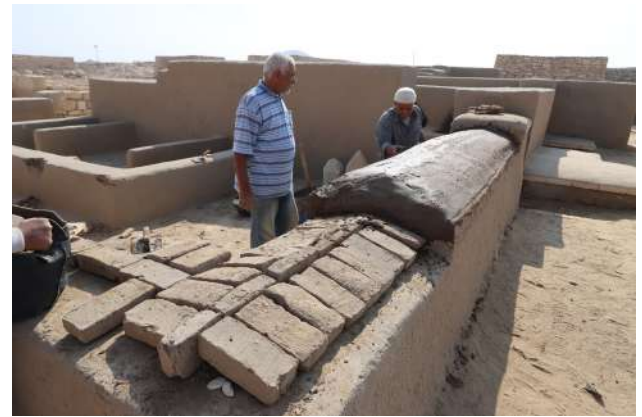
Figure 9: Rounded shape forming the protective capping prepared with bricks and two coats of plaster finish.

For the better protection of the walls and their plaster from rain damage, it was agreed to test rounded shape capping. This capping has three main advantages when compared to a flat surface. First, it represents a huge mass at the top of the wall,

with good capacity to absorb substantial amounts of rainwater. Second, a rounded shape favors the partition of water flowing down towards the wall faces, thus greatly limiting the possibility of flow concentration, and therefore, the formation of deep gullies. Third is that by providing a mass of earth at the top of the wall, the phenomenon that occurs during limited rains - of the transfer of matter from the top of the wall towards the vertical surfaces - is favored, repeating on these occasions the process of formation of a thin protective plaster-like layer.

To keep the changes reasonable in aesthetic terms, the first experimental capping that was realized at the site was limited in height, and to make the process quick and easy, the shape was designed to be obtained simply by laying bricks on the edge and by modelling plastic mortar. The finish is obtained with two coats of plaster, the final one being flush with the plaster layer of the wall faces (Fig. 9).

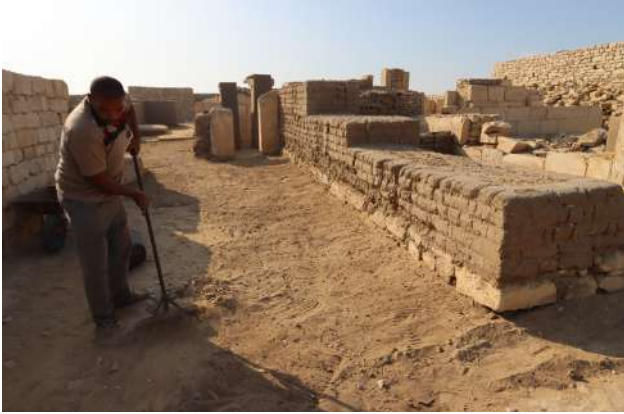
Figure 10: Levelling of the ground around the structures for proper drainage and the recovery of the stone wall basement.

To avoid the possibility of water stagnating by the sides of the bases of the mud brick walls, a scenario that would endanger their stability, the test zone (Méhaa complex) was studied to identify its potential “natural” slopes. The idea was to install a drainage system that drives the water towards potential superficial drainage canals or existing ancient drainage pits. Zones where water could stagnate far from the wall bases were also identified. The response here was to first clean the debris and then undertake a ground (or floors) levelling with slopes of approximately 5cm/m towards either the center of the rooms or areas which could serve as superficial drainage canals. Where a stone wall basis was present, the cleaning was done in a way which would ensure that this original protective measure would be recovered on at least 10 cm high (Fig. 10). That was possible at places where the ground (floor) is made of compacted earth (or debris). But, there are also numerous places at the site where this system will not be possible due to the presence of flat stone floors, which is why an additional experiment has been launched.

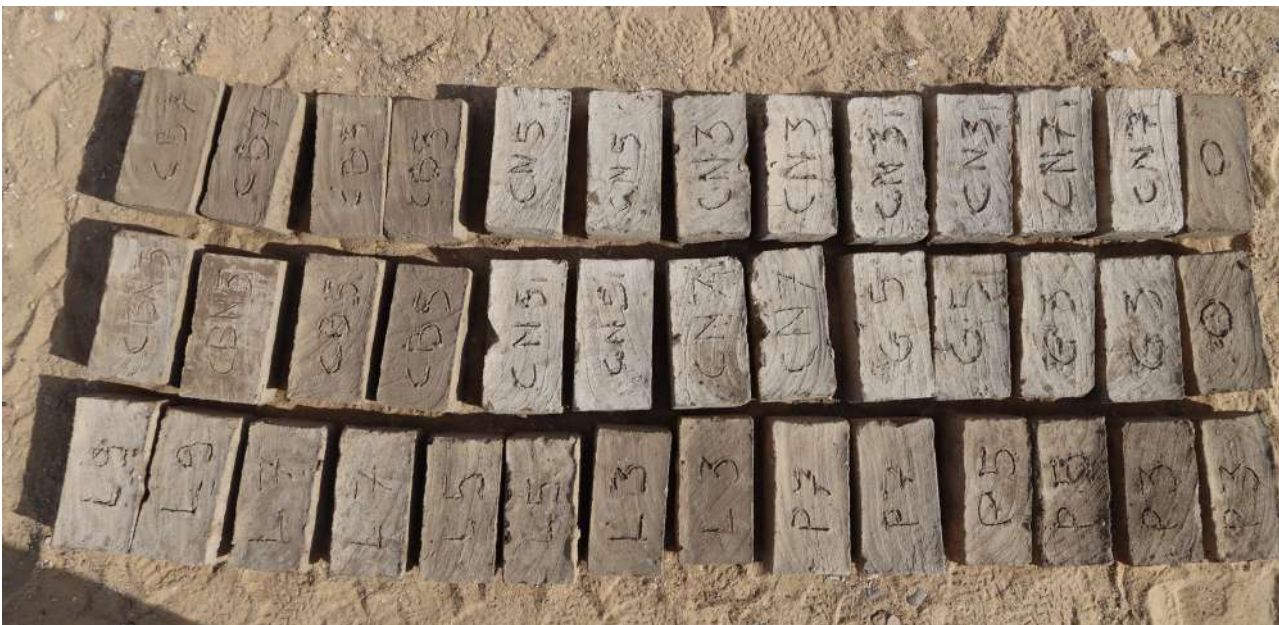
Figure 11: Samples of bricks prepared using a variety of stabilizers and dosages.

ples were prepared using the locally available soil with the following additives: cement, white cement, lime, and gypsum (Fig. 11). These samples will be tested next season, primarily through a cycle of capillarity tests to check the capability of the bricks to withstand a temporary humid state.
