# Conservation of the earthen architectural assets at Pepy I necropolis archaeological site: how to adapt to climate change?

Joffroy Thierry, Xavier Hénaff

# CONSERVATION OF THE EARTHEN ARCHITECTURAL ASSETS AT PEPEY I NECROPOLIS ARCHAEOLOGICAL SITE: HOW TO ADAPT TO CLIMATE CHANGE?

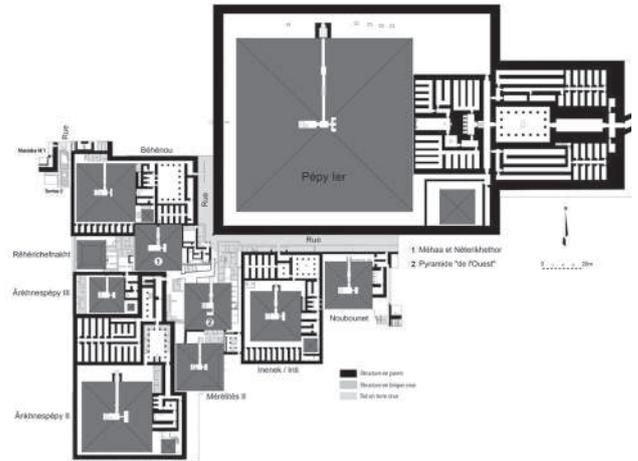
Figure 1: General plan of the Pepy I necropolis.  
© MafS, X. Hénaff

In terms of organization, the funerary complex dedicated to the king (pyramid and funerary temple) is delimited by a large 4m wide enclosure (1<sup>st</sup> circle)<sup>4</sup>. A 5 m wide street runs around the enclosure. This street serves all the funerary complexes of the royal family (royal wives and children) which are estab-

Lastly, the necropolis of the elite is established behind the royal family, constituting the third and final circle. The plan of the necropolis, as it appears today, allows us to partly identify the western limit of the second circle: the western enclosures of the complexes of queens *Ankhnespépy II*, *Ankhnespépy III* and *Béhénou* have a perfect rectilinear alignment which is oriented on a north-south axis, demonstrating the planned distinction between the necropolises of the royal family and of the high dignitaries. Moreover, a street similar to that separating the king from the queens runs along the western side of this wall, providing access to all the mastabas in line.

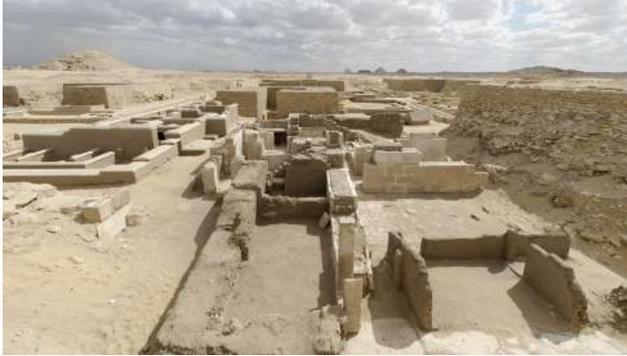
Figure 2: Funerary complex of Queen *Méhaa* and her son *Hornetjerikhet* (right), and the anonymous “Pyramide de l'Ouest” (left); use of massive brick walls and mixed constructions.

tures faced with limestone. To illustrate these cases, we can cite as examples the complex of Queen *Méhaa* and her son Prince *Hornetjerikhet* (Fig. 2) and Tomb No. 2 (excavated in 2022), the main parts of which are made of bricks, with the outer walls covered with limestone “slabs”.

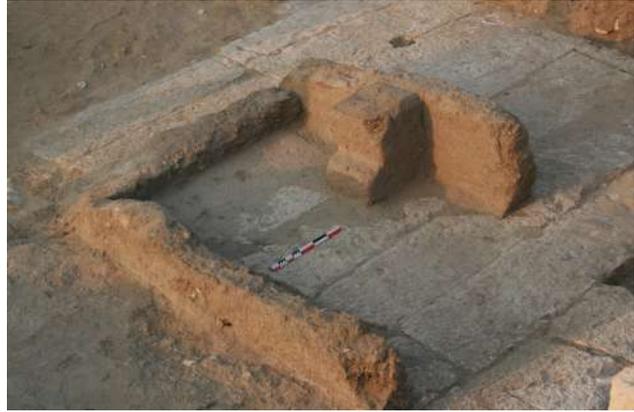
Figure 3: Queen *Behenou*'s complex: small mudbrick building discovered north of the pyramid. Construction of one to two bricks thick covered in places with a gypsum coating.

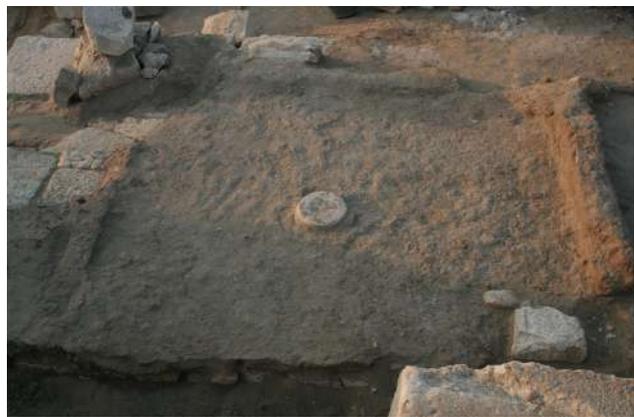
Figure 4: Queen *Behenou*'s complex: small mudbrick building erected in the courtyard north of the pyramid. An earthen floor was laid on a pre-existing pavement.

Many of the buildings described above contain earthen plaster which is sometimes covered with a layer of gypsum. The floors are also very often covered with a layer of earth mixed with small pebbles and/or cobbles<sup>5</sup>. These were used in the construction of the streets and the setting of the floors of the buildings’ rooms, even when the latter were laid on limestone paving (Fig. 4).

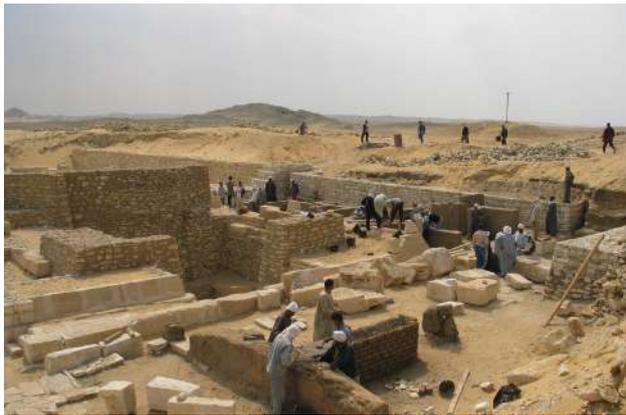
Figure 5: Conservation works on the mudbrick structures (methods A and B).

**Method A:** partial reconstruction of the walls with identical mud bricks made with local materials; the earth as well as the straw and degreasing agent (limestone chips and pebble fragments) are taken from the silt at the nearby village.

**Method B:** covering the faces of the structures with earthen plaster made according to traditional methods; a particular aspect (such as traces of smoothing) must make them easily distinguishable from the original elements.

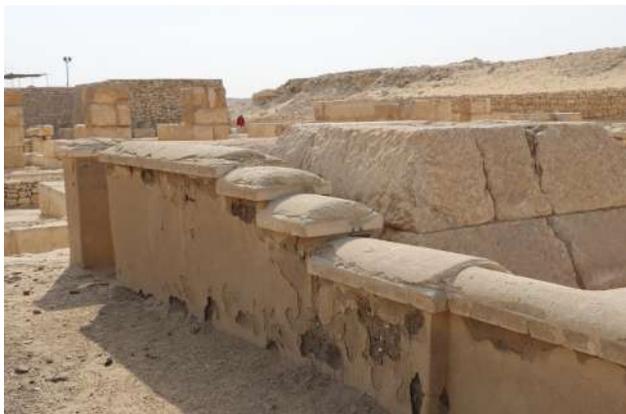
Figure 6: The conservation works (method C) did not prove efficient during the 2020 rains.

At the top of the walls: the flat shapes lead to the formation of gullies, the extent of which varies greatly depending on the shape and surface of the rainwater collection area. The joints between the bricks, especially those positioned as a stretcher, are areas of weakness. Concrete protective caps (method C) that had already been criticized for their poor aesthetics by the Egyptian authorities have also proved insufficient, if not leading to specific types of erosion, just underneath them (Fig. 6).

Method C: covering the wall levels in order to protect the tops of the walls with “caps”; first, the structures are completed in order to create a rectilinear top with bricks (method A); when the wall is several rows thick, only the outer courses are rebuilt while those constituting the core are replaced with a filling (fragments of limestone, bricks and earth combined). Finally, the “caps”, made with modern fired bricks bound with lime mortar, are mounted in an overhanging position, and covered by a semi cylindrical shape made from the same mortar mentioned above.

In combination with methods A and B, method C effectively protects the tops of the walls, and the overflow pushes the runoff beyond the wall. Unfortunately, the Antiquities Service has often reminded us of the lack of aestheticism of this choice, which we have therefore had to replace as best we could for several years. This represents a great deal of work for the Mission, as this method had become systematic in covering all brick walls since the 1990s. Over time, there is a natural tendency for the “caps” to fall off, resulting in infiltrations between the disjointed bricks, causing cracks in the heart of the walls and the plaster to detach. The main consequence is that the walls “open up” following vertical cracks to the base.

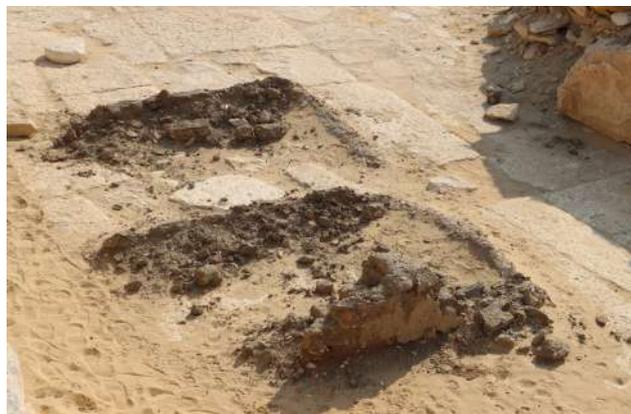
At the bases of the walls: erosion in the form of “destructive furrows” exists in zones prone to runoff and / or water stagnation. These instances of erosion are very important where damp is retained by sand or powdery earth deposits on the surrounding ground. Wall (and floor) configurations on stone slabs are also very unfavourable (Fig. 7).

Figure 7: The small structure (see Figure 4) built right above stone slabs suffered badly in 2020.

An unfortunate but clear pattern at the Pepy I necropolis is that when heavy rains occur, the capacity of mud structures built on stone flooring systems around the main buildings (pyramids or mastaba) to cope with the water is very limited. Several structures that had withstood several years without problems were seriously affected during the 2020 heavy rains, to the point that it is now difficult to restore them except by rebuilding them as they were documented when brought to light. This limited reconstruction is ethically possible, but there is also the opportunity to propose a reconstruction using more resistant materials, at least for the first one or two rows of bricks, which are most at risk. The way to do that is known as stabilization (DOAT *et al.*, 1979), though how to undertake it to create and use mud bricks with compatible aspects / colors requires experimentation. To that end, a first series of sam-

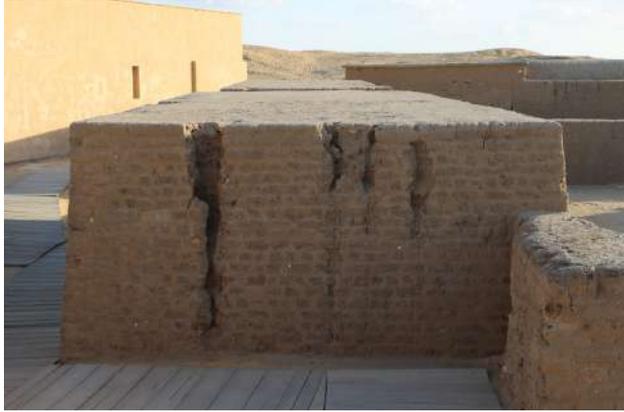
On the walls themselves, the phenomena observed starts at the surface of the wall which has the initial potential to absorb the first drops of water. When the surface is saturated, there is a continuity of absorption inside the structure (possibly including through micro cracks), but this is also when the water accumulating at the surface starts to flow. That process always starts at the top of the wall as it is more exposed, though if the rain is accompanied by wind, then the exposed elevations can be prone to a similar phenomenon. The main issue, then, is that the water accumulating on the top surface of the wall finds a way to flow down to the vertical surfaces. How this happens depends on the regularity of the top surface, but it is clear that even if the top of the wall is flat, it is never flat enough to ensure that the flow of water is equally distributed. That issue leads to the creation of concentrated flows which, if the rainfall lasts long enough, results in the erosion of the vertical faces of the walls in the form of gullies. An important point here is that the thicker the wall, the more water is collected, and thus the deeper is the gully formation (Fig. 8).

Figure 8: Gullies formed on a recently partially reconstructed entry pylon of one of the tombs of the New Kingdom necropolis at Saqqara.

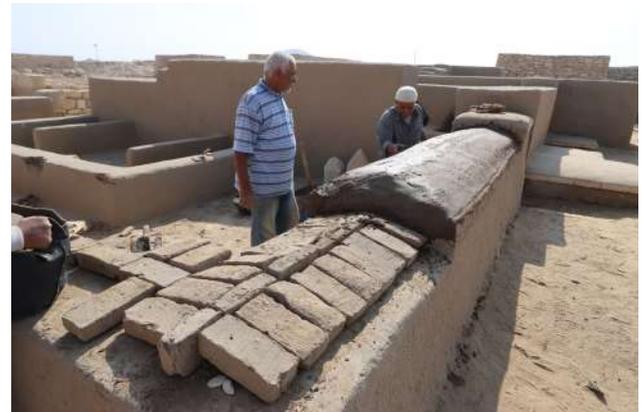
Figure 9: Rounded shape forming the protective capping prepared with bricks and two coats of plaster finish.

For the better protection of the walls and their plaster from rain damage, it was agreed to test rounded shape capping. This capping has three main advantages when compared to a flat surface. First, it represents a huge mass at the top of the wall,

with good capacity to absorb substantial amounts of rainwater. Second, a rounded shape favors the partition of water flowing down towards the wall faces, thus greatly limiting the possibility of flow concentration, and therefore, the formation of deep gullies. Third is that by providing a mass of earth at the top of the wall, the phenomenon that occurs during limited rains - of the transfer of matter from the top of the wall towards the vertical surfaces - is favored, repeating on these occasions the process of formation of a thin protective plaster-like layer. To keep the changes reasonable in aesthetic terms, the first experimental capping that was realized at the site was limited in height, and to make the process quick and easy, the shape was designed to be obtained simply by laying bricks on the edge and by modelling plastic mortar. The finish is obtained with two coats of plaster, the final one being flush with the plaster layer of the wall faces (Fig. 9).

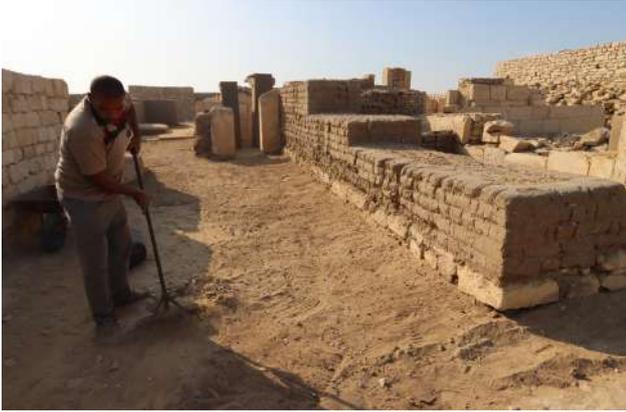
Figure 10: Levelling of the ground around the structures for proper drainage and the recovery of the stone wall basement.

To avoid the possibility of water stagnating by the sides of the bases of the mud brick walls, a scenario that would endanger their stability, the test zone (Méhaa complex) was studied to identify its potential “natural” slopes. The idea was to install a drainage system that drives the water towards potential superficial drainage canals or existing ancient drainage pits. Zones where water could stagnate far from the wall bases were also identified. The response here was to first clean the debris and then undertake a ground (or floors) levelling with slopes of approximately 5cm/m towards either the center of the rooms or areas which could serve as superficial drainage canals. Where a stone wall basis was present, the cleaning was done in a way which would ensure that this original protective measure would be recovered on at least 10 cm high (Fig. 10). That was possible at places where the ground (floor) is made of compacted earth (or debris). But, there are also numerous places at the site where this system will not be possible due to the presence of flat stone floors, which is why an additional experiment has been launched.

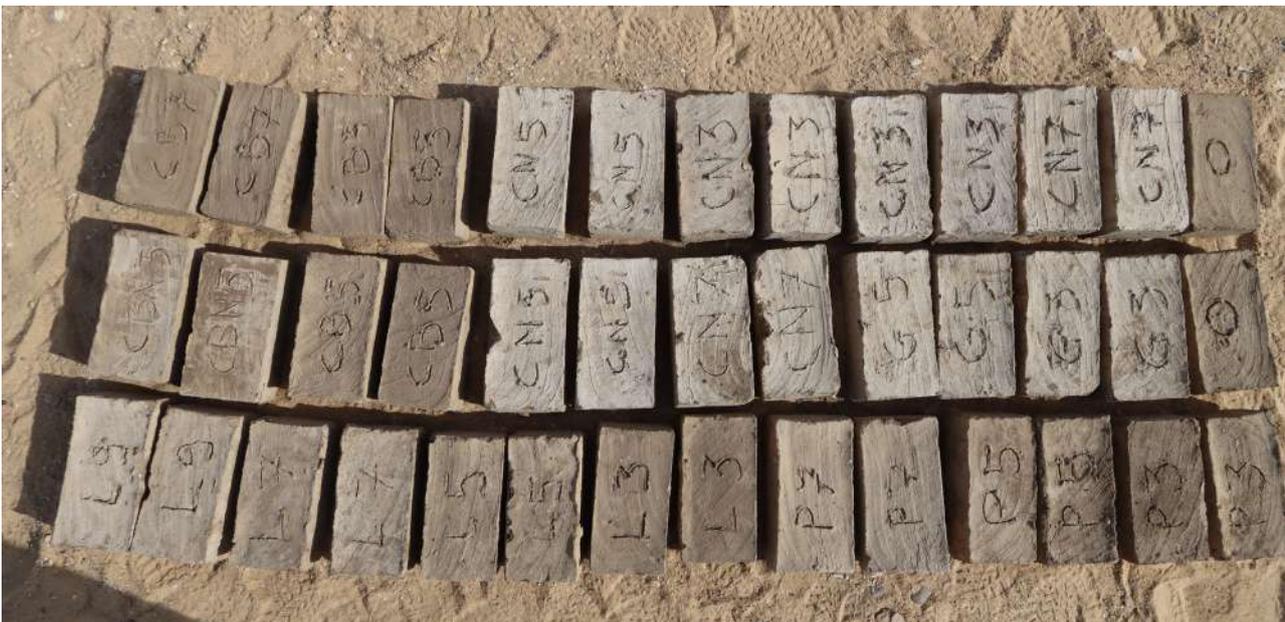
Figure 11: Samples of bricks prepared using a variety of stabilizers and dosages.

ples were prepared using the locally available soil with the following additives: cement, white cement, lime, and gypsum (Fig. 11). These samples will be tested next season, primarily through a cycle of capillarity tests to check the capability of the bricks to withstand a temporary humid state.
