Conservation of the earthen architectural assets at Pepy I necropolis archaeological site: how to adapt to climate change?

CONSERVATION OF THE EARTHEN ARCHITECTURAL ASSETS AT PEPEY I NECROPOLIS ARCHAEOLOGICAL SITE: HOW TO ADAPT TO CLIMATE CHANGE?

THIERRY JOFFROY

XAVIER HÉNAFF

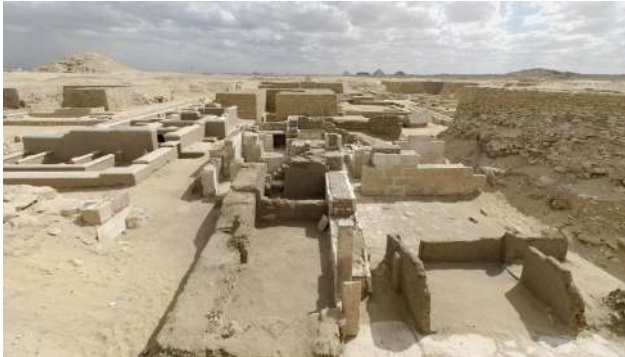
tures faced with limestone. To illustrate these cases, we can cite as examples the complex of Queen *Méhaa* and her son Prince *Hornetjerikhet* (Fig. 2) and Tomb No. 2 (excavated in 2022), the main parts of which are made of bricks, with the outer walls covered with limestone “slabs”.

Figure 2: Funerary complex of Queen *Méhaa* and her son *Hornetjerikhet* (right), and the anonymous “Pyramide de l'Ouest” (left); use of massive brick walls and mixed constructions.

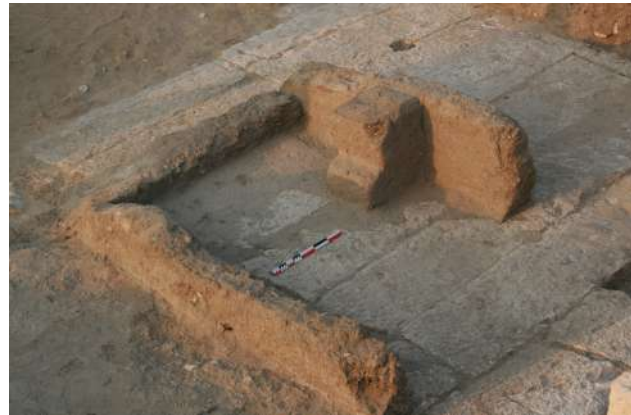
Figure 3: Queen *Behenou*'s complex: small mudbrick building discovered north of the pyramid. Construction of one to two bricks thick covered in places with a gypsum coating.

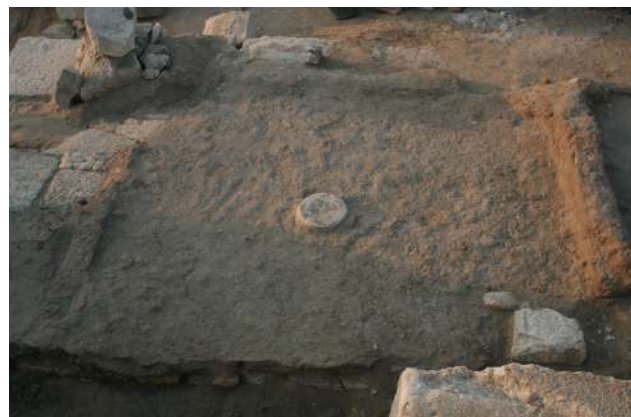
Many of the buildings described above contain earthen plaster which is sometimes covered with a layer of gypsum. The floors are also very often covered with a layer of earth mixed with small pebbles and/or cobbles⁵. These were used in the construction of the streets and the setting of the floors of the buildings’ rooms, even when the latter were laid on limestone paving (Fig. 4).

Figure 4: Queen *Behenou*'s complex: small mudbrick building erected in the courtyard north of the pyramid. An earthen floor was laid on a pre-existing pavement.

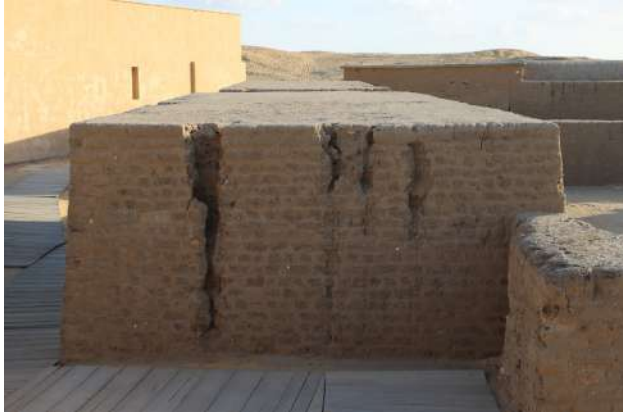
On the walls themselves, the phenomena observed starts at the surface of the wall which has the initial potential to absorb the first drops of water. When the surface is saturated, there is a continuity of absorption inside the structure (possibly including through micro cracks), but this is also when the water accumulating at the surface starts to flow. That process always starts at the top of the wall as it is more exposed, though if the rain is accompanied by wind, then the exposed elevations can be prone to a similar phenomenon. The main issue, then, is that the water accumulating on the top surface of the wall finds a way to flow down to the vertical surfaces. How this happens depends on the regularity of the top surface, but it is clear that even if the top of the wall is flat, it is never flat enough to ensure that the flow of water is equally distributed. That issue leads to the creation of concentrated flows which, if the rainfall lasts long enough, results in the erosion of the vertical faces of the walls in the form of gullies. An important point here is that the thicker the wall, the more water is collected, and thus the deeper is the gully formation (Fig. 8).

Figure 8: Gullies formed on a recently partially reconstructed entry pylon of one of the tombs of the New Kingdom necropolis at Saqqara.
