# **Over-voltage and cross-conduction hard switching stress on schottky gate-type p-GaN HEMT in half-bridge operation. Experimental and physical approaches**

# Over-Voltage and Cross-Conduction Hard Switching Stress on Schottky Gate-Type p-GaN HEMT in Half-Bridge Operation Experimental and Physical Approaches

L. Ghizzo<sup>a,b,c\*</sup>, D. Trémouilles<sup>c</sup>, F. Richardeau<sup>b</sup>, S. Vinnac<sup>b</sup>,  
F. Jamin<sup>a</sup>, G. Guibaud<sup>a</sup>

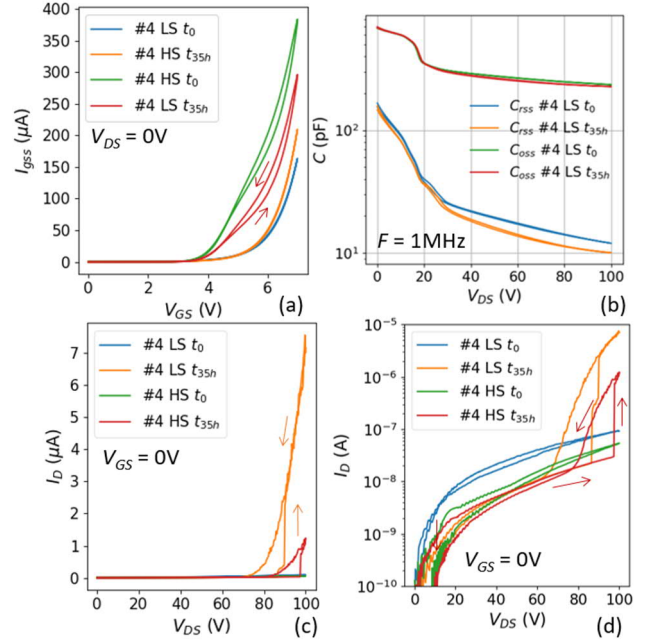
Figure 3: Characterization of the stress board #4 before ( $t_0$ ) and after 35 hours of stress ( $t_{35h}$ ) at 120V with no cross-conduction ( $T_d = 120ns$ ). (a) Gate leakage current  $I_{gss} = f(V_{GS})$  at  $V_{DS} = 0V$ . (b)  $C_{rss}$  and  $C_{oss}$  under  $V_{DS}$  at  $F = 1$  MHz. (c) Drain leakage current  $I_{dss} = f(V_{DS})$  at  $V_{GS} = 0V$ . (d) Display of (c) with log scale. The main degradation to observe is the high drain source leakage current that appears around  $V_{DS} = 90V$  for LS and  $V_{DS} = 98V$  for HS.

The transistors of boards #4 and #5 were stressed on the drain with a switched voltage of 120% of their rating (i.e.  $V_{dc} = 120V$ ). The irreversible degradation is visible on both transistors of board #4 as shown in Fig.3(c) on the drain leakage  $I_{dss} = f(V_{DS})$ . This degradation is visible starting at  $V_{DS} = 90V$  for the LS, and around  $V_{DS} = 98V$  for the HS. It is characterized by a steep increase of the drain leakage current. Below this voltage, the leakage current mainly overlaps with the curve at  $t=t_0$  and the drain leakage is around  $10nA$  at this voltage. When  $V_{DS}$  is reduced again (backward sweep), the leakage current gets back to a normal value as in the forward sweep as shown in Fig.3(d). This leakage current seems to be between drain and source, as the gate current during this measurement is not changed (similar curves to  $I_{dss}$  of board #2 in Fig.3(a)).

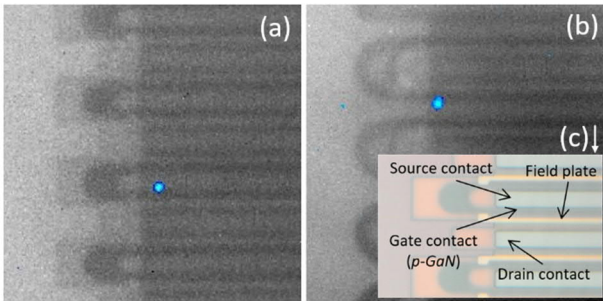
Figure 9: InGaAs camera PEM image of the emission spots. (a) Defect near the gate that might be a GD leakage current through the AlGaN barrier (b) defect near the drain metal that is expected to be a DS leakage current through the GaN layer. (c) optical zoom of the metal structure seen from the backside. The blur in these pictures cannot be avoided as it depends on the camera resolution and the remaining GaN thickness of  $10\mu\text{m}$  we look through with the IR camera.

A localization of physical degradation has been conducted with infrared Lock-In Thermography (LIT) (Fig.8) indicating the location of possible physical degradations in the transistor. Many hotspots were revealed on the whole active surface of the device. As shown in Fig. 9, that uses another type of localization of defect method called Photon Emission Microscopy (PEM), the emission spots (defects zones) are on two different locations on the metal pattern of the transistor represented on Fig.9c. One of them is near the gate, between the gate and the field plate (FP) (Fig.9a) while the other is closer to the drain contact, between the field plate and the drain metal (Fig.9b). The most stressed devices (#1,#2,#3: High voltage and cross-conduction), have numerous spots in both LIT and PEM (more than 20) and are on the two locations that have been described before, but mainly near the drain edge. In general, it has been observed that spots are near the drain for devices that have been stressed at  $V_{\text{DS}}=120\text{V}$  and near the gate for 67V stress. A non-stressed device was also tested and presented no such hot spots.
