Over-Voltage and Cross-Conduction Hard Switching Stress on Schottky Gate-Type p-GaN HEMT in Half-Bridge Operation Experimental and Physical Approaches

L. Ghizzo^{a,b,c*}, D. Trémouilles^c, F. Richardeau^b, S. Vinnac^b,
F. Jamin^a, G. Guibaud^a

Abstract

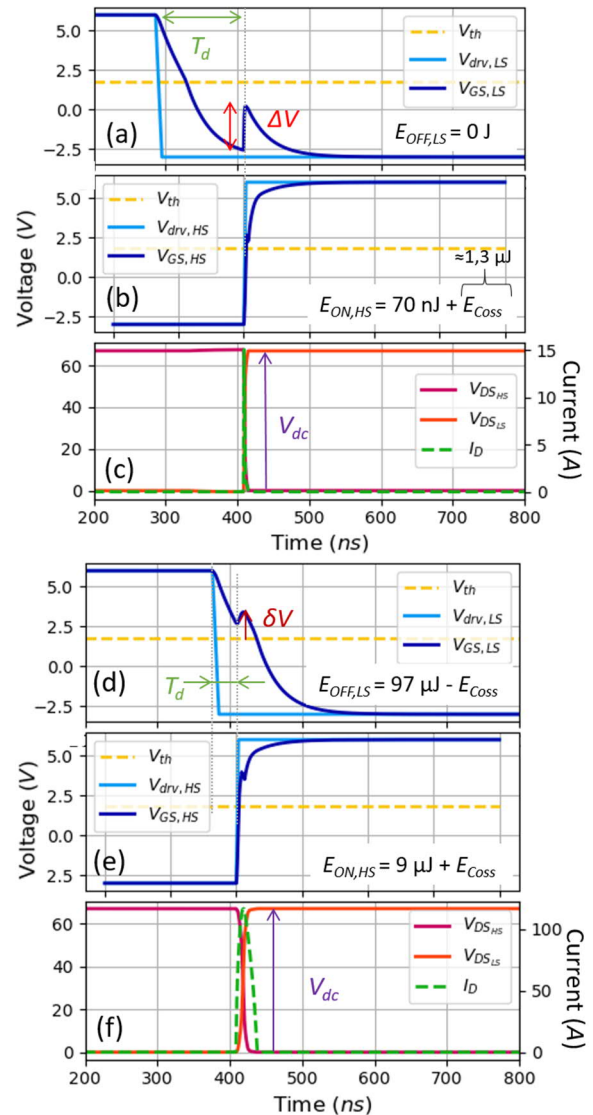
Figure 2: (a) LTspice simulated waveforms of the driver voltage V_{drv} and gate voltage V_{GS} at the turn-off of the LS transistor. (b) driver voltage V_{drv} and gate voltage V_{GS} at the turn-on of the HS transistor, the threshold voltage V_{th} is in dashed line. (c) LS and HS transistors' V_{DS} and drain current. (d) V_{drv} , V_{GS} at the turn-off of the LS transistor with a small T_d that generates cross-conduction. (e) driver voltage V_{drv} and gate voltage V_{GS} at the turn-on of the HS transistor, (e) LS and HS transistors' V_{DS} and drain current (multiplied by 10) in the case of cross-conduction.

The waveforms of Fig.2 illustrate the main parameters of interest. All stress parameters are matched to their respective daughterboards' numbers in table 1. Two main stress parameters are studied. The switched voltage V_{dc} , on the transistors of boards #4 and #5 for V_{dc} chosen voluntarily high (120 % of the rating) and on boards #7 and #11 for a smaller value ($V_{dc} = 67V$: 2/3 of the rating). The cross-conduction will be studied (with a small T_d and high $R_{G,OFF}$) on boards #1,#2,#3 for a high V_{dc} value and

on #9 and #10 for a smaller value. When the LS transistor is off, the turn-on of the HS transistor through the small $R_{G,ON}$ produces a strong positive dv/dt on the LS drain. The negative dv/dt applied to the C_{GD} of the LS transistor generates a current peak from the gate to the driver through $R_{G,OFF}$ that induces the spike ΔV in Fig.2(a). A high $R_{G,OFF}$ value of 50Ω produces a large V_{GS} spike and combined with a short T_d it generates a cross-conduction phenomenon. In fact, if $T_d \approx 20 - 30ns$, the spike will appear earlier on the decreasing slope of V_{GS} at the turn-off, and could exceed the threshold voltage [3]. The active turn-on of one transistor forces the re-triggering on the opposite transistor that is turning off (or that has just turned off), as shown in Fig.2(d)(e)(f). For the duration of the spike (≈ 10 to $20ns$) LS and HS 2DEGs are simultaneously fully activated and a significant current flows through both channels under a smaller dv/dt than in a long dead-time case (26 kV/ μs without cross-conduction and 11 kV/ μs with cross-conduction). Indeed, as illustrated in Fig. 2(d) the extra 2DEG formed in the LS transistor can be assimilated to a transient load subtracted from the active HS 2DEG and therefore reducing the resulting current injected into C_{OSS} across LS and HS devices. The energy at turn-on $E_{turn-on}$ is then increased ($\times 10$) with an additional cross-conduction energy $E_{cross-cond}$ and more stressful and could be expressed as [4][5]:

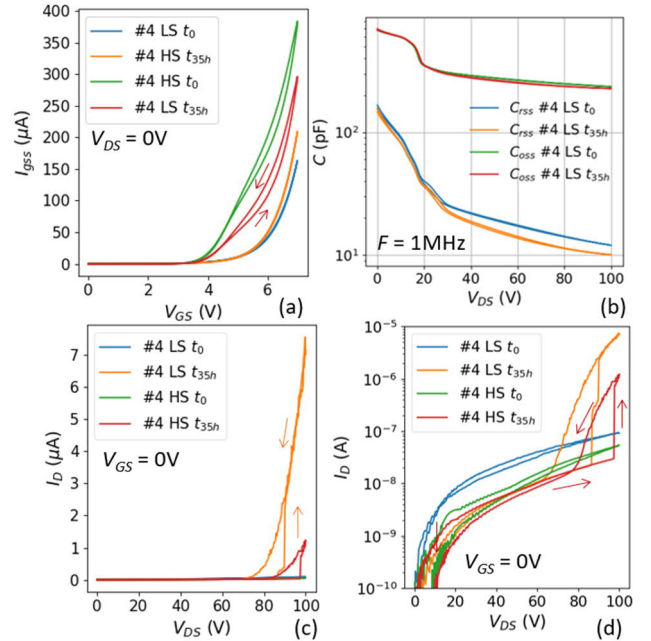
Figure 3: Characterization of the stress board #4 before (t_0) and after 35 hours of stress (t_{35h}) at 120V with no cross-conduction ($T_d = 120ns$). (a) Gate leakage current $I_{gss} = f(V_{GS})$ at $V_{DS} = 0V$. (b) C_{rss} and C_{oss} under V_{DS} at $F = 1$ MHz. (c) Drain leakage current $I_{dss} = f(V_{DS})$ at $V_{GS} = 0V$. (d) Display of (c) with log scale. The main degradation to observe is the high drain source leakage current that appears around $V_{DS} = 90V$ for LS and $V_{DS} = 98V$ for HS.

The transistors of boards #4 and #5 were stressed on the drain with a switched voltage of 120% of their rating (i.e. $V_{dc} = 120V$). The irreversible degradation is visible on both transistors of board #4 as shown in Fig.3(c) on the drain leakage $I_{dss} = f(V_{DS})$. This degradation is visible starting at $V_{DS} = 90V$ for the LS, and around $V_{DS} = 98V$ for the HS. It is characterized by a steep increase of the drain leakage current. Below this voltage, the leakage current mainly overlaps with the curve at $t=t_0$ and the drain leakage is around $10nA$ at this voltage. When V_{DS} is reduced again (backward sweep), the leakage current gets back to a normal value as in the forward sweep as shown in Fig.3(d). This leakage current seems to be between drain and source, as the gate current during this measurement is not changed (similar curves to I_{dss} of board #2 in Fig.3(a)).

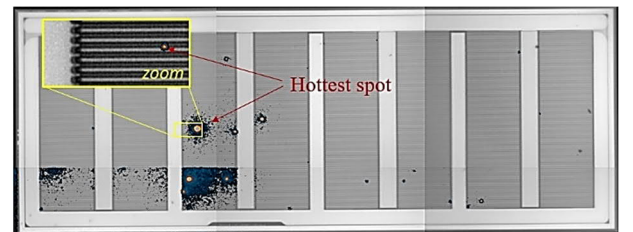
Figure 8: Infrared light LIT of transistor #2 LS (stitching of several images) with a 5x magnification under an electric polarization between 75V and 95V (lock-in frequency 25Hz), applied with probes landed on the electrical vias. The acquisition time is 3 to 5s. The LS transistor of board 2 was cut-off from the

board, all the board layers (PCB and copper layers), leadframe and transistor package were mechanically removed by parallel lapping. The silicon substrate was thinned to a thickness of $100\mu\text{m}$. The view of the chip on Fig.8 is an upside-down view of the chip's GaN layers through the silicon substrate. Around 20 hot spots appear on the chip with one hotter than the others (10x magnification zoom in small window).

A localization of physical degradation has been conducted with infrared Lock-In Thermography (LIT) (Fig.8) indicating the location of possible physical degradations in the transistor. Many hotspots were revealed on the whole active surface of the device. As shown in Fig. 9, that uses another type of localization of defect method called Photon Emission Microscopy (PEM), the emission spots (defects zones) are on two different locations on the metal pattern of the transistor represented on Fig.9c. One of them is near the gate, between the gate and the field plate (FP) (Fig.9a) while the other is closer to the drain contact, between the field plate and the drain metal (Fig.9b). The most stressed devices (#1,#2,#3: High voltage and cross-conduction), have numerous spots in both LIT and PEM (more than 20) and are on the two locations that have been described before, but mainly near the drain edge. In general, it has been observed that spots are near the drain for devices that have been stressed at $V_{\text{DS}}=120\text{V}$ and near the gate for 67V stress. A non-stressed device was also tested and presented no such hot spots.

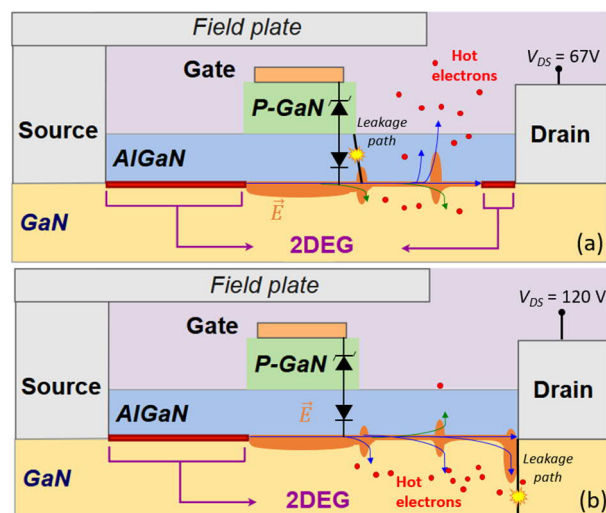
Figure 10: (a) Formation of the gate leakage path through degradation caused by the emission of hot electrons at (a) $V_{DS} = 67V$ and (b) $V_{DS} = 120V$. The yellow “explosions” symbols illustrate the defect heating/light emission captured with LIT and PEM on Fig. 9 through the GaN layer.

The spots located between gate and field plate could be related to the gate-drain leakage current observed on transistors of boards #1,#8,#9 (HS only), #10 and #11. It could be the failure of the D_{pin} diode in the gate stack see Fig.10a or may correspond to a leakage path on the sidewall of the p-GaN layer as illustrated in blue in Fig. 11. This zone is a weak spot in terms of insulation, the

This leakage path is expected to be at the edge of the drain metal and to be vertical across the GaN layer as illustrated on Fig. 10(b) and Fig. 11 in yellow. The leakage current then reaches the conductive epitaxial layers (AlGaIn or GaN, the epitaxy is a stack of AlGaIn and GaN layers) below the GaN buffer and connected to the source electrode. This leakage is not across the whole silicon substrate as the thinning of the silicon substrate (10 μm to 2 μm) and backside package removal did not make the spot disappear.

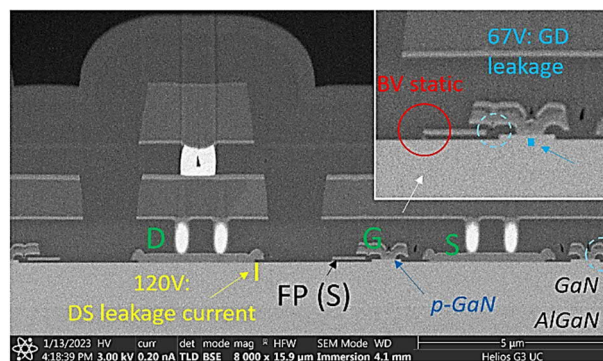
Figure 11: FIB cross-section of the active area showing the location where the defects are expected to be according to our hypothesis. In yellow the drain-source leakage which corresponds to Fig. 4c electrical signature. In blue the gate-drain leakage (Fig. 7ab) which is the failure of D_{pin} diode shown in Fig.10. Also, the form of the metal contact is not perfect due to fabrication maybe thermal relaxation. It makes a small spike and

a small cavity which reduces the dielectric insulation above (blue circles). This particular zone seems to be a weakness of this structure, in other pictures of the FIB Slice&View, it has been observed that the spike and the cavity could be bigger. In red the leakage path formed between drain and source in the previous study about static breakdown voltage. The AlGa_N barrier is not visible in this picture due to its small thickness.

form of the gate metal makes a spike and a cavity below, reducing the insulation distance. During the FIB Slice&View it has been observed that this distance could be much smaller than the one represented in Fig.11. Electrically, it shorts the equivalent D_{pin} diode between the p-GaN/AlGaN and AlGaN/GaN interfaces. This leakage current is correlated with the C_{rss} -knee shift to higher V_{DS} (Fig.7c). The preconditioned threshold voltage (see the full protocol in [6]) is also affected with an increase up to 30% as shown in figure 7. The C_{GD} -knee shift to higher V_{DS} is an indicator of degradation in the field plate (FP) area.

A drain-source leakage current between the field plate and the 2DEG across the AlGaIn and oxide layer under the field plate hypothesis can be ruled out thanks to another study we made on this part-number device (study of static V_{DS} breakdown voltage). This defect location leads to the melting of the FP and to a filament path (around 150V) see Fig 11, the current leakage path is a direct short and not an abnormal current leakage appearing only above 80V like in this case. A Focused Ion Beam (FIB) Slice and View verified this failure mechanism (Fig. 11 in red).
