Over-Voltage and Cross-Conduction Hard Switching Stress on Schottky Gate-Type p-GaN HEMT in Half-Bridge Operation Experimental and Physical Approaches [ESREF'23]

Over-Voltage and Cross-Conduction Hard Switching Stress on Schottky Gate-Type p-GaN HEMT in Half-Bridge Operation Experimental and Physical Approaches

Abstract

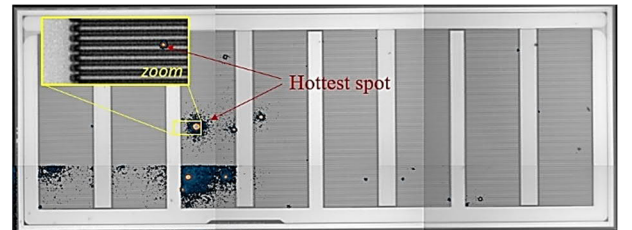
Figure 8: Infrared light LIT of transistor #2 LS (stitching of several images) with a 5x magnification under an electric polarization between 75V and 95V (lock-in frequency 25Hz), applied with probes landed on the electrical vias. The acquisition time is 3 to 5s. The LS transistor of board 2 was cut-off from the

board, all the board layers (PCB and copper layers), leadframe and transistor package were mechanically removed by parallel lapping. The silicon substrate was thinned to a thickness of $100\mu\text{m}$. The view of the chip on Fig.8 is an upside-down view of the chip's GaN layers through the silicon substrate. Around 20 hot spots appear on the chip with one hotter than the others (10x magnification zoom in small window).

A localization of physical degradation has been conducted with infrared Lock-In Thermography (LIT) (Fig.8) indicating the location of possible physical degradations in the transistor. Many hotspots were revealed on the whole active surface of the device. As shown in Fig. 9, that uses another type of localization of defect method called Photon Emission Microscopy (PEM), the emission spots (defects zones) are on two different locations on the metal pattern of the transistor represented on Fig.9c. One of them is near the gate, between the gate and the field plate (FP) (Fig.9a) while the other is closer to the drain contact, between the field plate and the drain metal (Fig.9b). The most stressed devices (#1,#2,#3: High voltage and cross-conduction), have numerous spots in both LIT and PEM (more than 20) and are on the two locations that have been described before, but mainly near the drain edge. In general, it has been observed that spots are near the drain for devices that have been stressed at $V_{\text{DS}}=120\text{V}$ and near the gate for 67V stress. A non-stressed device was also tested and presented no such hot spots.

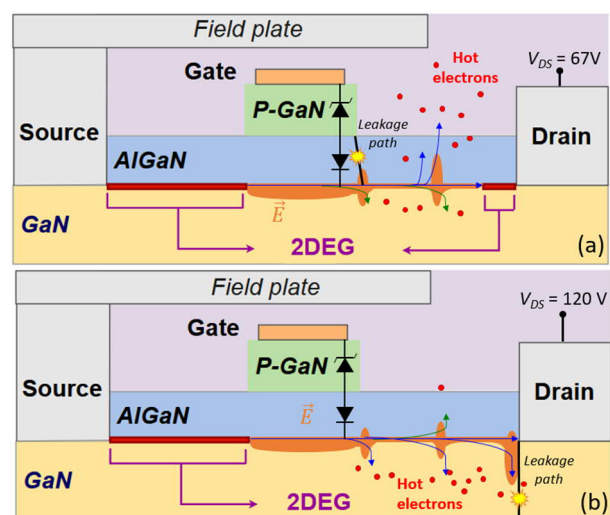
Figure 10: (a) Formation of the gate leakage path through degradation caused by the emission of hot electrons at (a) $V_{DS} = 67V$ and (b) $V_{DS} = 120V$. The yellow “explosions” symbols illustrate the defect heating/light emission captured with LIT and PEM on Fig. 9 through the GaN layer.

The spots located between gate and field plate could be related to the gate-drain leakage current observed on transistors of boards #1,#8,#9 (HS only), #10 and #11. It could be the failure of the D_{pin} diode in the gate stack see Fig.10a or may correspond to a leakage path on the sidewall of the p-GaN layer as illustrated in blue in Fig. 11. This zone is a weak spot in terms of insulation, the

This leakage path is expected to be at the edge of the drain metal and to be vertical across the GaN layer as illustrated on Fig. 10(b) and Fig. 11 in yellow. The leakage current then reaches the conductive epitaxial layers (AlGaIn or GaN, the epitaxy is a stack of AlGaIn and GaN layers) below the GaN buffer and connected to the source electrode. This leakage is not across the whole silicon substrate as the thinning of the silicon substrate (10 μm to 2 μm) and backside package removal did not make the spot disappear.

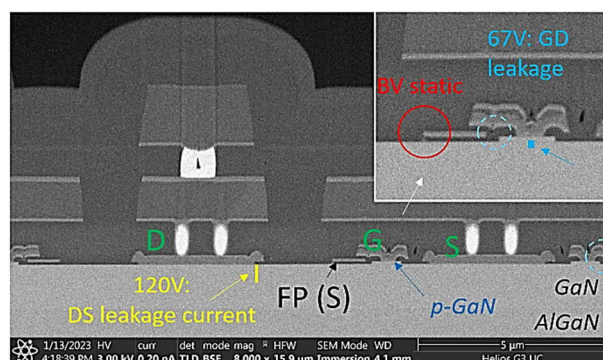
Figure 11: FIB cross-section of the active area showing the location where the defects are expected to be according to our hypothesis. In yellow the drain-source leakage which corresponds to Fig. 4c electrical signature. In blue the gate-drain leakage (Fig. 7ab) which is the failure of D_{pin} diode shown in Fig.10. Also, the form of the metal contact is not perfect due to fabrication maybe thermal relaxation. It makes a small spike and

a small cavity which reduces the dielectric insulation above (blue circles). This particular zone seems to be a weakness of this structure, in other pictures of the FIB Slice&View, it has been observed that the spike and the cavity could be bigger. In red the leakage path formed between drain and source in the previous study about static breakdown voltage. The AlGaN barrier is not visible in this picture due to its small thickness.

form of the gate metal makes a spike and a cavity below, reducing the insulation distance. During the FIB Slice&View it has been observed that this distance could be much smaller than the one represented in Fig.11. Electrically, it shorts the equivalent D_{pin} diode between the p-GaN/AlGaN and AlGaN/GaN interfaces. This leakage current is correlated with the C_{rss} -knee shift to higher V_{DS} (Fig.7c). The preconditioned threshold voltage (see the full protocol in [6]) is also affected with an increase up to 30% as shown in figure 7. The C_{GD} -knee shift to higher V_{DS} is an indicator of degradation in the field plate (FP) area.

A drain-source leakage current between the field plate and the 2DEG across the AlGaIn and oxide layer under the field plate hypothesis can be ruled out thanks to another study we made on this part-number device (study of static V_{DS} breakdown voltage). This defect location leads to the melting of the FP and to a filament path (around 150V) see Fig 11, the current leakage path is a direct short and not an abnormal current leakage appearing only above 80V like in this case. A Focused Ion Beam (FIB) Slice and View verified this failure mechanism (Fig. 11 in red).
