## Does Atmospheric Corrosion Alter the Sound Quality of the Bronze Used for Manufacturing Bells?

Mourad Bentahar, Aline Petitmangin, Caroline Blanc, Anne Chabas, Silvio Montresor, et al.. Does Atmospheric Corrosion Alter the Sound Quality of the Bronze Used for Manufacturing Bells?. *Materials*, 2023, 16 (13), pp.4763. 10.3390/ma16134763 . hal-04260826

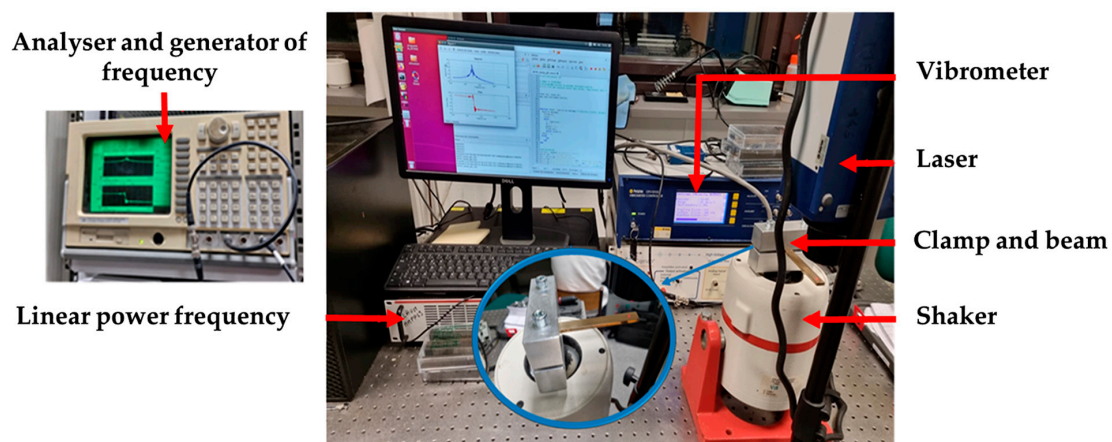
**Figure 2.** Experimental set-up to monitor the dynamic response of the bronze beams.

The dynamic characterization, at resonance, of the bronze beams in the intact and corroded states is carried out using the experimental setup shown in Figure 2.

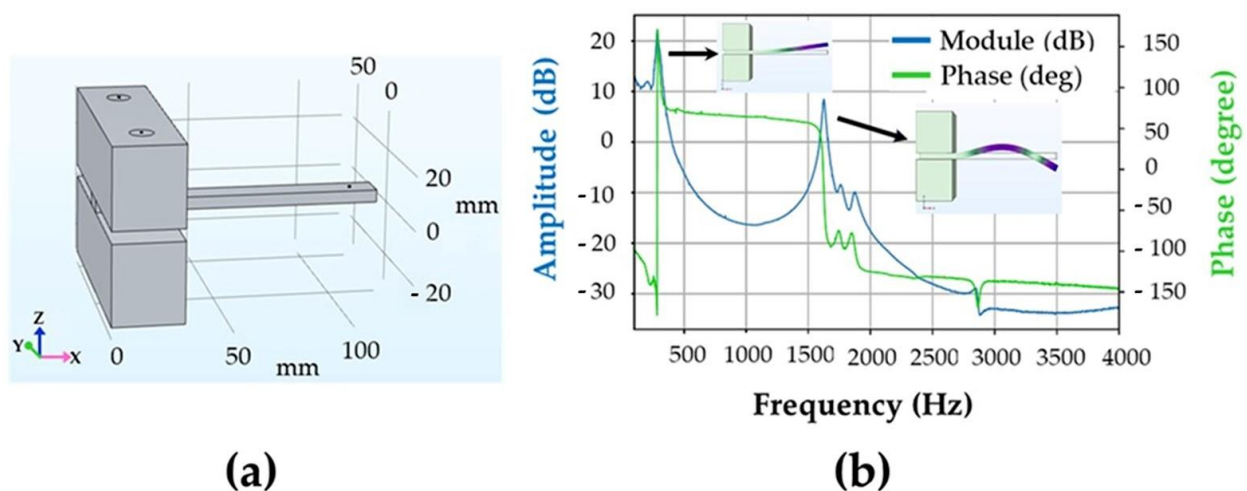
**Figure 3.** (a) Simulation conditions and (b) simulated resonance curves of the intact sample corresponding to 1st and 2nd order bending modes.

Numerical simulations are made using the software COMSOL Multiphysics<sup>TM</sup> (version 6.1) to identify the generated resonance modes. Finite element simulations are based on the mechanical properties of the bronze that have been obtained experimentally with the help of ultrasonic measurements. Density, Poisson ratio and Young modulus have been found as  $\rho=8798 \text{ kg/m}^3$ ;  $\nu=0.335$ ;  $E=92 \text{ GPa}$ , respectively. Simulated resonance curves are presented in Figure 3.

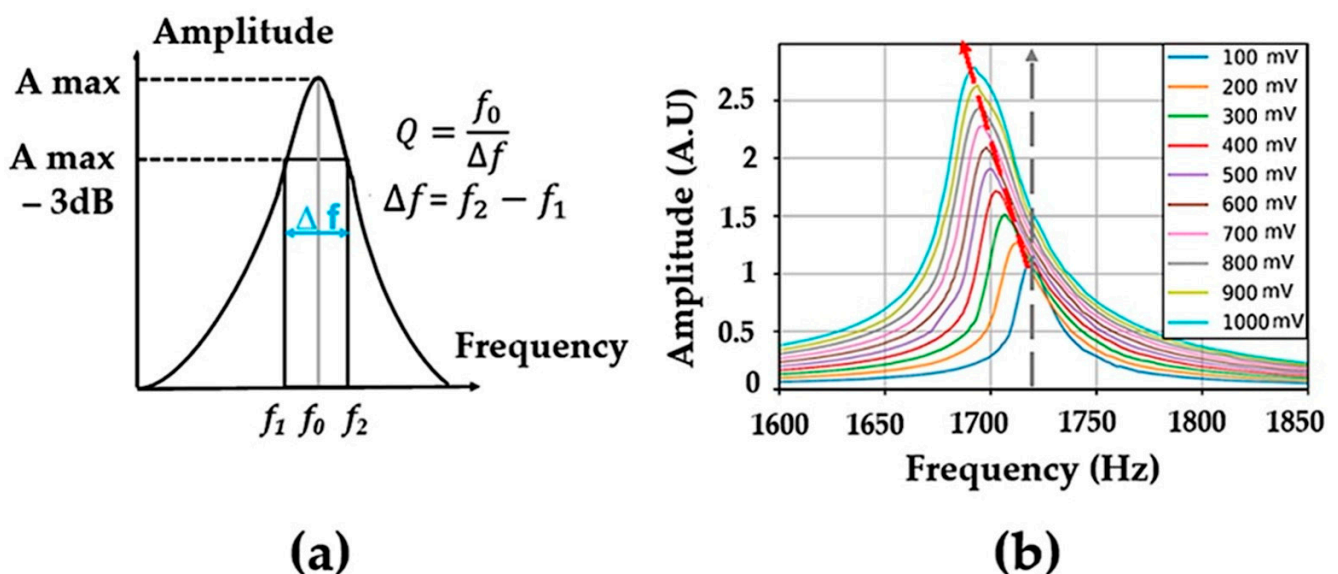
**Figure 4.** (a) Determination of the quality factor from a resonance curve; (b) Evolution of the bending resonance as a function of the excitation level for a bronze sample taken at the corroded state. The vertical line corresponds to the linear resonance (weak excitation).

where  $Q_0$  and  $Q$  are the quality factors measured at low ( $\varepsilon_0$ ) and higher ( $\varepsilon$ ) strain amplitudes.  $f$  is the resonance frequency at strain amplitude  $\varepsilon$ ,  $f_0$  is the resonance frequency at low strain amplitude (or excitation)  $\varepsilon_0$ .  $C_1$  and  $C_2$  represent the hysteretic nonlinearity corresponding to frequency ( $\alpha_f$ ) and quality factor ( $\alpha_Q$ ) [29]. The abovementioned coefficients were determined for different materials and were found to be very sensitive to the changes existing in their microstructures [17,30]. Figure 4 shows the evolution of the bending resonance as a function of the excitation level. The observed decrease in the resonance frequency is a consequence of the decrease in the elastic modulus (known as softening) due to the existing soft regions which are mainly situated in the corroded and micro-cracked areas.

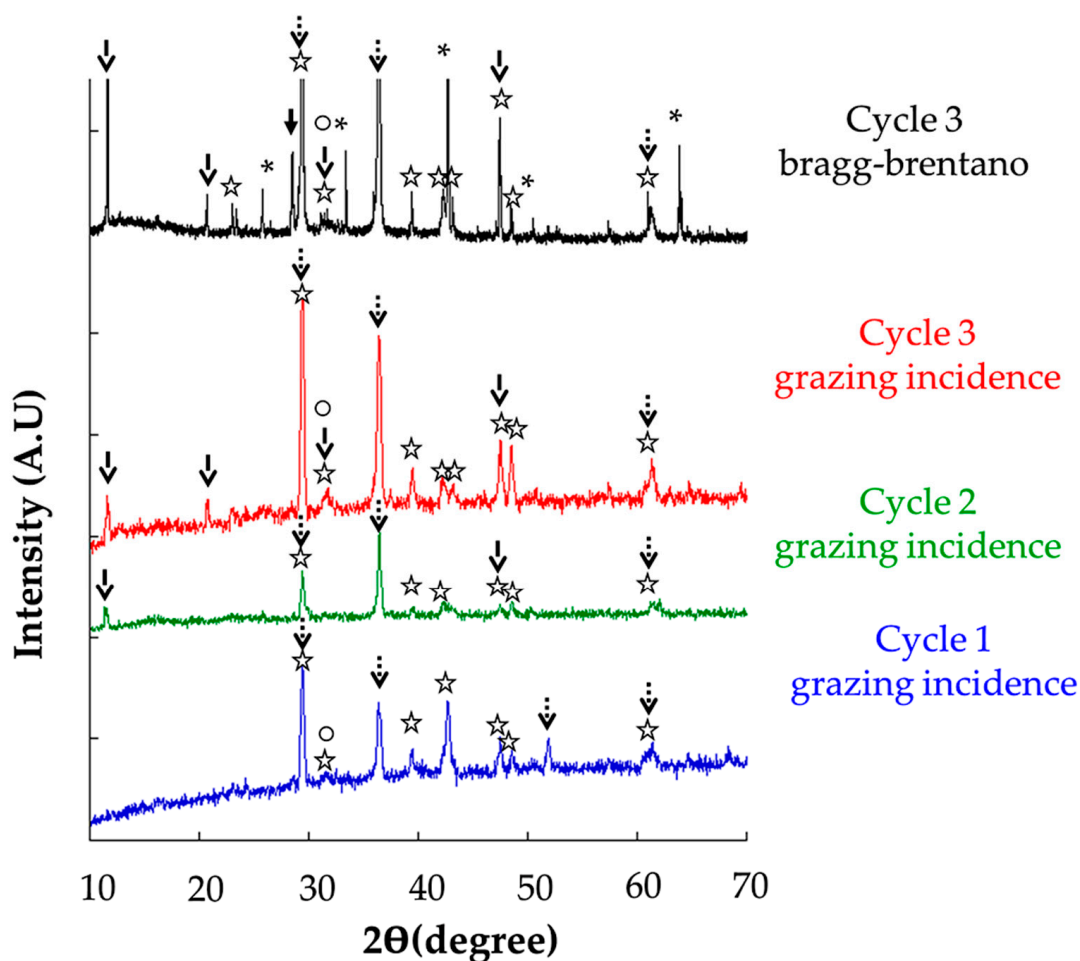
**Figure 5.** XRD spectra of the alteration layers in grazing incidence (cycles 1, 2, 3) and Bragg-Brentano (cycle 3) configuration.

To document the evolution of crystallization on the outer surface, XRD spectra obtained under grazing incidence after one, two, and three cycles are presented in Figure 5. Whatever the duration of the alteration, calcite and halite are detected. Because of their amorphous character, soot particles cannot be observed by XRD. The two main peaks of gypsum  $\text{CaSO}_4 \cdot 2\text{H}_2\text{O}$  ( $11.65^\circ$  and  $20.74^\circ$ ) appear from the second cycle and increase in intensity afterwards. Concerning the corrosion products of the alloy, the crystallization of cuprite  $\text{Cu}_2\text{O}$  (main peak at  $36.5^\circ$ ) is observed from the first cycle and develops with the duration of the alteration.

Whatever the duration of corrosion, an increase in the intensity of the main gypsum peak and a new phase, the nantokite  $\text{CuCl}$ , are observed (note that only the results of Cycle 3 are presented in Figure 5) in a Bragg Brentano configuration. However, nantokite is not detected under grazing incidence. This result suggests a deeper development of the nantokite in the corrosion layer. This point will be studied in detail in Section 3.1.2 and discussed in Section 4.

On the other hand, SEM-EDS analyzes of the corroded surface were also performed (Figure 6a). The signal corresponding to oxygen is present all over the altered surface. The one for sulfur is more contrasted with a diffuse signal associated with copper and oxygen and a more localized and higher signal with Ca, O and C, which is characteristic of the initial calcite deposit. Thus, the  $\text{CaCO}_3$  particles appear as preferential reaction sites for  $\text{SO}_2$ , leading to the crystallization of  $\text{CaSO}_4 \cdot 2\text{H}_2\text{O}$  gypsum under orthorhombic rods as seen in Figure 6a. The NaCl deposit corresponds to small cubic crystals rich in Cl and Na, distributed as clusters on the corroded surface and amalgamated with the carbon-rich soots. Their low XRD signal (Figure 5) is due to the small size of the halite crystals.

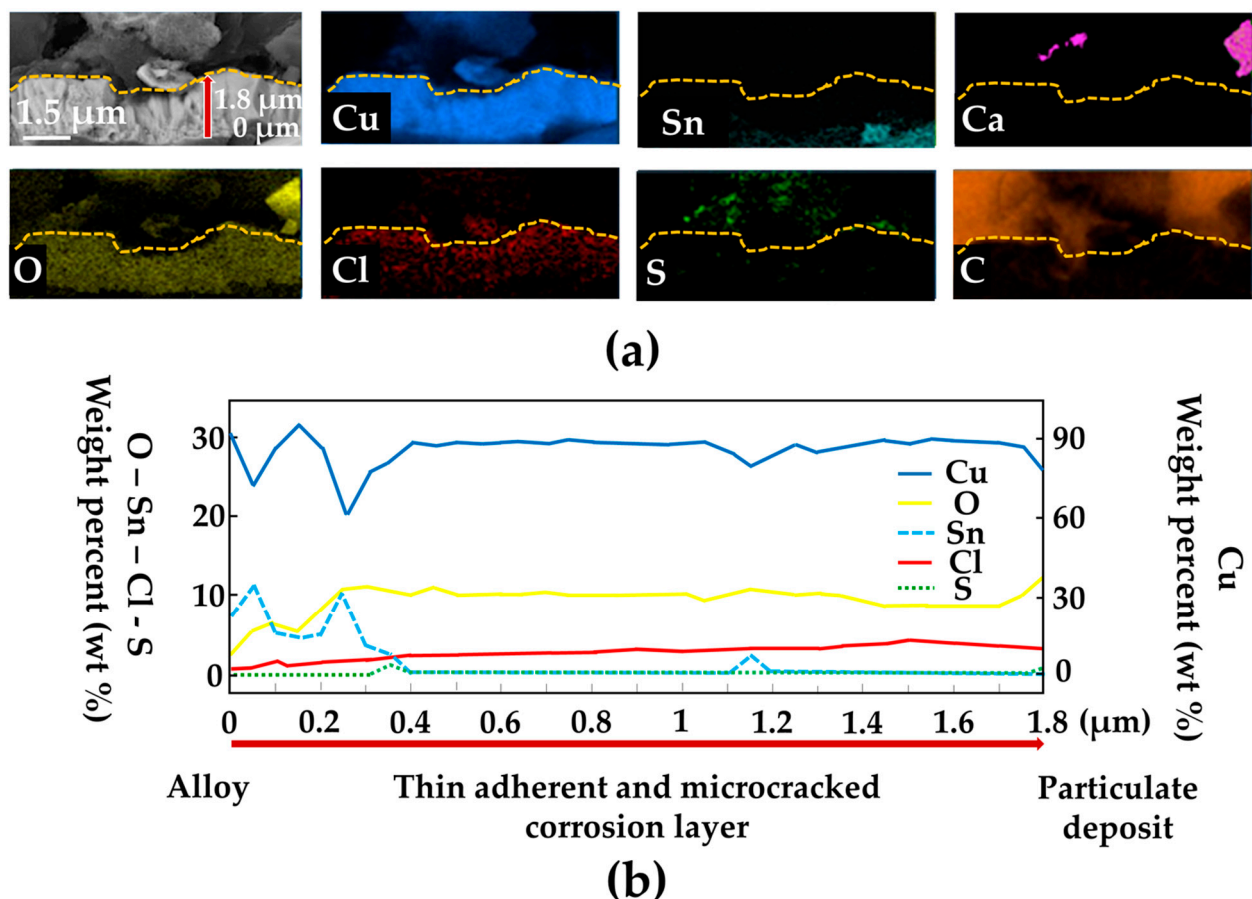
**Figure 7.** (a) SEM-EDS analysis and (b) composition of corrosion products in the lower part of the deposit determined by line analysis of the samples' cross-section.

To better understand the internal organization of the corrosion layer, SEM-EDS cross-sectional analyzes of the corrosion layer were performed. Figure 7a shows the cross-section obtained after the third cycle. Its thickness does not exceed 4  $\mu\text{m}$  because of the weak grip of the particulate clusters composed of calcite, gypsum and halite on the alloy substrate. This deposit was disturbed by the cross-sectional cutting. Thus, only the lower portion of the deposit is observable and consists of calcium (Ca) and carbon (C). The signal of sulfur is also detected and associated with that of copper (Cu), oxygen (O), carbon (C) and some traces of chlorine (Cl). The particulate deposit overlies a 1.8  $\mu\text{m}$  thick layer, adherent to the alloy and composed of copper and tin corrosion products. A composition profile of this layer is shown in Figure 7b. The Cl signal, more present than in the upper deposit, is associated with homogeneous Cu and O signals. Locally, very fine traces of S are also detected. On the other hand, associated with a depletion in Cu, the Sn signal is present more in-depth and in contact with the alloy.

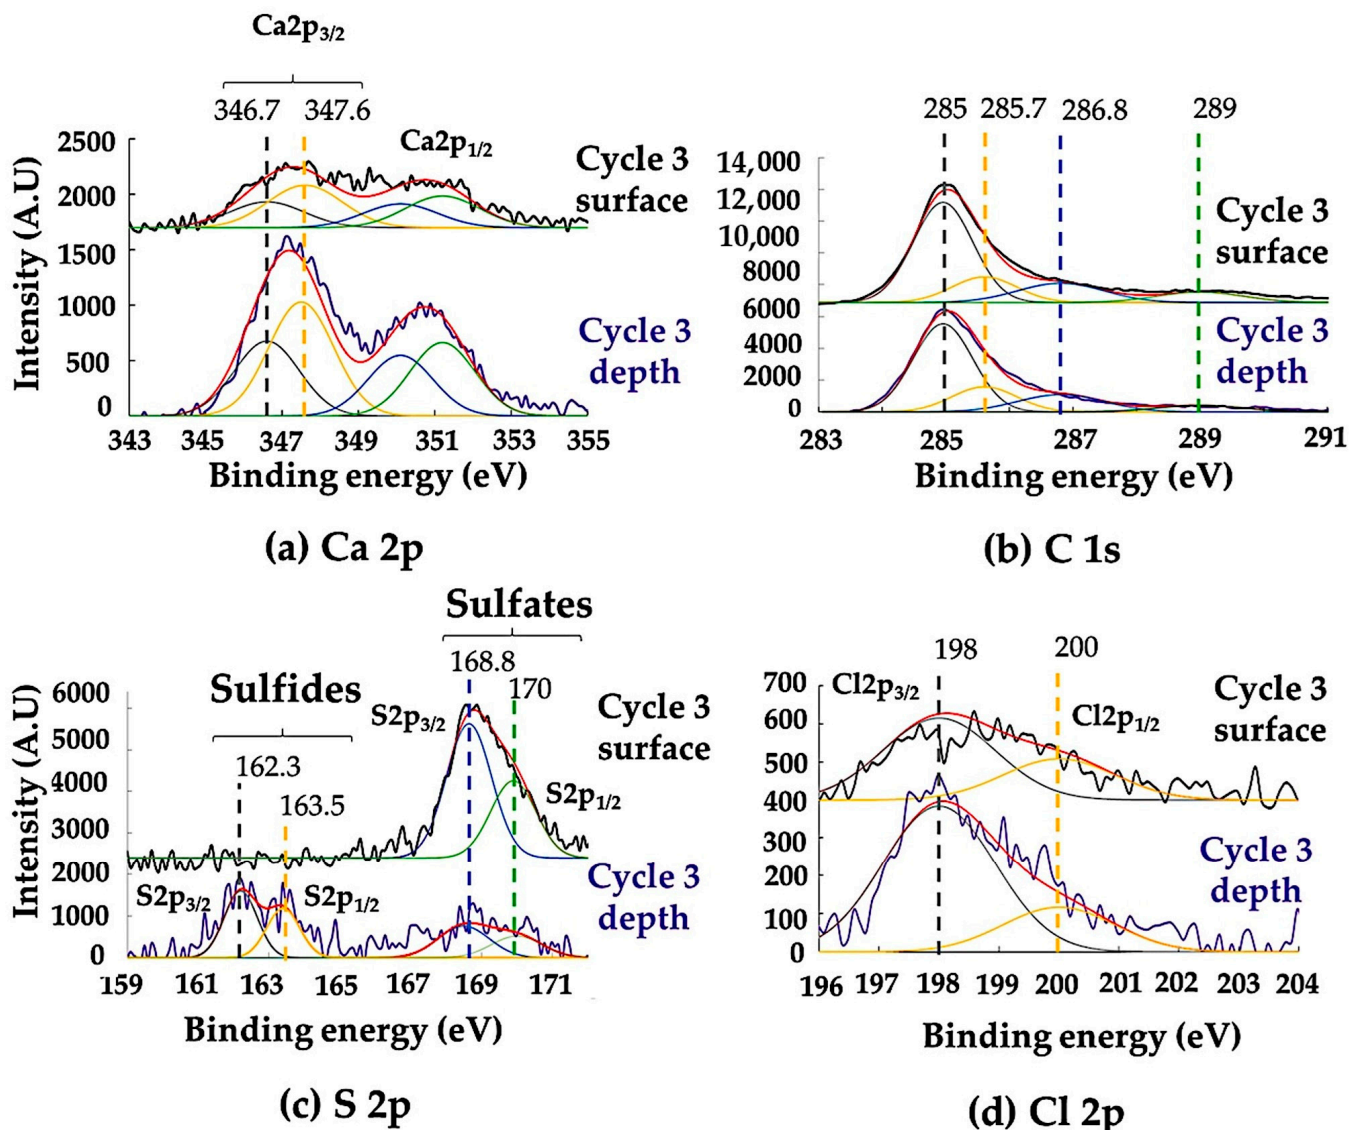
**Figure 8.** Deconvoluted XPS spectra of the surface and deep patina: (a) Ca 2p, (b) C 1s, (c) S 2p and (d) Cl 2p spectra.

The XPS analyzes are shown in Figures 8 and 9. To study the effects of alteration duration, the spectra of each cycle, obtained at the extreme surface or after ion abrasion, are compared when significant qualitative or quantitative differences were observed. Otherwise, only the spectra of Cycle 3, characteristic of the longest alteration, are presented.

The XPS spectra show many broad peaks, indicating that many poorly crystallized constituents are present in the alteration layer.

Finally, the Auger KLL of Na (497.1 eV, 501.2eV), located in the same window as Sn  $3d_{3/2}$  and characteristic of NaCl, decreases with stripping. This is not the case of chlorine (Figure 8d). This difference confirms the infiltration of marine aerosols, but not in the form of halite. Their dissolution releases  $\text{Cl}^-$  ions that infiltrate the particulate deposit and react with Cu to form deep CuCl nantokite, as evidenced by the Bragg Brentano XRD. No trace of copper hydroxychloride  $\text{CuCl}_2(\text{OH})_3$  is detected (absence of the Cu  $2p_{3/2}$  peak at 937 eV [44]).

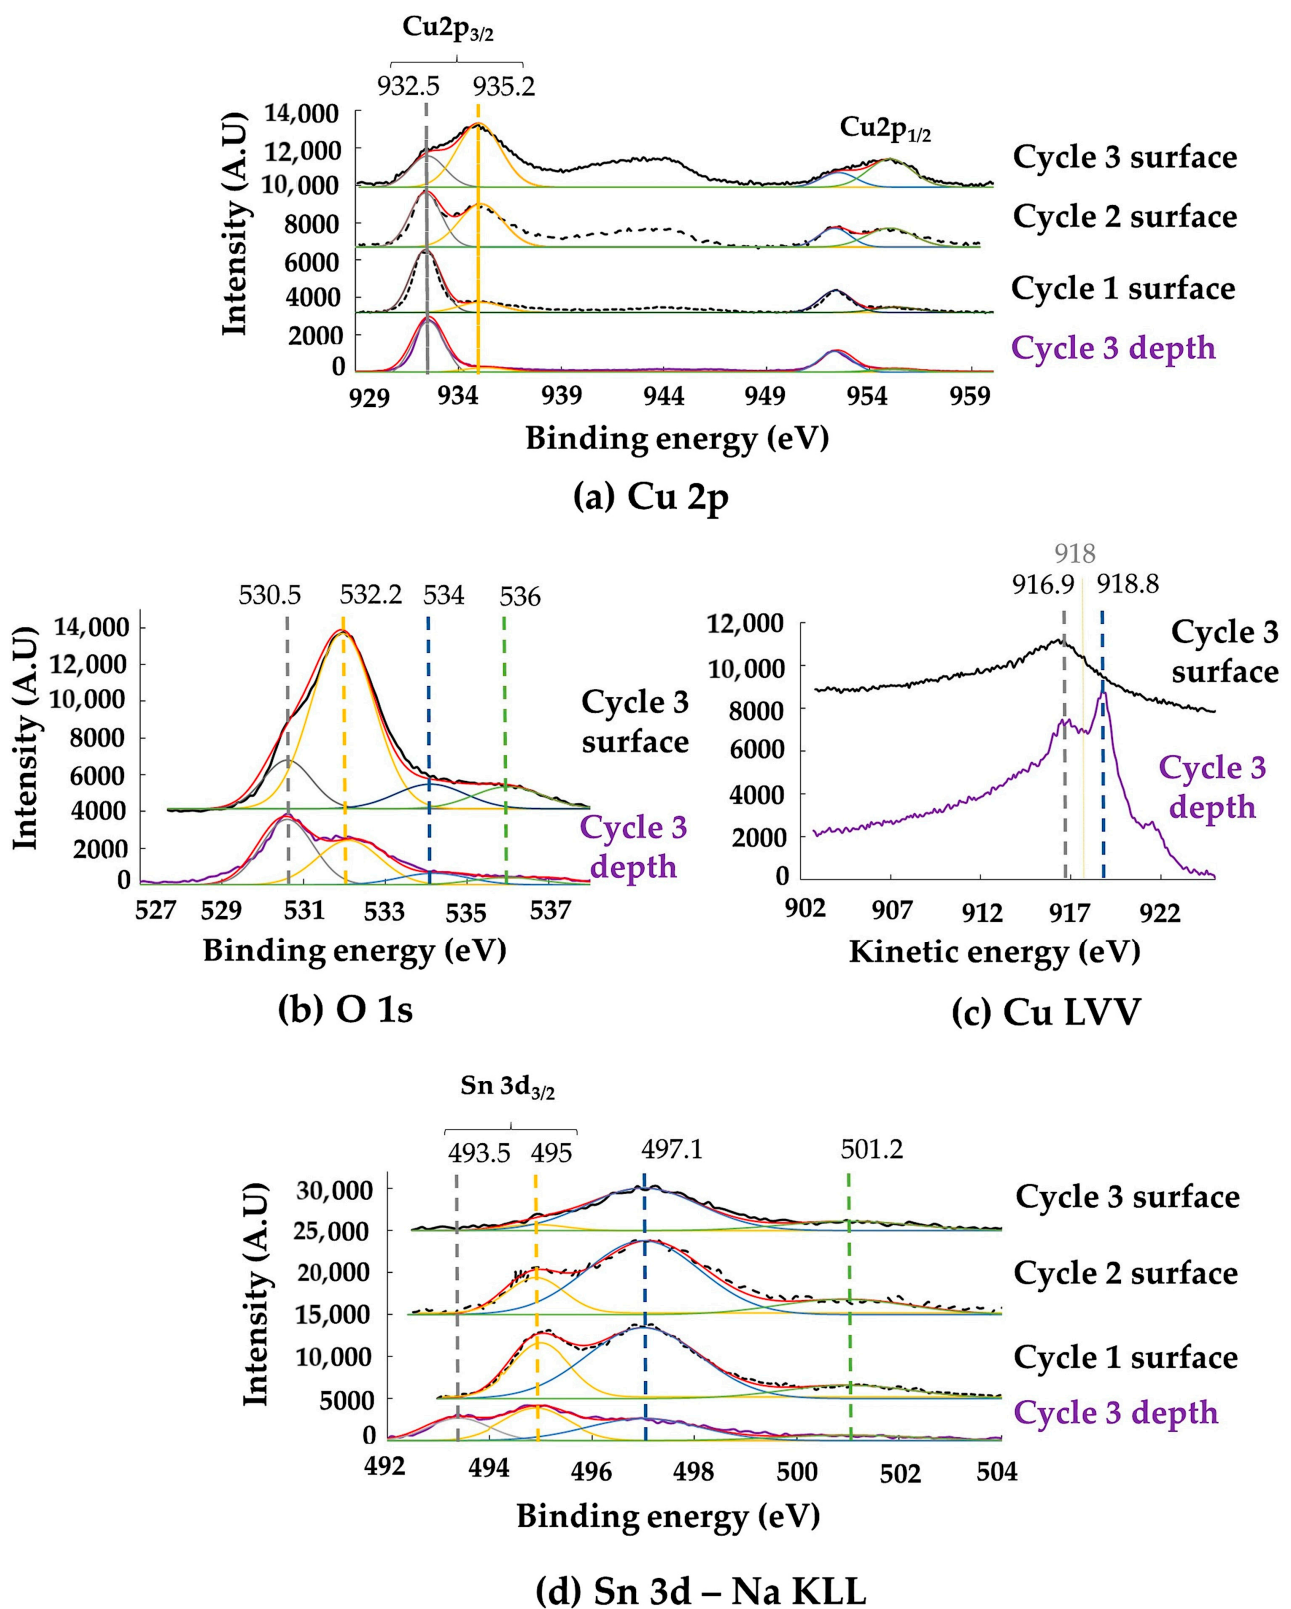
**Figure 9.** Deconvoluted XPS spectra of the surface and deep patina: (a) Cu 2p, (b) O 1s, (c) Cu LVV and (d) Sn 3d-Na KLL spectra.

Regarding the copper corrosion products in the microcracked alteration layer, whichever the alteration cycle, the satellite peaks between 940 and 945 eV in the Cu 2p<sub>3/2</sub> window correspond to the degree of copper oxidation Cu<sup>2+</sup> (Figure 9a).

The Cu  $2p_{3/2}$  peak at 935.2 eV and those of O 1s at 532.2 eV ( $O^{2-}$ ), 534–536 eV ( $OH^-$ ) (Figure 9b) associated with S  $2p_{3/2}$  at 168.8 eV are characteristic of more or less hydrated copper sulfates in the form of brochantite, antlerite or chalcantite, where copper has an

Concerning the tin corrosion products (Figure 9d), the Sn  $3d_{3/2}$  peaks at 495 eV and O 1s are at 495 eV and 530.5 eV, respectively. Since the chemical and spectral separation of tin oxides ( $\text{SnO}$  ( $\text{Sn}^{2+}$ ) and  $\text{SnO}_2$  ( $\text{Sn}^{4+}$ )) is difficult when only based on their core XPS spectra [38,39], we followed [40,41] and assumed that the Sn peaks are relative to the  $\text{Sn}^{4+}$  species ( $\text{SnO}_2$  tenorite). In the absence of abrasion, the Sn  $3d_{3/2}$  peak at 495 eV decreases in intensity after three cycles of alteration. The copper corrosion products close to the surface act as a shield and decrease the intensity of the signal of the tenorite located deeper, in contact with the alloy. With ion abrasion, the Sn  $3d_{3/2}$  peak at 493 eV of metallic tin appears, associated with that of  $\text{SnO}_2$  at 495 eV. The width of the S  $2p_{3/2}$ –S  $2p_{1/2}$  doublet from 161 eV to 164.5 eV, characteristic of sulfides ( $\text{S}^{2-}$ ), and the Sn  $3d_{3/2}$  peaks at 495 eV ( $\text{Sn}^{4+}$ ) and Cu  $2p_{3/2}$  at 530.5 eV ( $\text{Cu}^+$ ) cannot exclude traces of deep copper or tin sulfides [42,43].

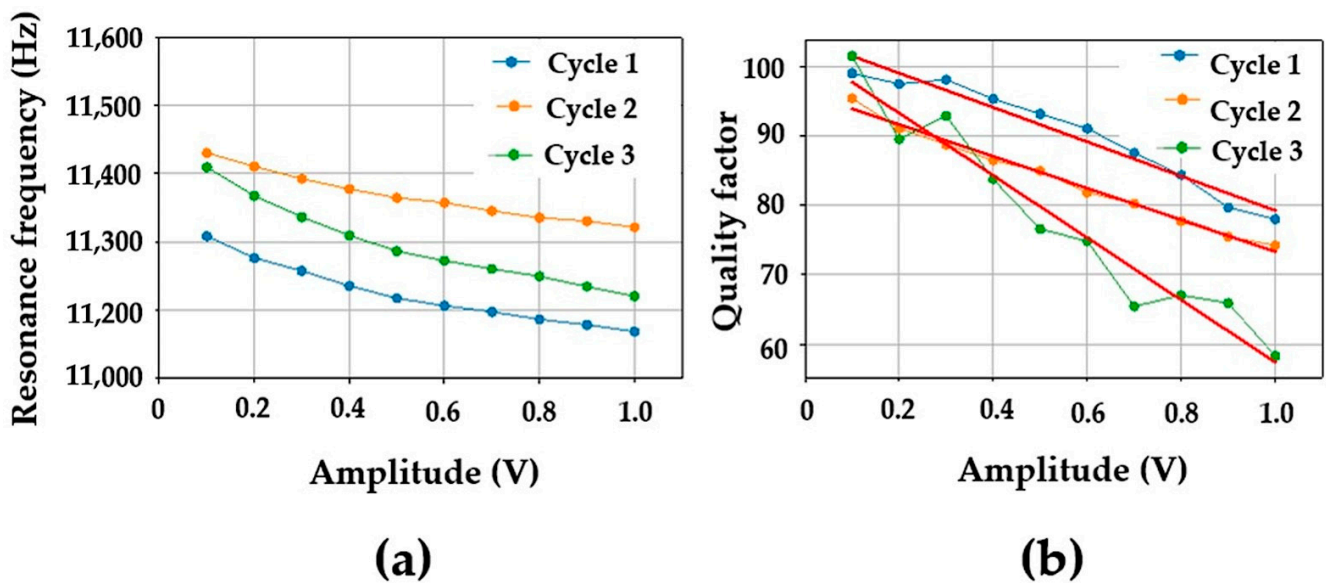
**Figure 10.** Evolution of the frequency (a) and the quality factor versus the excitation amplitude (b) corresponding to the 4th bending resonance as a function of the excitation level. The exposure times are: cycle 1 = 1 month, cycle 2 = 2 months and cycle 3 = 3 months.

Based on the experimental set-up presented above, nonlinear resonance experiments are performed in bending conditions at increasing excitation levels as described above. Results presented in Figure 10 show that the corrosion cycles create a softening in the elastic modulus. The softening is observed through the decrease in the resonance frequency when the excitation amplitude is increasing (the real part of the elastic modulus increases (or decreases) with increasing (or decreasing) resonance frequency). However, the decrease is not evolving in a monotonous way with the cycles applied. Indeed, at the weakest excitation level, the bending resonance frequency is the highest for Cycle 2 and the weakest for Cycle 1. Cycle 3 is found to be always between Cycles 1 and 2. On the other hand, the frequency drop due to an increase in excitation for each cycle is found to be  $\sim 120$  Hz,  $\sim 110$  Hz and  $\sim 190$  Hz for Cycles 1, 2 and 3, respectively. This result shows that regardless of the linear resonance frequency value (obtained at a weak level), the frequency drop between the weakest and the highest excitations can be used as an indicator to monitor the corrosion evolution. In addition, results related to the quality factor, which is inversely proportional to damping, show that the three cycles have almost the same value at the weakest excitation level. The slope of their evolution (see Table 2) with an increasing excitation shows that Cycles 1 and 2 have almost the same slopes with  $P_1 = -24.7 \times 10^{-3} (\text{v}^{-1})$  and  $P_2 = -22.84 \times 10^{-3} (\text{v}^{-1})$ , respectively. The slope for Cycle 3 is found to be  $P_3 = -44.80 \times 10^{-3}$ . This value, which is twice that found for Cycles 1 and 2, shows again the sensitivity of the nonlinear vibration method to the structural evolutions created by corrosion.

The study of the second-order effects related to the complex elastic modulus, through the resonance frequency and the quality factor, showed that the observed changes in the resonance frequency and the slope of the quality factor can double in just 1 month, between Cycles 3 and 2. It is important to recall that the deterioration concerns only one side of the samples studied. The corrosion depth being small had mainly affected the tested specimens superficially, attesting to the absence of a bulk effect on the elastic properties. This is the reason why the recorded nonlinear responses for Cycles 1 and 2 were similar, contrary to Cycle 3, for which a better sensitivity was found. Note that, at the initial intact state, neither frequency nor quality factors have changed as a function of the excitation.

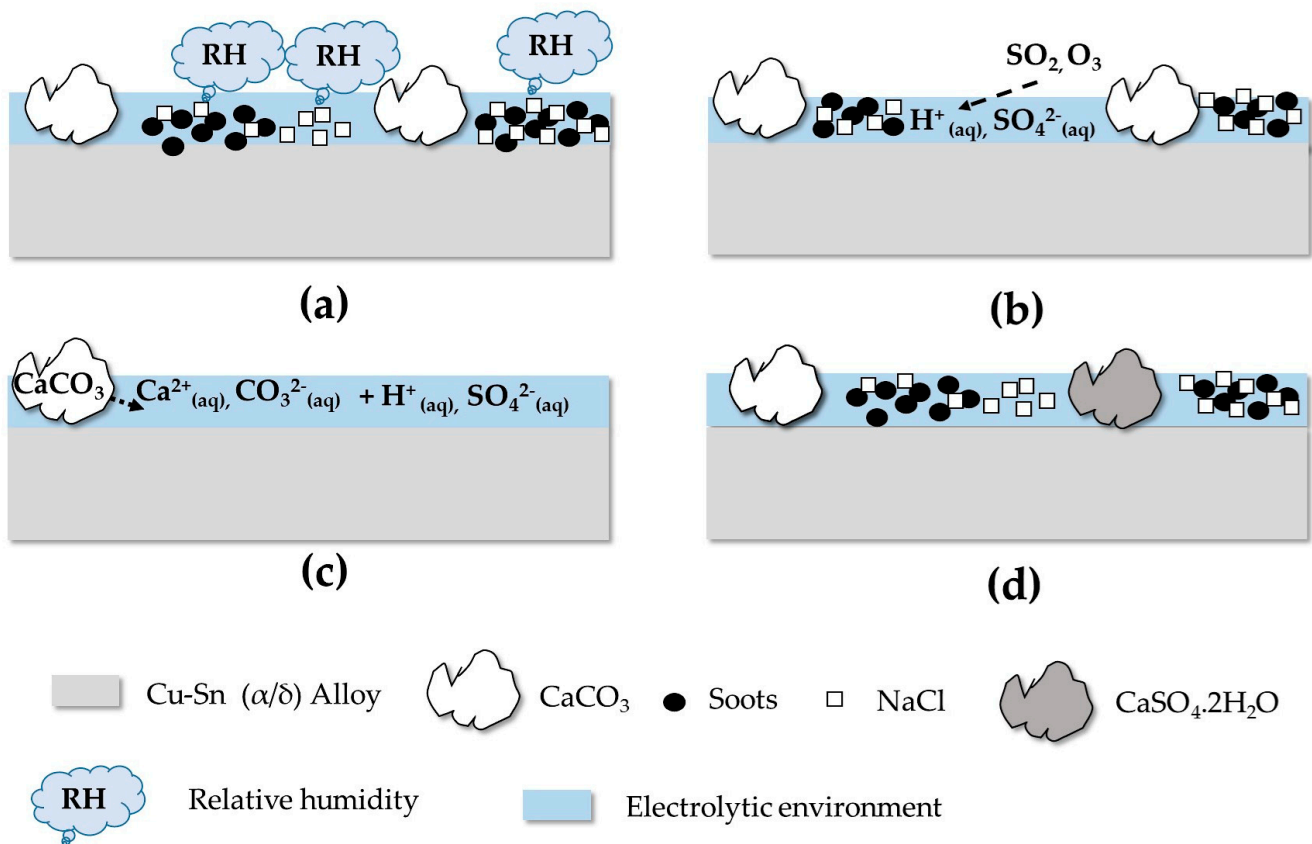
**Figure 11.** Diagram of the different reaction steps (a–d) between the atmosphere in the CIME chamber and the particulate deposit.

(1) Reaction between the atmosphere of the CIME chamber and the particulate deposit:

Soot and halite particles are known to have hygroscopic properties [45–47]. They tend to absorb ambient humidity to form an electrolytic environment where the anthropic gases  $\text{SO}_2$  and  $\text{O}_3$  can dissolve and react with the particulate clusters. Calcite is the most reactive element when in contact with sulfur dioxide and ozone. Indeed, a high concentration (600 ppb) of  $\text{O}_3$  injected into the CIME chamber is sufficient to oxidize  $\text{SO}_2$  to  $\text{SO}_3$  which, dissolved by the condensation water on the surface of the deposit, leads to the formation of  $\text{H}_2\text{SO}_4$  [48]. This one reacts with  $\text{Ca}^{2+}$  ions from the dissolution of calcite to form gypsum [49].

According to the XPS and DRX investigations, sulfur penetrates inside the deposit where calcium sulfides and sulfates were detected. Their formation results from the diffusion of  $\text{SO}_2$ ,  $\text{O}_3$  and  $\text{H}_2\text{SO}_4$  or from the dissolution of part of the gypsum. These results underline the micro-infiltrative and hygroscopic character of the particulate clusters with respect to humidity and anthropic gases that accelerate the underlying metallic corrosion [6,8] and the formation of insoluble corrosion products of the bronze [50].

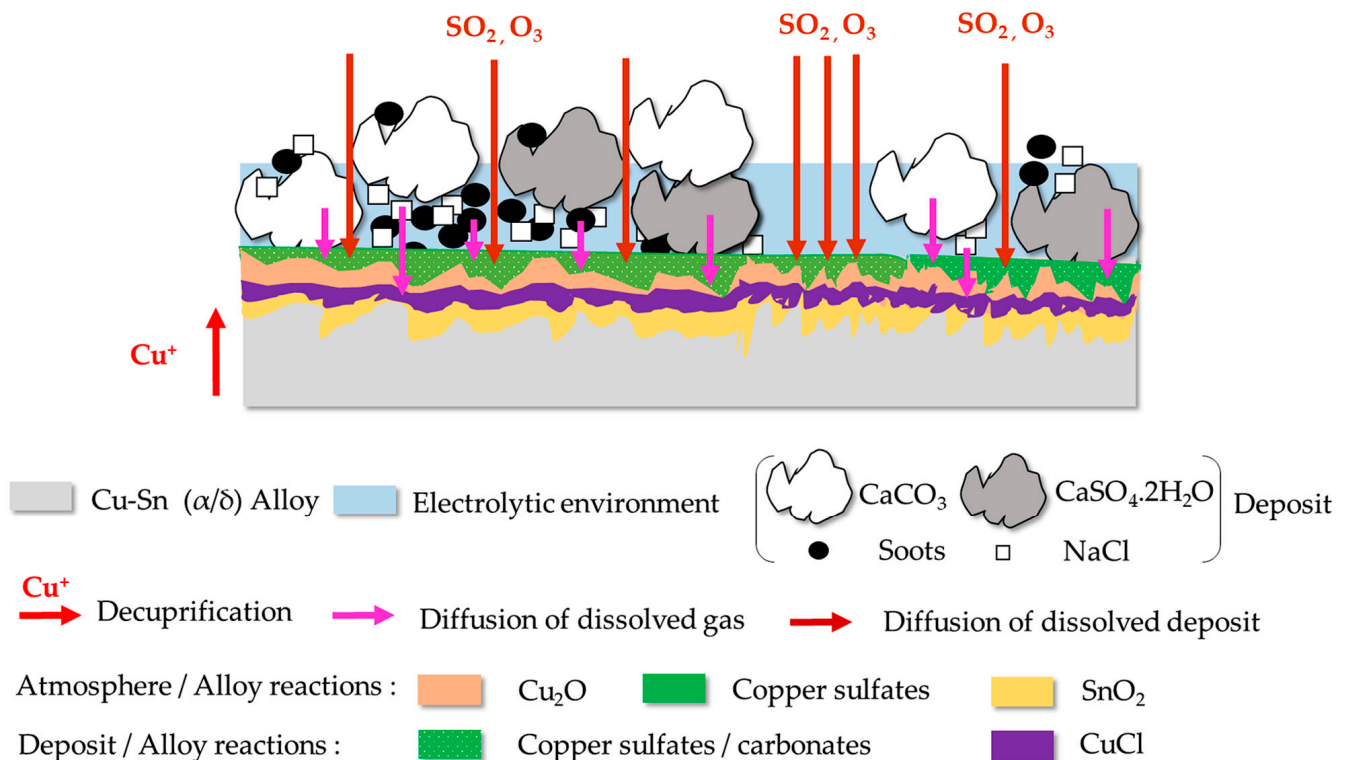
**Figure 12.** Diagram of the alloy reaction with the atmosphere in the CIME chamber and the particulate deposit.

The atmospheric conditions reproduced in the CIME chamber (400 ppb  $\text{SO}_2$ , 600 ppb  $\text{O}_3$ ) are corrosive enough to interact with the alloy underlying the deposit and form cuprite and copper sulfates. On the bronze surface, the particulate deposit is non-uniform. The electrolyte forms by condensation on the surface of the hygroscopic deposit and migrates towards the underlying alloy, or it condenses on contact with the alloy in the parts deprived of the deposit. The dissolved oxygen in the electrolyte causes thermodynamic instability

of copper:  $\text{Cu}^+$  cations are emitted (decuprification) and combine with oxygen to form a cuprite layer adhering to the alloy, near and under the particulate deposit.  $\text{Cu}_2\text{O}$  is one of the first corrosion products to appear [51]. For the copper sulfates, they come from the combination of  $\text{SO}_4^{2-}$  from the  $\text{SO}_2$  dissolved in the electrolyte and  $\text{Cu}^{2+}$  from the oxidation of  $\text{Cu}^+$  at the cuprite/electrolyte interface. Concerning the tin alteration, the corrosion products are in contact with the alloy, under the cuprite layer and as  $\text{SnO}_2$  tin oxide. Traces of tin and copper sulfides cannot be excluded.
