## Comparison of Dynamic Cobble Berm Revetments with Differing Cobble Characteristics

Ollie Foss, Chris Blenkinsopp, Paul Bayle, Kévin Martins, Stefan Schimmels, et al.. Comparison of Dynamic Cobble Berm Revetments with Differing Cobble Characteristics. Coastal Engineering, 2023, 183, pp.104312. 10.1016/j.coastaleng.2023.104312 . hal-04271886

Ollie Foss<sup>1</sup>, Chris E. Blenkinsopp<sup>1</sup>, Paul M Bayle<sup>1,2</sup>, Kévin Martins<sup>3</sup>, Stefan Schimmels<sup>4</sup>, and Luis Pedro Almeida<sup>5,6</sup>

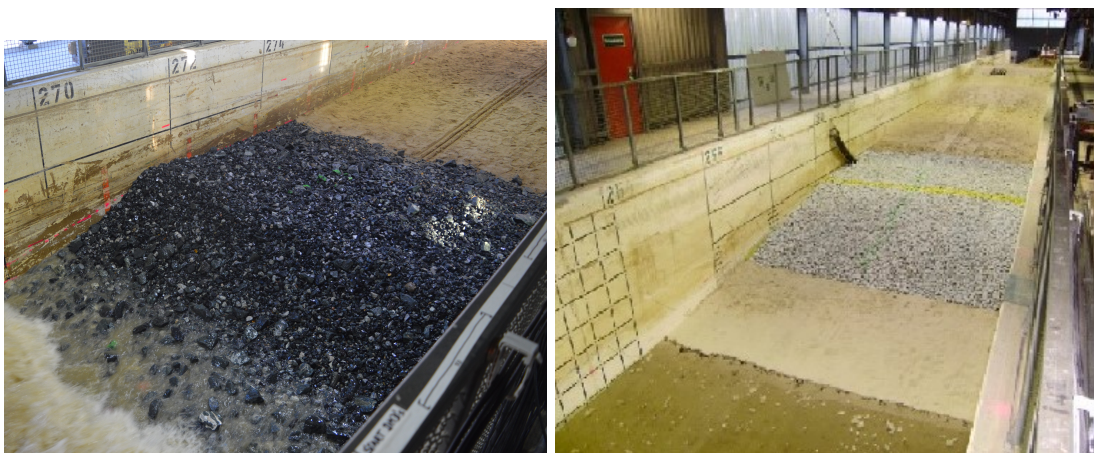
Figure 1: Left) The poorly-sorted revetment. Right) The well-sorted revetment

159 comprised of poorly-sorted, angular material equivalent to quarry run that would be ex-  
160 pected to be widely available throughout the developed and developing world. This work  
161 compares the results from both experiments (see [Figure 1](#) for comparative photo of the  
162 two revetment structures).

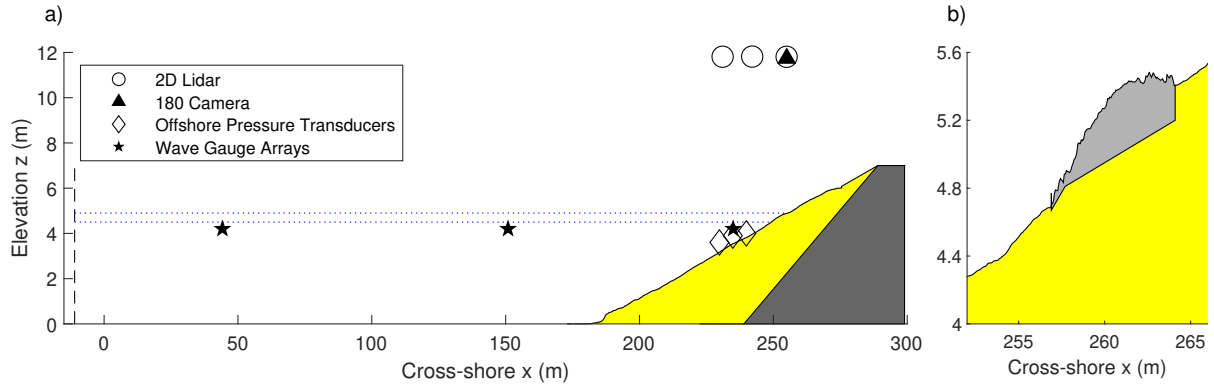
**Figure 2:** a) Schematic of initial experiment setup including instrument locations and profile of the placed beach. The vertical dashed line indicates the location of the wave paddle and the horizontal dotted lines give the lowest and highest water level during the experiment. b) Close-up schematic of the initial poorly-sorted revetment placement. The grey box is the placed revetment shape.

The revetment was constructed on a 1:15 sandy beach. The sand used during the experiment was the same as that for DynaRev1 and had the following grain size characteristics;  $D_{50} = 0.33$  mm,  $D_{10} = 0.20$  mm and  $D_{90} = 0.65$  mm. The total volume of sand used for the beach construction was  $875 \text{ m}^3$ . The entire beach profile including the revetment was constructed 11 m further from the wave paddle than in DynaRev1 and is shown in Figure 2b. This shift is not expected to influence the results as it simply increased the length of the deepwater section of the flume. To aid comparison between the two experiments, an adjusted 2-dimensional co-ordinate system was defined for DynaRev2, with the cross-shore origin located in front of the wave paddle such that the wave paddle is located at  $x = -11$  m and continues in the positive direction towards the beach. The vertical elevation from the base of the flume defines the  $z$ -direction such that 0 m represents the floor of the flume as shown in Figure 2.

237  $D_{50} = 44$  mm with a grading value of  $D_{85}/D_{15} = 3.79$  (see Equation 1 in subsection 2.4  
238 for details). The front slope had an incline of 1:6.3 and the toe was located at  $x = 256.9$   
239 m and  $z = 4.67$  m. Using the runup equation for gravel beaches developed by Poate  
240 et al. (2016) the 2 % exceedance runup elevation was predicted to be 0.72 m, therefore  
241 the crest was constructed at  $x = 260.8$  m and  $z = 5.42$  m corresponding to the predicted  
242  $R_{2\%}$  for a water level  $z_{wl} = 4.7$  m. Behind the crest, the poorly-sorted revetment was  
243 approximately horizontal and intersected the sand beach at  $x = 264.1$  m. The total  
244 volume of placed cobbles was 9.375 m<sup>3</sup> and weighed 16.5 t.

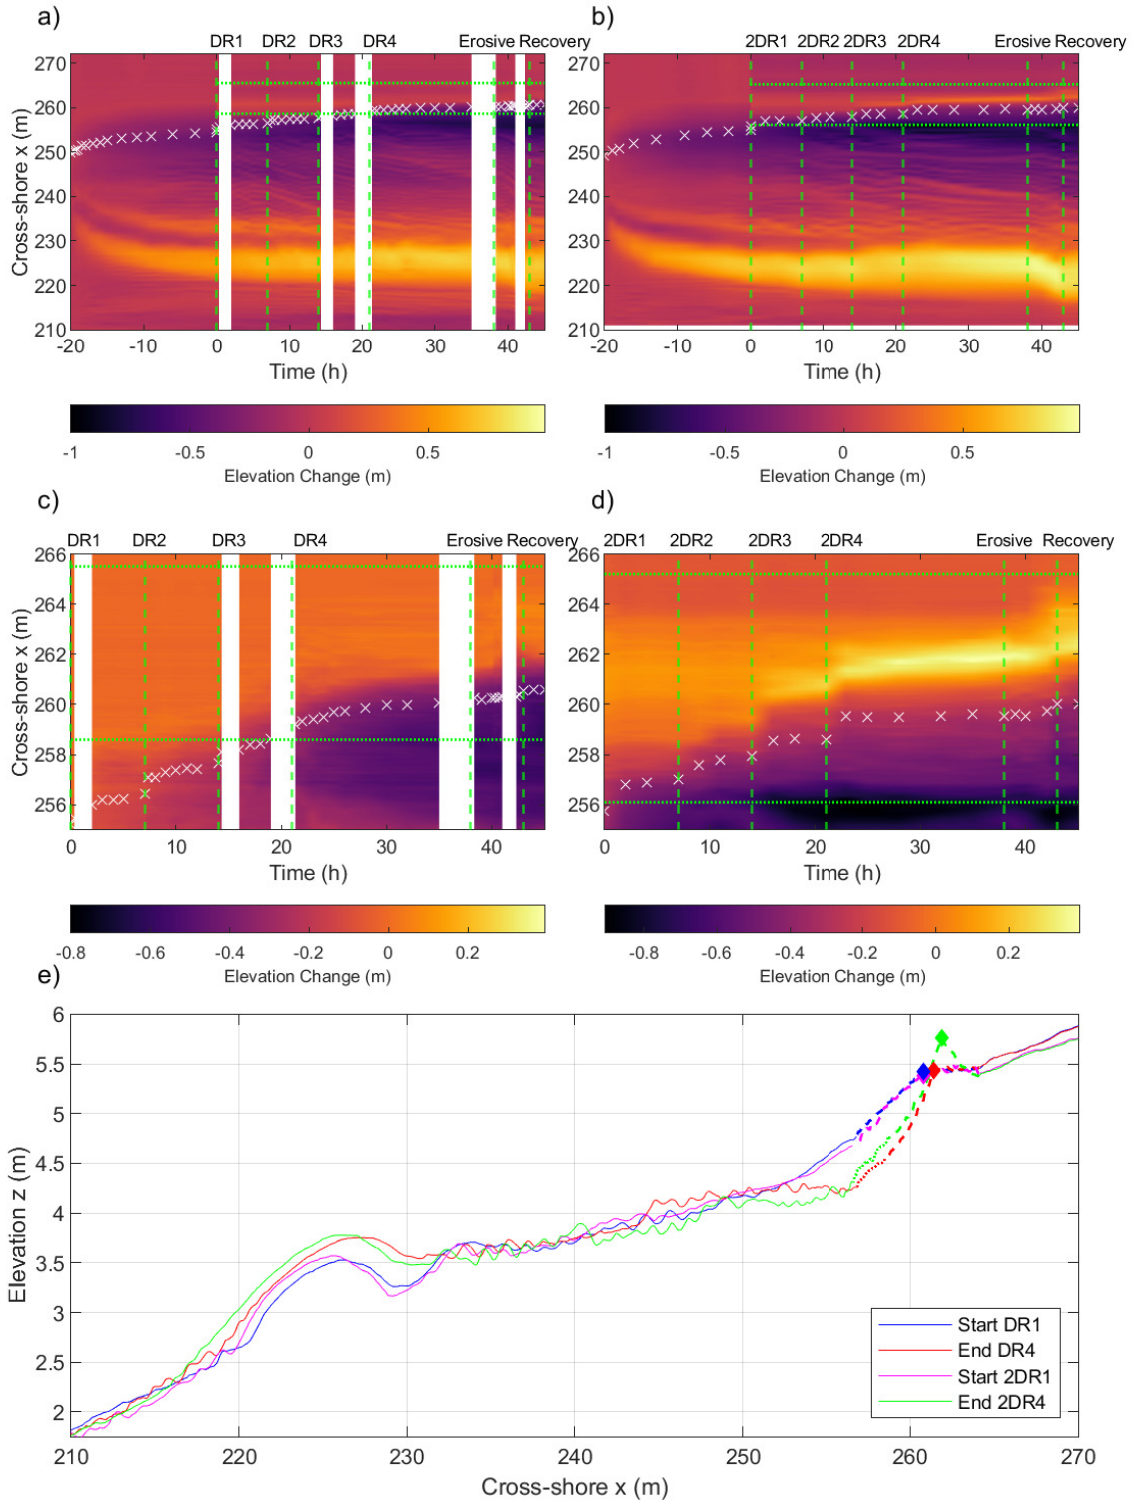
**Figure 3:** Bed elevation change relative to initial beach profile over the entire experiment for a) DynaRev1, well-sorted revetment, b) DynaRev2, poorly-sorted revetment. Revetment surface elevation change relative to installed profile for c) DynaRev1, d) DynaRev2. The dashed green vertical lines represent the time of a 0.1 m water level rise, and the dotted horizontal lines denote the maximum seaward and landward extent of the revetment during the experiment. The white crosses represent the shoreline position at the end of each run. e) Profile at the start and end of the 38 h of standard wave conditions for both the well-sorted revetment (DynaRev1) and poorly-sorted revetment (DynaRev2). The dashed line represents the cobble body, the dotted line represents the sparse cobble layer and the diamonds gives the crest location (see section 3.1.1).

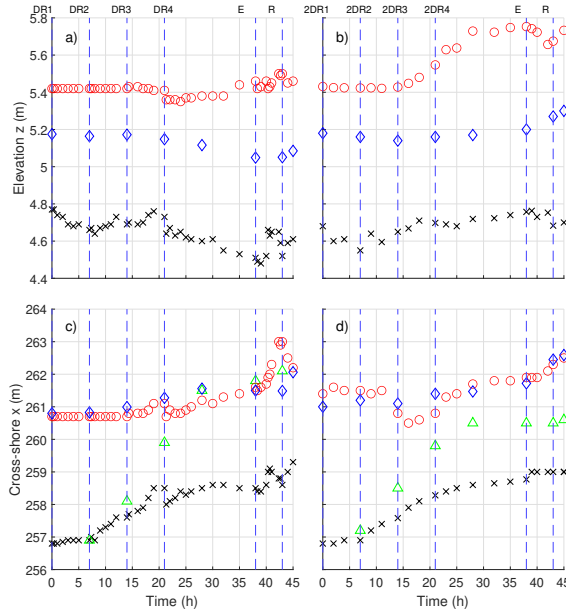
**Figure 5:** Vertical elevation of the toe (black crosses), centroid of the cross-sectional area (blue diamonds) and crest (red circles) for a) DynaRev1 and b) DynaRev2. Cross-shore location for the toe of the main cobble body (black crosses), the location of the intersection between the still water level and the sand-cobble interface beneath the revetment (green triangles), centroid of the cross-sectional area (blue diamonds) and crest (red circles) for c) DynaRev1 and d) DynaRev2.

375 revetment (Figure 4h) and a toe retreat of 1 m (Figure 5d). This resulted in an increase in  
 376 structure height and the front slope changed from a convex to a concave shape (Figure 4h).  
 377 Conversely, the well-sorted revetment (DynaRev1) showed similar crest and toe retreat  
 378 but the shape remained consistent with no crest growth (Figure 4g; Figure 5a and c). The  
 379 development of the peaked crest feature for the poorly-sorted revetment in DynaRev2 is  
 380 a result of the cobble population characteristics. Firstly, highly angular cobbles interlock  
 381 better, reducing the frequency of seaward cobble transport due to increased stability  
 382 under wave attack. Secondly, the wide size range of the poorly-sorted cobbles leads to  
 383 size sorting on the revetment surface, with larger cobbles accumulating near the toe and  
 384 primarily smaller cobbles being transported landward to form the peaked crest feature

426 leading to a larger elevation change over the body (Figure 4). As noted earlier the well-  
427 sorted revetments crest only shows minimal (0.04 m) of growth over the entire standard  
428 wave conditions (Figure 5a).

439 m (DynaRev2). The length of the well-sorted revetment was more variable during the  
 440 erosive wave testing due to the more changeable cobble toe location (Figure 5c and d).  
 441 The increased stability of the toe in the poorly-sorted revetment is due to the fact that  
 442 the toe contained many large cobbles which were not mobilised by the increased wave  
 443 energy (subsection 3.3).

497 reduced sinking of the front face of the revetment. This can be seen clearly in the retreat  
498 of the sand water interfaces (SWI) for the revetments (see Figure 5 c,d), the location  
499 where the still water line intercepts the interpolated surface beneath the revetment. The  
500 final SWI location for the poorly-sorted revetment was 260.5 m at the end of standard  
501 wave conditions (38 h), which is 1.3 m further seaward than for the well-sorted revetment  
502 (see Figure 5). The poorly-sorted revetment preserves up to 52% more sand above the  
503 still water level under the structure. This reduced sand loss has the advantage of better  
504 preserving the revetment height compared to the still water level improving the ability  
505 to reduce overtopping.

636 The majority of revetment response in DynaRev2 happened within the first seven  
637 hours of test 2DR4 (21 – 28 h), after this the retreat slowed (Figure 5) and the degree of  
638 morphological change greatly reduced during the final 10 hours of standard wave condition  
639 testing (28–38 h), Figure 3) was reduced. This suggests that the revetment moves towards  
640 an equilibrium state within approximately 7 hours after each rise in water level. The  
641 ability of the revetment to rapidly reshape towards a new equilibrium condition is also  
642 seen in Figure 7 which shows that the revetment responds quickly to erosive conditions  
643 but is already re-establishing the peaked revetment crest after only 2 h of low energy  
644 recovery conditions. As the bulk of material remains part of the main cobble body and the  
645 geometry remains approximately constant, the revetment can be considered dynamically

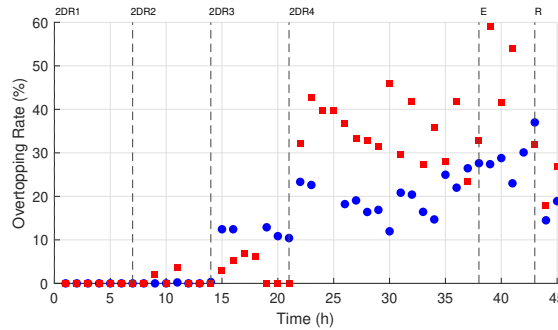
**Figure 6:** Hourly overtopping rate for the poorly-sorted revetment (blue) and the well-sorted revetment (red).

357 The crest was rarely overtopped during the first 14 hours of testing during DynaRev2  
358 (tests 2DR1 and 2DR2, 0 to 14 h), see Figure 6. The swash zone was limited to the  
359 front face of the cobble body and morphological change was confined to this region.  
360 Water infiltration into and through the structure eroded sand beneath the front face,  
361 reducing the elevation of both the toe and centre of mass of the revetment (red dots in  
362 Figure 4, blue diamonds in Figure 5). A single layer of sparse cobbles mixed with sand  
363 was formed at the front of the revetment, termed the sparse cobble layer (marked in green  
364 in Figure 4). This layer was formed from cobbles at the larger end of the size range, was  
365 approximately 1 m in cross-shore extent by  $t = 14$  h, did not extend seaward of the

388 Tests DR4 and 2DR4 ( $z_{wl} = 4.9$  m;  $t = 21$  to 38 h) were the longest (17 hours)  
 389 and experienced the highest overtopping rates (see Figure 6). During the first seven  
 390 hours the poorly-sorted revetment (DynaRev2) experienced accelerated morphological

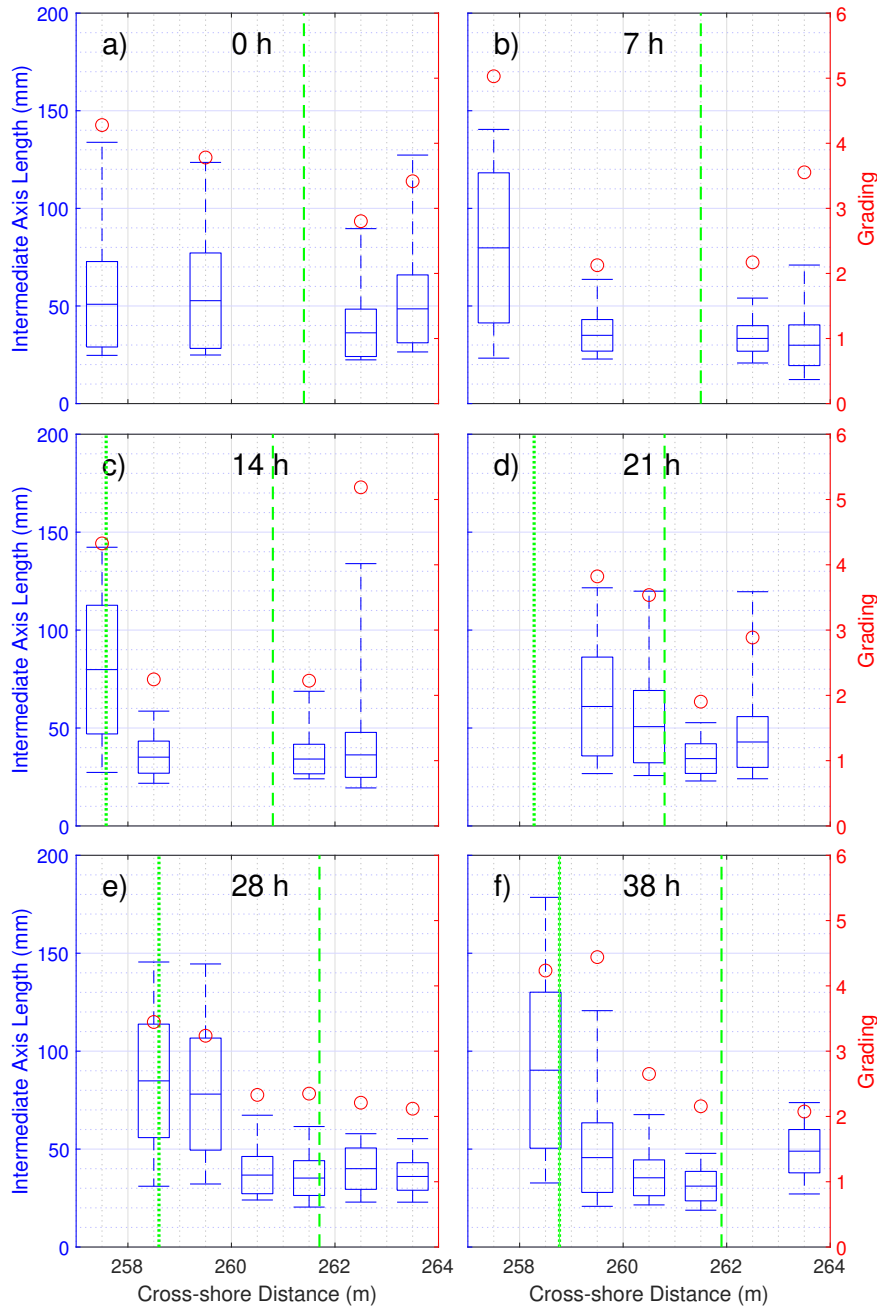
**Figure 8:** Surface grain size distribution across the poorly-sorted revetment at the end of each test ( $t = 0, 7, 14, 21, 28, 38$ ). The left hand y-axis corresponds to a box plot centred over the median intermediate axis length with inner bounds provided by the median absolute deviation and branches reaching  $D_{90}$  and  $D_{10}$ . The right hand y-axis and red circles indicate the grading value at each location (Grading =  $D_{85}/D_{15}$ ). Dotted green line represents the toe location and dashed green line represent crest location.

555 The distribution of cobbles on the surface of the poorly-sorted revetment was initially  
 556 very consistent at all cross-shore positions (Figure 8a). Subsequently, the surface cobbles  
 557 underwent a sorting process throughout the experiment as they were mobilised by wave

558 forcing. This sorting process led to the median cobble size decreasing landward of the  
 559 toe, combined with a smaller grading value (Figure 8), indicative of better sorted cobbles  
 560 moving landwards. This sorting was limited to the seaward limit of the revetment during  
 561 test 2DR1 (0-7 h,  $z_{wl} = 4.6$  m) when no overtopping occurred (see Figure 8b). Over-  
 562 topping appears to accelerate this process by transporting smaller, more easily mobilised  
 563 cobbles onto and landward of the crest during uprush where they become stranded and  
 564 bury existing larger cobbles. This sorting is most evident during the final water level  
 565 test 2DR4 (21-38 h,  $z_{wl} = 4.9$  m; see Figure 8 e,f) and is visible in the images shown in

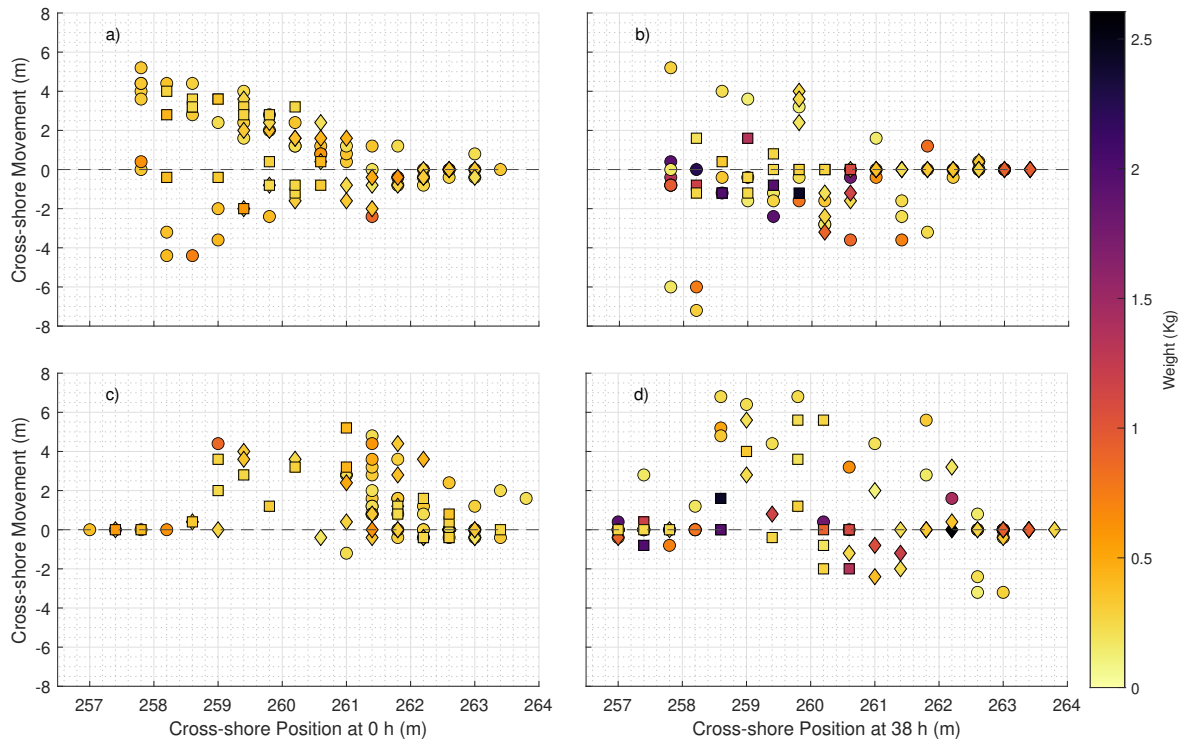
**Figure 9:** Absolute cross-shore distance travelled by tagged cobbles from their initial position, where positive is landward and negative is seaward for the a) well-sorted revetment (DynaRev1) and b) poorly-sorted revetment (DynaRev2) after 38 h of standard wave conditions. Absolute distance travelled by tagged cobbles from their detected position at 38h for the c) well-sorted revetment and d) poorly-sorted revetment during the erosion and recovery tests. The colour of each marker relates to the cobble weight as shown by the colour bar (left). The cobbles were distributed in three layers; revetment surface (circles), middle layer (diamonds) and sand-cobble interface (squares).

576 kg was detected more than 40 cm landward of its initial position by the end of standard  
 577 wave testing (38 h, see **Figure 9** b). Some cobbles larger than 2 kg were detected seaward  
 578 of their initial position. These are primarily from the surface and middle layer of the  
 revetment and have rolled down the front face of the revetment. A comparison of the

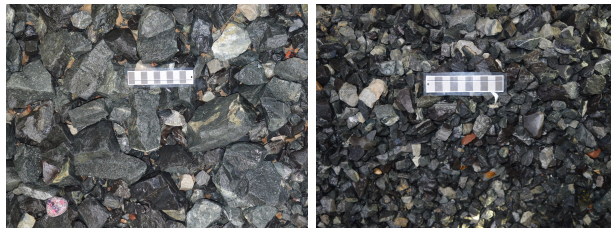
**Figure 10:** Photo of surface cobbles for the poorly-sorted revetment after standard wave conditions (38 h) at left) the toe of the revetment and right) the crest of the revetment. The total length of the scale bar is 198 mm.

566 **Figure 10** for both the toe and crest of the revetment. Throughout the experiment both  
 567 the smallest range of cobble sizes and smallest median cobble sizes were detected at the  
 568 crest of the structure (see **Figure 8**). Note, the RFID-tagged cobbles had a minimum  
 569 size of 40 mm and therefore this trend is not evident in **Figure 9** because the majority of  
 570 cobbles forming the crest are smaller than 40 mm. Conversely, the toe of the revetment  
 571 and the sparse cobble layer became less sorted with a higher median cobble size than was  
 572 initially present (see **Figure 8**). The median cobble size at the toe increased from 51 mm  
 573 at 0 h to 90 mm at 38 h. This is caused by a high proportion of smaller cobbles being  
 574 transported landward from the toe, leaving the larger, less easily mobilised cobbles to  
 575 form a stable toe for the revetment. Notably, no tagged cobble of weight greater than 2

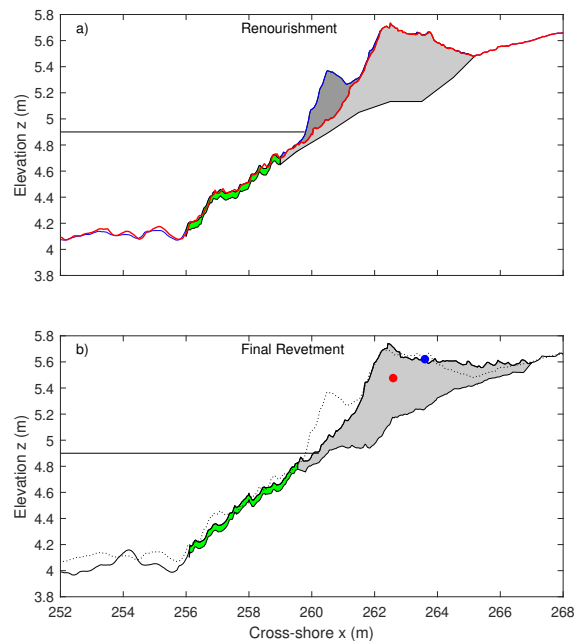
**Figure 11:** a) Renourished revetment where the light grey area outlined in red shows revetment cross-shore profile at the end of recovery wave conditions (2DDR1, 45 h, Table 1) and the dark grey area outlined in blue indicates the added material. b) The final shape of the revetment after 2 h 40 m of additional tests, the blue dot indicates the runup location under standard wave conditions. The dotted line indicates the revetment profile immediately following renourishment

612 Following the erosive and recovery wave conditions (38-45 h, Table 2) the thickness of  
613 the poorly-sorted revetment on the seaward slope had thinned substantially and the  
614 revetment consisted of a large crest feature with the majority of volume above the SWL,  
615 with a thin layer of larger stones extending to the original toe location ( $x = 256.9$  m)  
616 (see Figure 4). An opportunistic nourishment of the front slope was carried out where  
617 an additional  $2.25 \text{ m}^3$  of material was added by simply dumping it on the front face  
618 (Figure 11a). Additional erosive test were then carried out, these are not comparable  
619 to those carried out for the well-sorted revetment due to a shortened testing regime and  
620 different placement method - for the well-sorted revetment the renourishment was added  
621 as a constant thickness layer over the front face. The material added to the poorly-

622 sorted revetment in DynaRev2 was quickly reshaped by waves and integrated into the  
623 revetment. This had the primary effect of increasing the cobble depth of the front face but  
624 some material was transported beyond the landward limit of the revetment, increasing its  
625 length by 2 m. During these tests the toe retreated by a further 0.5 m but the crest was  
626 stabilised at the pre-nourishment location ( $x = 262.45$  m). The renourished revetment  
627 preserved its centre of mass beneath the peak of the crest and 0.22 m higher than the  
628 end of the resilience tests (38 h, 2DDR1) suggesting this is the most stable shape for  
629 these cobble characteristics. The overall effect of the added material was to increase the  
630 thickness of the front slope without affecting the overall behaviour of the revetment which  
631 continued to reshape rapidly in response to changing conditions.
