Comparison of Dynamic Cobble Berm Revetments with Differing Cobble Characteristics

Ollie Foss, Chris Blenkinsopp, Paul Bayle, Kévin Martins, Stefan Schimmels, et al.. Comparison of Dynamic Cobble Berm Revetments with Differing Cobble Characteristics. Coastal Engineering, 2023, 183, pp.104312. 10.1016/j.coastaleng.2023.104312 . hal-04271886

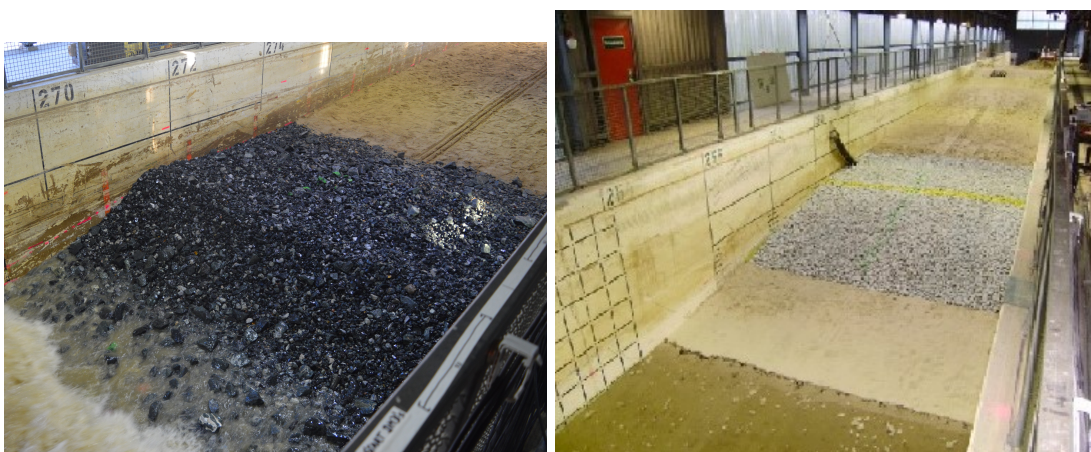
Figure 1: Left) The poorly-sorted revetment. Right) The well-sorted revetment

At present, dynamic cobble berm revetments designed using non-sorted gravels are effective at protecting their respective coasts. This current study examines the differences in morphological response of revetments designed using differing cobble populations. It is then contextualised in consideration of coastal protection techniques. It follows that published by Bayle et al. [Bayle et al. \(2020\)](#) which reported on the ‘DynaRev’ experimental investigation of a dynamic cobble berm revetment constructed using well-sorted, rounded cobbles (hereafter called DynaRev1). This work presents a comparable large-scale experiment (DynaRev2), designed similar to the DynaRev1 experiment to investigate the performance of a different dynamic cobble berm revetment under the same conditions. It was constructed with approximately the same geometry as the original revetment, but comprised of poorly-sorted, angular material equivalent to quarry run that would be expected to be widely available throughout the developed and developing world. This work compares the results from both experiments (see [Figure 1](#) for comparative photo of the two revetment structures).

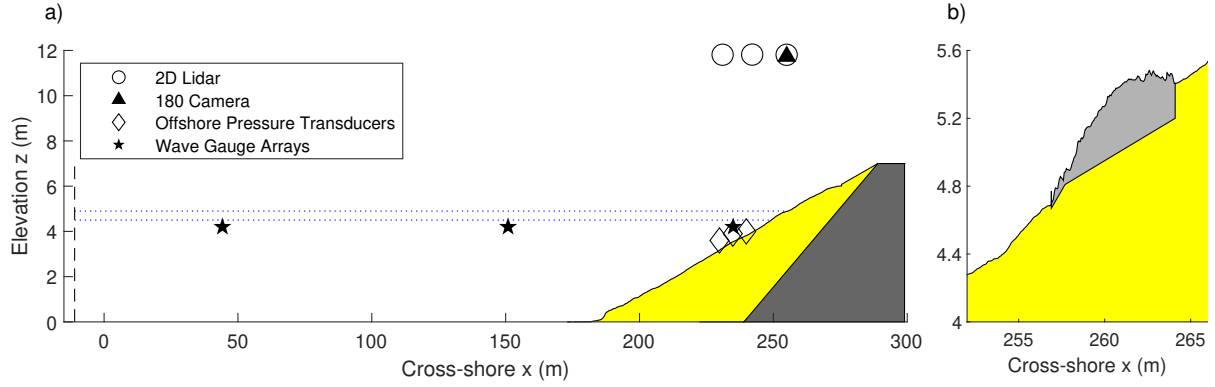
Figure 2: a) Schematic of initial experiment setup including instrument locations and profile of the placed beach. The vertical dashed line indicates the location of the wave paddle and the horizontal dotted lines give the lowest and highest water level during the experiment. b) Close-up schematic of the initial poorly-sorted revetment placement. The grey box is the placed revetment shape.

The revetment was constructed on a 1:15 sandy beach. The sand used during the experiment was the same as that for DynaRev1 and had the following grain size characteristics; $D_{50} = 0.33$ mm, $D_{10} = 0.20$ mm and $D_{90} = 0.65$ mm. The total volume of sand used for the beach construction was 875 m³. The entire beach profile including the revetment was constructed 11 m further from the wave paddle than in DynaRev1 and is shown in Figure 2b. This shift is not expected to influence the results as it simply increased the length of the deepwater section of the flume. To aid comparison between the two experiments, an adjusted 2-dimensional co-ordinate system was defined for DynaRev2, with the cross-shore origin located in front of the wave paddle such that the wave paddle is located at $x = -11$ m and continues in the positive direction towards the beach. The vertical elevation from the base of the flume defines the z -direction such that 0 m represents the floor of the flume as shown in Figure 2.

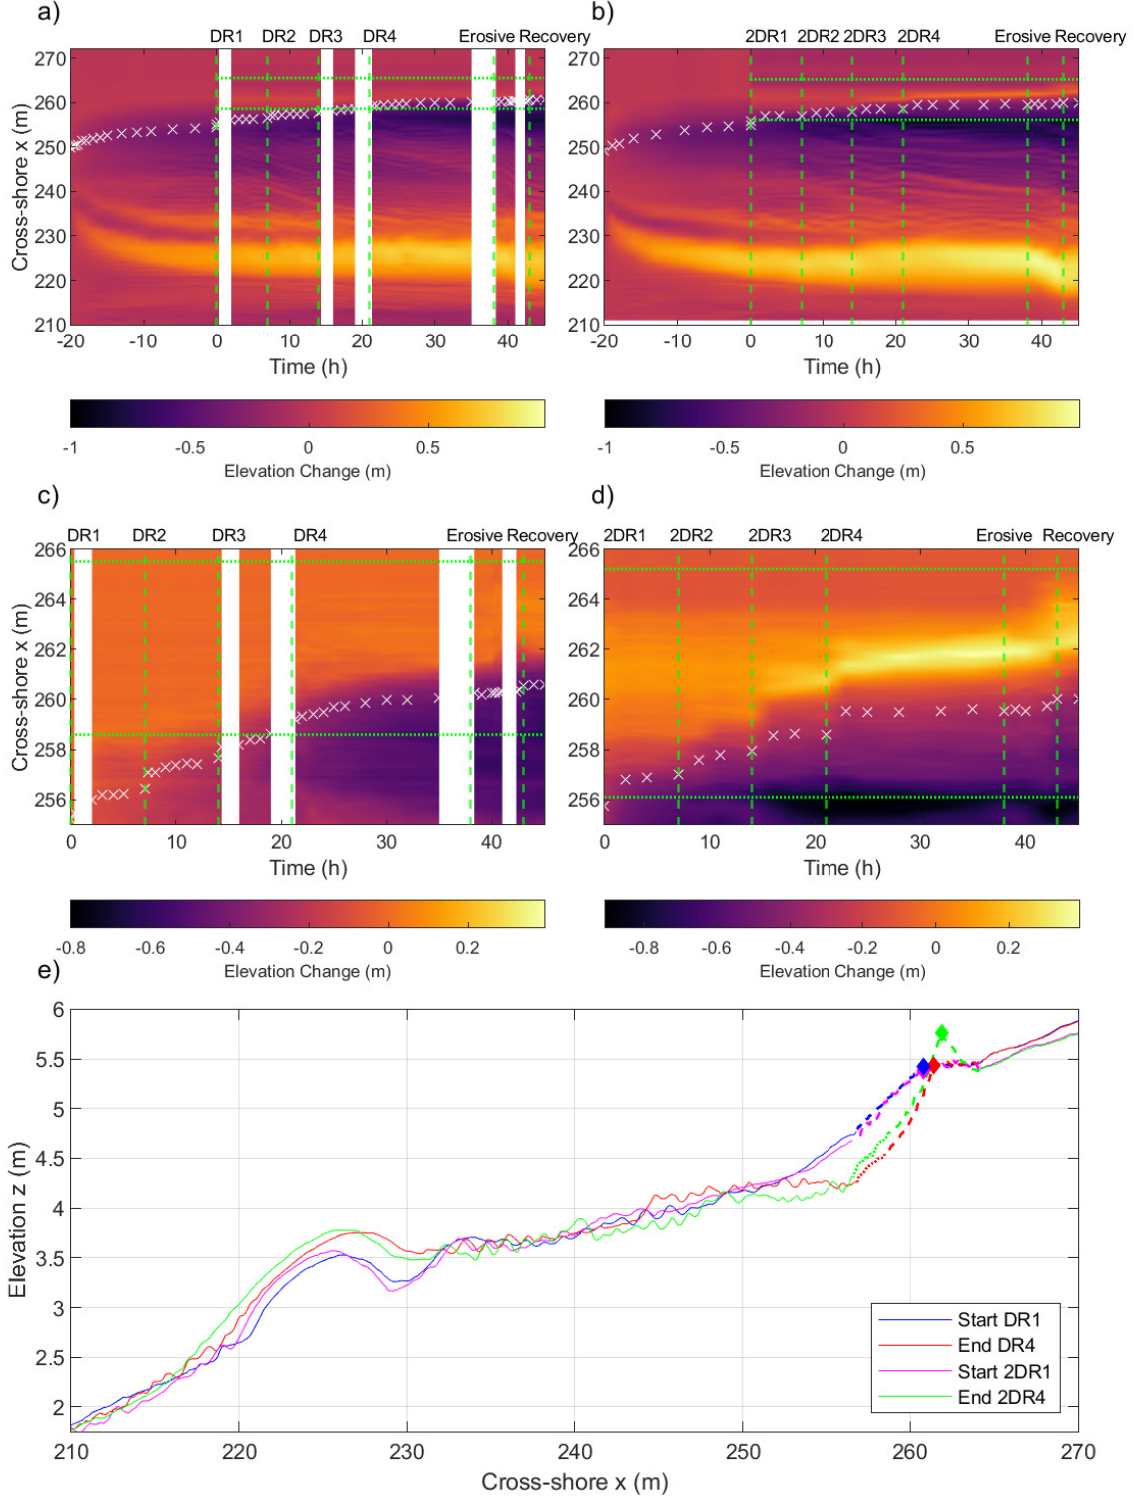
Figure 3: Bed elevation change relative to initial beach profile over the entire experiment for a) DynaRev1, well-sorted revetment, b) DynaRev2, poorly-sorted revetment. Revetment surface elevation change relative to installed profile for c) DynaRev1, d) DynaRev2. The dashed green vertical lines represent the time of a 0.1 m water level rise, and the dotted horizontal lines denote the maximum seaward and landward extent of the revetment during the experiment. The white crosses represent the shoreline position at the end of each run. e) Profile at the start and end of the 38 h of standard wave conditions for both the well-sorted revetment (DynaRev1) and poorly-sorted revetment (DynaRev2). The dashed line represents the cobble body, the dotted line represents the sparse cobble layer and the diamonds gives the crest location (see [section 3.1.1](#)).

The morphological evolution of the revetments and sandy beach immediately seaward of the revetment for both DynaRev1 and DynaRev2 is presented in Figure 3a,b. Note that 0 h corresponds to the time of revetment installation, explaining the sudden accretion between $x = 259$ and $x = 262.5$. Negative times correspond to test DR0/2DR0 (see Table 1) before revetment installation, when only the sand beach was present. In both experiments the beach behaved in a similar manner during the 20 h of wave action prior to revetment installation (-20 h to 0 h). The geometry of the revetment at the end of each test is shown in Figure 4 to aid interpretation of Figure 3.

458 Both beaches were considered to be approaching an equilibrium state and presented
 459 similar morphologies (Figure 3). The notable difference being the slightly larger and
 460 further seaward outer bar in DynaRev2 prior to the installation of the poorly-sorted
 461 revetment. Over the main region of interest between $x = 210$ m and $x = 270$ m the root
 462 mean square difference between the beach profiles at $t = 0$ h was just 0.3 m. This agrees

After installation of the poorly-sorted revetment in DynaRev2, the outer bar accumulated sand resulting in a vertical and predominantly seaward growth of the outer bar (Figure 3). The source of this sand is from three primary processes; sand erosion beneath the revetment, the development of a trough immediately seaward of the revetment structure and smoothing out of the smaller inner bar. Morphological changes are strongest in the two hours immediately following the third and fourth water level rise ($z_{wl} = 4.8$ and 4.9 m), the same period in which the revetment and trough underwent significant morphological change. The well-sorted revetment in DynaRev1 showed a similar accretion of sand in the outer bar driven by the same processes. Less sand erodes immediately seaward of the well-sorted revetment leading to a smaller trough, indicating that sand erosion from beneath the structure contributes more for the well-sorted revetment in DynaRev1. The sand erosion beneath the revetment leads to a sinking effect for both revetments. This process can be tracked throughout the experiment by comparing the approximate location that the still water level intercepts the sand-cobble interface beneath the revetment (green triangles in Figure 5). For both revetments this is a continuing process throughout the first three water level tests ($z_{wl} = 4.6$ to 4.8 0 – 27 h). If water level rise is discounted the During the forth water level test (27 – 38h) this process halted for the poorly-sorted revetment in DynaRev2 but continued at a reduced rate for the well-sorted revetment in DynaRev1. This results in a significantly less of the poorly sorted revetments main cobble body being below the still water level at the end of the water level tests (19.9 % in DynaRev1 vs 5.71 % in DynaRev2, Figure 2k and l).

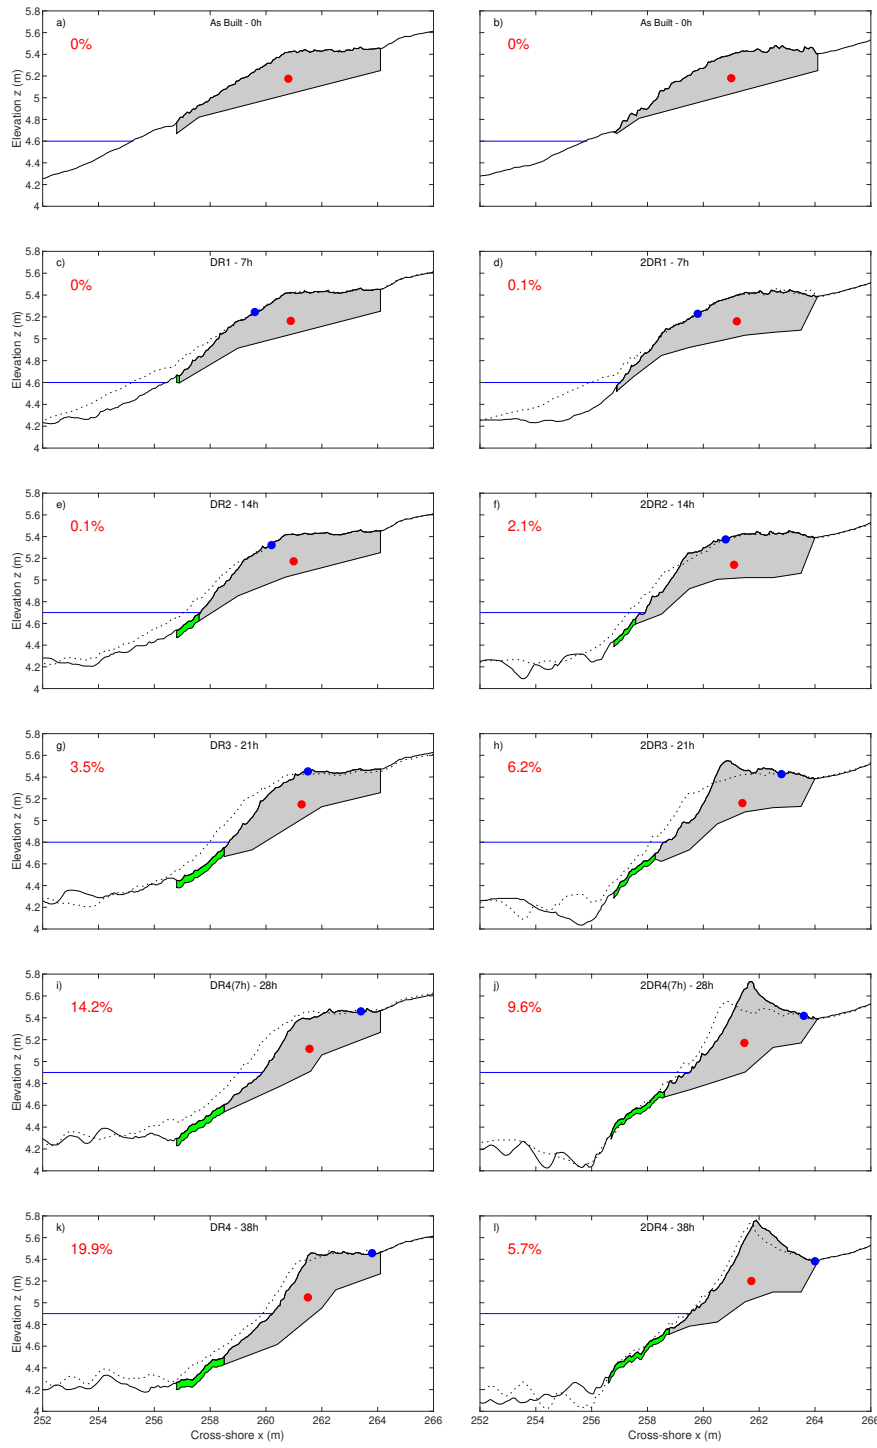
Figure 4: Revetment shape as-built and at the end of each indicated test for the well-sorted revetment (DynaRev1, left) and poorly-sorted revetment (DynaRev2, right). The grey area represents the cobble only portion of the revetment. The green area represents the sparse cobble layer. The blue dot indicates the cross-shore position that was exceeded by 2% of wave run-up events, the red dot indicates the centre of mass of the revetment and the dashed line is the revetment surface from the previous panel. The red value gives the percentage of the main cobble body below the still water level

Tests DR3 and 2DR3 ($z_{wl} = 4.8$ m; $t = 14$ to 21 h) resulted in the divergence in the response of the two revetments (Figure 4g and h). The new water level led to an increased rate of overtopping for both revetments driving morphological change, see Figure 6 for further details. Landward transport of cobbles driven by overtopping events led to the development of a very peaked crest behind the initial crest location for the poorly-sorted

revetment (Figure 4h) and a toe retreat of 1 m (Figure 5d). This resulted in an increase in structure height and the front slope changed from a convex to a concave shape (Figure 4h). Conversely, the well-sorted revetment (DynaRev1) showed similar crest and toe retreat but the shape remained consistent with no crest growth (Figure 4g; Figure 5a and c). The development of the peaked crest feature for the poorly-sorted revetment in DynaRev2 is a result of the cobble population characteristics. Firstly, highly angular cobbles interlock better, reducing the frequency of seaward cobble transport due to increased stability under wave attack. Secondly, the wide size range of the poorly-sorted cobbles leads to size sorting on the revetment surface, with larger cobbles accumulating near the toe and primarily smaller cobbles being transported landward to form the peaked crest feature (see section 4.3 for further analysis of surface cobble size distributions). This process results in the elevation gain and landward movement of the crest feature for the poorly-sorted revetment in DynaRev2 as it develops under wave forcing.

The cross-shore extent of the main cobble body of both revetments reduced under the standard wave conditions (Figure 4) and are similar throughout the experiment. Because the landward limit of the revetment did not move under stand wave testing, this can be attributed to the retreat of the toe. However, whereas the toe of the well-sorted revetment sank as it retreated due to loss of sand volume beneath the structure, the toe of the poorly-sorted revetment retreated up the beach profile (Figure 5c and d). Therefore, taking the elevation change between the toe and crest as the height of the revetment it appears that both revetments grew rapidly in height under the highest water level ($z_w = 4.9$), but for the poorly-sorted revetment this is due to upward growth of the structure as opposed to the sinking of the sand-cobble interface for the poorly-sorted revetment, leading to a larger elevation change over the body (Figure 4). As noted earlier the well-sorted revetments crest only shows minimal (0.04 m) of growth over the entire standard wave conditions (Figure 5a).

650 The behaviour of the cobble body for the poorly-sorted revetment in DynaRev2 under
651 wave attack is that of a coherent structure, see Figure 4. The location of the toe, crest
652 and centre of gravity retreat in unison under standard wave conditions (Figure 5), which
653 can be viewed as a retreat of the whole body. Further, the cobble body of the revetment
654 is estimated to contain up to 97% of the original material at the end of the testing ($t = 45$
655 h). The rapid development of a peaked crest constructed from smaller angular cobbles
656 acted to limit overtopping to a greater degree than that shown in DynaRev1. Overtopping
657 was highest after the revetment crest was pushed over landward by a series of energetic
658 overtopping events, reducing the effective crest height (see 41-43 h in Figure 5 b). This
659 highlights the importance of the crest for protecting the upper beach and hinterland from

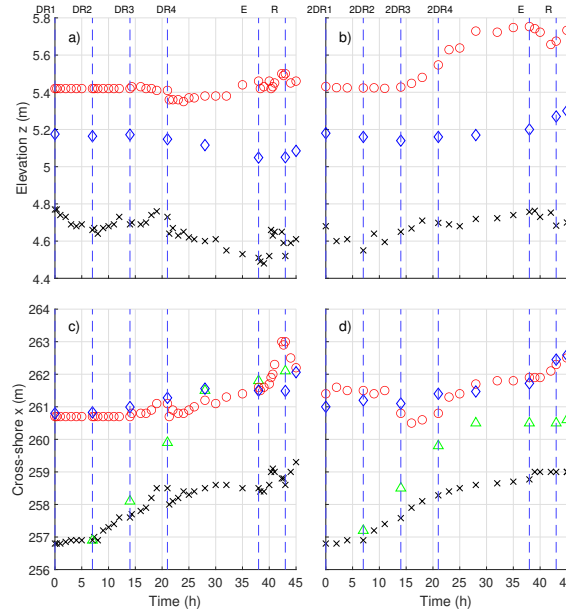
Figure 5: Vertical elevation of the toe (black crosses), centroid of the cross-sectional area (blue diamonds) and crest (red circles) for a) DynaRev1 and b) DynaRev2. Cross-shore location for the toe of the main cobble body (black crosses), the location of the intersection between the still water level and the sand-cobble interface beneath the revetment (green triangles), centroid of the cross-sectional area (blue diamonds) and crest (red circles) for c) DynaRev1 and d) DynaRev2.

439 m (DynaRev2). The length of the well-sorted revetment was more variable during the
 440 erosive wave testing due to the more changeable cobble toe location (Figure 5c and d).
 441 The increased stability of the toe in the poorly-sorted revetment is due to the fact that
 442 the toe contained many large cobbles which were not mobilised by the increased wave
 443 energy (subsection 3.3).

636 The majority of revetment response in DynaRev2 happened within the first seven
637 hours of test 2DR4 (21 – 28 h), after this the retreat slowed (Figure 5) and the degree of
638 morphological change greatly reduced during the final 10 hours of standard wave condition
639 testing (28–38 h), Figure 3) was reduced. This suggests that the revetment moves towards
640 an equilibrium state within approximately 7 hours after each rise in water level. The
641 ability of the revetment to rapidly reshape towards a new equilibrium condition is also
642 seen in Figure 7 which shows that the revetment responds quickly to erosive conditions
643 but is already re-establishing the peaked revetment crest after only 2 h of low energy
644 recovery conditions. As the bulk of material remains part of the main cobble body and the
645 geometry remains approximately constant, the revetment can be considered dynamically

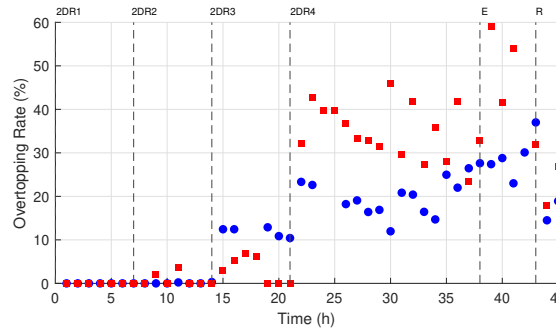
Figure 6: Hourly overtopping rate for the poorly-sorted revetment (blue) and the well-sorted revetment (red).

The crest was rarely overtopped during the first 14 hours of testing during DynaRev2 (tests 2DR1 and 2DR2, 0 to 14 h), see Figure 6. The swash zone was limited to the front face of the cobble body and morphological change was confined to this region. Water infiltration into and through the structure eroded sand beneath the front face, reducing the elevation of both the toe and centre of mass of the revetment (red dots in Figure 4, blue diamonds in Figure 5). A single layer of sparse cobbles mixed with sand was formed at the front of the revetment, termed the sparse cobble layer (marked in green in Figure 4). This layer was formed from cobbles at the larger end of the size range, was approximately 1 m in cross-shore extent by $t = 14$ h, did not extend seaward of the

Tests DR4 and 2DR4 ($z_{wl} = 4.9$ m; $t = 21$ to 38 h) were the longest (17 hours) and experienced the highest overtopping rates (see Figure 6). During the first seven hours the poorly-sorted revetment (DynaRev2) experienced accelerated morphological

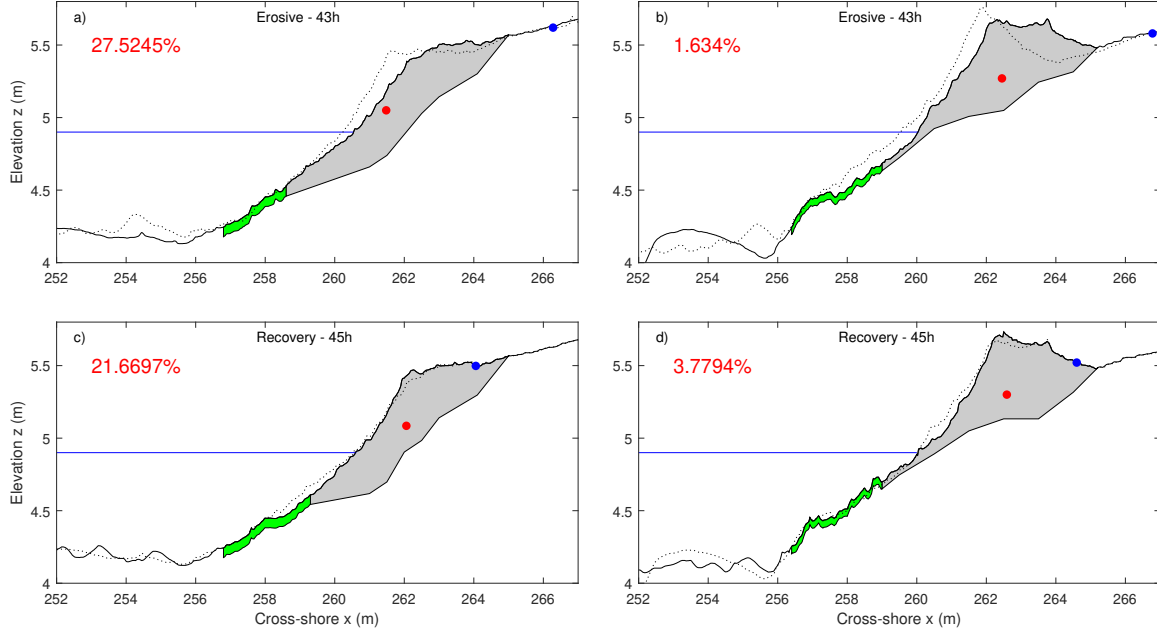
Figure 7: Revetment shape at the end of erosive (2DRE3, 38 to 43 h) and recovery (2DRR1, 43 to 45 h) wave conditions for the well-sorted revetment (left) and poorly-sorted revetment (right). The grey area represents the cobble only portion of the revetment. The green area represents the sparse cobble layer (see subsection 3.1.1). The blue dot gives the cross-shore position which was exceeded by 2% of wave run-up events, the Red dot indicates the centre of mass and the dashed line is the revetment surface from the previous panel for the respective design.

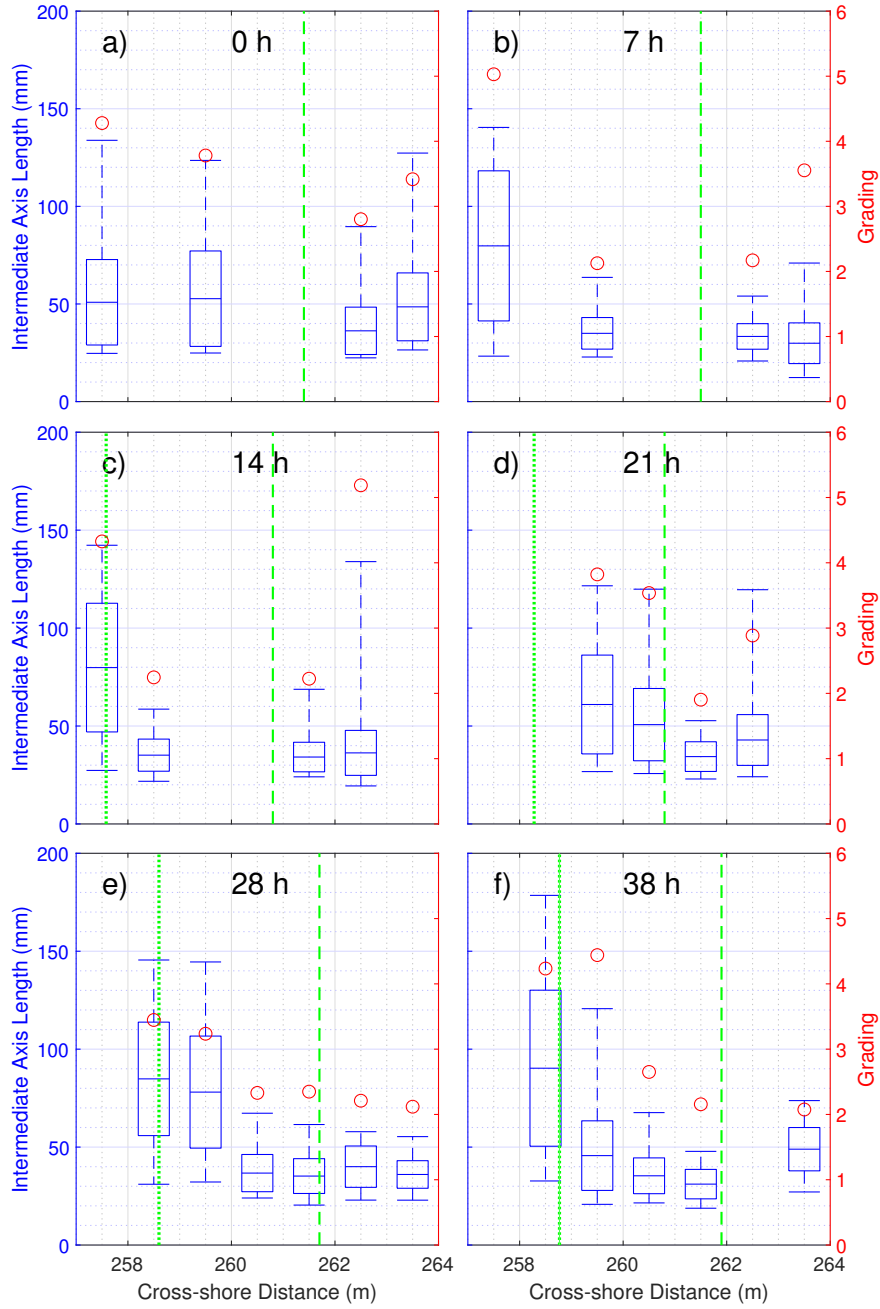
Figure 8: Surface grain size distribution across the poorly-sorted revetment at the end of each test ($t = 0, 7, 14, 21, 28, 38$). The left hand y-axis corresponds to a box plot centred over the median intermediate axis length with inner bounds provided by the median absolute deviation and branches reaching D_{90} and D_{10} . The right hand y-axis and red circles indicate the grading value at each location (Grading = D_{85}/D_{15}). Dotted green line represents the toe location and dashed green line represent crest location.

The distribution of cobbles on the surface of the poorly-sorted revetment was initially very consistent at all cross-shore positions (Figure 8a). Subsequently, the surface cobbles underwent a sorting process throughout the experiment as they were mobilised by wave

forcing. This sorting process led to the median cobble size decreasing landward of the toe, combined with a smaller grading value (Figure 8), indicative of better sorted cobbles moving landwards. This sorting was limited to the seaward limit of the revetment during test 2DR1 (0-7 h, $z_{wl} = 4.6$ m) when no overtopping occurred (see Figure 8b). Overtopping appears to accelerate this process by transporting smaller, more easily mobilised cobbles onto and landward of the crest during uprush where they become stranded and bury existing larger cobbles. This sorting is most evident during the final water level test 2DR4 (21-38 h, $z_{wl} = 4.9$ m; see Figure 8 e,f) and is visible in the images shown in

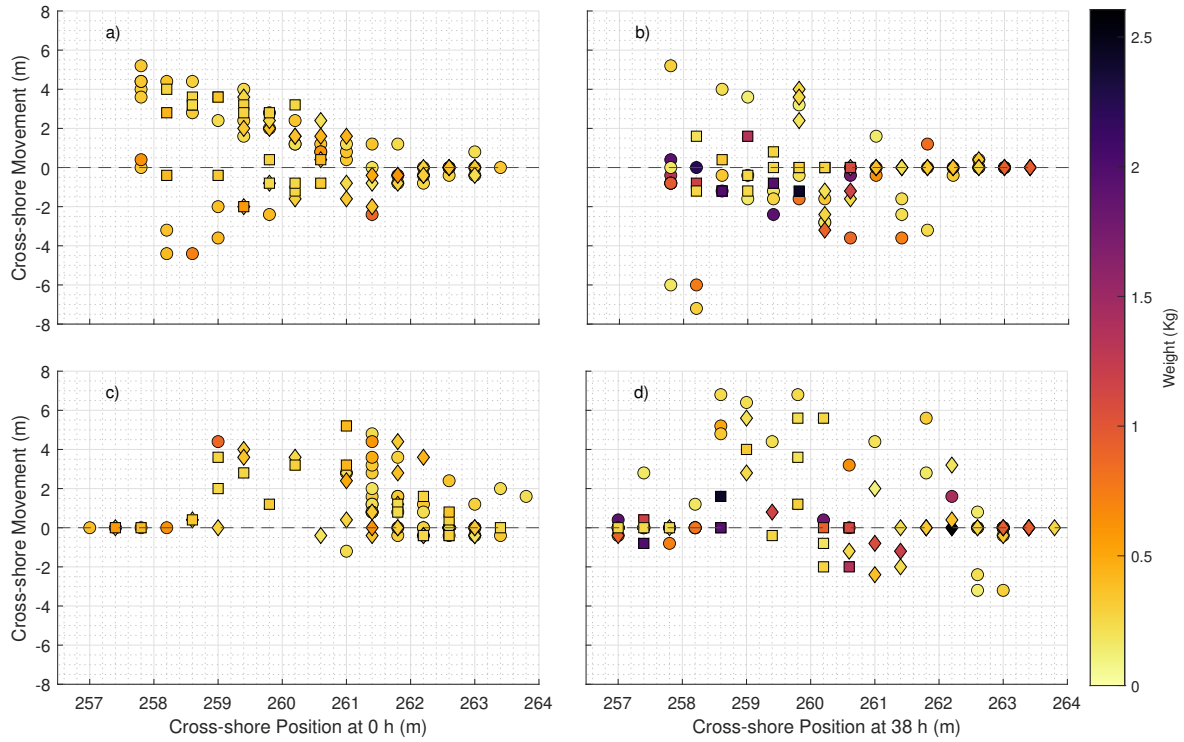
Figure 9: Absolute cross-shore distance travelled by tagged cobbles from their initial position, where positive is landward and negative is seaward for the a) well-sorted revetment (DynaRev1) and b) poorly-sorted revetment (DynaRev2) after 38 h of standard wave conditions. Absolute distance travelled by tagged cobbles from their detected position at 38h for the c) well-sorted revetment and d) poorly-sorted revetment during the erosion and recovery tests. The colour of each marker relates to the cobble weight as shown by the colour bar (left). The cobbles were distributed in three layers; revetment surface (circles), middle layer (diamonds) and sand-cobble interface (squares).

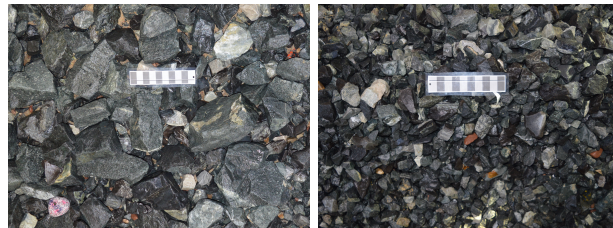
Figure 10: Photo of surface cobbles for the poorly-sorted revetment after standard wave conditions (38 h) at left) the toe of the revetment and right) the crest of the revetment. The total length of the scale bar is 198 mm.

Figure 10 for both the toe and crest of the revetment. Throughout the experiment both the smallest range of cobble sizes and smallest median cobble sizes were detected at the crest of the structure (see Figure 8). Note, the RFID-tagged cobbles had a minimum size of 40 mm and therefore this trend is not evident in Figure 9 because the majority of cobbles forming the crest are smaller than 40 mm. Conversely, the toe of the revetment and the sparse cobble layer became less sorted with a higher median cobble size than was initially present (see Figure 8). The median cobble size at the toe increased from 51 mm at 0 h to 90 mm at 38 h. This is caused by a high proportion of smaller cobbles being transported landward from the toe, leaving the larger, less easily mobilised cobbles to form a stable toe for the revetment. Notably, no tagged cobble of weight greater than 2 kg was detected more than 40 cm landward of its initial position by the end of standard wave testing (38 h, see Figure 9 b). Some cobbles larger than 2 kg were detected seaward of their initial position. These are primarily from the surface and middle layer of the revetment and have rolled down the front face of the revetment. A comparison of the

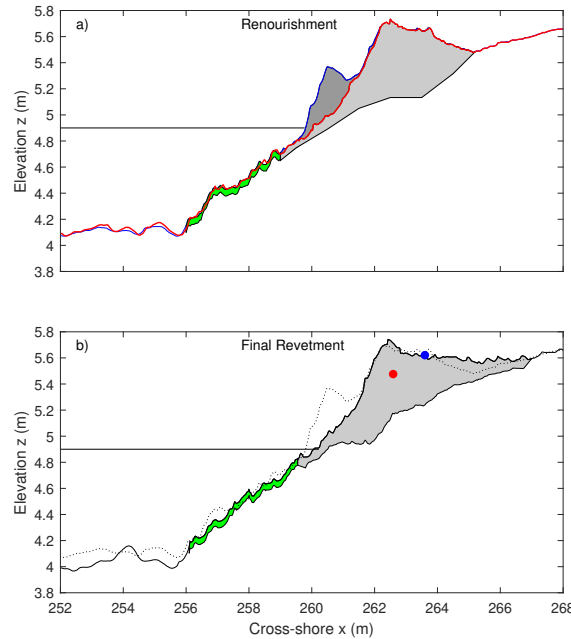
Figure 11: a) Renourished revetment where the light grey area outlined in red shows revetment cross-shore profile at the end of recovery wave conditions (2DDR1, 45 h, Table 1) and the dark grey area outlined in blue indicates the added material. b) The final shape of the revetment after 2 h 40 m of additional tests, the blue dot indicates the runup location under standard wave conditions. The dotted line indicates the revetment profile immediately following renourishment

Following the erosive and recovery wave conditions (38-45 h, Table 2) the thickness of the poorly-sorted revetment on the seaward slope had thinned substantially and the revetment consisted of a large crest feature with the majority of volume above the SWL, with a thin layer of larger stones extending to the original toe location ($x = 256.9$ m) (see Figure 4). An opportunistic nourishment of the front slope was carried out where an additional 2.25 m^3 of material was added by simply dumping it on the front face (Figure 11a). Additional erosive test were then carried out, these are not comparable to those carried out for the well-sorted revetment due to a shortened testing regime and different placement method - for the well-sorted revetment the renourishment was added as a constant thickness layer over the front face. The material added to the poorly-sorted revetment in DynaRev2 was quickly reshaped by waves and integrated into the revetment. This had the primary effect of increasing the cobble depth of the front face but some material was transported beyond the landward limit of the revetment, increasing its length by 2 m. During these tests the toe retreated by a further 0.5 m but the crest was stabilised at the pre-nourishment location ($x = 262.45$ m). The renourished revetment preserved its centre of mass beneath the peak of the crest and 0.22 m higher than the end of the resilience tests (38 h, 2DDR1) suggesting this is the most stable shape for these cobble characteristics. The overall effect of the added material was to increase the thickness of the front slope without affecting the overall behaviour of the revetment which continued to reshape rapidly in response to changing conditions.
