Wear resistance and friction analysis of Ti6Al4V cylindrical ball-burnished specimens with and without vibration assistance

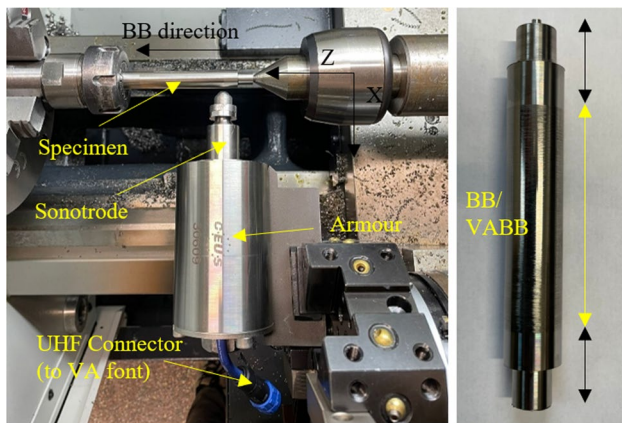
Fig. 1 Ball-burnishing tool and Ti6Al4V tribology sample

enters into a resonance mode, generating the movement of the sonotrode with an amplitude of vibration of 8 μm .

The ball-burnishing force applied onto the specimen surface is the summary of the force based on a calibrated spring lodged, the ultrasonic vibratory force (when it is applied), and the low-frequency force variations due to the surface irregularities during the feed movement of the tool.

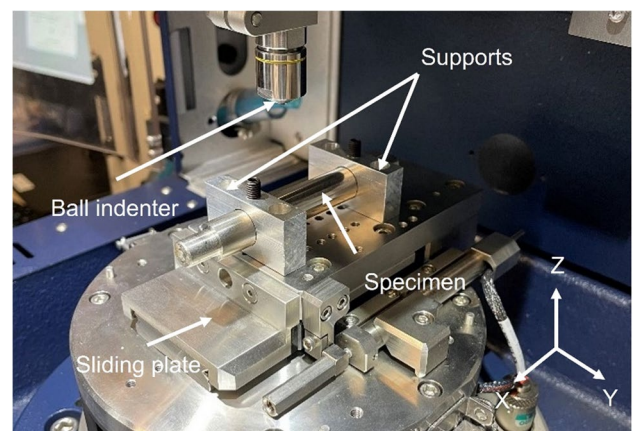
Fig. 2 Tribology setup for the new customized test

strategy to test this new surface is perpendicular to the peaks and valleys and, therefore, parallel to the generatrix of the specimen and following a linear displacement. The equipment used for the tribology testing is a UMT TriboLab by BRUKER with the configuration presented in Fig. 2.

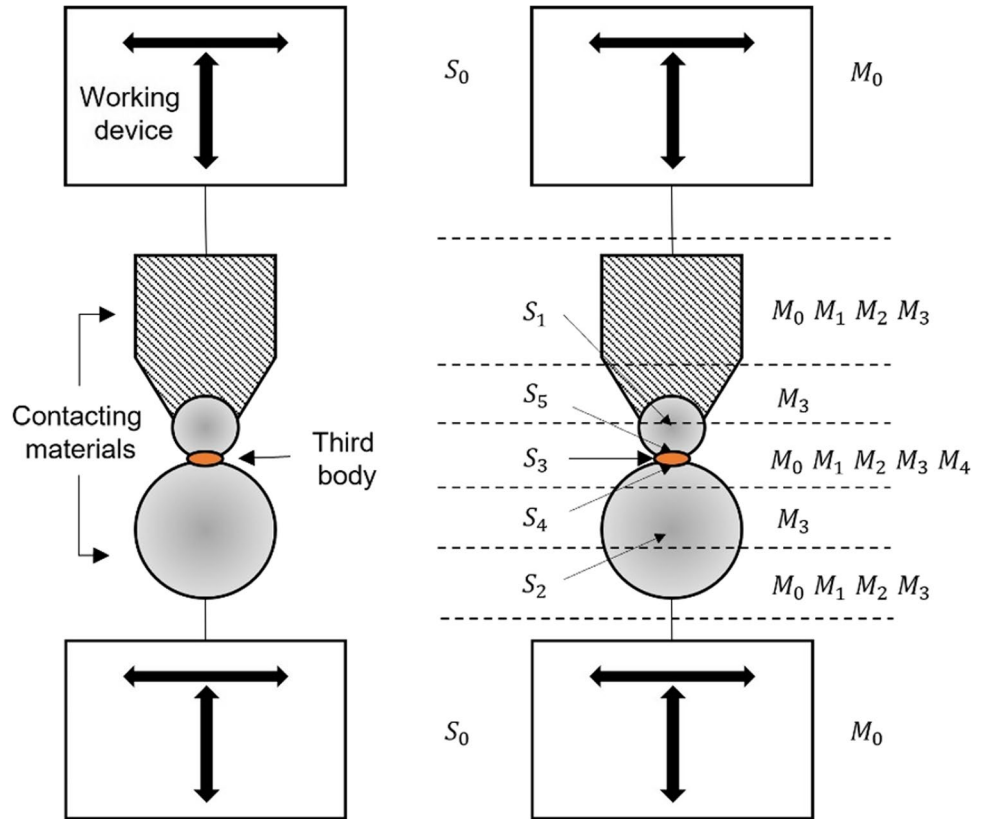
Fig. 3 Tribological triplet and accommodation mechanisms schematic

Secondly, the accommodation mechanisms are defined in sites and modes. The sites correspond to the working device S_0 , the contacting materials as S_1 and S_2 , the third body volume, originated due to the material transfer between the two bodies, as S_3 and the superficial parts of this as S_4 and S_5 . The modes correspond to the fracture mechanics and material

behavior, being the elastic deformation M_0 , the plastic deformation M_1 , the fracture M_2 , the shearing M_3 , and the rolling mode M_4 . The schema of this set-up is described in Fig. 3.

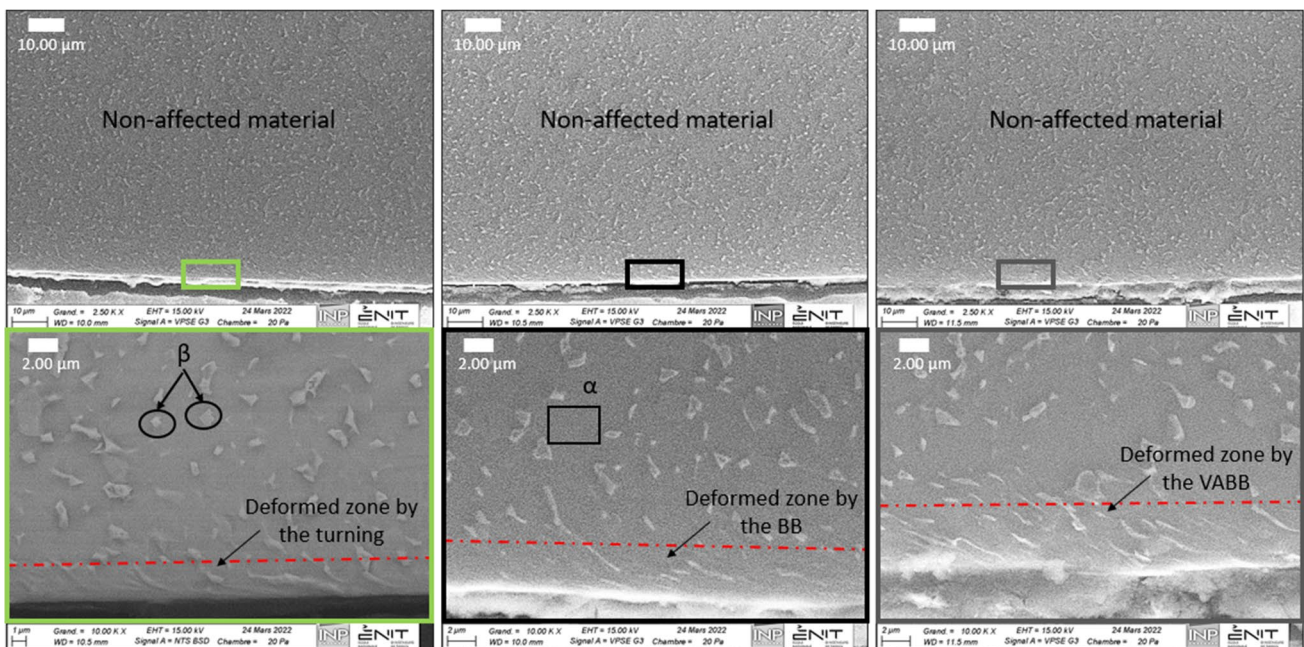
Fig. 4 Cross-section microstructures by columns: 1st column corresponding to machined surface, 2nd column corresponding to the 130–5-0 sample (BB), and 3rd column corresponding to the 130–5-40 sample (VABB)

The microstructures shown in Fig. 4 correspond to a cross-sectional part of samples 8 (130–5-0) for ball burnishing (BB) and 9 (130–5-40) for vibration-assisted ball burnishing (VABB). It also extracted a non-burnished sample section in order to do the comparison between the three resultant microstructures. The general images (see Fig. 8, 1st row) show a perspective of β -grains over an α matrix, which defines the general microstructure of these Ti6Al4V specimens.

The images display a shearing and compression effect on the phase α/β near the surface. As it can be seen, depending on the process performed, the depth of affectation varies from 2 to 2.5 μm , achieved during the machining process, to 4.5–5 μm when the vibration assistance is added into the ball burnishing process, which when it is applied alone its effect is estimated to be 3–3.5 μm of affectation depth. Theoretically, the burnishing force and the friction force, introduced between the specimen and the tool, derivate in a significant grain size reduction due to the shearing of the process [33]. This effect is described within the external layer where the microstructure shows the characteristics of recrystallization and grain deformation in terms of β phase grains horizontal elongation (as it is shown in Fig. 4, 2nd and 3rd columns) or twinning and stacking-faults [34], while in the machining, these grains are bulkier and more perpendicular to the sample edge. This later with plastic deformation has stored more deformation energy, added to the fact that the dislocation

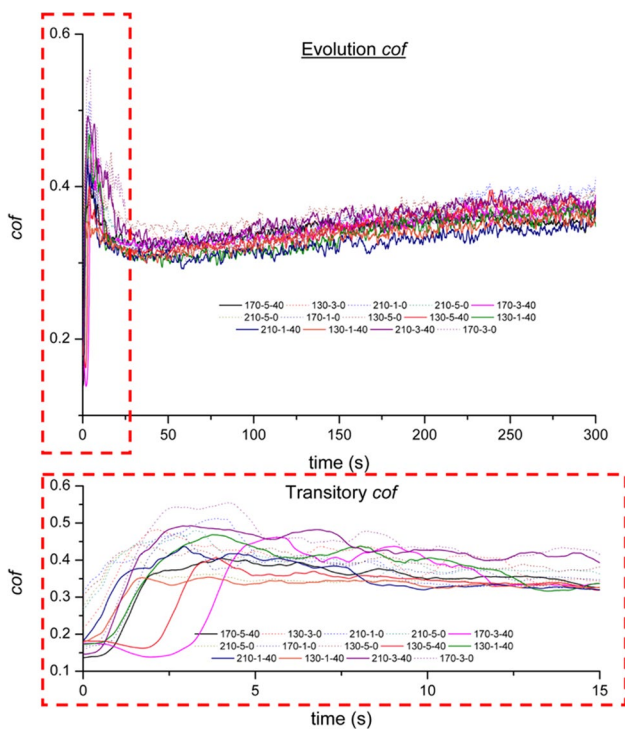
Fig. 5 Coefficient of friction steady and transitory state evolution during the test

The coefficient of friction evolution plots is represented in Fig. 5 for all the samples in the function of the test time. As can be seen, all the curves are characterized by three regions corresponding to the transitory (divided in ascendant and descendant slope) and steady-state. In the first one, the *cof* increases immediately due to the plastic deformation of the surface asperities and generates the track, which can be estimated during the first 5 s of the total test. Then, this coefficient is reduced dramatically and its created a friction valley that could coincide with the new microstructure that originated during the BB or VABB.

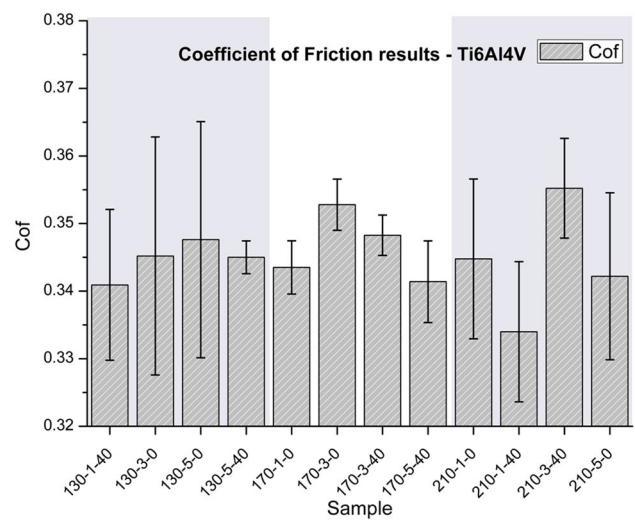
Fig. 6 Overall coefficient of friction

In overall terms, the absolute analysis of the coefficient of friction (see Fig. 6) shows that there is a friction reduction of around 4.5–5% of the difference between the best and the worst performance, which indicates that the influence of the burnishing parameters is not really significant in terms of friction reduction at larger times. The best results were obtained with a combination of 210 N of force, 1 pass, and the addition of the vibration assistance, with a final value of 0.335.

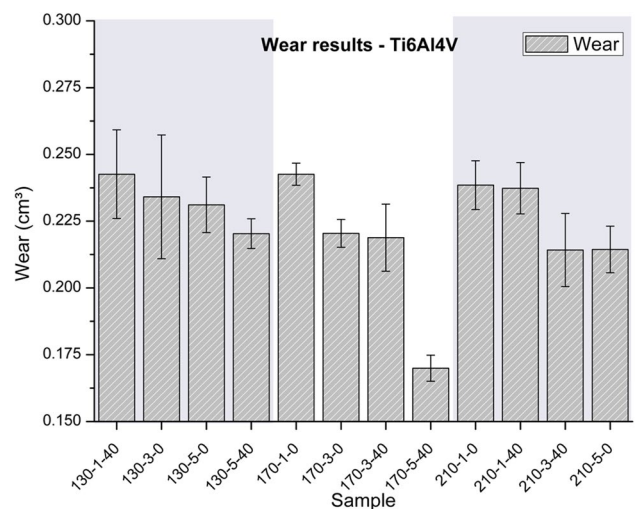
Fig. 7 Wear results for each combination

The results obtained in terms of wear were more significant and conclusive than the friction results in overall terms. First of all, it was obtained the volume difference after each tribology test using a non-contact profilometer, measuring the initial and the wear track generated, superimposing them, and subtracting the difference, resulting in a volume difference in cubic micrometers. The results are presented in Fig. 7.

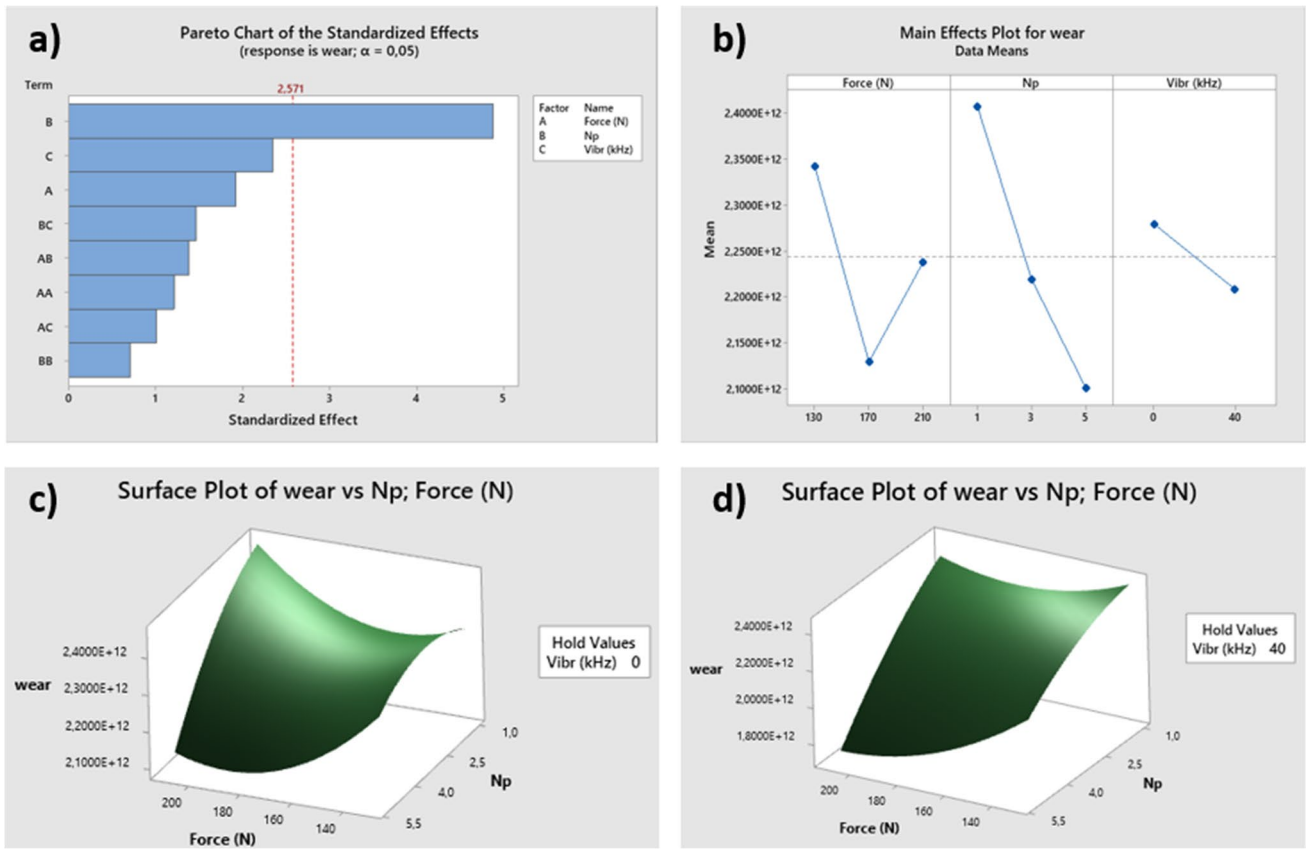
Fig. 8 a Pareto Chart being wear as the output. b ANOVA main effect plot being wear as the. c Surface plot for BB’s sample wear. d Surface plot for VABB’s samples wear

Figure 8a and b shows the Pareto chart and the main effects plot corresponding to the ANOVA analysis. It also calculated the interactions between all ball burnishing input

The *p*-value analysis determines that the number of passes is the most important and the only interaction with a *p*-value lower than 5%; it also noticed that the addition of the vibration assistance is close to becoming significant, having a 0.05 *p*-value; then, it could be considered that has a considerable weight on the final output wear result. In addition, the main effects plot, Fig. 8b, shows that the increase in the number of passes reduces the wear of a tribology test, which coincided with other authors [37].

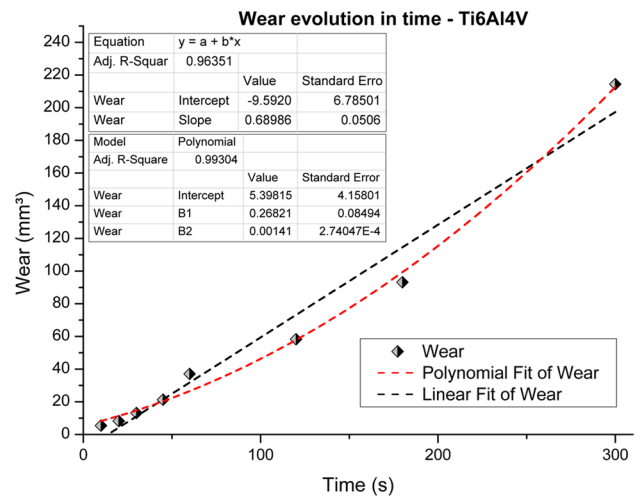
Fig. 9 Wear evolution along the time with sample 170–3–40

In addition, a time variation test was performed in order to determine the linearity and the variation of the wear over time. As it is shown in Fig. 9, the results show a very strong correlation with a linear interpolation but it is almost equal to a second-degree polynomial interpolation. The trend of this curve is ascendant, which means that during the first stages of the test, the surface is probably hardened and resists more the abrasion of the ball-contact cylinder, which may be related to the first layer created due to the ball burnishing process applied. Therefore, the wear resistance could be enhanced during the first tribological part, while when the bulk material layer is reached (after

2–3.5 μm , depending on the sample), the wear starts to increase, pointing that the ball burnishing could enhance the wear resistance. This hypothesis should be analyzed in deep in further investigations.

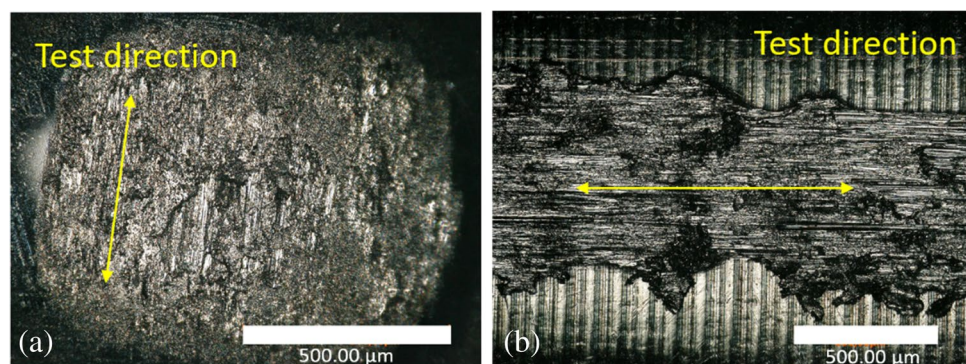
Fig. 10 a Third body resultant volume. b The specimen's worn

Regarding the resultant third body (see Fig. 10a), it is present a crack in the middle zone of the body that is related to the shearing produced during the repeated passes that occurred during the test, deforming and eventually cracking the contact surface. So, the resulting mechanism for the third body can be defined as $S_3M_0M_1M_3$.

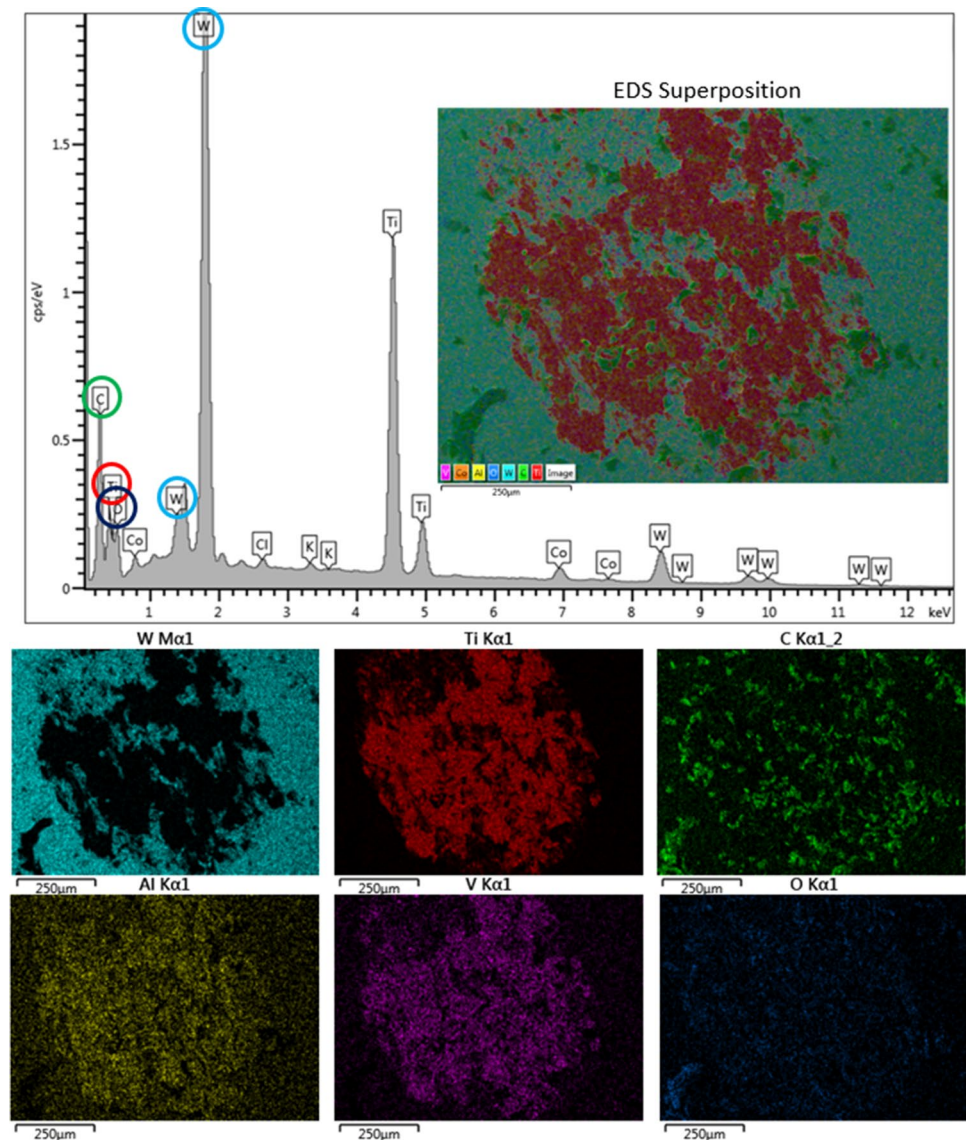
Fig. 11 EDS analysis

In addition, the EDS test (see Fig. 11) on the third body surface revealed that the central part of this new body is formed by Ti, V, and Al components, which indicates the material transfer from the specimen to the ball by adhesion. It was also analyzed the oxygen presence, concluding that there is no relevance for the accommodation modes and sites by corrosion or new titanium or iron oxide formation.
