# From the Hydroclimatic Disaster to the Forced (Re)construction: Case Study of the Akatani Watershed in Japan <sup>†</sup>

**Abstract:** On 5–6 July 2017 (J17), an unusual series of rainfalls induced a concentration of precipitations in Northern Kyushu, Japan, reaching 516 mm in 24 h in Asakura City, a first in its history since the beginning of observation in 1976. This triggered unprecedented hydro-meteorological hazards (landslides, debris flows, and floods) in forested mountainous areas, such as in the Akatani watershed, where the estimated discharge reached 520 m<sup>3</sup>/s at its outflow. It induced numerous deaths, structural damages, destruction of river channels, and deposition of sediment in flood plains. If smaller-scale hazards have usually driven authorities to build protection systems in the watershed, the J17 crisis called for a full remodeling of it, interrupting waterways and reshaping slope shapes and structures. Considering the means deployed by the central government for this reconstruction, the J17 event triggered a full “re-construction” of rivers, modifying the hydrosystem’s functioning at the watershed scale. Thus, our objective is to show that after th

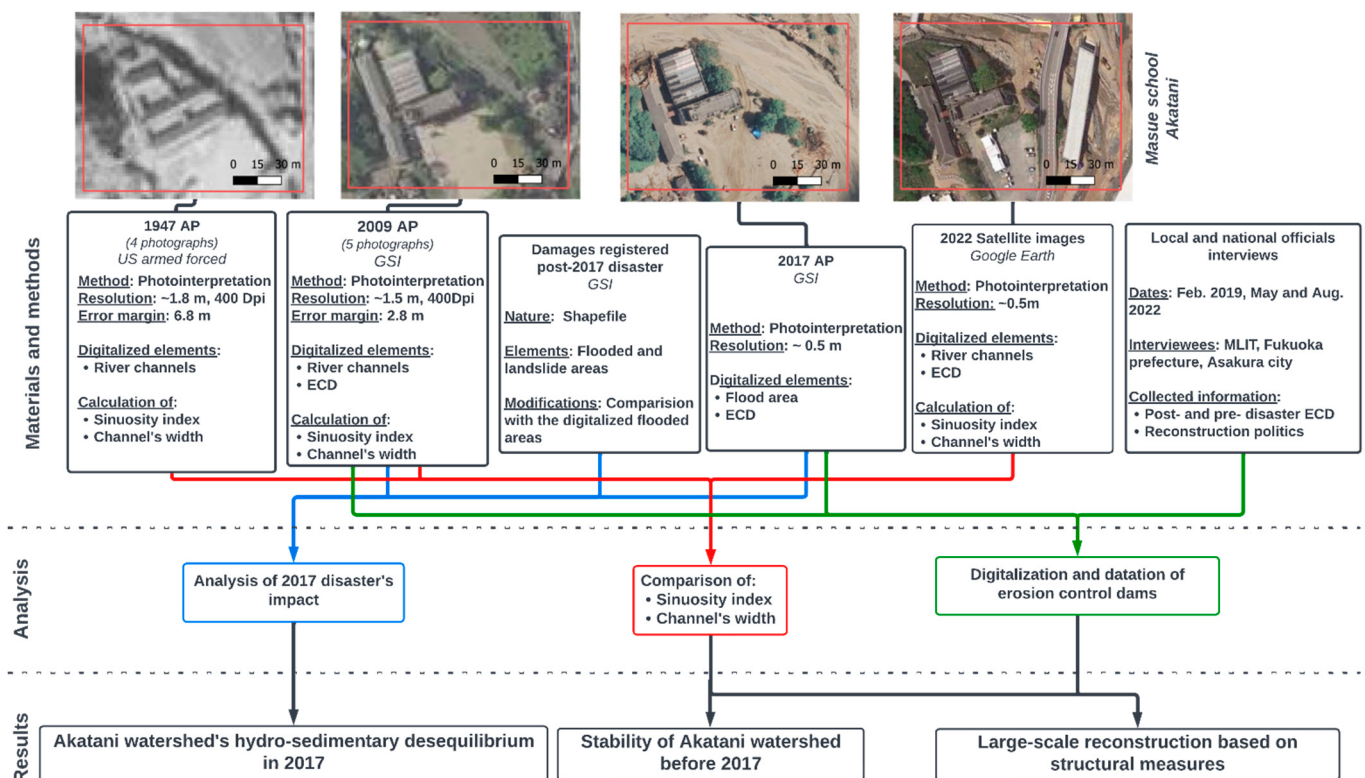
Figure 2. Diagram of the used methods and materials.

To highlight the J17 disaster's impacts and follow reconstruction policies, we based the methodology on a diachronic analysis of multi-source imagery from 1947 to 2022 (Figure 2). To show the relative stability of the AK watershed before 2017 and the disequilibrium the J17 crisis caused, we analyzed the watershed's evolution over 75 y by comparing the (i) river sinuosity index, (ii) channel width, and (iii) construction of erosion control structures (ECSs). These comparisons were made with manually georeferenced aerial photographs (APs) for 1947, 2009 [5], and 2017 [6] and 2022 satellite images (Figure 2). Aps mainly cover the AK watershed area, with a focus on valley bottoms. Due to the physiography of the area, we used the polynomial 2 function for the georeferencing. We accepted a margin error of 1 to 2 pixels for each georeferenced AP. We used 2017 and 2022 images to georeference the 2009 APs. Due to the similarity of land use, we georeferenced the 1947 APs with the help of 1980s APs [6]. Margin errors are most important for 1947, due to the bad quality of the photos.

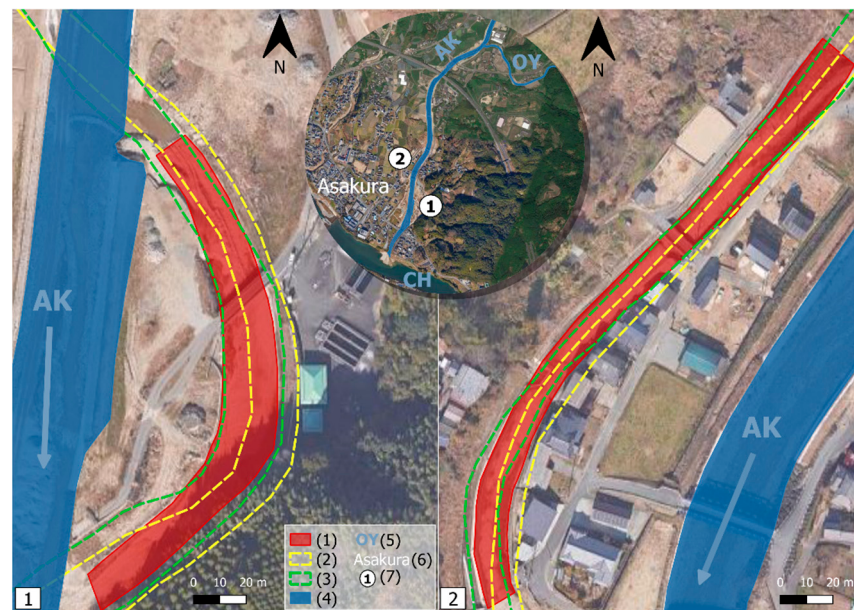
**Figure 3.** Example of remaining channels used to calculate margin errors. (1) Disconnected channel; (2) 1947 channel; (3) 2009 channel; (4) 2022 channel; (5) hydronym; (6) toponym; (7) channel location.

With 1947, 2009, 2017, and 2022 resources, we digitalized river channels and ECDs (Figure 2). Because of the chosen method, errors may occur in the digitalization process. To calculate the margin error of the digitalized elements, we used two disconnected channels visible in 2022's images (Figure 3). Every 15 m, we calculated and merged the difference between pre-disaster and disconnected channels for each bank (Figure 3). Errors may be due to the vegetation along rivers, limits of photointerpretation, or mismatches during the georeferencing process. To identify rivers' modification, we calculated their width and sinuosity index for 3 periods (Figure 2). The following thresholds characterize the sinuosity indexes: <1.05: straight; 1.05–1.3: sinuous; 1.3–1.5: moderate meandering; >1.5: meandering form [7]. For their width, we calculated the mean length from one bank to the other with transects every 100 m.

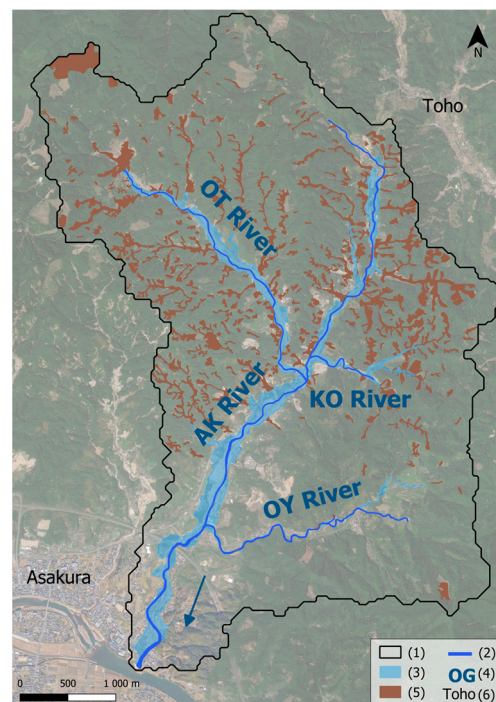
**Figure 4.** Spatial coverage of hydroclimatic hazards after the heavy rainfall of the J17 event. (1) AK watershed area; (2) 2009 channel; (3) 2017 flood [11]; (4) hydronym; (5) landslide area [11]; (6) toponym.

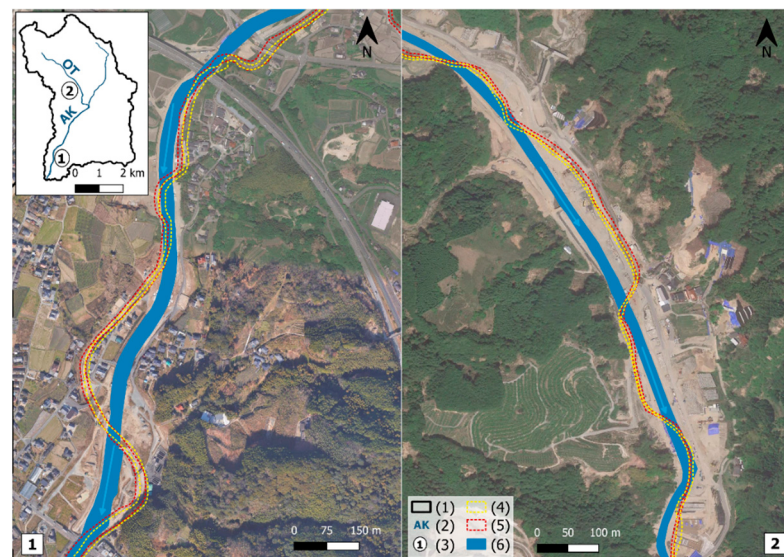
**Figure 5.** Close-up of sinuosity index evolution. (1) AK watershed; (2) hydronym; (3) close-up location; (4) 1947 channel; (5) 2009 channel; (6) 2022 channel.

valley bottoms. In 2009, three of them remained sinuous (Table 2). The upstream part of the AK channel is the only one considered straight, with a sinuosity index less than 1.05. The highest indexes are for the downstream of the AK (1.10) and OT (1.07) channels. In 2022, a real shift in their sinuosity occurred, with all rates below 1.05. The AK downstream sinuosity index decreased the most, from 1.10 to 1.03 (Table 2). Figure 5 illustrates this straightening process in the AK downstream and OT. While the rivers' paths were mainly similar in 1947 and 2009, the 2022 channels show an abrupt change.

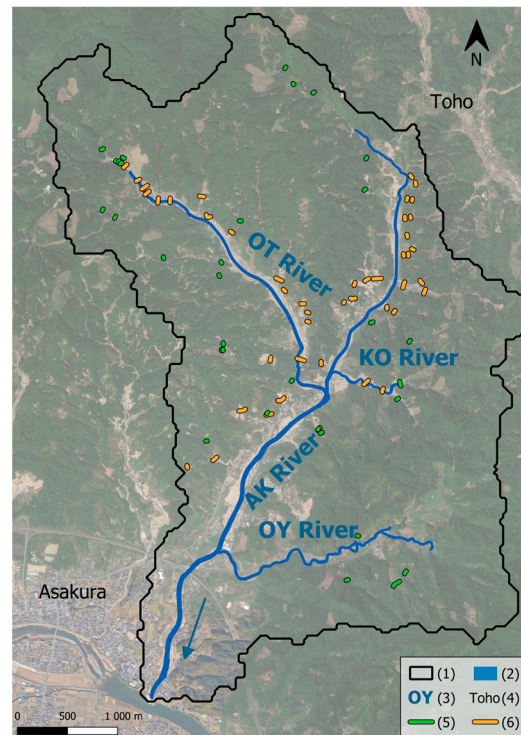
**Figure 6.** ECDs constructed in the AK watershed before and after 2017. (1) AK watershed area; (2) 2022 channels; (3) hydronym; (4) toponym; (5) pre-2017 dams; (6) post-2017 dams.

In addition to remodeling valley bottoms, the government added ECSs. Erosion control was valorized by governmental actors in the process of AK watershed reconstruction. Before 2017, there were 33 dams (Figure 6). Among them, 27 were managed by the MAFF and only 6 of them by the prefecture. After 2017, the central government planned the construction of 30 new sabo dams and the MAFF constructed 15 more chisan dams (Figure 6). In total, we inventoried 78 ECDs in the watershed in 2022. Between 2017 and 2022, the number of sabo dams was thus multiplied by 5.

ECDs are located in mountainous areas, and 92% of them were constructed in the AK or OT watersheds. New constructions are closer to valley bottoms than the pre-disaster ones (Figure 6). In the OT river, many sabo dams are at the outflow of mountainous subwatersheds [13]. Here, two main types of sabo dams were constructed: (i) closed-type dams, storing sediments, and (ii) slit dams, which catch large-scale debris and allow flow to circulate (Figure 7).

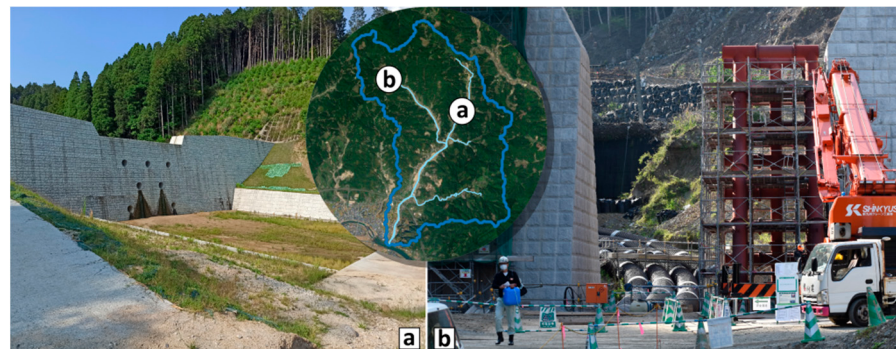
**Figure 7.** Illustration of the sabo dam constructed in the AK River. (a) Closed-type sabo dam AK16, ©M. Dumont, 2022; (b) slit-type sabo dam OT15-6, ©V. Siccard, 2022.

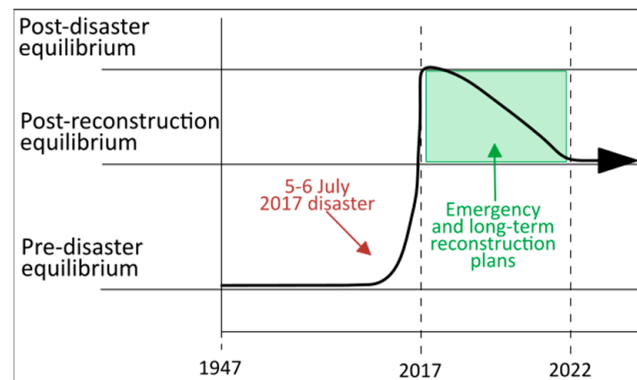
**Figure 8.** Dynamic of AK watershed's rivers. Adapted from Chorley and Kennedy (1971) [14].

The J17 disaster can be considered as an LFHM hydroclimatic event. The disruption induced a different equilibrium from the previously existing one. Right after the crisis, aerial images showed a new river equilibrium with partly destroyed river channels and an evolution of river style from single channels to braided ones. However, because of the necessity of reconstruction of the AK watershed, a new equilibrium was designed by the Japanese government. With the enlargement and the straightening of their channels, rivers are reaching a new balance between the pre- and post-disaster ones (Figure 8).
