# From the Hydroclimatic Disaster to the Forced (Re)construction: Case Study of the Akatani Watershed in Japan <sup>†</sup>

**Keywords:** post-disaster reconstruction; River System Sabo; Akatani watershed

*Proceedings* **2023**, *87*, 42. <https://doi.org/10.3390/IECG2022-14820>

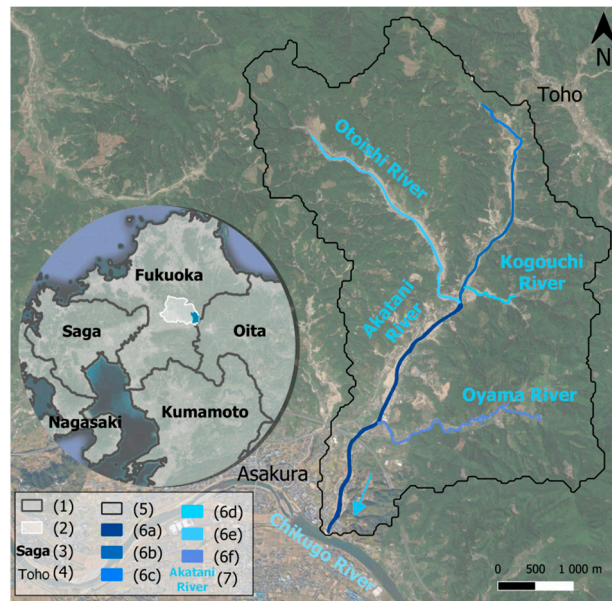
**Figure 1.** Location of AK watershed (approximately 20 km<sup>2</sup>). (1) Prefecture boundaries; (2) Asakura boundaries; (3) prefecture name; (4) toponym; (5) AK watershed; (6a) AK downstream; (6b) AK mid-stream; (6c) AK upstream; (6d) KO stream; (6e) OT stream; (6f) OY stream; (7) hydronym.

Landslides were accompanied by debris flows and river floods, affecting mountainous villages and cities located in the CH’s floodplain. This resulted in several structural damages and deaths; damages were evaluated at JPY 224,070 M with 3067 dwellings impacted and 41 victims in Fukuoka and Oita prefectures, including 22 in the Akatani (AK) watershed (Figure 1) [4]. The amount of dragged sediment in the watershed approximately reached 2.9 M m<sup>3</sup>, floods inundated 106 ha, and 258 houses were affected by the disaster [3]. During the J17 crisis, the four rivers of the AK watershed (AK; OT: Otoishi; OY: Oyama; KO: Ogouchi) (Figure 1) were damaged, especially rivers AK and OT. We divide them into sections for calculations (Figure 1).

After J17, river channels were redesigned to “increase the reliability of flood control” by widening and straightening rivers [12], increasing AK bankfull discharge from 50 m<sup>3</sup>/s to 330 m<sup>3</sup>/s at the CH’s confluence [3]. This evolution is detailed in Table 1 for each section presented in Figure 1.

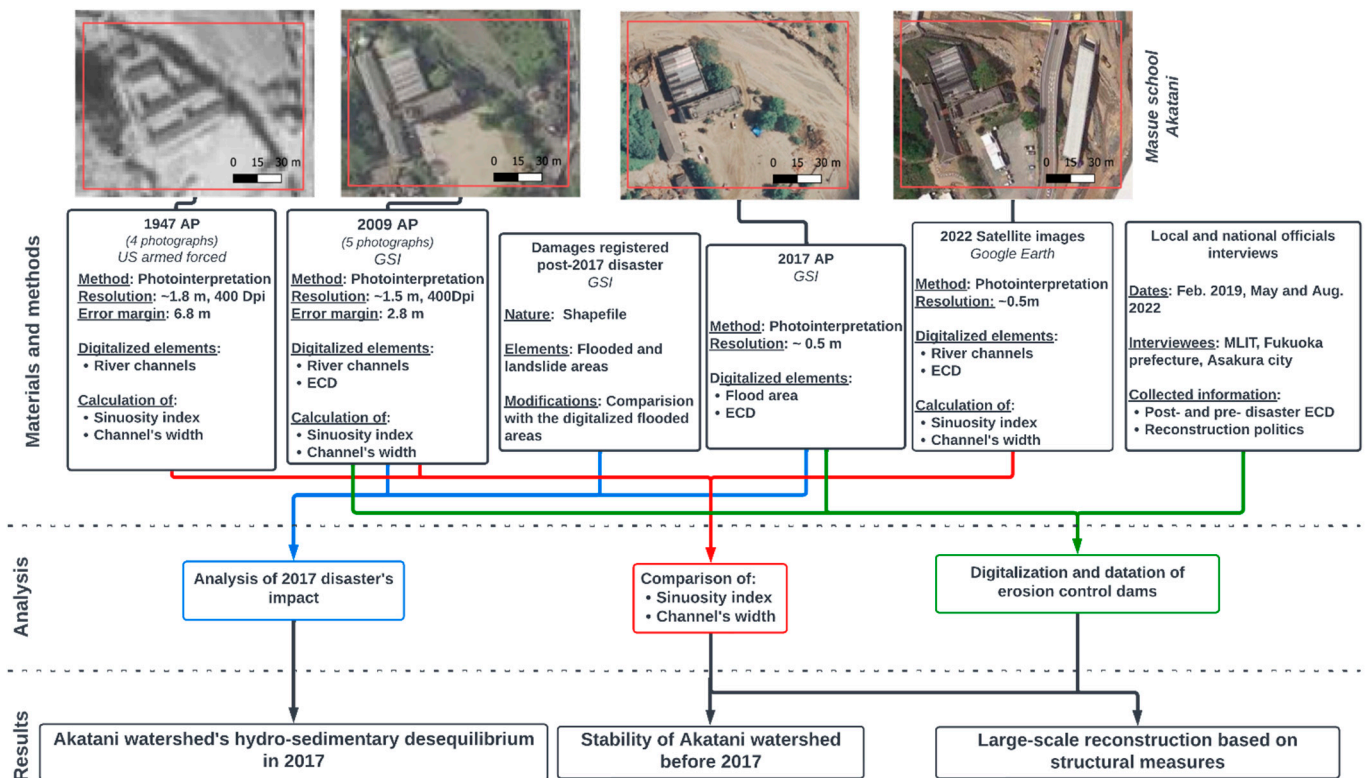
Figure 2. Diagram of the used methods and materials.

To highlight the J17 disaster’s impacts and follow reconstruction policies, we based the methodology on a diachronic analysis of multi-source imagery from 1947 to 2022 (Figure 2). To show the relative stability of the AK watershed before 2017 and the disequilibrium the J17 crisis caused, we analyzed the watershed’s evolution over 75 y by comparing the (i) river sinuosity index, (ii) channel width, and (iii) construction of erosion control structures (ECSs). These comparisons were made with manually georeferenced aerial photographs (APs) for 1947, 2009 [5], and 2017 [6] and 2022 satellite images (Figure 2). Aps mainly cover the AK watershed area, with a focus on valley bottoms. Due to the physiography of the area, we used the polynomial 2 function for the georeferencing. We accepted a margin error of 1 to 2 pixels for each georeferenced AP. We used 2017 and 2022 images to georeference the 2009 APs. Due to the similarity of land use, we georeferenced the 1947 APs with the help of 1980s APs [6]. Margin errors are most important for 1947, due to the bad quality of the photos.

With 1947, 2009, 2017, and 2022 resources, we digitalized river channels and ECDs (Figure 2). Because of the chosen method, errors may occur in the digitalization process. To calculate the margin error of the digitalized elements, we used two disconnected channels visible in 2022’s images (Figure 3). Every 15 m, we calculated and merged the difference between pre-disaster and disconnected channels for each bank (Figure 3). Errors may be due to the vegetation along rivers, limits of photointerpretation, or mismatches during the georeferencing process. To identify rivers’ modification, we calculated their width and sinuosity index for 3 periods (Figure 2). The following thresholds characterize the sinuosity indexes: <1.05: straight; 1.05–1.3: sinuous; 1.3–1.5: moderate meandering; >1.5: meandering form [7]. For their width, we calculated the mean length from one bank to the other with transects every 100 m.

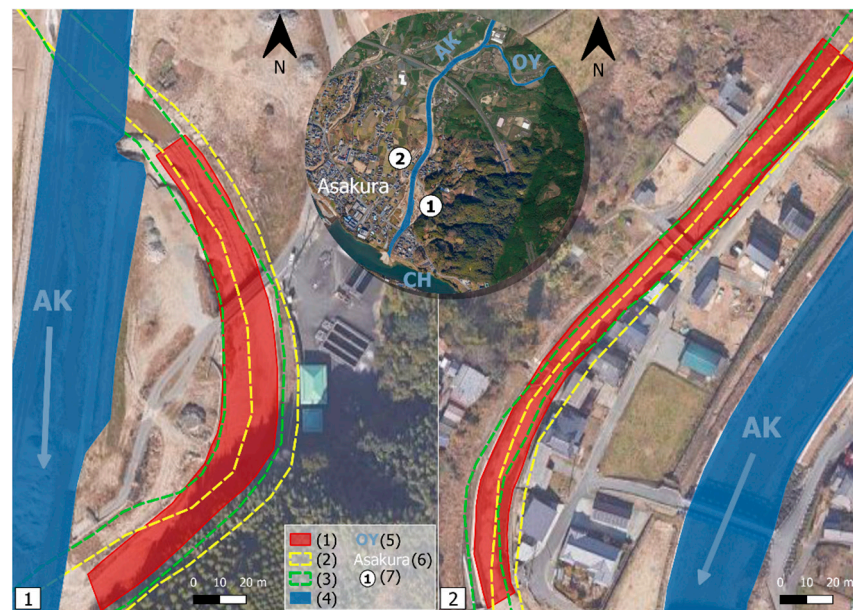
**Figure 3.** Example of remaining channels used to calculate margin errors. (1) Disconnected channel; (2) 1947 channel; (3) 2009 channel; (4) 2022 channel; (5) hydronym; (6) toponym; (7) channel location.

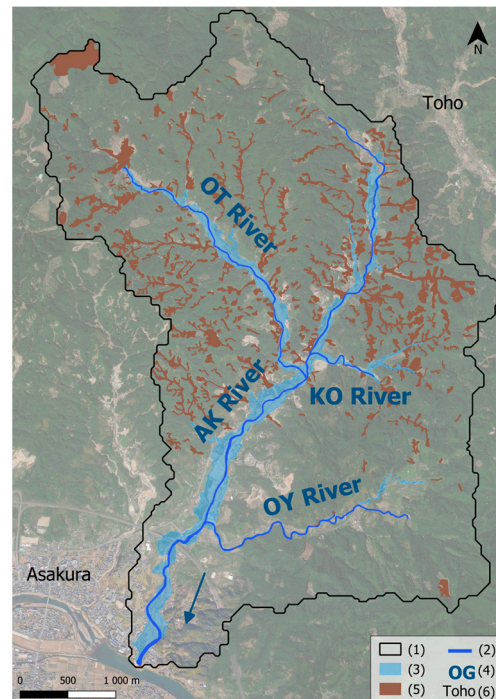
**Figure 4.** Spatial coverage of hydroclimatic hazards after the heavy rainfall of the J17 event. (1) AK watershed area; (2) 2009 channel; (3) 2017 flood [11]; (4) hydronym; (5) landslide area [11]; (6) toponym.

Heavy rainfalls concentrated in a short period of time such as the J17 event are rare in the AK watershed [2]. The Kyushu Regional Management Service Association (KRMSA) has registered significant disasters, such as hydroclimatic-related ones, since 679 for the Fukuoka prefecture. Very few registered events explicitly involve the AK watershed: one in 1921 and the J17 one [8]. This shows that hydro-meteorological hazards rarely trigger high-magnitude disasters in the watershed, strengthening the singularity of the J17 disaster. The AK watershed registered significant damages in 2017. In the mountains, landslides and debris flows were triggered in several sub-basins, carrying driftwood (Figure 4) [9]. Downstream, river floods inundated valley bottoms, carrying sediments from the upper slope erosion. In addition to the deaths, these hazards damaged building and transportation systems in the AK watershed [10].

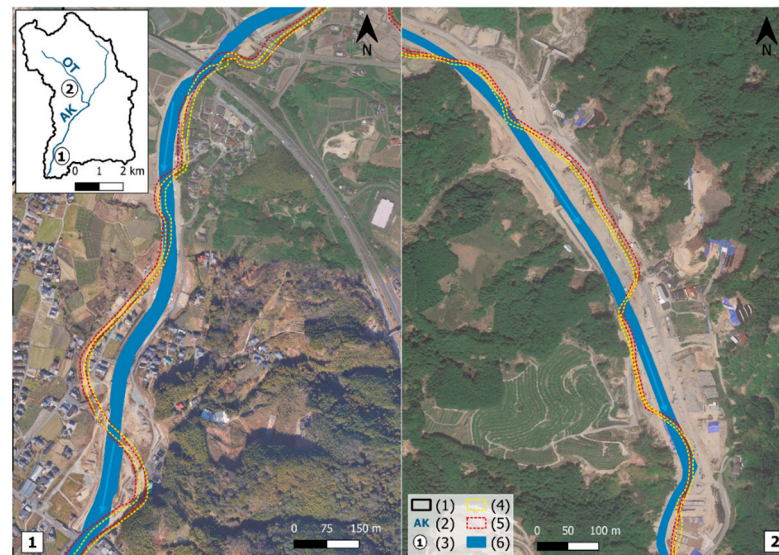
**Figure 5.** Close-up of sinuosity index evolution. (1) AK watershed; (2) hydronym; (3) close-up location; (4) 1947 channel; (5) 2009 channel; (6) 2022 channel.

valley bottoms. In 2009, three of them remained sinuous (Table 2). The upstream part of the AK channel is the only one considered straight, with a sinuosity index less than 1.05. The highest indexes are for the downstream of the AK (1.10) and OT (1.07) channels. In 2022, a real shift in their sinuosity occurred, with all rates below 1.05. The AK downstream sinuosity index decreased the most, from 1.10 to 1.03 (Table 2). Figure 5 illustrates this straightening process in the AK downstream and OT. While the rivers' paths were mainly similar in 1947 and 2009, the 2022 channels show an abrupt change.

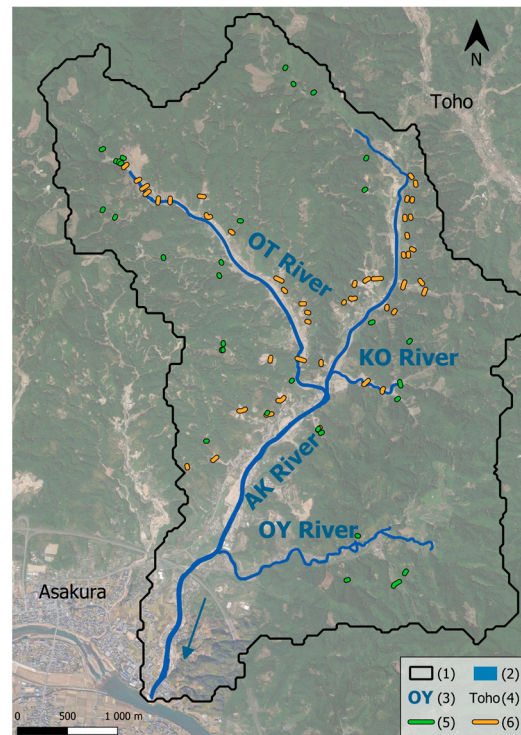
**Figure 6.** ECDs constructed in the AK watershed before and after 2017. (1) AK watershed area; (2) 2022 channels; (3) hydronym; (4) toponym; (5) pre-2017 dams; (6) post-2017 dams.

In addition to remodeling valley bottoms, the government added ECSs. Erosion control was valorized by governmental actors in the process of AK watershed reconstruction. Before 2017, there were 33 dams (Figure 6). Among them, 27 were managed by the MAFF and only 6 of them by the prefecture. After 2017, the central government planned the construction of 30 new sabo dams and the MAFF constructed 15 more chisan dams (Figure 6). In total, we inventoried 78 ECDs in the watershed in 2022. Between 2017 and 2022, the number of sabo dams was thus multiplied by 5.

ECDs are located in mountainous areas, and 92% of them were constructed in the AK or OT watersheds. New constructions are closer to valley bottoms than the pre-disaster ones (Figure 6). In the OT river, many sabo dams are at the outflow of mountainous subwatersheds [13]. Here, two main types of sabo dams were constructed: (i) closed-type dams, storing sediments, and (ii) slit dams, which catch large-scale debris and allow flow to circulate (Figure 7).

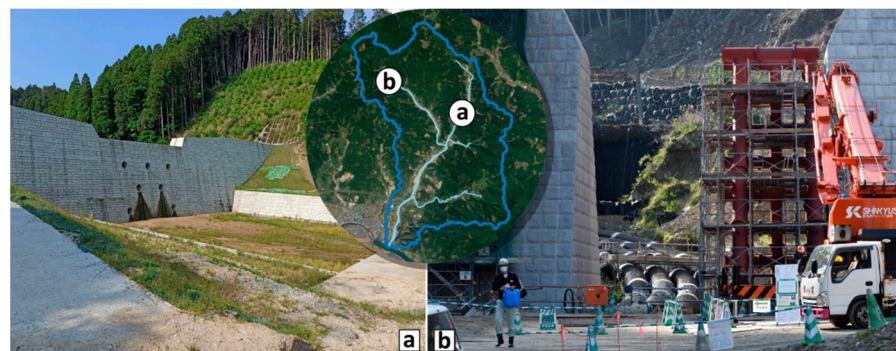
**Figure 7.** Illustration of the sabo dam constructed in the AK River. (a) Closed-type sabo dam AK16, ©M. Dumont, 2022; (b) slit-type sabo dam OT15-6, ©V. Siccard, 2022.

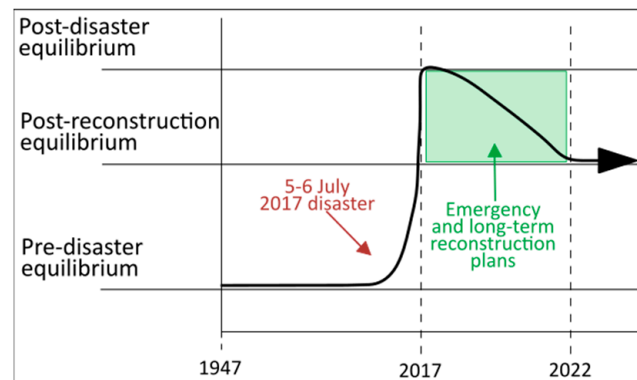
**Figure 8.** Dynamic of AK watershed’s rivers. Adapted from Chorley and Kennedy (1971) [14].

The J17 disaster can be considered as an LFHM hydroclimatic event. The disruption induced a different equilibrium from the previously existing one. Right after the crisis, aerial images showed a new river equilibrium with partly destroyed river channels and an evolution of river style from single channels to braided ones. However, because of the necessity of reconstruction of the AK watershed, a new equilibrium was designed by the Japanese government. With the enlargement and the straightening of their channels, rivers are reaching a new balance between the pre- and post-disaster ones (Figure 8).
