Effect of the scanning strategy and tribological conditions on the wear resistance of IN718 obtained by Laser Metal Deposition

Théo Zurcher, Gaëtan Bouvard, Jean-Christophe Abry, Eric Charkaluk,
Vincent Fridrici

Théo Zurcher, Gaëtan Bouvard, Jean-Christophe Abry, Eric Charkaluk, Vincent Fridrici. Effect of the scanning strategy and tribological conditions on the wear resistance of IN718 obtained by Laser Metal Deposition. *Wear*, 2023, 534-535, pp.205152. 10.1016/j.wear.2023.205152 . hal-04289644

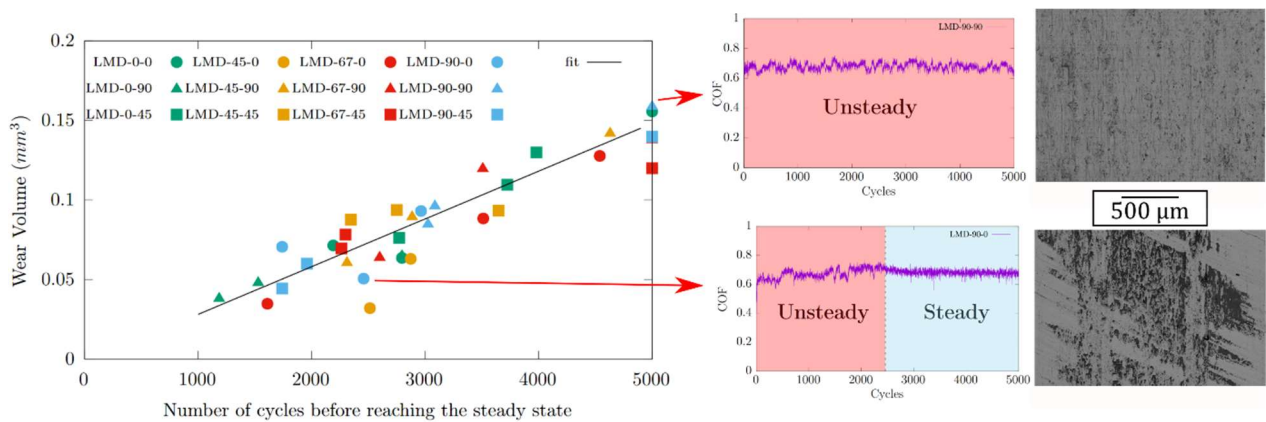
Figure 7: Correlation between the wear volume, the evolution of the COF, and the wear mechanisms for wear tests performed at 2 N. The naming system in the key area can be read as follow: LMD-Strategy-Sliding direction.

Figure 7 shows the evolution of the wear volume as a function of the starting cycle of the steady state. From this graph, it can be stated that the latter the steady state appears, the larger the wear volume. Moreover, this evolution of wear has a linear trend. Given how scattered the results obtained by the tests performed on the sample with the same strategy or the same sliding direction are, it can be concluded that this phenomenon is not dependent on those parameters. To better understand why the tests possessing a steady state have a lower wear volume, two cases were isolated as depicted in Figure 7. The first case is a test leading to a high wear volume whereas the second case is illustrated by a test having more than half as much wear volume as the first case. The first case never reached the steady state and the main wear mechanisms observed are abrasion and adhesion. For the second case, a steady state appears around the 2500th cycle. After 5000 cycles, the main wear mechanisms noticed are abrasion and oxidation of wear debris. The oxides are highlighted in Figure 8. The oxides are cracked with cracks perpendicular to the sliding direction. Those cracks can be explained by the brittleness

Figure 7 allows to state that the latter the steady state appears (i.e. the oxidized transfer layer), the more the LMD sample is worn. From those results, it can be concluded that when oxides remain in the contact, the latter act as a protective layer which prevent the wear of the coating.

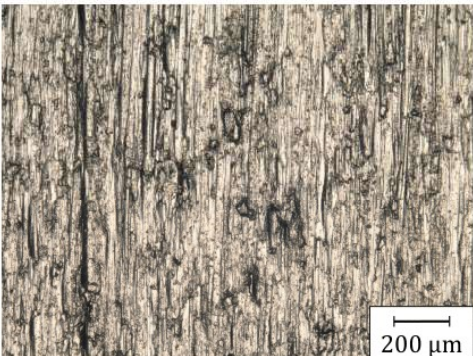
Figure 8: Optical images of worn surfaces of the LMD samples at a) 2 N (with a steady state of the COF); b) 10 N; c) 20 N; d) 40 N; e) 50 N

Several wear tests with different loading conditions were performed. Figure 8 gathers the optical pictures taken inside the wear track. As seen previously, at 2 N, abrasion is the main wear mechanisms (Figure 8 a)) and oxidized wear debris are present as transfer layer. At 10 N, the oxidized transfer layer disappears to make way for abrasion and adhesion. As exposed in Figure 8 b), narrow and shallow grooves are observed inside the worn area with adhered debris. At 20 N, the same observations are noted. Starting from 40 N, it can be noticed in Figure 8 d) and e) that the wear is mainly due to abrasion with much less adhesion. Thick and deep grooves inside the wear tracks are observed with some big debris which are cold-welded.

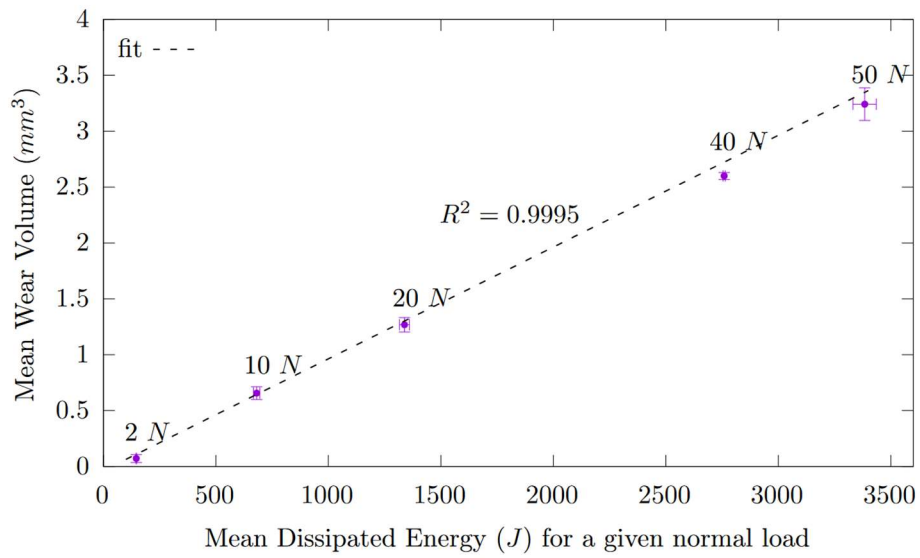
Figure 11: Mean wear volume as a function of the mean dissipated energy

Interestingly, as shown in Figure 11, the wear follows an increasing linear trend as a function of the dissipated energy linked to the normal load. Also, the small error bars are the witnesses of the high repeatability of the

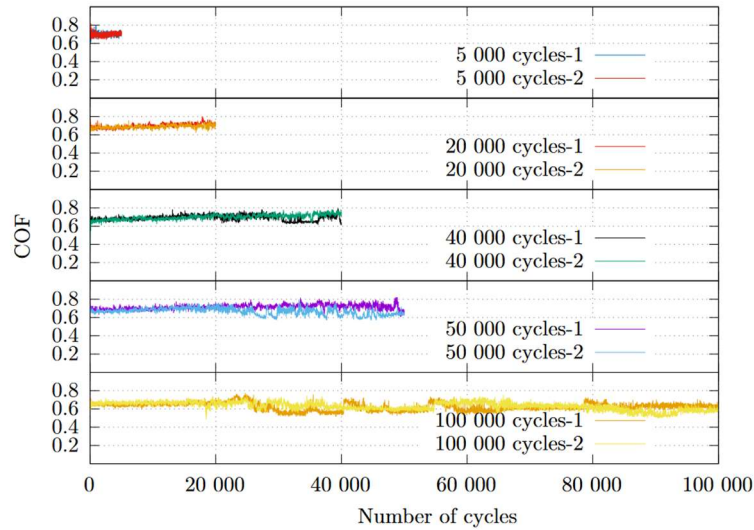
Figure 13: Evolution of the COF as a function of the number of cycles

The evolutions of the COF of 2 wear tests for different numbers of cycles are shown in Figure 13. Until 20 000 cycles, a stable evolution of the COF is observed with a mean value of 0.69. Then, from 20 000 cycles, the evolution of the COF starts to become less steady with a slight drop of the COF around 0.6. Interestingly, as displayed in Figure 14 a), after several cycles (in the range between 40 000 and 50 000 cycles), the wear volume stops increasing and remains the same. As shown in Table 8, the wear rates decrease with time. The wear rate starts with an initial value of $7 \cdot 10^{-4} \text{mm}^3/\text{Nm}$ for the first 20 000 cycles. Then, it starts to decrease until 50 000. After 50 000, the wear rate becomes non-significant (i.e. close to 0). This phenomenon is shown in Figure 14 a), where the wear volume reaches a plateau above 50 000. On the other hand, as displayed in Figure 14 b), the mass loss of the pin never stops to increase. Those first results testify that, after a certain amount of time, the counter-body stops wearing the coating and starts to wear itself on the coating surface. Also, even after long wear tests, no differences in terms of wear were observed between the two LMD samples with different scanning strategies. As shown in Figure 15 a), after 20 000 cycles, the pin had barely encountered the layer/layer interface. However, after 50 000 cycles (Figure 15 b)), the pin passed through several of them. As the wear volume keeps increasing until 50 000 cycles despite encountering the interface, it can be stated that the latter does not impact the wear behavior. Moreover, given that after 100 000 cycles, the pin surely encounters at least one time the interface between two layers (i.e. the wear depth is higher than the layer thickness) and because the wear volume is approximately the same for both strategies, it can be stated that in addition of the interface, the scanning strategy does not impact wear behavior as well.

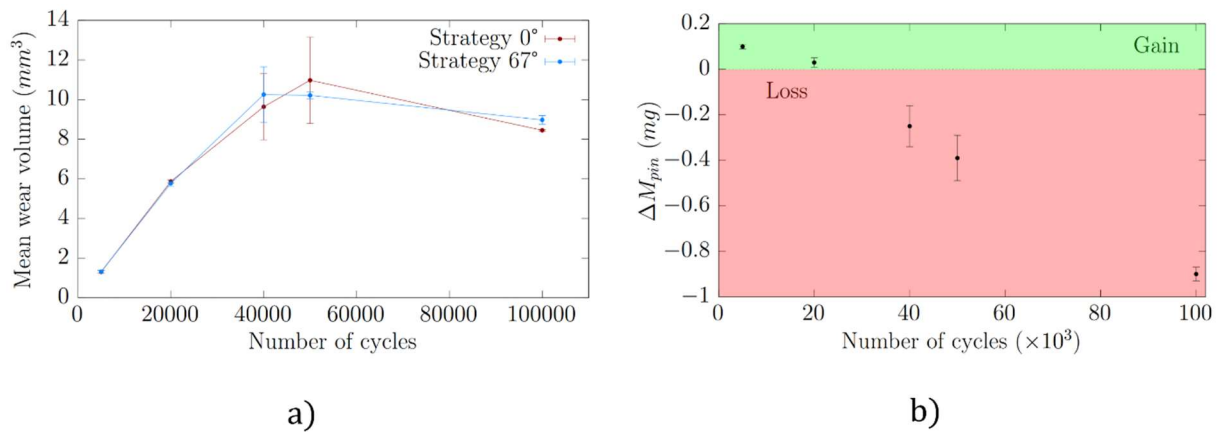
Figure 14: a) Mean wear volume of the coating; b) Mass difference of the pin as a function of the number of cycles (Test performed with: $F_n = 20 \text{ N}$; $f = 3 \text{ Hz}$; $t = 5000 \text{ cycles}$)

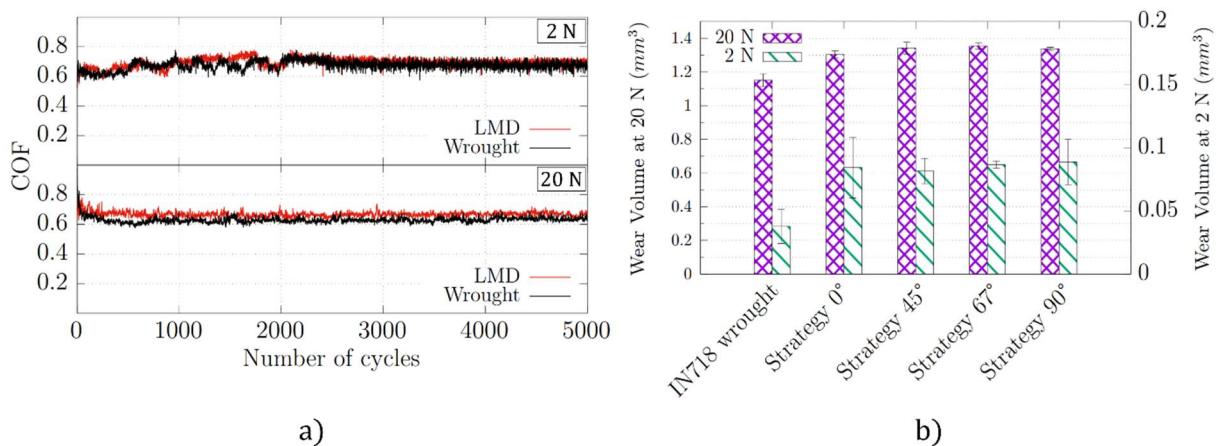
Figure 19 : a) Comparison of the evolution of the COF between the two processes for normal loads of 2 and 20 N; b) Wear volume comparison between wrought IN718 and the four different LMD samples

The capability of a coating deposited by LMD to have at the very least the same wear resistance as the original piece is one of the criteria that defines a good wear-resistant coating. The wear resistance of the coated part by LMD is compared with a conventionally manufactured IN718. Interestingly, as exposed in Figure 19 a), the trend of the COF looks the same for both processes no matter the normal load used. It can be noted that, at 20 N, the COF is slightly lower when tests are performed on the wrought samples. However, a higher wear resistance of the wrought IN718 compared to the LMD samples is observed in Figure 19 b) and in Table 9. On average, LMD samples have a wear volume 14% larger than the wrought samples. As highlighted in Figure 20, because of the milling process, hardness variation is similar between both types of samples until 100 μm below the surface although the hardness of the samples built by LMD is slightly higher. As a consequence, hardness cannot explain the higher wear resistance of the wrought IN718. To identify the discrepancies in terms of wear mechanism at 20 N between both types of samples, the wear tracks were observed from different angles as displayed in Figure 21. From the top view, the wear tracks reveal different wear mechanisms depending on the processes used to process this alloy. The worn surface of the tests performed on the wrought alloy shows signs of strong plastic deformation (Figure 21 b)) with much less abrasion than for tests carried out on the LMD samples. From a transversal point of view, several layers are noticed. For the LMD sample (Figure 21 c) and e)), the first layer is composed of adhered IN718 debris. The presence of cracks below this layer testifies its easy delamination from the worn surface. Underneath, a highly plastically deformed region lies. The cellular sub-microstructure is no longer perceived and broken Laves phases are found. Then, further deep, the microstructure gets back to its classical cellular structure. For the conventional IN718, the transversal view reveals a thinner layer of adhered debris on the sliding surface. Some δ phases are found inside the adhered debris. The slip bands found inside the recrystallized grains is the proof of the plastic deformation induced by the dry wear test at the subsurface.

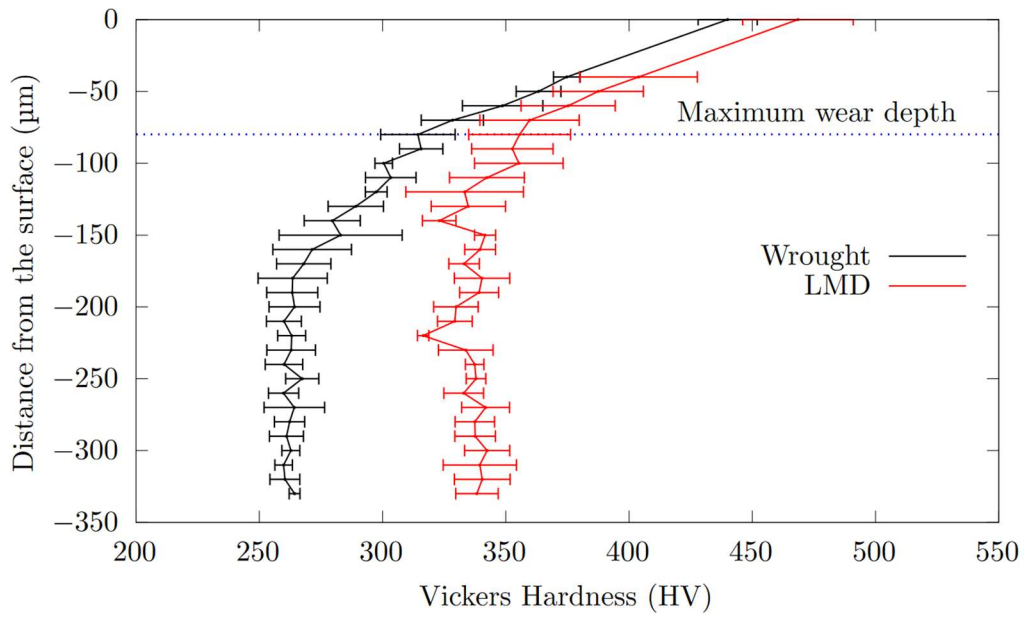
Figure 20: Hardness profile underneath the top milled surface (blue dotted lines shows the maximum depth reached after having performed a 20 N wear test for 5 000 cycles)

Given the small hardness difference between both samples at the maximum wear depth shown in Figure 20, the wear volume discrepancies cannot be only justified through this material property. Such results might be explained through other aspects. One of them is the high amount of dislocations. The latter is caused by the deformation induced by the constrained thermal expansion and shrinkage of the material due to the LMD process. This leads to an initial amount of dislocations higher in the LMD as-built samples than in the wrought samples (subjected to successive heat treatments) [39]. As highlighted in Figure 22, in the unstrained regions far below the worn surface, the number of local defects with a misorientation around 1° is much greater in the LMD than the wrought. Those defects are directly linked to the high amount of dislocations trapped in the cell walls of the LMD sub-microstructure [40]. They might cause a hasty work-hardening of the LMD samples during the
