Effect of the scanning strategy and tribological conditions on the wear resistance of IN718 obtained by Laser Metal Deposition

Théo Zurcher, Gaëtan Bouvard, Jean-Christophe Abry, Eric Charkaluk,
Vincent Fridrici

Théo Zurcher, Gaëtan Bouvard, Jean-Christophe Abry, Eric Charkaluk, Vincent Fridrici. Effect of the scanning strategy and tribological conditions on the wear resistance of IN718 obtained by Laser Metal Deposition. *Wear*, 2023, 534-535, pp.205152. 10.1016/j.wear.2023.205152 . hal-04289644

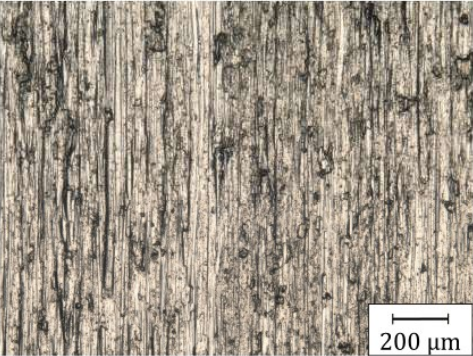
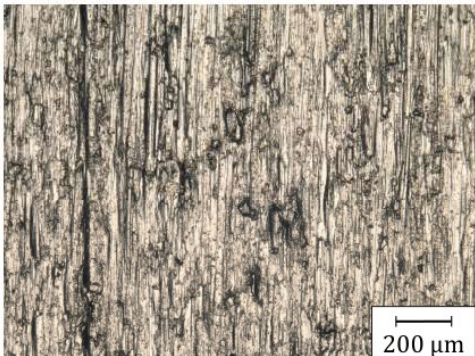
Figure 8: Optical images of worn surfaces of the LMD samples at a) 2 N (with a steady state of the COF); b) 10 N; c) 20 N; d) 40 N; e) 50 N

Several wear tests with different loading conditions were performed. Figure 8 gathers the optical pictures taken inside the wear track. As seen previously, at 2 N, abrasion is the main wear mechanisms (Figure 8 a)) and oxidized wear debris are present as transfer layer. At 10 N, the oxidized transfer layer disappears to make way for abrasion and adhesion. As exposed in Figure 8 b), narrow and shallow grooves are observed inside the worn area with adhered debris. At 20 N, the same observations are noted. Starting from 40 N, it can be noticed in Figure 8 d) and e) that the wear is mainly due to abrasion with much less adhesion. Thick and deep grooves inside the wear tracks are observed with some big debris which are cold-welded.
