# Recommendation of RILEM TC 271-ASC: New accelerated test procedure for the assessment of resistance of natural stone and fired-clay brick units against salt crystallization

**Abstract** This recommendation is devoted to testing the resistance of natural stone and fired-clay brick units against salt crystallization. The procedure was developed by the RILEM TC 271-ASC to evaluate the durability of porous building materials against salt crystallization through a laboratory method that allows for accelerated testing without compromising

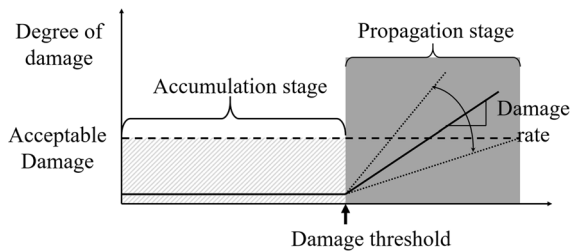
**Fig. 1** Schematic representation of the durability of a stone or brick subjected to salt damage [3], adapted from the concept proposed by Tuutti [4] to describe the durability of reinforced concrete

The procedure involves a novel approach [3], that draws from literature on reinforced concrete durability [4]. It operates under the assumption that sufficient salt needs to accumulate in the pores (pore filling) to initiate damage. As a consequence, salt damage is regarded as a two-stage process: (i) in the accumulation stage, salts accumulate in the pores of the material (but the degree of pore filling is not yet sufficient to initiate damage); (ii) in the propagation stage, repeated salt dissolution/crystallization cycles cause damage to initiate and propagate (Fig. 1).

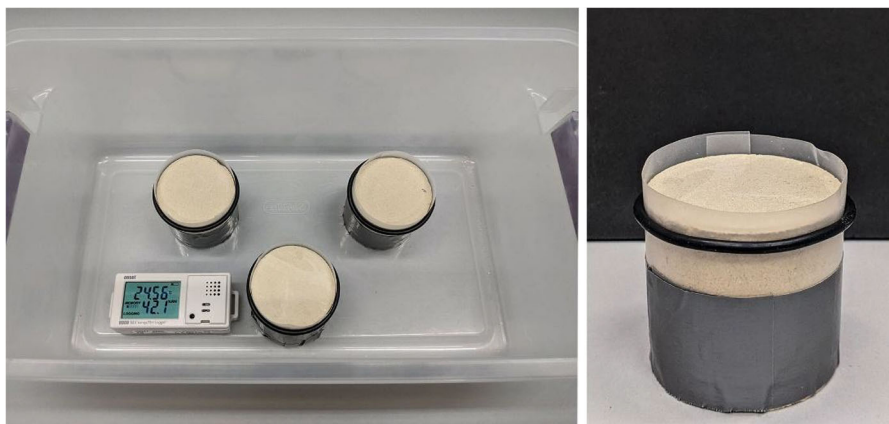
**Fig. 2** Picture showing the specimens enclosed in a box with a T and RH sensor (left). Detail of a specimen (50 mm diameter and 50 mm height) sealed at the side with paraffin film, secured with tape and rubber O-ring (right)

The lateral surface of the specimens should be sealed with paraffin film, after pre-heating them in an oven at 50 °C for 10 min, to achieve better adherence. The paraffin film should extend 0.5 cm above the top surface of the specimens. A rubber O-ring should be used to secure good adhesion between the paraffin film and the uppermost area of the lateral surface of the specimen. Textile tape (water resistant and water vapour tight) can be used to secure the ends of the paraffin film and ensure sealing tightness during the entire test (Fig. 2).

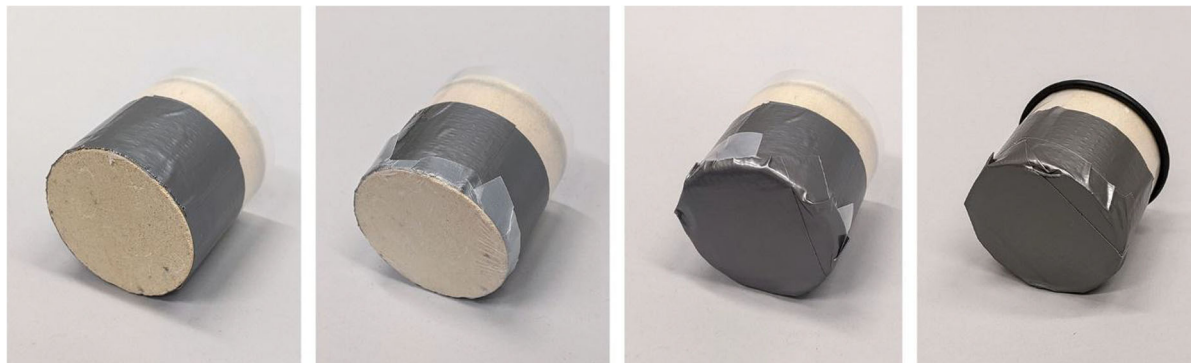
**Fig. 3** Bottom of the specimen (left) is first sealed with paraffin film (middle) and then with textile tape to ensure perfect sealing (right)

Immediately after the full absorption of the salt solution, the bottom surface of the specimens is sealed by covering it with a first layer of paraffin film and a second layer of tape, as shown in Fig. 3. Afterwards, the specimens are weighed again, and their mass is recorded ( $m_s$ ).

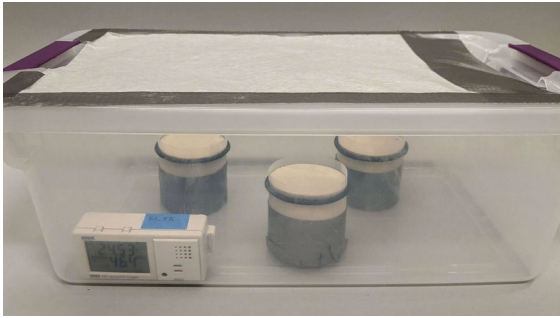
**Fig. 4** Example of a box for storing the specimen during the test. The top of the box is closed with Japanese paper to allow for air exchange while limiting air velocity

test (Fig. 4). The distance between specimens and between these and the box walls should be at least 2 cm. The temperature and relative humidity in the box should be monitored with a sensor. The weight of each specimen should be recorded over time.

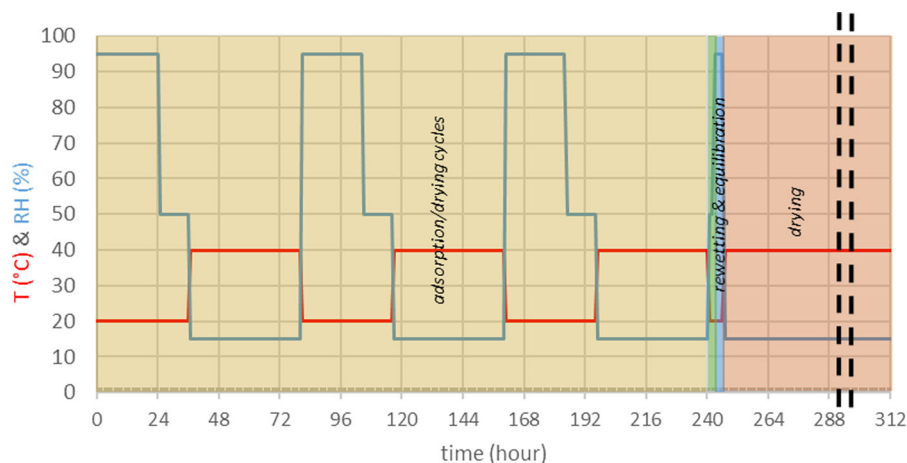
**Fig. 5** Representation of a 3-week T and RH cycle of the propagation stage—NaCl test

The propagation stage consists of four 3-week cycles. Each of these cycles consists of 3 sub-cycles of temperature and relative humidity, plus one rewetting of the specimens with demineralized water through their bottom surface. More specifically, each 3-week cycle consists of (Fig. 5):

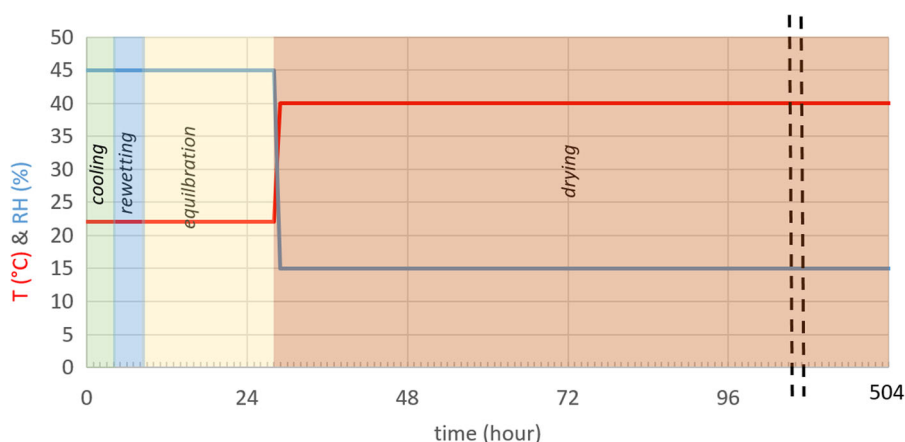
**Fig. 6** Representation of a 3-week T and RH cycle of the propagation stage— $\text{Na}_2\text{SO}_4$  test

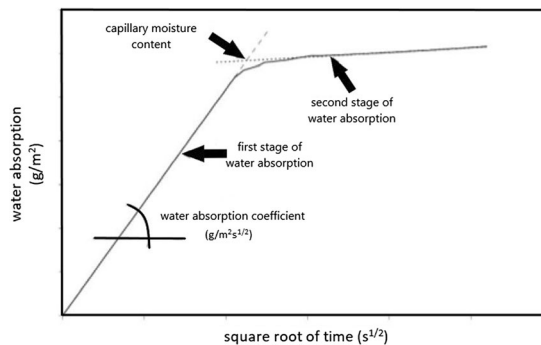
**Fig. 7** Schematic of a typical water absorption by capillarity test result showing the point where the capillary moisture content of the material is determined

The capillary moisture content of the material must be determined first by performing the water absorption test according to EN 1925:1999 ("Determination of water absorption coefficient by capillarity" [7]). The capillary moisture content of the material is the mean water content at the end of the first stage of water absorption. It is determined as the point of intersection of straight lines drawn through the first and second stages of water absorption on a  $t^{1/2}$  plot (Fig. 7).
