Assessing the Hazard of Deep-Seated Rock Slope Instability through the Description of Potential Failure Scenarios, Cross-Validated Using Several Remote Sensing and Monitoring Techniques

Charlotte Wolff ^{1,*}, Michel Jaboyedoff ¹ , Li Fei ¹, Andrea Pedrazzini ², Marc-Henri Derron ¹, Carlo Rivolta ³ and Véronique Merrien-Soukatchoff ^{1,4}

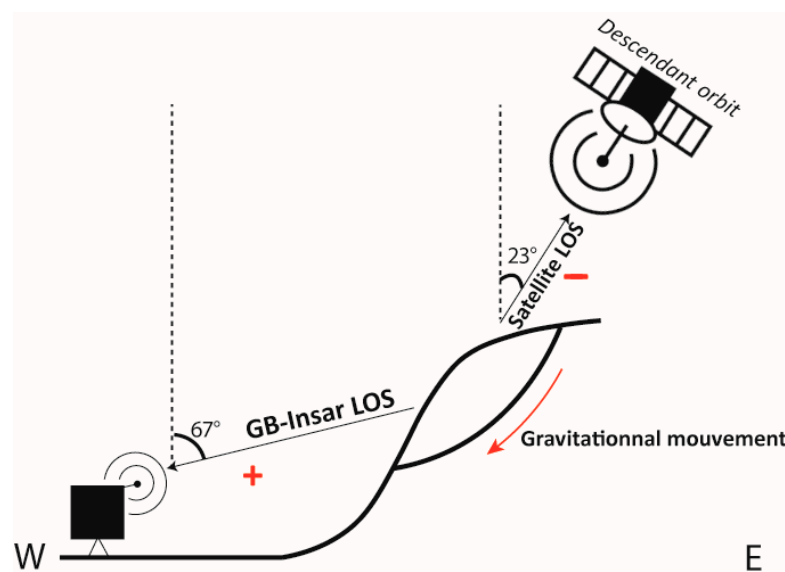
Figure 5. Expected displacement signs along the satellite and GB-InSAR LOS. GB- and satellite InSAR, respectively, provide data on sub-horizontal and sub-vertical displacements.

Since InSAR monitoring collects data only in the LOS of the device, GB-InSAR and satellite InSAR provide information along the line making an angle with the vertical of, respectively, 67° and 23° (Figure 5). According to the topography and the fracture orientations, the displacement direction of the unstable volume is expected to be down- and westwards. Thus, it is expected to find negative movement in the LOS of the satellite and positive ones in the LOS of the GB-InSAR.

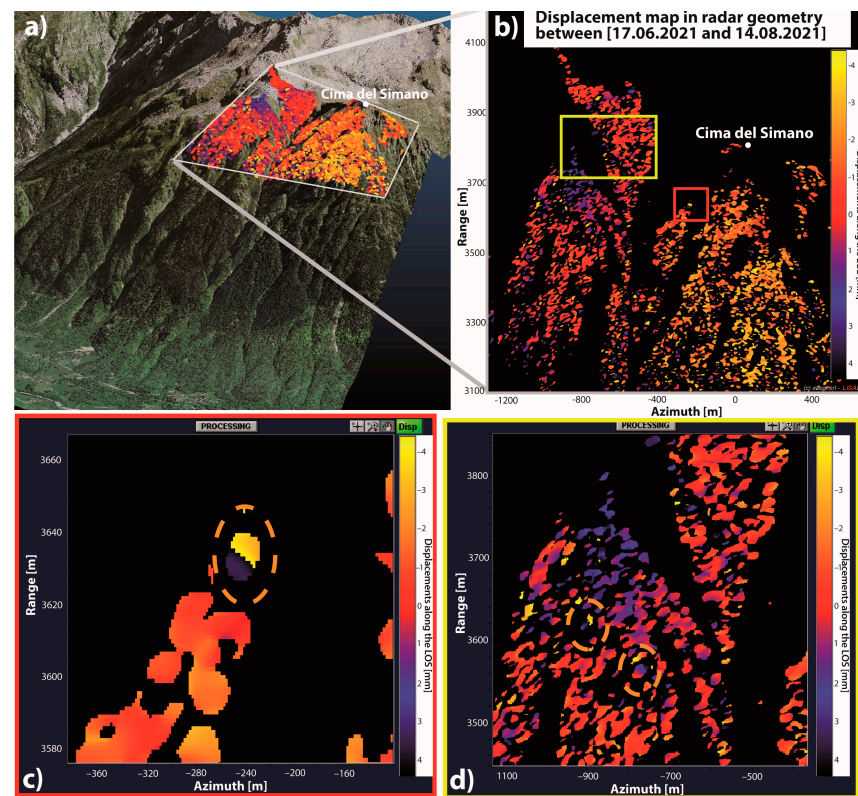
Figure 8. Wrapped GB-InSAR interferogram between June 2021 and August 2021 highlighting toppling blocks. The positive displacement values correspond to displacements toward the GB-InSAR. (a) The interferogram in geographical coordinates draped on a 3D orthophoto. (b) Interferogram in radar geometry (c). (d) Zoom on zones where toppling movements are detected. The upper part of each toppling block shows negative displacements due to wrapping effects.

The fallen and toppled blocks detected by LiDAR (Figure 7) and GB-InSAR (Figure 8) are located within areas prone to movement. The region exhibiting signs of displacement after InSAR analysis (Figure 11) is susceptible to both planar and wedge sliding. In the case of planar sliding, the primary joint set responsible for the destabilization is j3. The locations of the blocks prone to toppling in Figure 15c correspond to the positions of the blocks observed toppling in the field (Figure 1c), with j1 as the primary joint set controlling the movement.

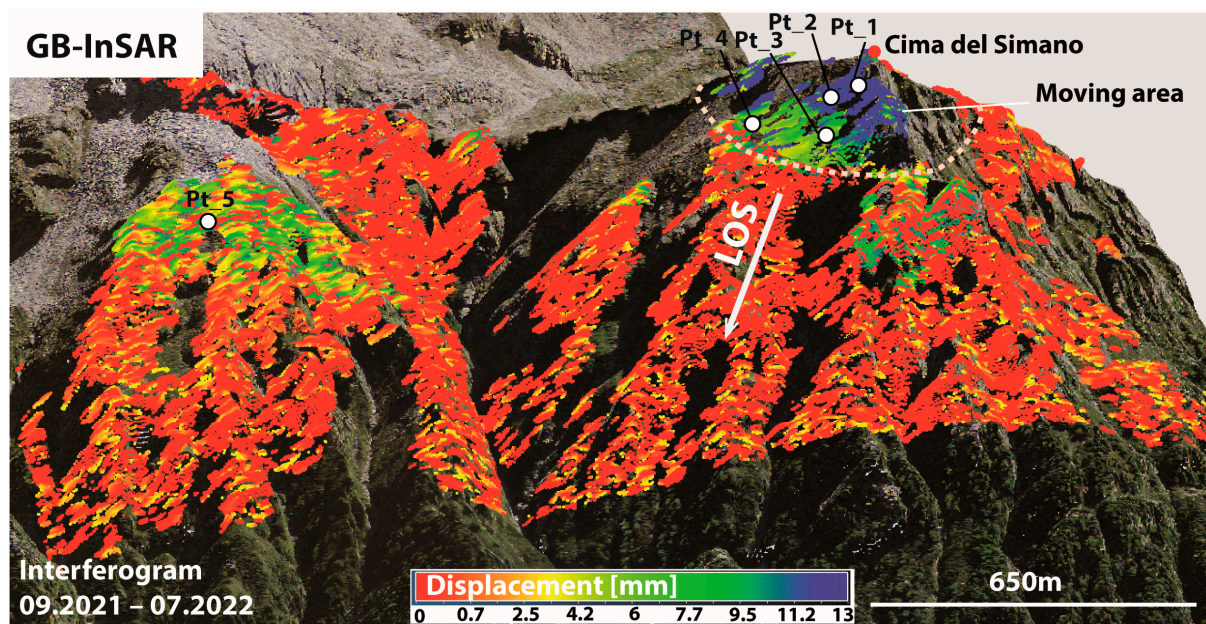
Figure 9. Unwrapped GB-InSAR interferogram between September 2021 and July 2022, highlighting an unstable zone with slow movements on top of the mountain. The displacement speeds of points Pt₁ to Pt₅ are plotted in Figure 13.

The 10-month interferogram computed for the dates between September 2021 and July 2022 was unwrapped to obtain a displacement map along the LOS, oriented at 67° toward the vertical and in the direction 281° . It shows up a surface of slow movements located below the summit, with displacements toward the GB-InSAR between 4 mm and 13 mm (Figure 9), corresponding to a slow block sliding.

Additionally, height points located on the cliff (Figure 9) and showing signs of movements according to the GB-InSAR were selected and their displacement speeds during

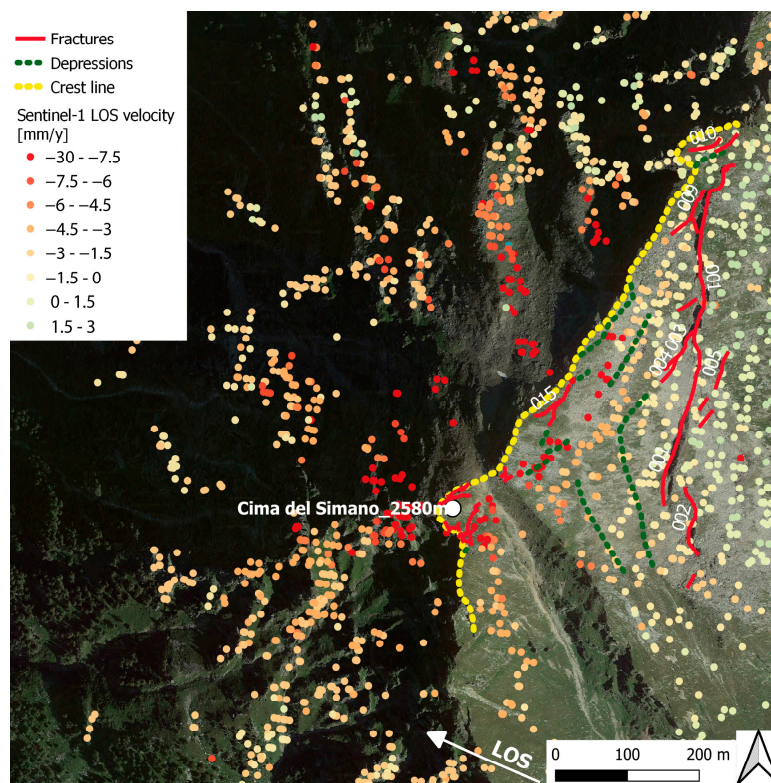
Figure 10. Sentinel-1 PSs speed displacement map over the study area, from the IPTA processing by Gamma AG of the radar images acquired between 2015 and 2021.

The Sentinel-1 PSs analysis, over 6 years, shows the same ranges of displacement velocity, between 4 mm and 13 mm per year along the LOS (23° toward the vertical), which prolongates about 60 m behind the crest (Figure 10). The displacements measured with the two techniques are coherent and seem constant over the years.

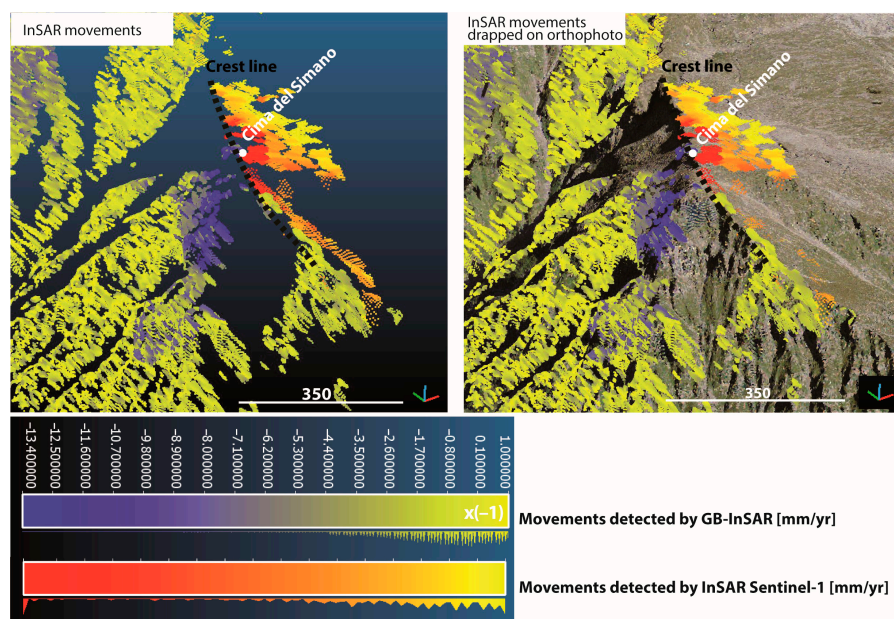
Figure 11. Spatial combination of the GB-InSAR (blue) and the satellite InSAR (red) displacements in the same 3D map delimiting an area with slow movements. The GB-InSAR movements must be multiplied by (-1) ; the movements are directed toward the GB-InSAR. GB- and satellite InSAR results are coherent, showing a similar range of displacement. The combination of the two results highlights the continuity of movements between the deep slope and the back slope.

The GB- and satellite InSAR speed displacement maps were then merged in the same 3D map where the moving surface is easily identified (Figure 11). This encompasses an area of a wider extent; the triggered mechanism could be a deep-seated landslide.

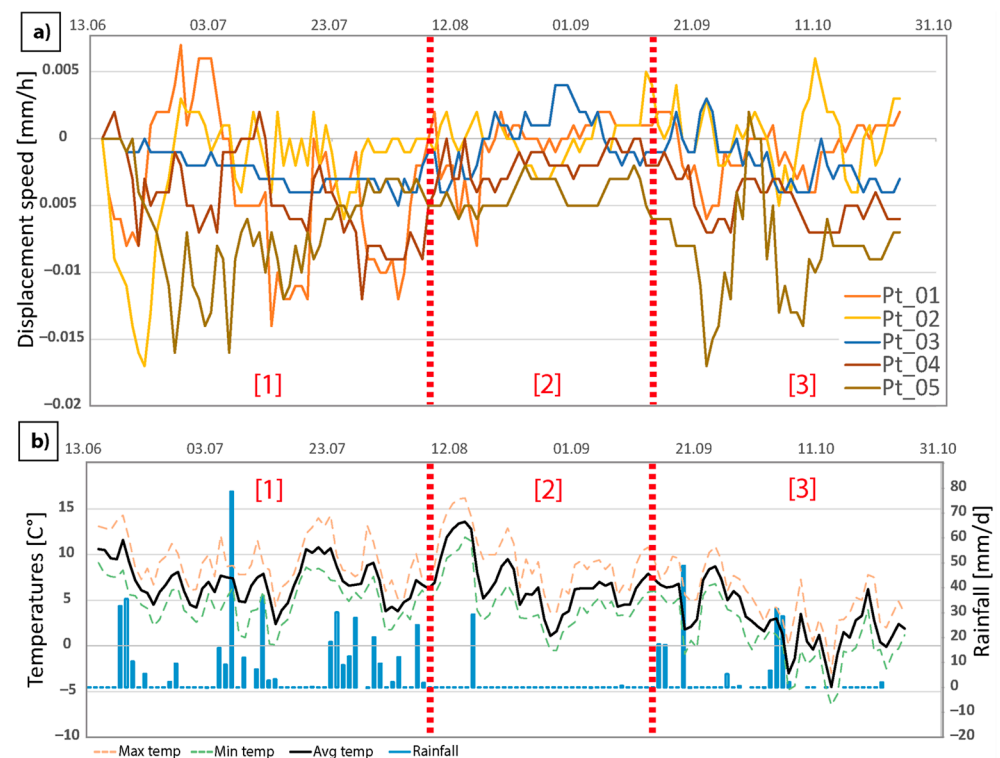
Figure 13. Correlation between GB-InSAR speed displacement and meteorological condition during the Summer 2021. (a) Variation of displacement speed for 5 points located on Figure 8. (b) Temperatures and precipitations measured by the national meteorological station. During the periods '1' and '3', the precipitations were more intense and the displacements more important than during period '2'.

the 4 months of GB-InSAR monitoring in 2021 are plotted (Figure 13a), as well as the temperatures and precipitations recorded by the meteorological station SLFI2 (Figure 13b).

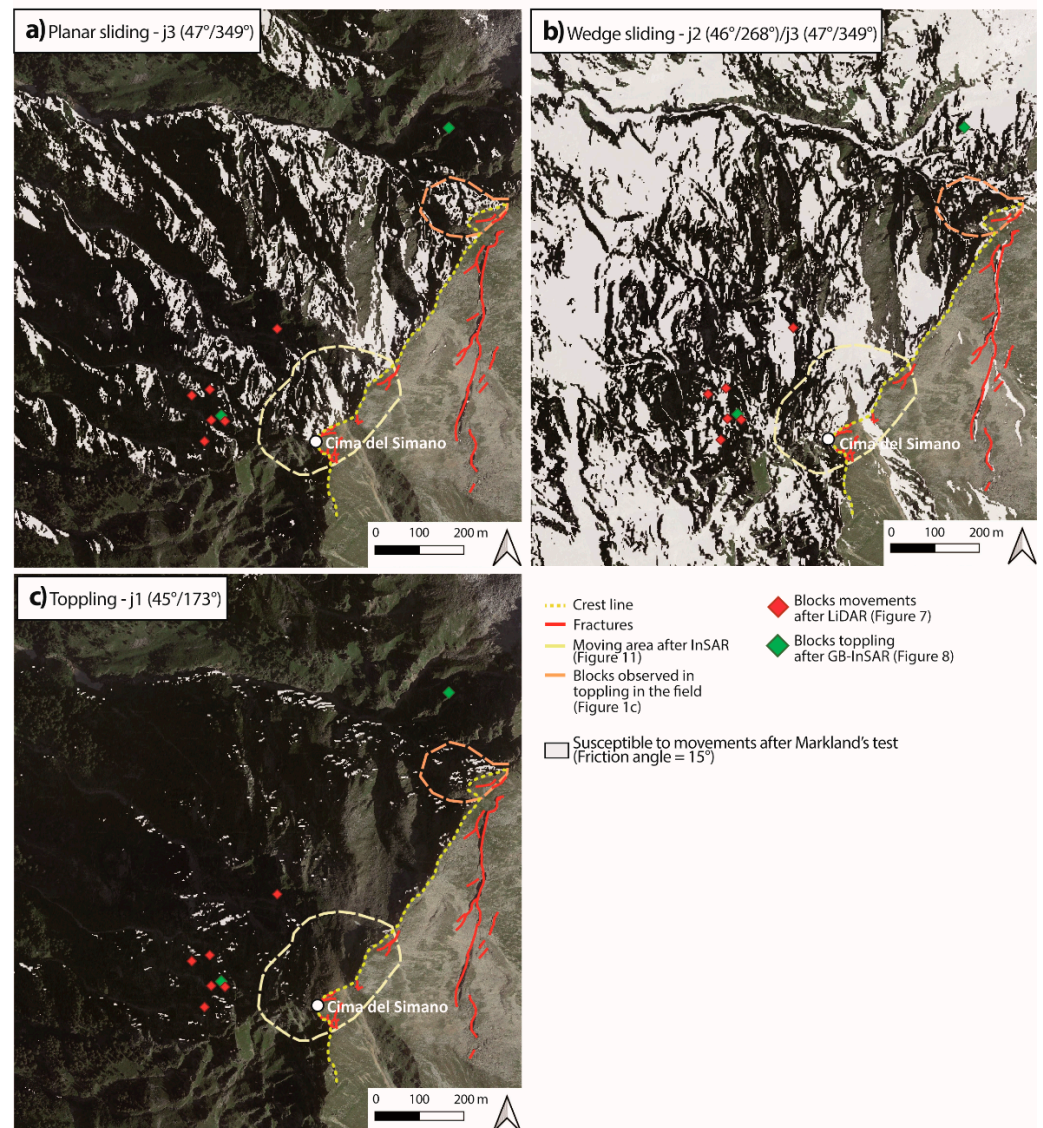
Figure 15. Markland's tests with the discontinuity sets detected in the Swisstopo DEM for a friction angle of 15° . (a) Susceptibility to planar sliding considering planes from j3. Angles of lateral limits are 20° . (b) Susceptibility to wedge sliding involving j2 ($46^\circ/268^\circ$) and j3 ($47^\circ/349^\circ$). (c) Susceptibility to toppling with planes from j1. Angles of lateral limits are 20° .

The Markland's tests were conducted with the three discontinuity sets extracted from the Swisstopo DEM. They confirm the susceptibility to planar sliding along planes belonging to joint sets j1, j2 (Supplementary Figure S1a,b) or j3 (Figure 15a) to wedge sliding involving j2 and j3 (Figure 15b) and highlight the locations of potential toppling blocks involving joint sets j1 (Figure 15c) and j3 (Supplementary Figure S1c).

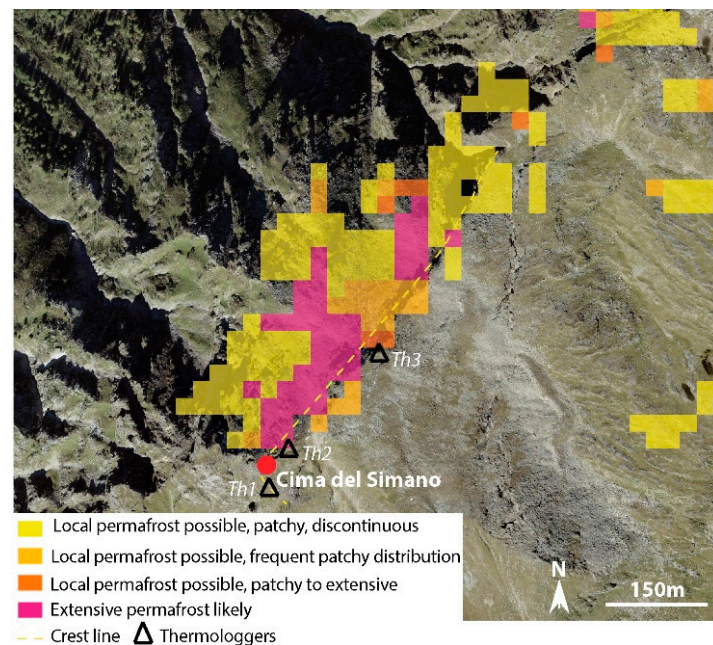
Figure 16. Permafrost map from [70] suggesting the presence of permafrost where the thermologgers were installed.

The negative temperatures registered by TH3_{down} suggest the potential presence of permafrost at depth, as suggested by the Swiss Federal Office for the Environment (OFEN, [70]) on the Swisstopo portal (Figure 16). But with the climate changes it may have disappeared, causing the destabilization of the surface, and the recent acceleration of global warming could increase this destabilization.

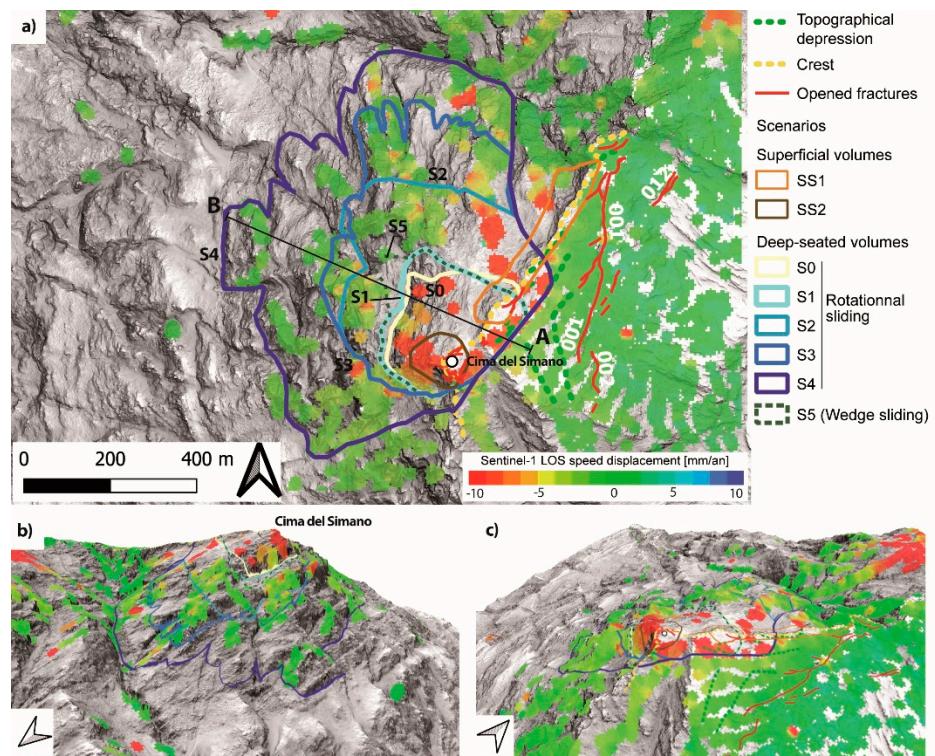
Figure 17. Delimitation of the eight scenarios. (a) In 2D. [AB] corresponds to the cross section of Figure 19d. (b), (c) In 3D.

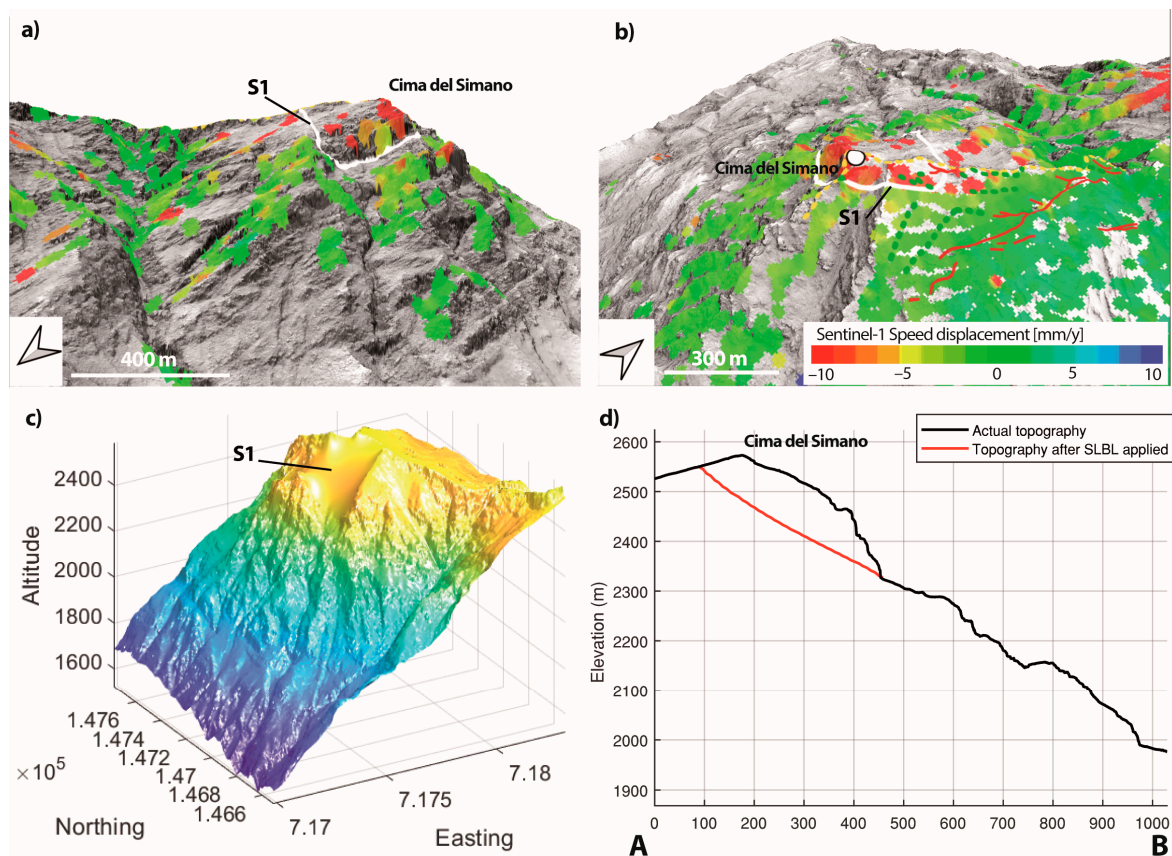
Figure 19. Detailed description of the rotational sliding scenario S1. (a,b) Delimitation drawn on 3D map corresponding to the moving area according to InSAR. (c) Topography after applying the SLBL algorithm. (d) Cross-section along the sliding direction line [AB] presented Figure 17.

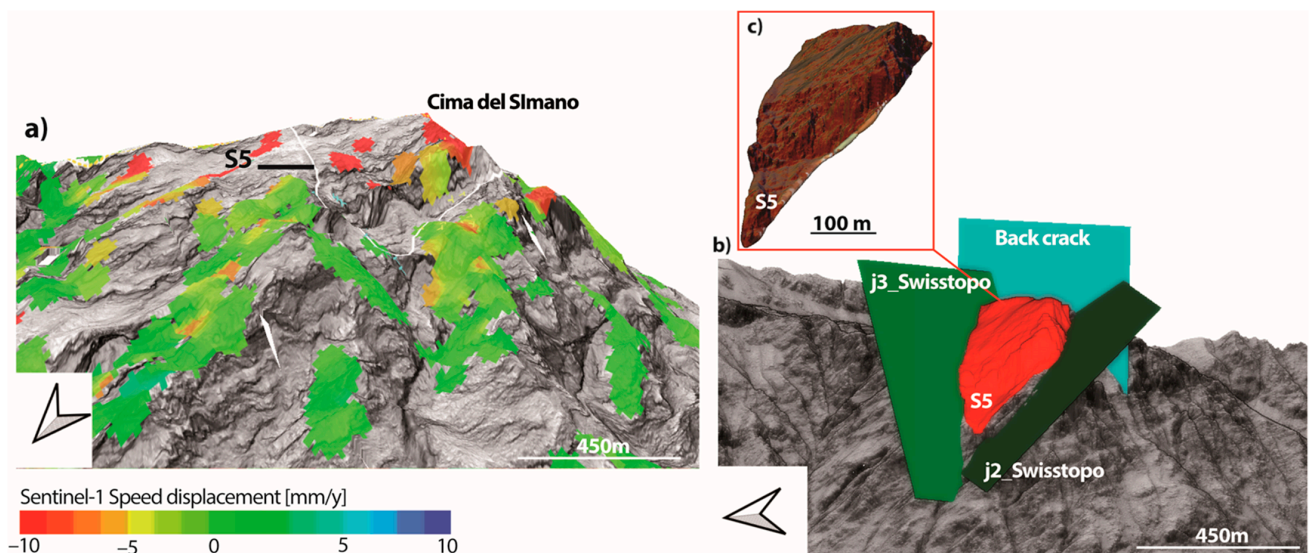
Figure 20. Detailed description of the wedge sliding scenario S5. (a) Delimitation drawn on 3D map corresponding to the moving area according to InSAR. (b) Geometry constraining the sliding of volume S5. (c) Extracted volume meshed with Cloud Compare.

The volumes of those scenarios computed with the SLBL vary from $3 \times 10^6 \text{ m}^3$ to $5 \times 10^7 \text{ m}^3$. An additional deep-seated scenario 'S5' (Figure 20a) is proposed considering a wedge sliding between two plans from the discontinuity sets j2 and j3. The geometry of the scenario was created in Cloud Compare using three planes, two of them belonging, respectively, to the two discontinuity sets and the third one to a back crack oriented at $85^\circ/315^\circ$ (Figure 20b). The volume was estimated by meshing the extracted PC corresponding to the unstable compartment with the Poisson Recon tool ([72], Figure 20c).

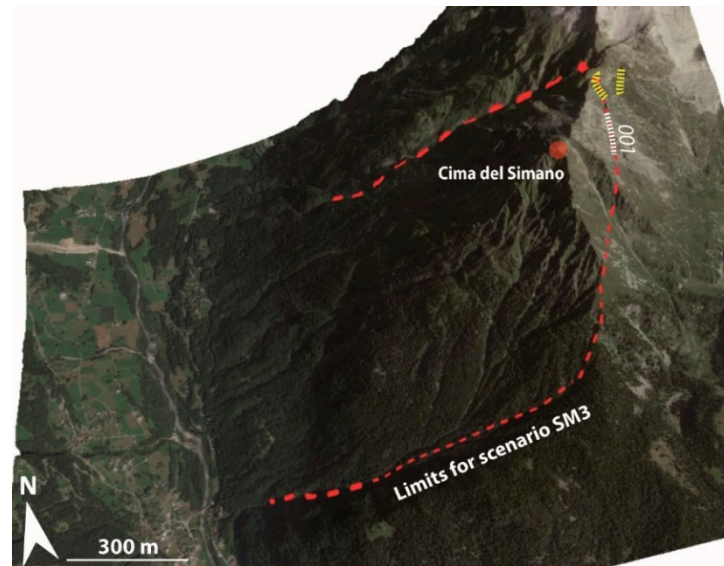
Figure 21. Hypothetical delimitation for the unstable compartment involving the main open fracture '001'. In white dash line, the location of the open fracture and, in yellow dash line, the prolongation of a fracture visible in the topography.

'001' and encompasses a huge volume. In the field, several fractures were observed toward the North of the main fracture, and likely represent its prolongations. Figure 21 displays the limits suggested for the scenario SM3.
