# Assessing the Hazard of Deep-Seated Rock Slope Instability through the Description of Potential Failure Scenarios, Cross-Validated Using Several Remote Sensing and Monitoring Techniques

Charlotte Wolff <sup>1,\*</sup>, Michel Jaboyedoff <sup>1</sup> , Li Fei <sup>1</sup>, Andrea Pedrazzini <sup>2</sup>, Marc-Henri Derron <sup>1</sup>, Carlo Rivolta <sup>3</sup> and Véronique Merrien-Soukatchoff <sup>1,4</sup>

**Abstract:** Foreseeing the failure of important unstable volumes is a major concern in the Alps, especially due to the presence of people and infrastructures in the valleys. The use of monitoring and remote sensing techniques is aimed at detecting potential instabilities and the combination of several techniques permits the cross-validation of the detected movements. Supplemented with field mapping and structural analysis, it is possible to define possible scenarios of rupture in terms of volume, mechanisms of failure and susceptibility. A combined observation strategy was applied to the study of major instability located in the Ticinese Alps (Switzerland), Cima del Simano, where the monitoring started in 2006 with the measurement of opened cracks with extensometers. Sin

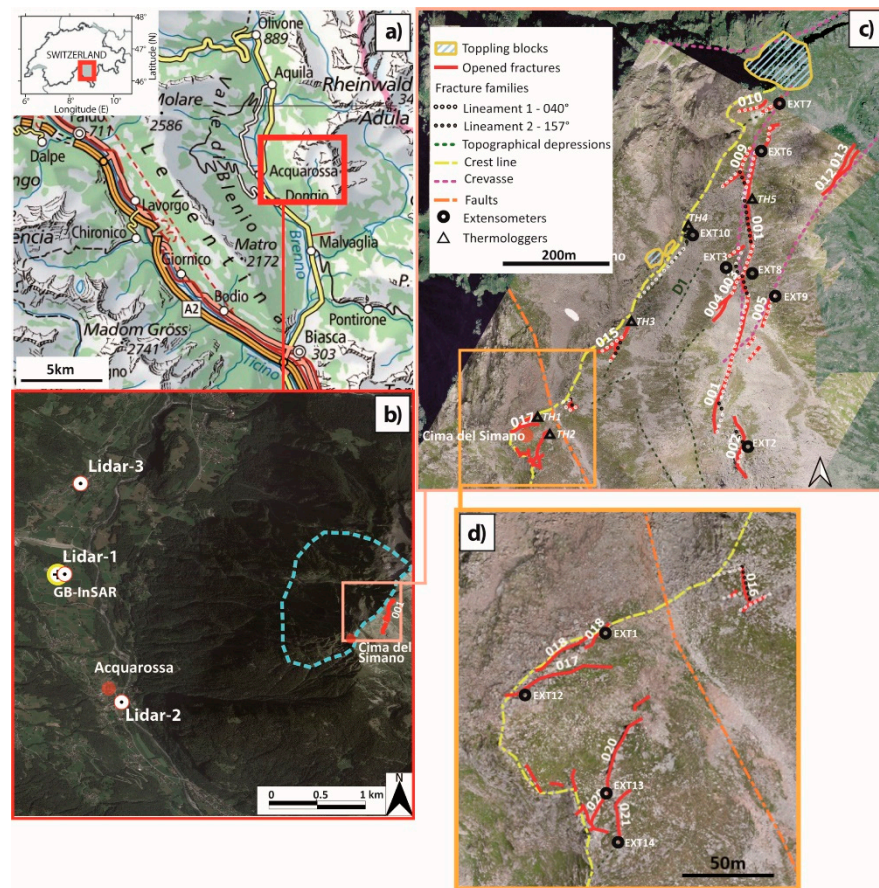
**Figure 1.** Characterization of the case study with the location of the remote sensing devices installation. (a) Localization. (b) LiDAR and GB-InSAR installed in the Valley, distance 3.5 km from the mountain peak. The area illuminated by the GB-InSAR is delimited in blue (c). (d) Mapping on the orthophoto from SfM photogrammetry of the fractures, faults and depressions on top of Cima del Simano and extensometers and thermometers installed in the fractures.

In the Ticino Canton (Switzerland), landslides are recurrent natural hazard phenomena occurring due to very steep slopes induced by glaciers, rapid uplift [38] and heavy rainfalls. Many studies map and describe those threats [14,39]. One of the present concerns is the Cima del Simano Mountain in the Blenio Valley, near the village of Acquarossa (Figure 1a). The area of instability is part of the Simano Nappes [40] and is made up of an orthogneiss with the main schistosity oriented, on average, to  $20^\circ/035^\circ$  [41]. The top, reaching an altitude of 2500 m, displays several fractures of various sizes. A 500 m-long major opened crack is located at 100 m toward the southeast behind the crest and identified as '001' in Figure 1b. Nevertheless, numerous other cracks of a smaller length and smaller aperture are also visible closer to the crest line and some delineate clear depressions (Figure 1c,d). They follow two main lineaments oriented at  $040^\circ$  and  $157^\circ$  towards north, respectively mapped in white and black in Figure 1c. A regional fault also crosses the mountain perpendicularly to the crest. A major depression named D1 in Figure 1c is visible in the field and is covered by the debris of rocks (Figure 2).

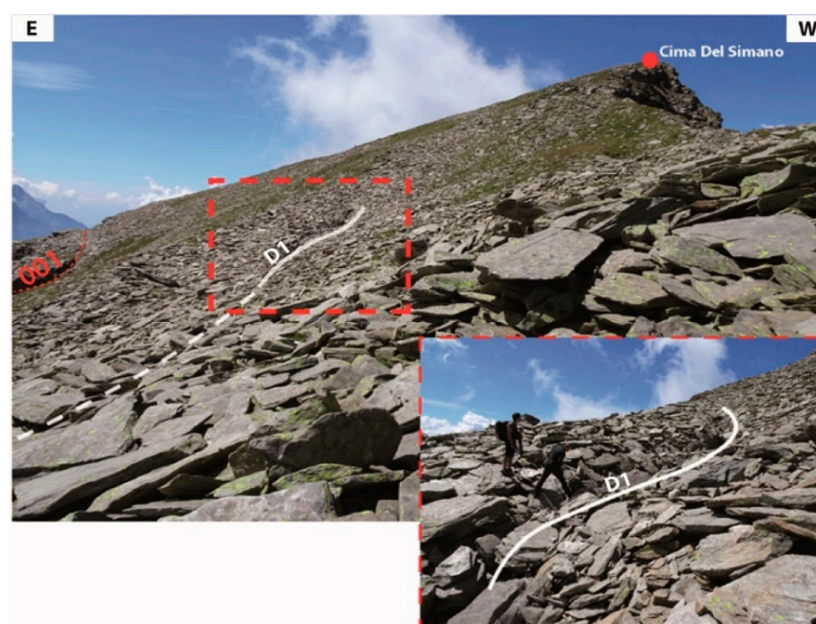
**Figure 2.** Photo of the depression D1 mapped in Figure 1c.

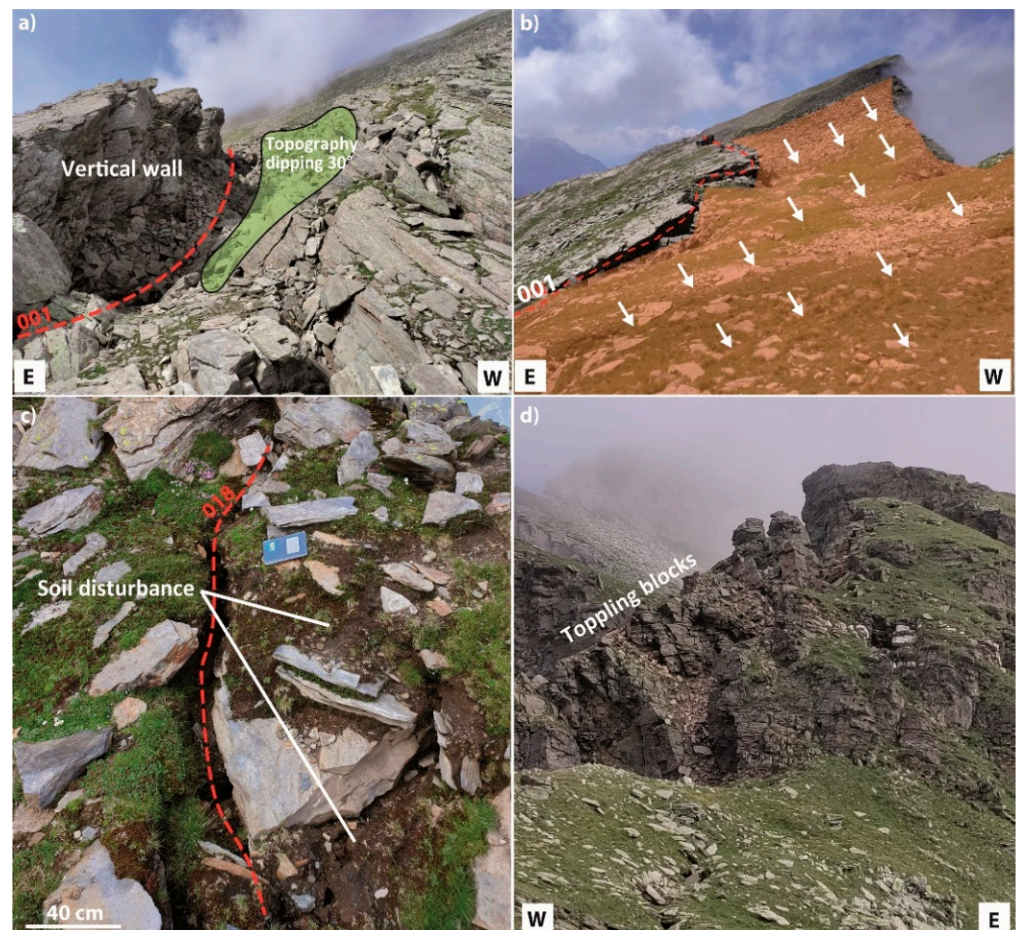
**Figure 3.** Photos depicting the main characteristics of the Cima del Simano instabilities. (a,b) Main open fracture; (c) Traces of movements in one of the openings near the crest; (d) Fractured blocks in toppling. Their location is shown in Figure 1c.

The southeastern wall of the major fracture '001' is nearly vertical. The opposite wall is only visible in the northern part, near fractures '003' and '004', and covered by debris in the southern part, near fracture '002'. The topography facing the southeastern wall slopes at a  $30^\circ$  angle toward the southeast (Figure 3a). This fracture seems to be the result of a gravitational movement of the northwestern block moving downward (Figure 3b). Signs of recent movements and instabilities are revealed close to the crest in some of the fractures, such as the presence of soil disturbance found in the fracture '018' (Figure 3c) or the presence of unstable blocks along the crest that are clearly toppling (Figure 3d).

From the observations in the field (Figure 3d) and the LiDAR results (Figure 7), the most likely events to occur are the toppling of small blocks located near the crest, also confirmed by Markland's tests (Figure 15c). But one can also consider scenarios of potential sliding movements of larger volumes involving the small fractures found near the crest ('015', '017', '018' in Figure 1) and the joint families j1, j2 and/or j3 (Figure 15a). We considered two such scenarios of Small Sliding (volume  $< 10^5 \text{ m}^3$ ), denoted 'SS1' and 'SS2' (Figure 17a). The SLBL algorithm [46] was applied with the assumption that the sliding surface is almost planar. The unstable volumes computed were, respectively,  $2.30 \times 10^5 \text{ m}^3$  and  $2.59 \times 10^5 \text{ m}^3$  (Figure 18b,c).

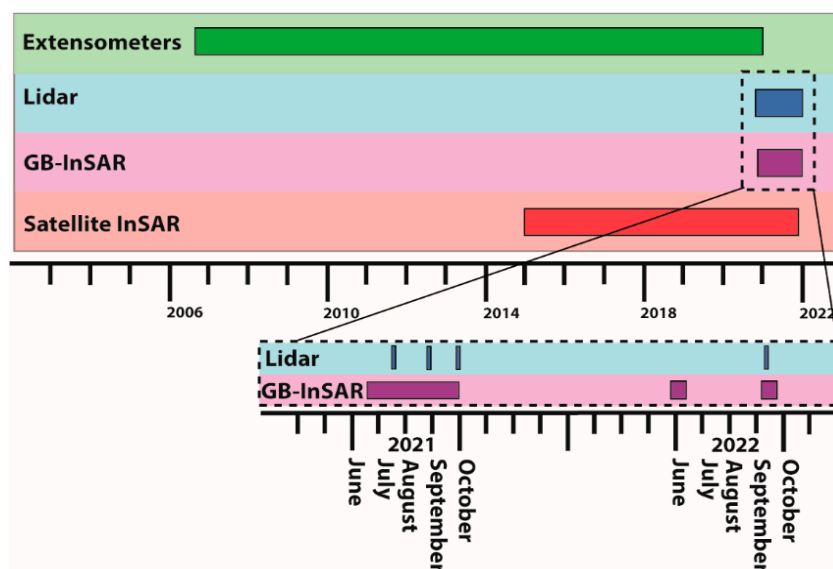
**Figure 4.** Temporal coverage of the field monitoring started in 2006 with extensometers measurements and more intensive monitoring since 2021 with LiDAR and GB-InSAR campaigns.

Several different remote techniques were used to characterize the rock mass and monitor the various movements at different spatial scales (Table 1). The canton of Ticino started monitoring in 2006 using manual extensometers in open cracks to measure their aperture every year (Figure 1c,d). A more intensive monitoring started in 2021 with LiDAR and GB-InSAR campaigns and the processing of the Sentinel-1 satellite radar images by Gamma AG. Figure 4 presents the temporal coverage for each remote sensing technique used in the study.

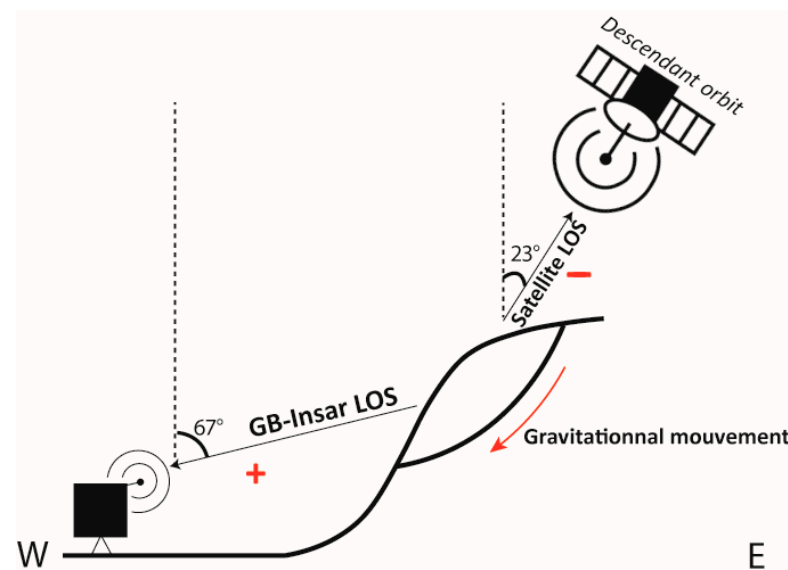
**Figure 5.** Expected displacement signs along the satellite and GB-InSAR LOS. GB- and satellite InSAR, respectively, provide data on sub-horizontal and sub-vertical displacements.

Since InSAR monitoring collects data only in the LOS of the device, GB-InSAR and satellite InSAR provide information along the line making an angle with the vertical of, respectively,  $67^\circ$  and  $23^\circ$  (Figure 5). According to the topography and the fracture orientations, the displacement direction of the unstable volume is expected to be down- and westwards. Thus, it is expected to find negative movement in the LOS of the satellite and positive ones in the LOS of the GB-InSAR.

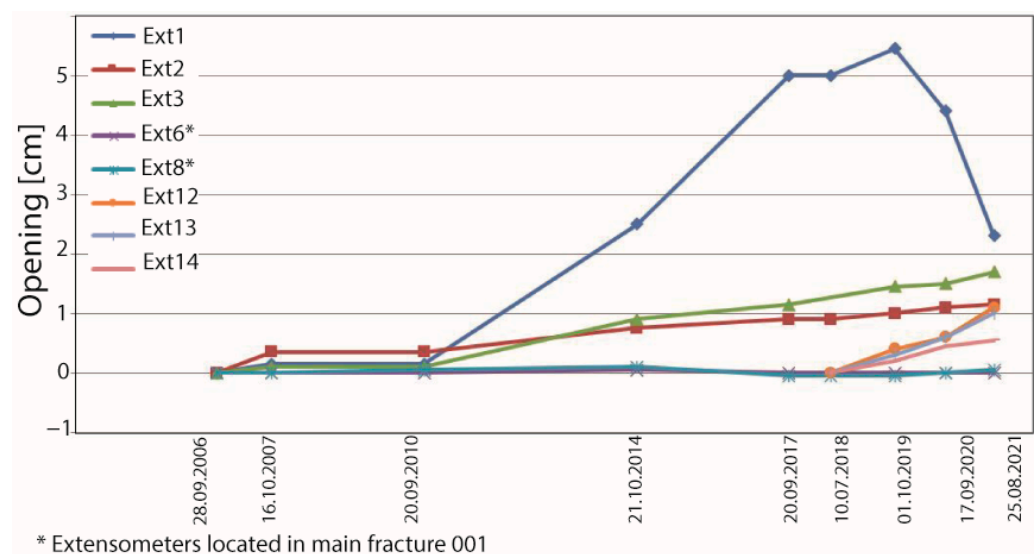
**Figure 6.** Fractures opening measurements since 2006, provided by the Ticino Canton. The main fracture 001 seems stable (corresponding to Ext6 and Ext8). The fractures closer to the crest seem active (Ext1, Ext2, Ext12, Ext13 and Ext14).

The extensometer measures (one measure per year) provide good indications of the crack's activity. Figure 6 displays the evolution with time of the aperture of the cracks, the ones marked with a star are located in the major crack '001' and the others in the fractures are situated close to the crest. The crack '001' is inactive since the movements are insignificant. However, the aperture of the cracks near the crest increased, evidencing the instabilities whose mechanism, extent and volume are defined in this study.

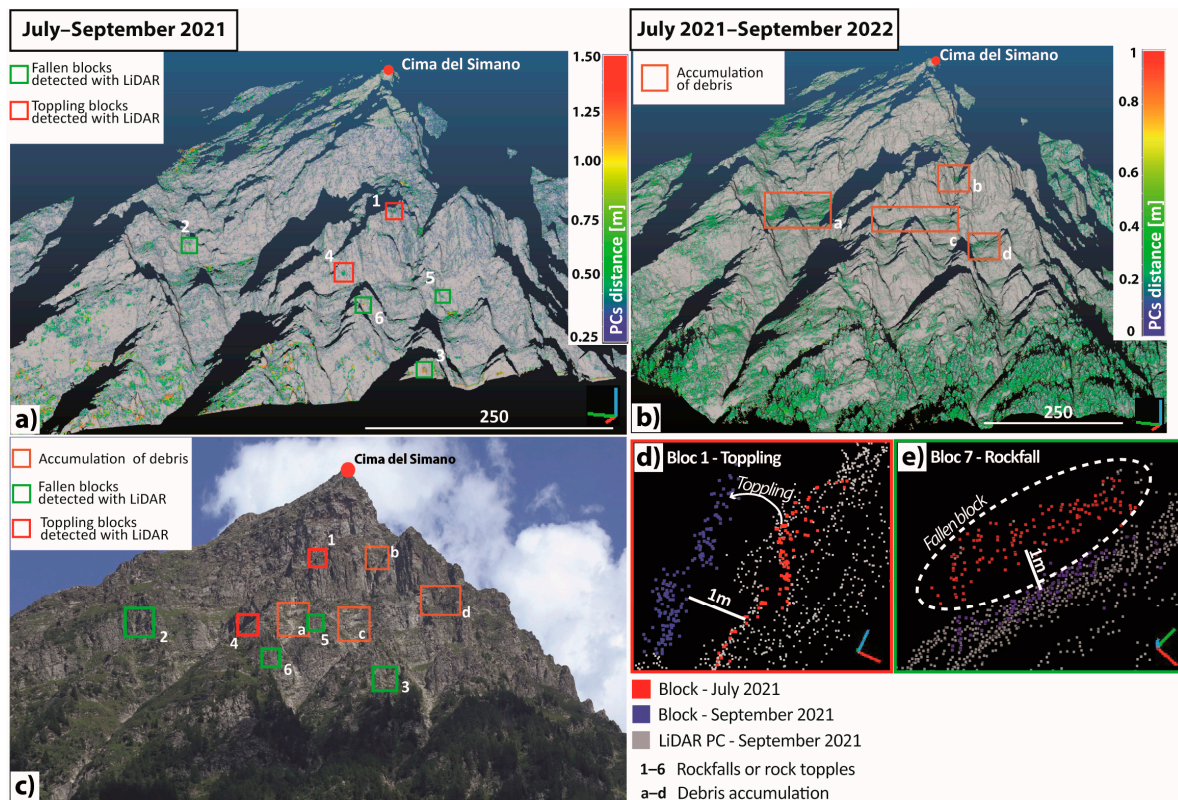
**Figure 7.** Rockfall sources, topplings and accumulation of debris detected by LiDAR PCs comparison. (a) Distance between PCs acquired in July 2021 and September 2021 and detection of rockfalls and toppling blocks. (b) Distance between PCs acquired in July 2021 and September 2022 and detection of debris from rockfalls. (c) Rockfalls, topplings and debris accumulations reported on a panorama. (d) Details of block 1 in toppling: the points forming the block in September (blue) are farther from the cliff than those forming the bloc in July (red). (e) Details of block 7 that fell between July and September 2021: the points belonging to the PC of September (blue) are aligned with the vertical cliff and thus belong to the latter, whereas the points from the PC of July (red) delineate the fallen block.

The distance between the two PCs, acquired in July and September 2021, was computed and only points with a distance greater than 20 cm and gathered in clusters were extracted, highlighting zones where significant rockfalls or movements occurred in the steep cliffs of Cima del Simano (Figure 7a). With a detailed analysis of the zones of interest, it was then possible to discriminate the blocks that fell (the points forming the volume are no longer present, Figure 7e) from those that were undergoing toppling or sliding (the points forming the volume are still apparent, but have undergone a small shift, Figure 7d). The highlighted zones found in 3D were then reported on a panorama of the cliff to better locate them (Figure 7c).

The same analysis was applied to PCs acquired between July 2021 and September 2022. This time, in addition to some rockfalls and toppled blocks that could be distinguished, wider areas where debris accumulated from small rockfalls, as shown in Figure 7b, were reported on the panorama (Figure 7c).

The fallen and toppled blocks detected by LiDAR (Figure 7) and GB-InSAR (Figure 8) are located within areas prone to movement. The region exhibiting signs of displacement after InSAR analysis (Figure 11) is susceptible to both planar and wedge sliding. In the case of planar sliding, the primary joint set responsible for the destabilization is j3. The locations of the blocks prone to toppling in Figure 15c correspond to the positions of the blocks observed toppling in the field (Figure 1c), with j1 as the primary joint set controlling the movement.

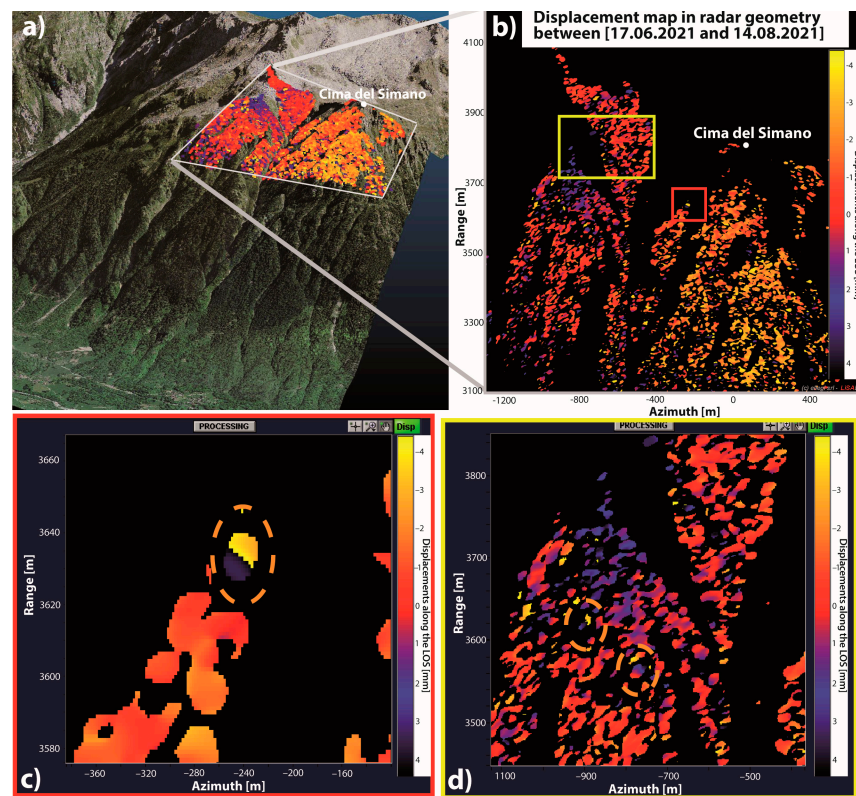
**Figure 8.** Wrapped GB-InSAR interferogram between June 2021 and August 2021 highlighting toppling blocks. The positive displacement values correspond to displacements toward the GB-InSAR. (a) The interferogram in geographical coordinates draped on a 3D orthophoto. (b) Interferogram in radar geometry (c). (d) Zoom on zones where toppling movements are detected. The upper part of each toppling block shows negative displacements due to wrapping effects.

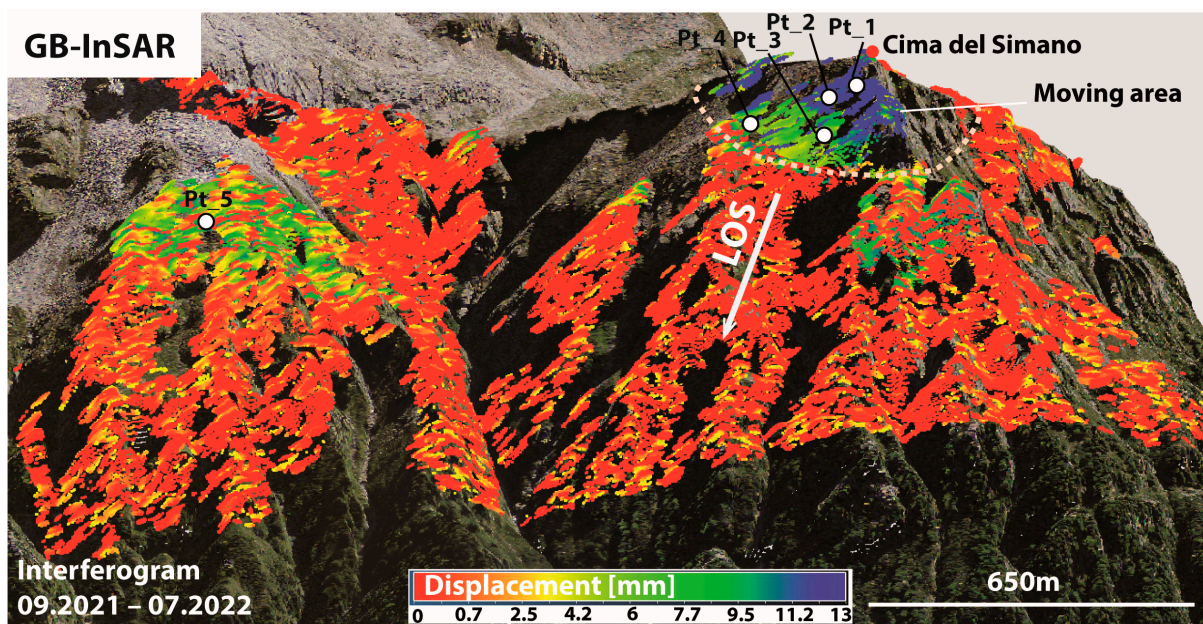
**Figure 9.** Unwrapped GB-InSAR interferogram between September 2021 and July 2022, highlighting an unstable zone with slow movements on top of the mountain. The displacement speeds of points Pt\_1 to Pt\_5 are plotted in Figure 13.

The 10-month interferogram computed for the dates between September 2021 and July 2022 was unwrapped to obtain a displacement map along the LOS, oriented at  $67^\circ$  toward the vertical and in the direction  $281^\circ$ . It shows up a surface of slow movements located below the summit, with displacements toward the GB-InSAR between 4 mm and 13 mm (Figure 9), corresponding to a slow block sliding.

Additionally, height points located on the cliff (Figure 9) and showing signs of movements according to the GB-InSAR were selected and their displacement speeds during

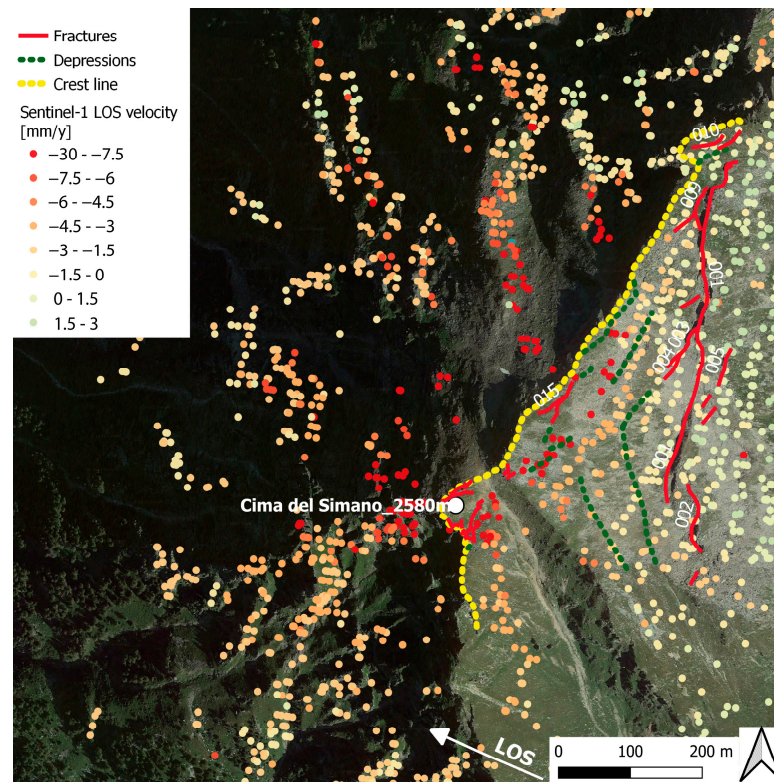
**Figure 10.** Sentinel-1 PSs speed displacement map over the study area, from the IPTA processing by Gamma AG of the radar images acquired between 2015 and 2021.

The Sentinel-1 PSs analysis, over 6 years, shows the same ranges of displacement velocity, between 4 mm and 13 mm per year along the LOS ( $23^\circ$  toward the vertical), which prolongates about 60 m behind the crest (Figure 10). The displacements measured with the two techniques are coherent and seem constant over the years.

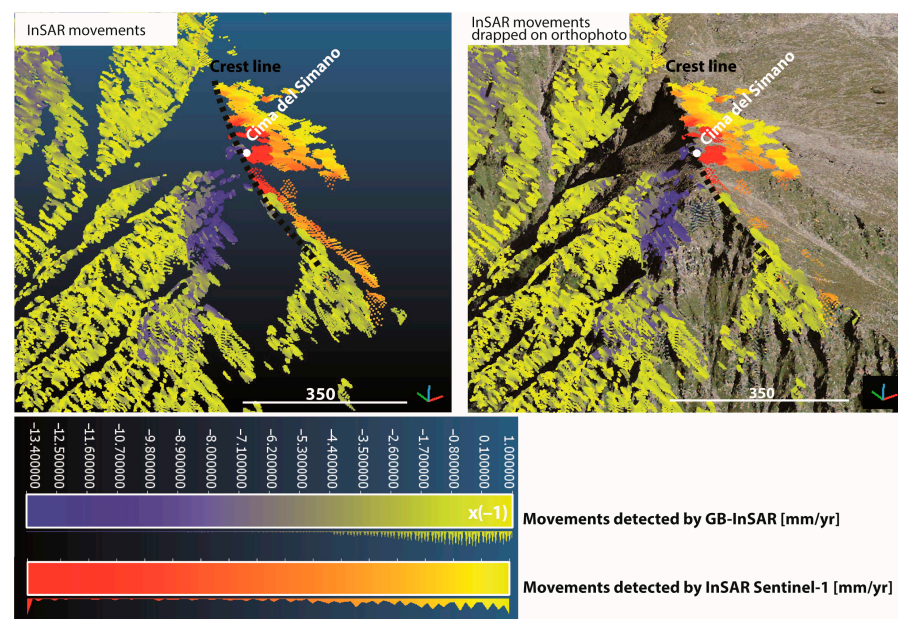
**Figure 11.** Spatial combination of the GB-InSAR (blue) and the satellite InSAR (red) displacements in the same 3D map delimiting an area with slow movements. The GB-InSAR movements must be multiplied by  $(-1)$ ; the movements are directed toward the GB-InSAR. GB- and satellite InSAR results are coherent, showing a similar range of displacement. The combination of the two results highlights the continuity of movements between the deep slope and the back slope.

The GB- and satellite InSAR speed displacement maps were then merged in the same 3D map where the moving surface is easily identified (Figure 11). This encompasses an area of a wider extent; the triggered mechanism could be a deep-seated landslide.

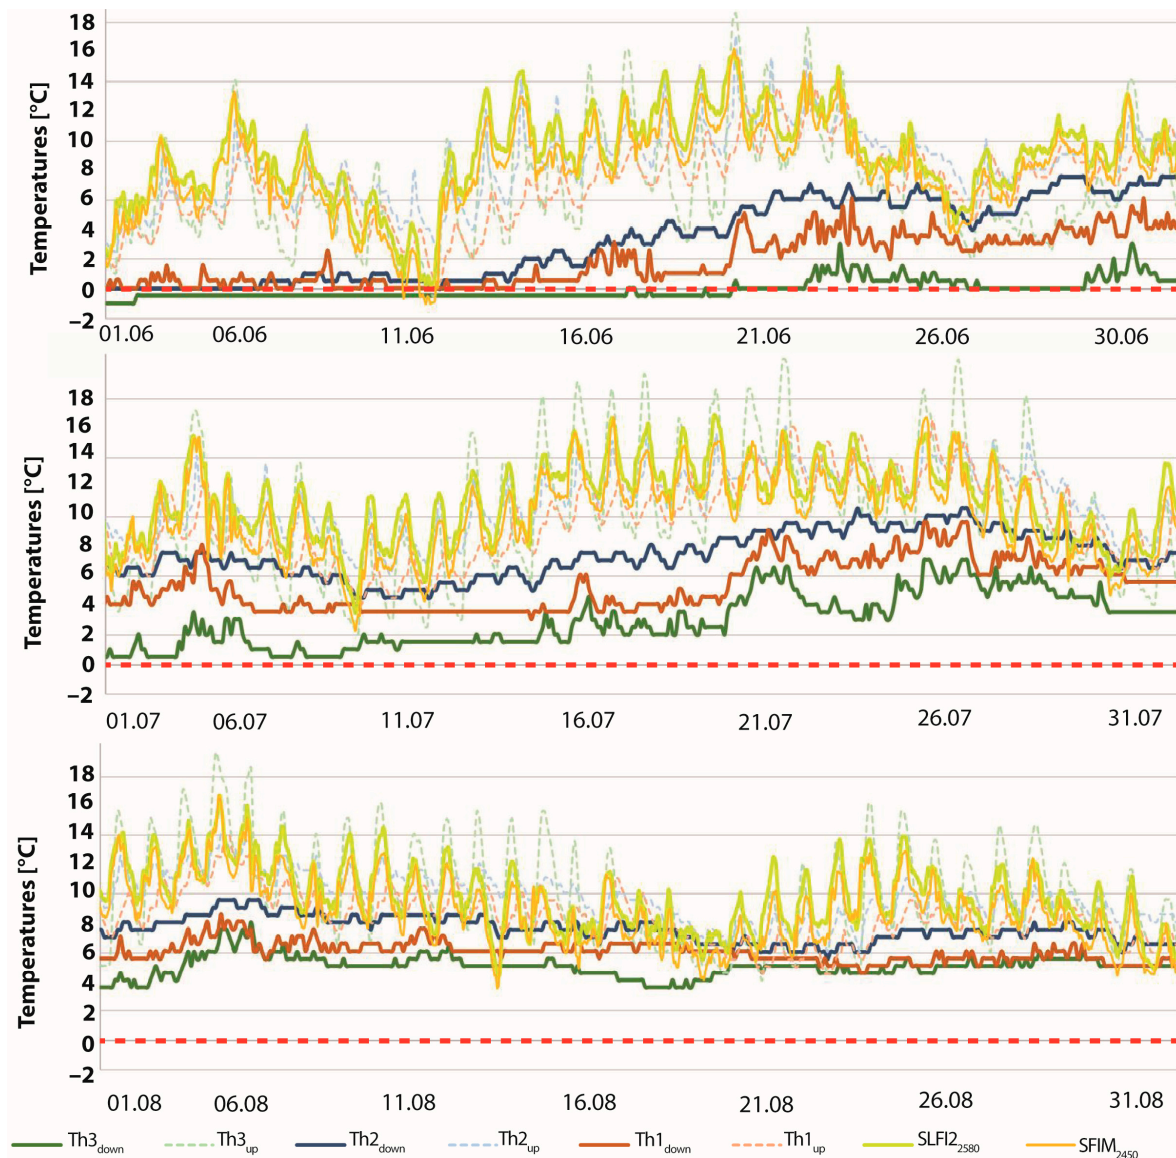
**Figure 12.** Variation of temperatures registered by the thermologgers (Figure 1c) and by the two national meteorological stations SLFI2 (2580 m) and SFIM (2450 m). Up for thermologgers close to the surface and Down for those deep in the fractures. The red dash line is the limit between negative and positive temperatures. The Down thermologgers register less variations of temperature, the latter remaining close to 0 °C.

After one year of acquisition with a frequency of one measure per two-hour, the thermologger data were gathered and the variations plotted in Figure 12 for the three months of June, July and August 2022, since it has been noticed that the loggers had difficulties registering the temperatures when the latter were below 0 °C for an extensive period of time. The temperatures recorded by thermologgers near the surface (Up) show an average variation between 8 °C at night and 15 °C during the day, while those recorded by the thermologgers deep in the fractures (Down) are more stable, around 6 °C throughout the day. The thermologgers TH3<sub>down</sub> registered negative temperatures in June.

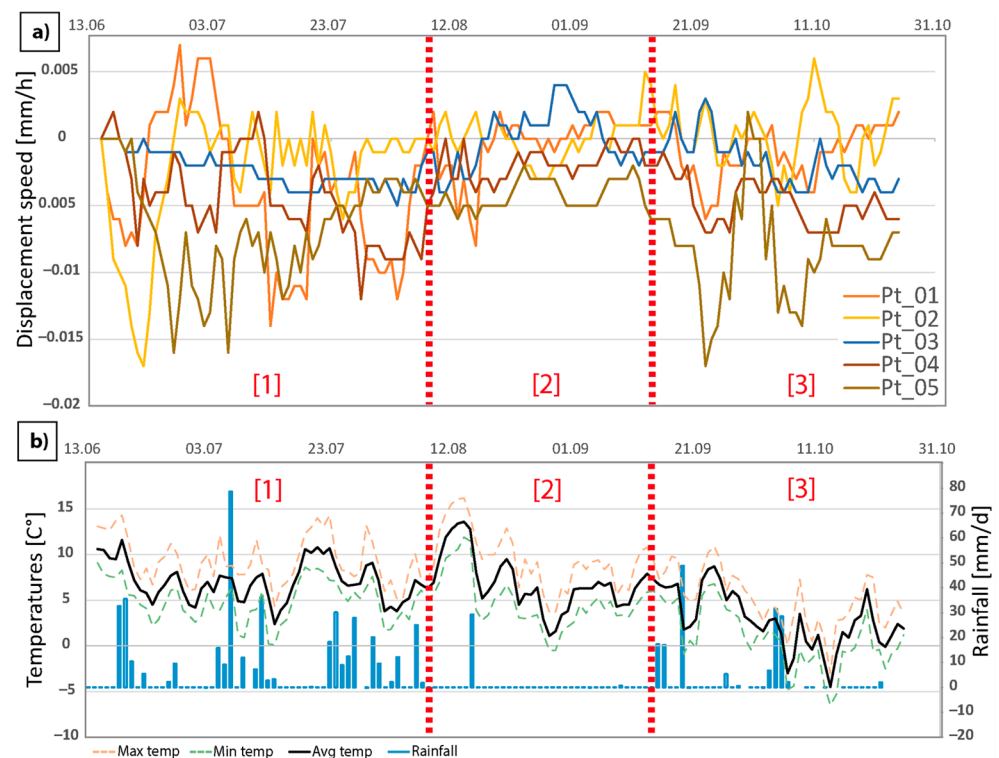
**Figure 13.** Correlation between GB-InSAR speed displacement and meteorological condition during the Summer 2021. (a) Variation of displacement speed for 5 points located on Figure 8. (b) Temperatures and precipitations measured by the national meteorological station. During the periods ‘1’ and ‘3’, the precipitations were more intense and the displacements more important than during period ‘2’.

the 4 months of GB-InSAR monitoring in 2021 are plotted (Figure 13a), as well as the temperatures and precipitations recorded by the meteorological station SLFI2 (Figure 13b).

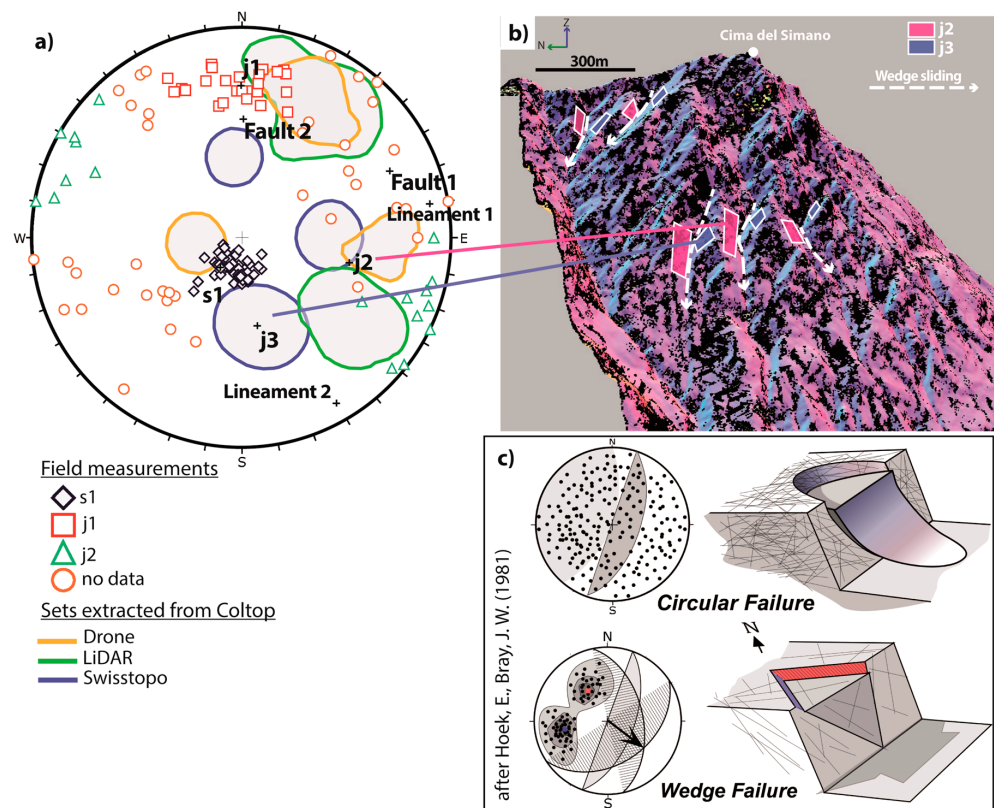
**Figure 14.** Structural analysis. (a) Lower hemisphere stereonet of the discontinuities measured on the field and on the Swisstopo DEM, the LiDAR and the drone PCs with Coltop. (b) Planes j2 and j3 forming a wedge located on the Swisstopo DEM PC. (c) Geometric condition and stereography pattern in the case of a rotational slope failure and of a wedge failure, after [56].

The plotted orientations are dispersed over the entire stereonet. This stereonet pattern is characteristic of a rotational deep-seated landslide because the fracturing is high (Figure 3) and the discontinuities are spread in all directions (Figure 14c, [56,66,67]). Nevertheless, the sets  $j_2$  and  $j_3$  could also form a sliding wedge along the sliding line oriented at  $51^\circ/127^\circ$  (Figure 14b).

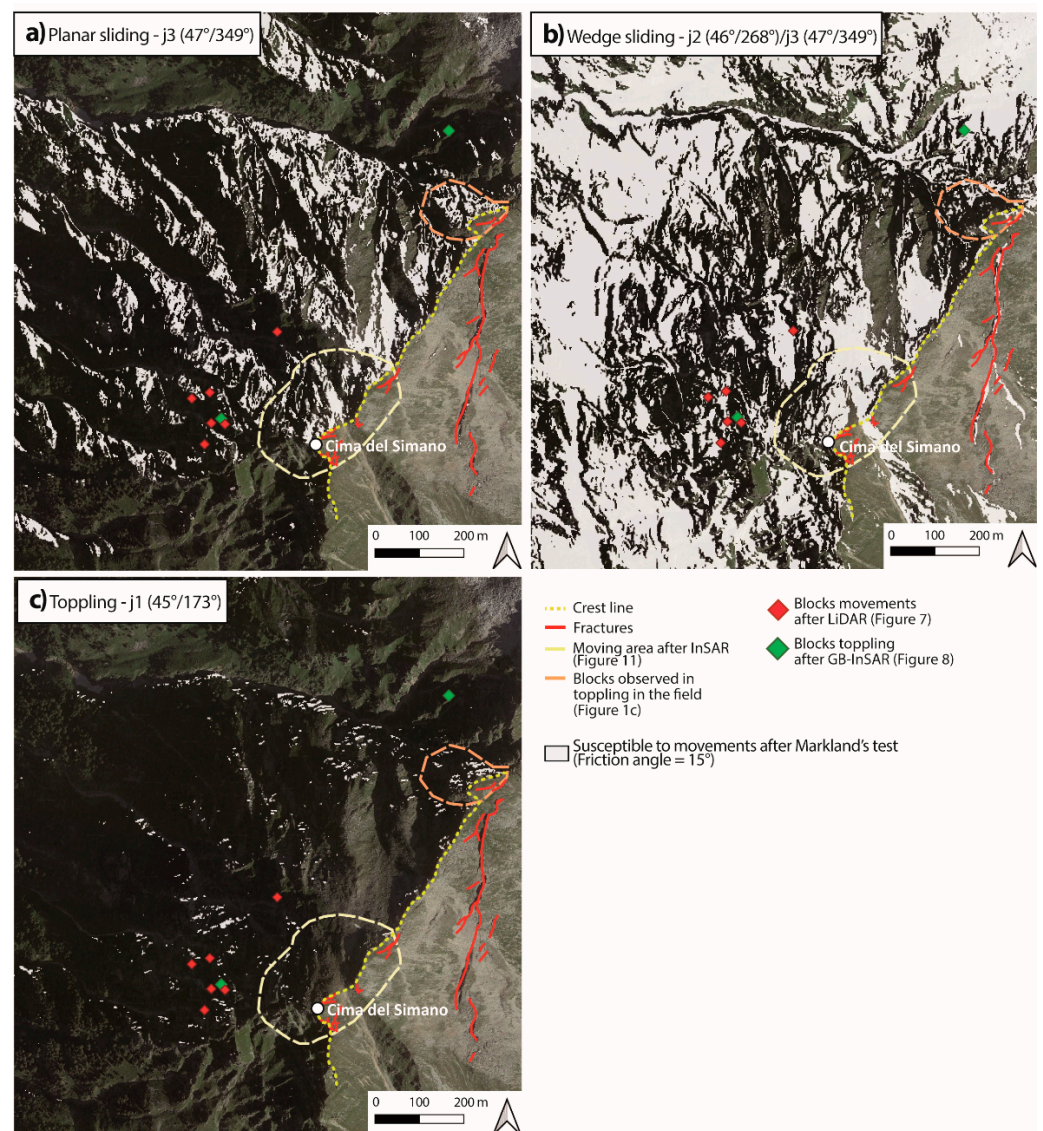
**Figure 15.** Markland's tests with the discontinuity sets detected in the Swisstopo DEM for a friction angle of  $15^\circ$ . (a) Susceptibility to planar sliding considering planes from j3. Angles of lateral limits are  $20^\circ$ . (b) Susceptibility to wedge sliding involving j2 ( $46^\circ/268^\circ$ ) and j3 ( $47^\circ/349^\circ$ ). (c) Susceptibility to toppling with planes from j1. Angles of lateral limits are  $20^\circ$ .

The Markland's tests were conducted with the three discontinuity sets extracted from the Swisstopo DEM. They confirm the susceptibility to planar sliding along planes belonging to joint sets j1, j2 (Supplementary Figure S1a,b) or j3 (Figure 15a) to wedge sliding involving j2 and j3 (Figure 15b) and highlight the locations of potential toppling blocks involving joint sets j1 (Figure 15c) and j3 (Supplementary Figure S1c).

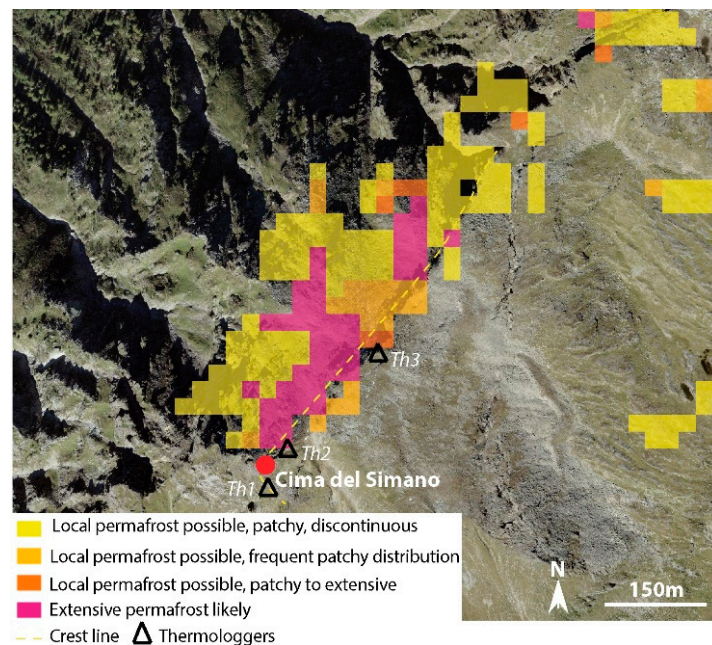
**Figure 16.** Permafrost map from [70] suggesting the presence of permafrost where the thermologgers were installed.

The negative temperatures registered by TH3<sub>down</sub> suggest the potential presence of permafrost at depth, as suggested by the Swiss Federal Office for the Environment (OFEN, [70]) on the Swisstopo portal (Figure 16). But with the climate changes it may have disappeared, causing the destabilization of the surface, and the recent acceleration of global warming could increase this destabilization.

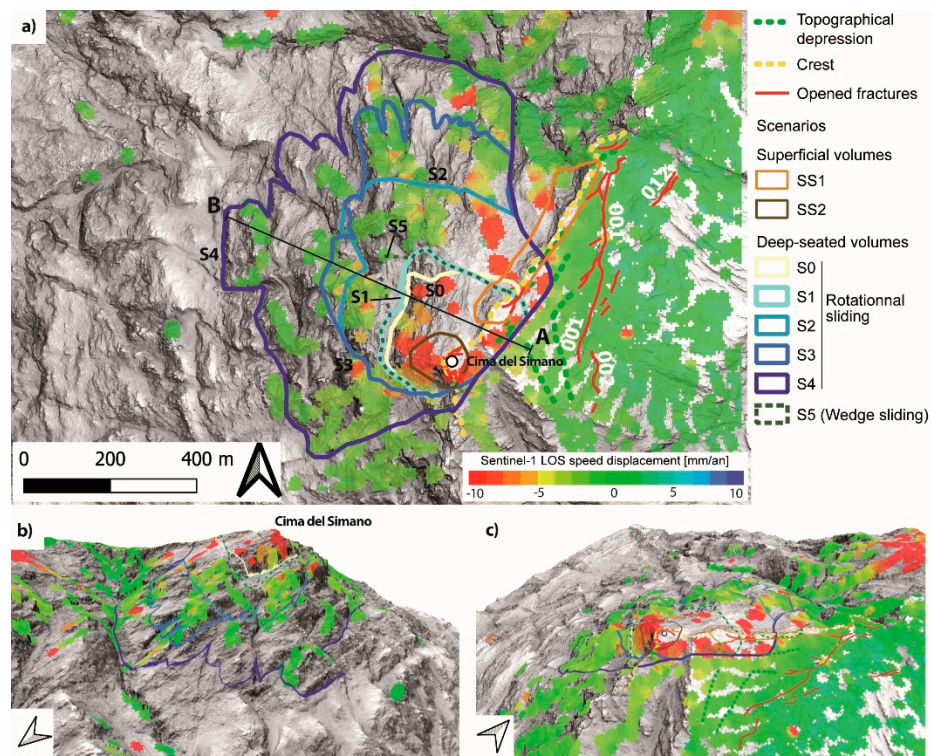
**Figure 17.** Delimitation of the eight scenarios. (a) In 2D. [AB] corresponds to the cross section of Figure 19d. (b), (c) In 3D.

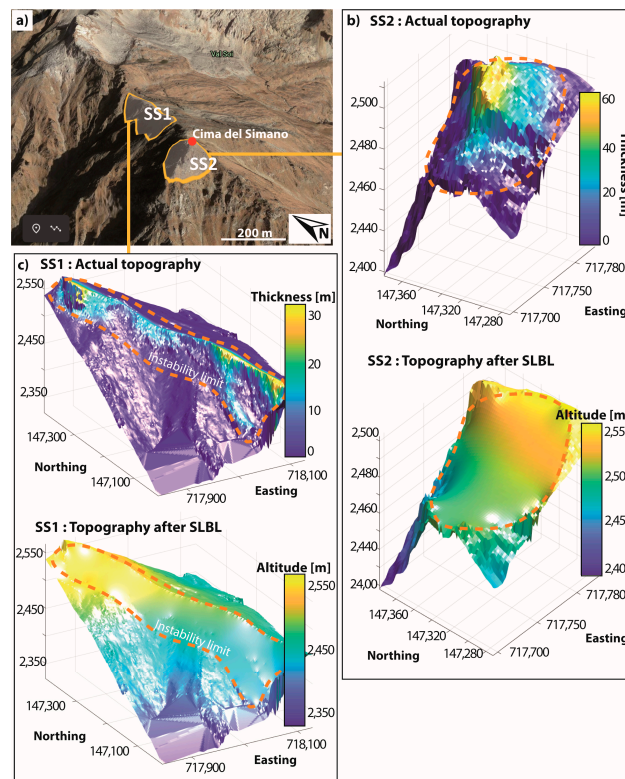
**Figure 18.** Rupture scenarios ‘SS1’ and ‘SS2’ for small volumes that could trigger rockfalls. (a) Potential instabilities outlined for the two scenarios. (b) and (c) SLBL results for scenarios ‘SS1’ and ‘SS2’ estimating, respectively, an unstable volume of  $230 \times 10^3 \text{ m}^3$  and  $251 \times 10^3 \text{ m}^3$  that could be released in the case of a slope failure.

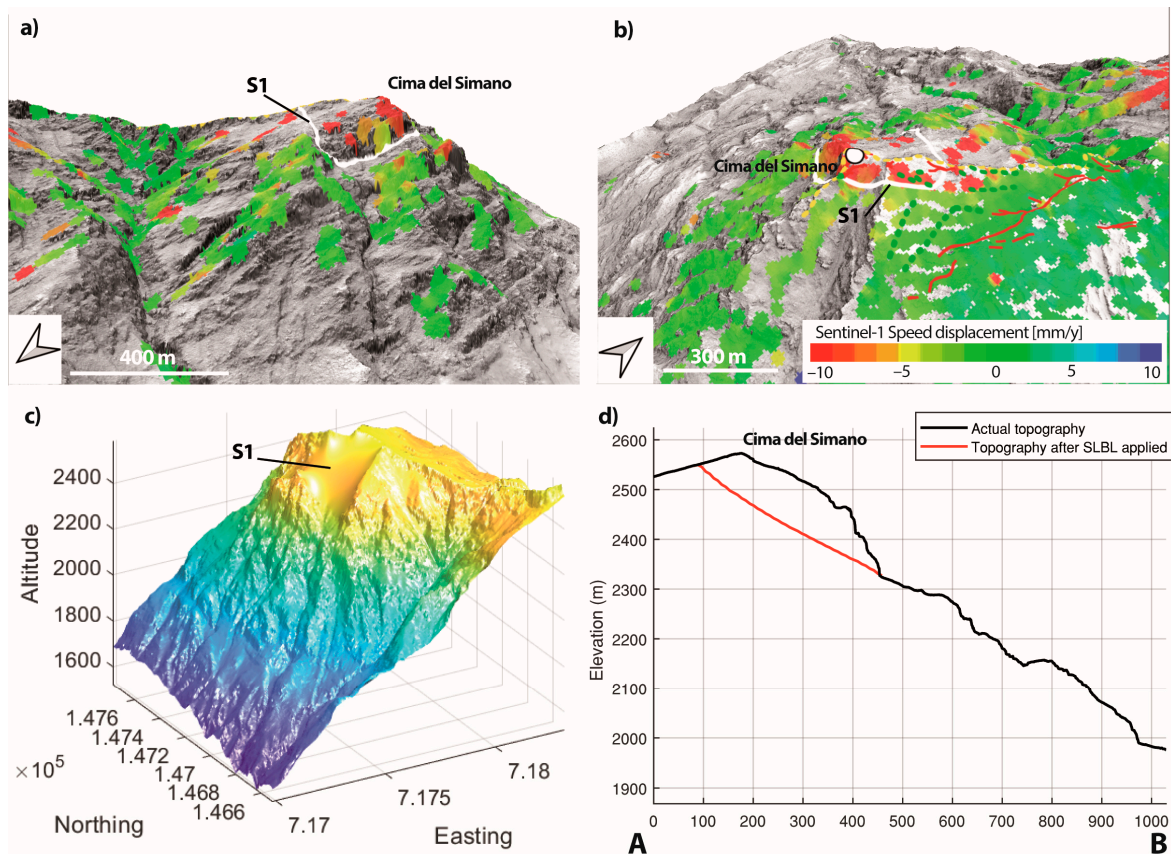
**Figure 19.** Detailed description of the rotational sliding scenario S1. (a,b) Delimitation drawn on 3D map corresponding to the moving area according to InSAR. (c) Topography after applying the SLBL algorithm. (d) Cross-section along the sliding direction line [AB] presented Figure 17.

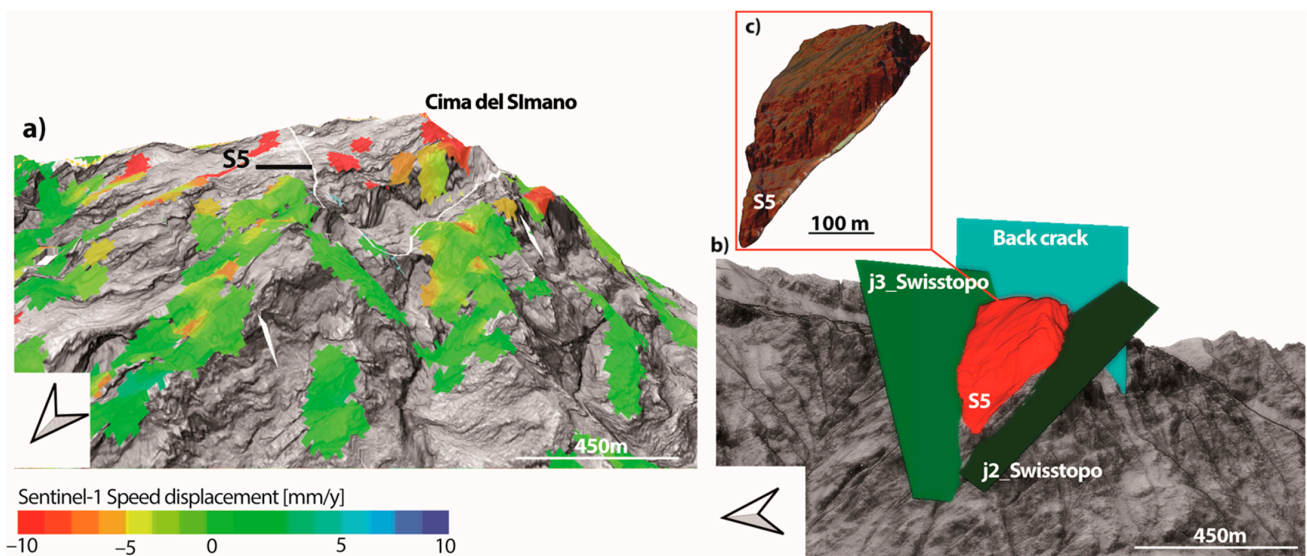
**Figure 20.** Detailed description of the wedge sliding scenario S5. (a) Delimitation drawn on 3D map corresponding to the moving area according to InSAR. (b) Geometry constraining the sliding of volume S5. (c) Extracted volume meshed with Cloud Compare.

The volumes of those scenarios computed with the SLBL vary from  $3 \times 10^6 \text{ m}^3$  to  $5 \times 10^7 \text{ m}^3$ . An additional deep-seated scenario 'S5' (Figure 20a) is proposed considering a wedge sliding between two plans from the discontinuity sets j2 and j3. The geometry of the scenario was created in Cloud Compare using three planes, two of them belonging, respectively, to the two discontinuity sets and the third one to a back crack oriented at  $85^\circ/315^\circ$  (Figure 20b). The volume was estimated by meshing the extracted PC corresponding to the unstable compartment with the Poisson Recon tool ([72], Figure 20c).

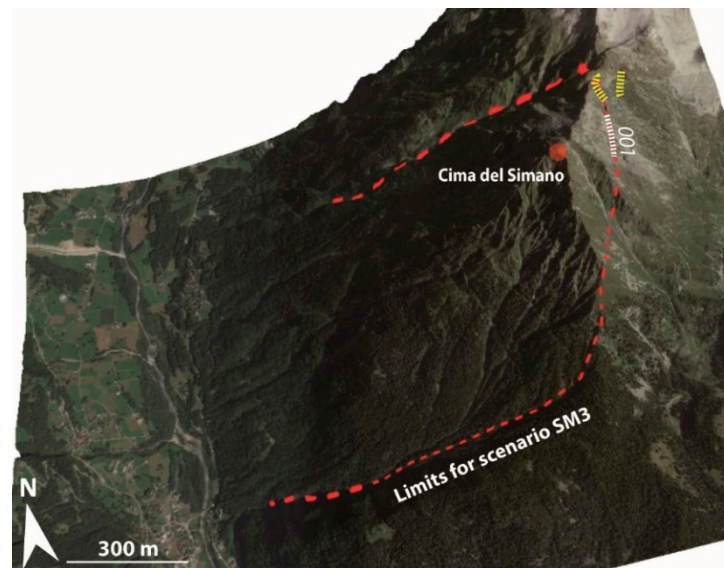
**Figure 21.** Hypothetical delimitation for the unstable compartment involving the main open fracture '001'. In white dash line, the location of the open fracture and, in yellow dash line, the prolongation of a fracture visible in the topography.

'001' and encompasses a huge volume. In the field, several fractures were observed toward the North of the main fracture, and likely represent its prolongations. Figure 21 displays the limits suggested for the scenario SM3.

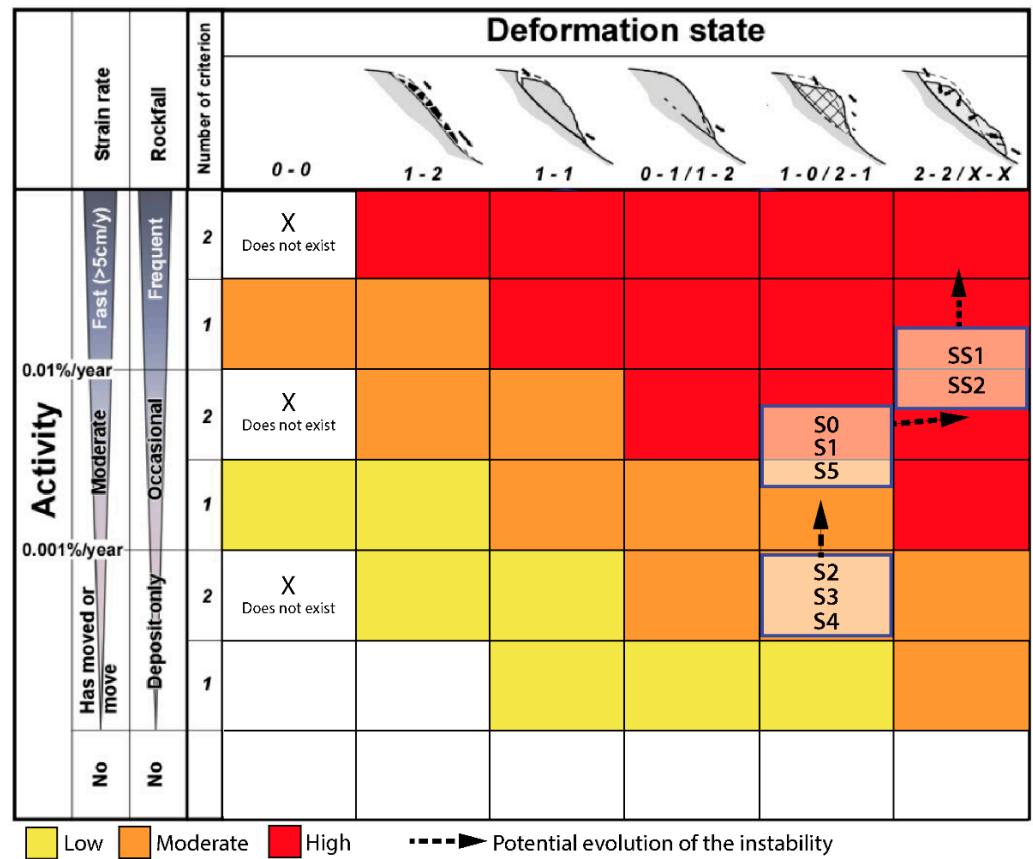
Figure 22. Attempt to locate Cima del Simano suggested instabilities on the susceptibility chart proposed by [73], based on the combination of information on deformation states and rates, and potential evolution of the instability.

Scenarios 'SS1' and 'SS2' show clear signs of movement and rockfall activity for an average displacement speed, respectively, of 9 mm/y and 11 mm/y, equivalent to a deformation rate between 0.016%/yr and 0.018%/yr. The displacements are similar at the top and at the toe of the delimited scenarios. Observations in the field indicate that the rock

is highly fractured with signs of rockfall activity, which may be indicative of significant internal deformations. The deformation state is of type 2-2 and the susceptibility can be supposed to be high.

For scenarios ‘S0’, ‘S5’ and ‘S1’, delimiting the moving areas, their total instability lengths are, respectively, about 200 m, 250 m and 300 m, for a displacement speed of 7 mm/yr in average, leading to a deformation rate of, respectively, 0.0035%/yr, 0.0028%/yr and 0.0023%/yr, with very little rockfall activity, mostly located at the crest. From the InSAR results, the instability experiences more deformation at its crest than at its toe. The deformation state could be 1-0 and the corresponding susceptibility is moderate to high.
