Assessing the Hazard of Deep-Seated Rock Slope Instability through the Description of Potential Failure Scenarios, Cross-Validated Using Several Remote Sensing and Monitoring Techniques

Charlotte Wolff ^{1,*}, Michel Jaboyedoff ¹ , Li Fei ¹, Andrea Pedrazzini ², Marc-Henri Derron ¹, Carlo Rivolta ³ and Véronique Merrien-Soukatchoff ^{1,4}

Abstract: Foreseeing the failure of important unstable volumes is a major concern in the Alps, especially due to the presence of people and infrastructures in the valleys. The use of monitoring and remote sensing techniques is aimed at detecting potential instabilities and the combination of several techniques permits the cross-validation of the detected movements. Supplemented with field mapping and structural analysis, it is possible to define possible scenarios of rupture in terms of volume, mechanisms of failure and susceptibility. A combined observation strategy was applied to the study of major instability located in the Ticinese Alps (Switzerland), Cima del Simano, where the monitoring started in 2006 with the measurement of opened cracks with extensometers. Since 2021, the monitoring has been completed by LiDAR, satellite and GB-InSAR ob

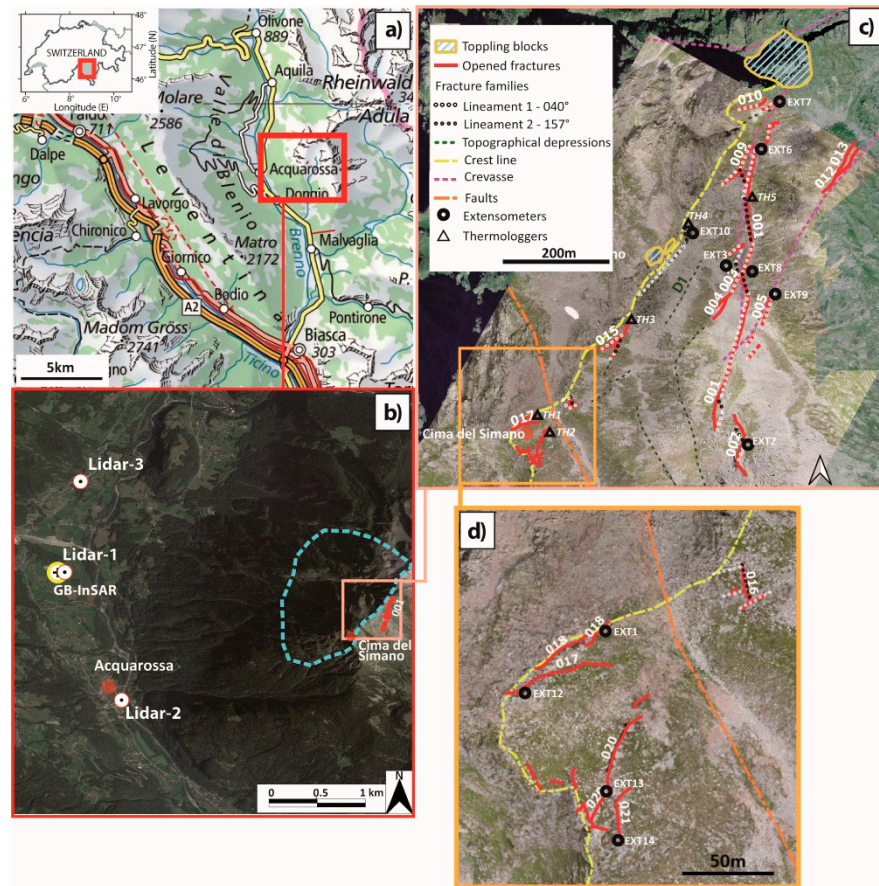
Figure 1. Characterization of the case study with the location of the remote sensing devices installation. (a) Localization. (b) LiDAR and GB-InSAR installed in the Valley, distance 3.5 km from the mountain peak. The area illuminated by the GB-InSAR is delimited in blue (c). (d) Mapping on the orthophoto from SfM photogrammetry of the fractures, faults and depressions on top of Cima del Simano and extensometers and thermometers installed in the fractures.

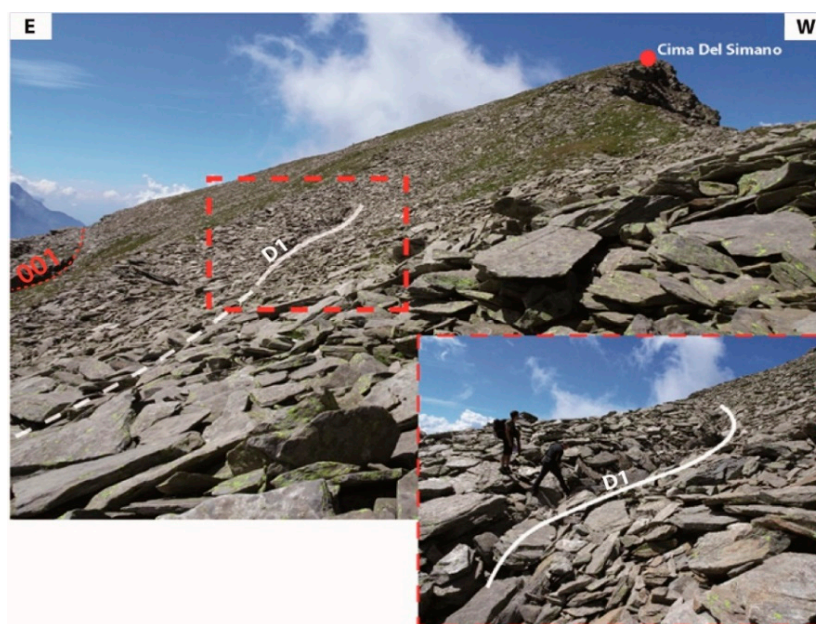
Figure 2. Photo of the depression D1 mapped in Figure 1c.

In the Ticino Canton (Switzerland), landslides are recurrent natural hazard phenomena occurring due to very steep slopes induced by glaciers, rapid uplift [38] and heavy rainfalls. Many studies map and describe those threats [14,39]. One of the present concerns is the Cima del Simano Mountain in the Blenio Valley, near the village of Acquarossa (Figure 1a). The area of instability is part of the Simano Nappes [40] and is made up of an orthogneiss with the main schistosity oriented, on average, to $20^\circ/035^\circ$ [41]. The top, reaching an altitude of 2500 m, displays several fractures of various sizes. A 500 m-long major opened crack is located at 100 m toward the southeast behind the crest and identified as '001' in Figure 1b. Nevertheless, numerous other cracks of a smaller length and smaller aperture are also visible closer to the crest line and some delineate clear depressions (Figure 1c,d). They follow two main lineaments oriented at 040° and 157° towards north, respectively mapped in white and black in Figure 1c. A regional fault also crosses the mountain perpendicularly to the crest. A major depression named D1 in Figure 1c is visible in the field and is covered by the debris of rocks (Figure 2).

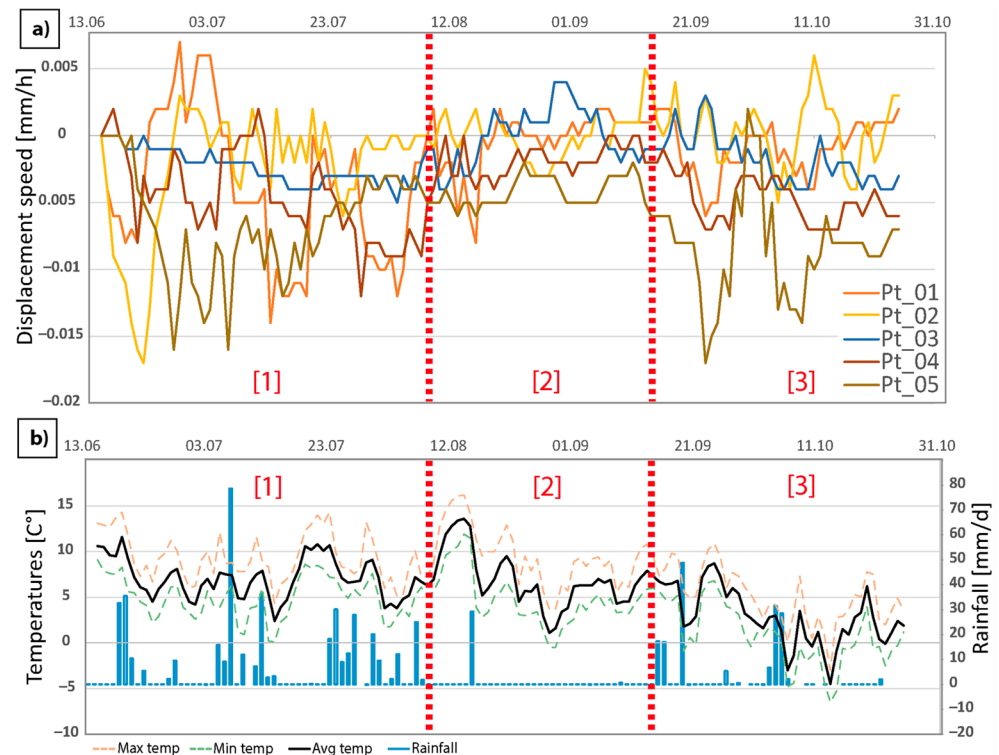
Figure 13. Correlation between GB-InSAR speed displacement and meteorological condition during the Summer 2021. (a) Variation of displacement speed for 5 points located on Figure 8. (b) Temperatures and precipitations measured by the national meteorological station. During the periods ‘1’ and ‘3’, the precipitations were more intense and the displacements more important than during period ‘2’.

Additionally, height points located on the cliff (Figure 9) and showing signs of movements according to the GB-InSAR were selected and their displacement speeds during

the 4 months of GB-InSAR monitoring in 2021 are plotted (Figure 13a), as well as the temperatures and precipitations recorded by the meteorological station SLFI2 (Figure 13b).

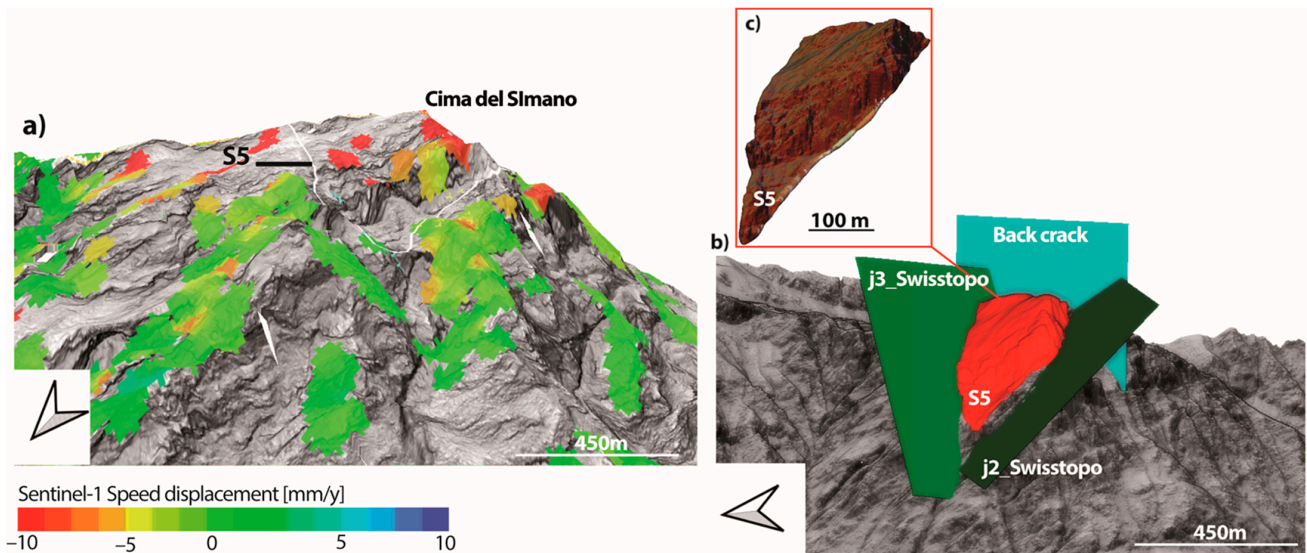
Figure 20. Detailed description of the wedge sliding scenario S5. (a) Delimitation drawn on 3D map corresponding to the moving area according to InSAR. (b) Geometry constraining the sliding of volume S5. (c) Extracted volume meshed with Cloud Compare.

The volumes of those scenarios computed with the SLBL vary from $3 \times 10^6 \text{ m}^3$ to $5 \times 10^7 \text{ m}^3$. An additional deep-seated scenario 'S5' (Figure 20a) is proposed considering a wedge sliding between two plans from the discontinuity sets j2 and j3. The geometry of the scenario was created in Cloud Compare using three planes, two of them belonging, respectively, to the two discontinuity sets and the third one to a back crack oriented at $85^\circ/315^\circ$ (Figure 20b). The volume was estimated by meshing the extracted PC corresponding to the unstable compartment with the Poisson Recon tool ([72], Figure 20c).
