# Mechanical behaviour for aeronautical structures with embedded electric cables under low energy impact

**Abstract.** *The work focuses on the mechanical strength of composite structures with embedded electrical functionalities submitted to low energy impact. This material is defined for aeronautical applications as multilayers of glass fibre composite with flat electrical cable layers embedded. The main question is about the damage involved by the low energy impact, and its influence on the electrical cables layer performances. The impact leads to failure with no external signs of damage and insulation degradation. The dynamic experimental campaigns are carried out on drop tower tests with hemispherical tool. localized damage mechanisms at conductor interfaces are observed and a finite element model is performed. A link between impact energies and loss of electrical performance of multifunctional samples is established.*

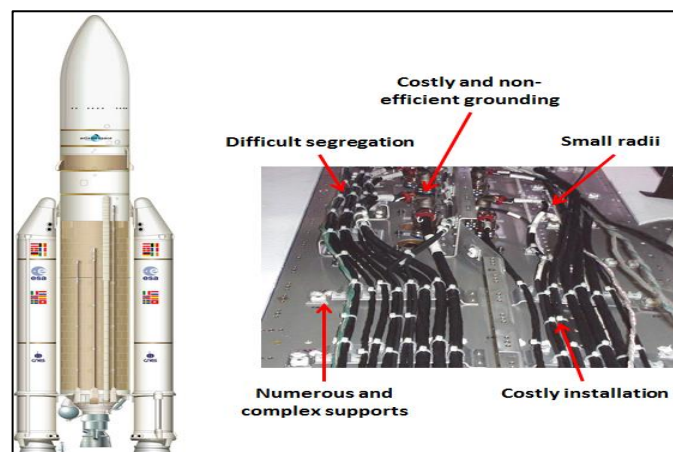
**Figure 1.** Installation and segmentation of the wire is time-consuming.

Ariane Group wished to investigate the replacement of conventional wiring solutions for space launcher applications (cf. figure 1). Such a technology would also offer the potential to carry synergies

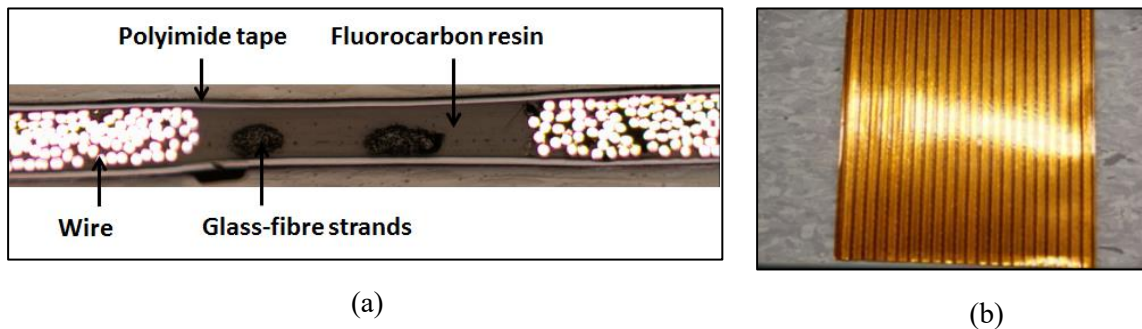
**Figure 2.** (a) Cross section of flat electrical cable, (b) sample of flat electrical cable.

The electrical cables have a nominal width of about 85mm containing 17 AWG20 electrical conductors with a width of about 3mm each once laminated inside the cable. Besides, it is worth noting that to ensure the electrical cable's flatness, the fluorocarbon resin sections were filled with two glass-fibres between every electrical wire, as shown in figure 2.

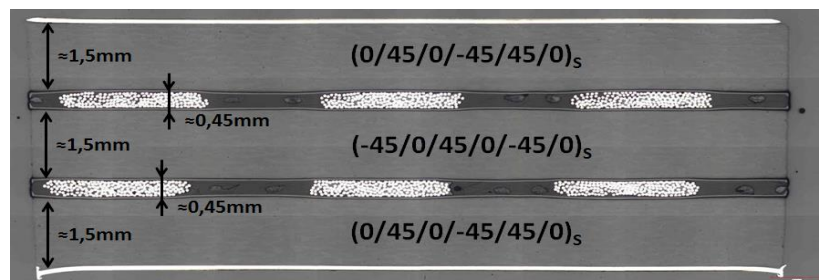
**Figure 3.** Cross-section of multi-layered composite functional structure.

The solution investigated consists in superposing two flat electrical cables to have sufficient electrical wires for power and data transmission and return current functions. Hence, two flat electrical cables are laid one above the other within the composite structure. The distance between them is chosen according to the required characteristic impedance of the line. This divides the composite structure into three lay-ups of thickness  $h$ , with  $h=1.5\text{mm}$ . Additionally, two copper foils are laminated on the outer surfaces of the multifunctional structure for electromagnetic shielding purposes.

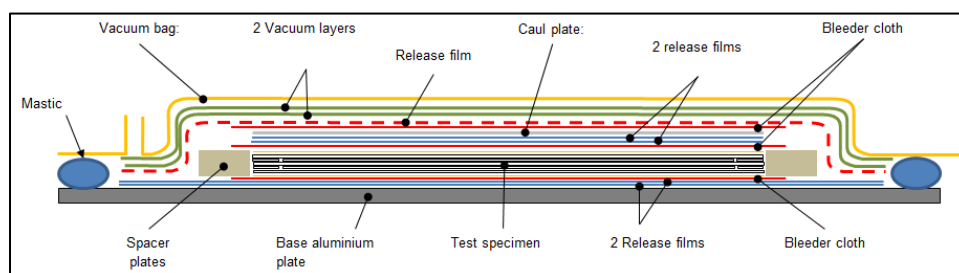
**Figure 4.** Curing environment of plates and specimens tested.

The composite plies are glass preregs, i.e. pre-impregnated woven sheets of glass fibre with epoxy resin, that require a cure cycle of 180min at  $160^\circ\text{C}$  under pressure between 1 and 5 bar in an autoclave according to the manufacturer's datasheet. The curing environment is presented in Figure 4. The outer stacking sequences of composite plies are  $[0/45/0/-45/45/0]_s$  and the inner stacking sequence is  $[-45/0/45/0/-45/0]_s$ . The composite plies, flat electrical cables and copper foils were manually laid up in this configuration while performing intermediate compacting and suitable surface treatment of the electrical cables (such as dry-cleaning) to ensure good interface properties between the composite and the cables. This manufacturing process was used to manufacture every plate and test specimens presented.

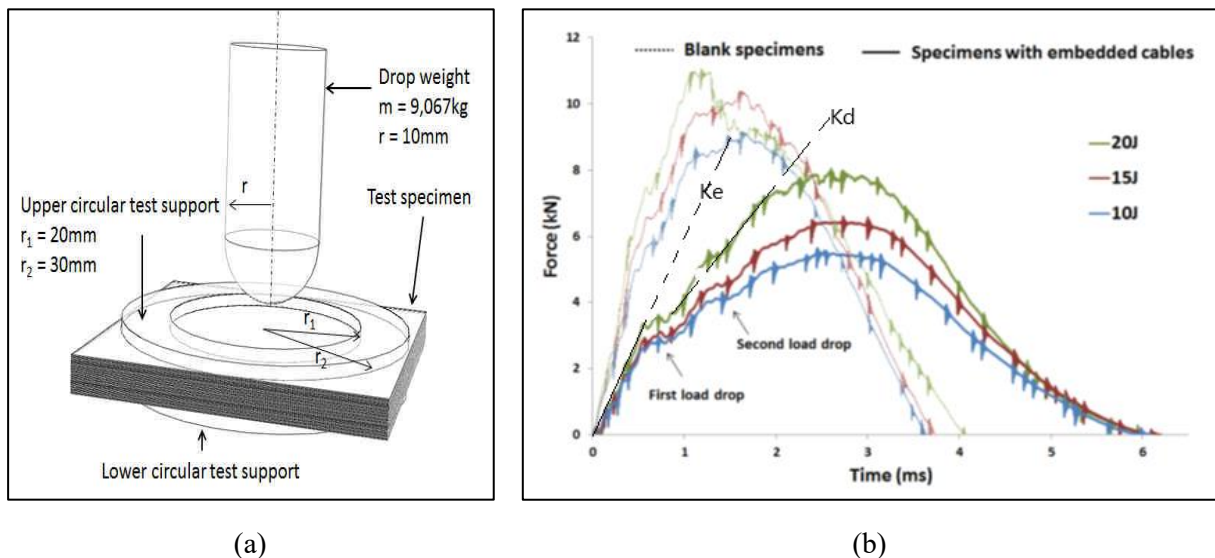
**Figure 5.** (a) Drop weight test impact setup (b) Comparison between the contact force histories of the multifunctional and blank test specimens impacted at 10J, 15J and 20J.

Impact tests are carried out on an Imatek drop weight tower at 10J, 15J and 20J with a constant weight of 9,067kg dropped from a height varying from 0,11m to 0,22m to achieve the required impact energies. The impactor is made of hardened steel and has a diameter of 20mm. The test specimens have dimensions of 60x60mm<sup>2</sup> and are pneumatically clamped between two cylinders with  $D_{int} = 40\text{mm}$  and  $D_{ext} = 60\text{mm}$  (figure 5a).

The contact forces recorded by a piezoelectric sensor at the bottom of the impactor are plotted for three test specimens impacted at 10J, 15J and 20J (Figure 5.b) for specimens without embedded cable (Blank specimens) and specimens with embedded cables. The curves exhibit a dome shape, while at 20J a more severe discontinuity appears at approximately 1,2ms for Blank specimen. In addition, it turns out that the impact response (contact force history and damage mechanisms) observed is very similar to what is described in the work of Xiao, et al. [4] where thick laminates have been impacted with a similar impactor and boundary conditions. Bi-linear behaviour can be deduced from the contact force history, where the initial linear behaviour (slope  $K_e$ ) is followed by a slight drop and another linear behaviour (with a slope  $K_d$  and  $K_d < K_e$  indicating losses of flexural and shear stiffness).

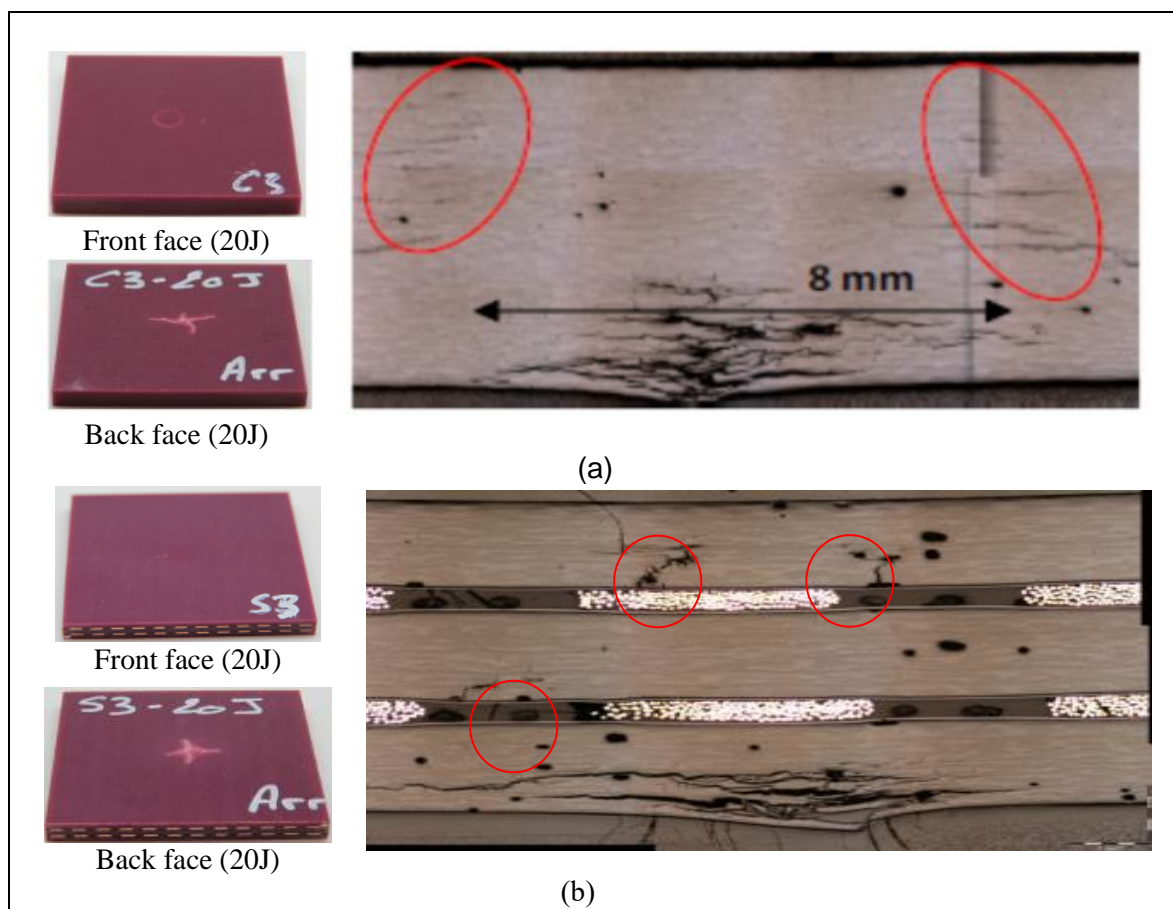
**Figure 6.** (a) Post-impact microscopic observations of the damage distribution within the multifunctional test specimens (b) microscopic observations within blank specimens.

This is likely to be associated with local matrix cracks followed by initiation of delamination in a ring shape through the thickness of the laminates as observed in figure 6. Indeed, delamination initiation is mainly due to high transverse shear which are localized around the impact zone, hence resulting in a ring shape and propagating through the laminate due to the transverse shear loading. Once the delamination has propagated, fibre failure begins on the back face of the test specimens at 15J and 20J.

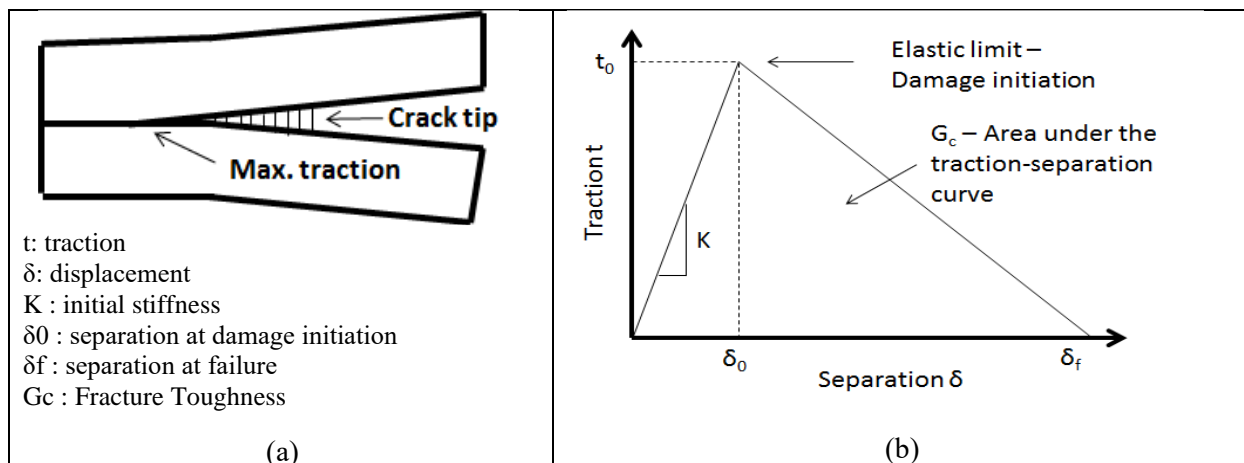
**Figure 7.** (a) Cohesive damage evolution at the interface, (b) traction-displacement curve behaviour.

To reproduce the sliding inside the cables under inter-laminar shear strains, cohesive interactions are defined at the interface between cable and the composite plies, as shown in figure 7.a. When treated with a traction-separation relationship, damage initiation is related to the maximum traction on the load – displacement curve, (figure 7.b), and is followed by a softening phase that simulates the progressive decohesion of the interface with increasing damage [6].

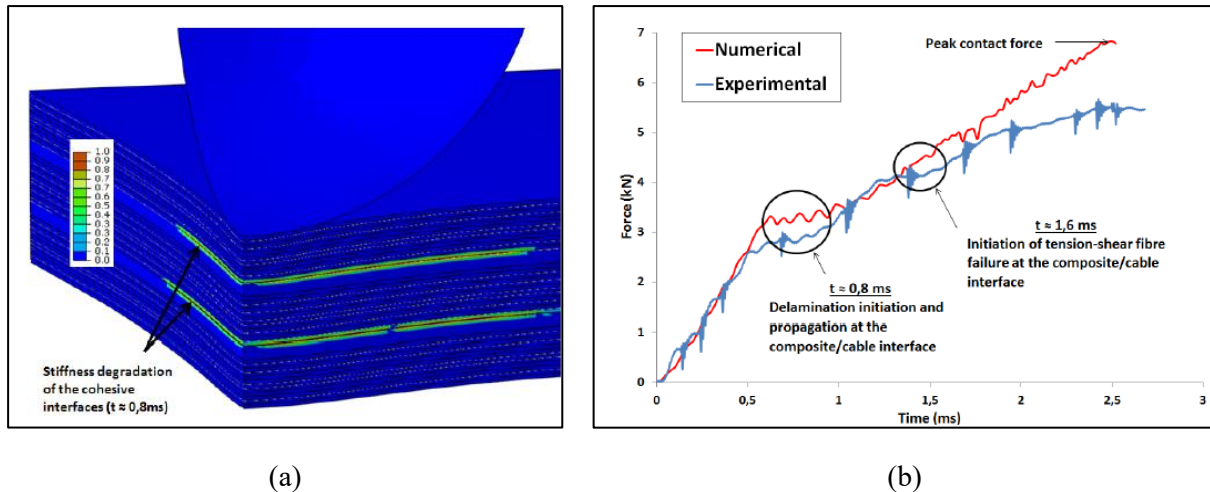
**Figure 8.** Numerical impact simulation of multifunctional specimen, (a) location of damage at interfaces, (b) impact force history comparison with experimental test.

In the numerical model, transverse shear strains seem to initiate inter-laminar damage and delamination at the interface of the flat cable layers in figure 8.a and identify in the contact force histories figure 7.b. It is observed that the fibre tension-shear failure which seems to initiate at the interface with the embedded cables is a consequence of the sliding that occurs inside the embedded cables. Indeed, sliding among the cables first occurs and is well reproduced by the cohesive surface to-surface interaction. This triggers the first load drop observed experimentally at 0,8 ms. It induces

higher inter-laminar and tensile strains on the adjacent composite plies, which leads to tension-shear fibre fracture captured at approximately 1,6ms.

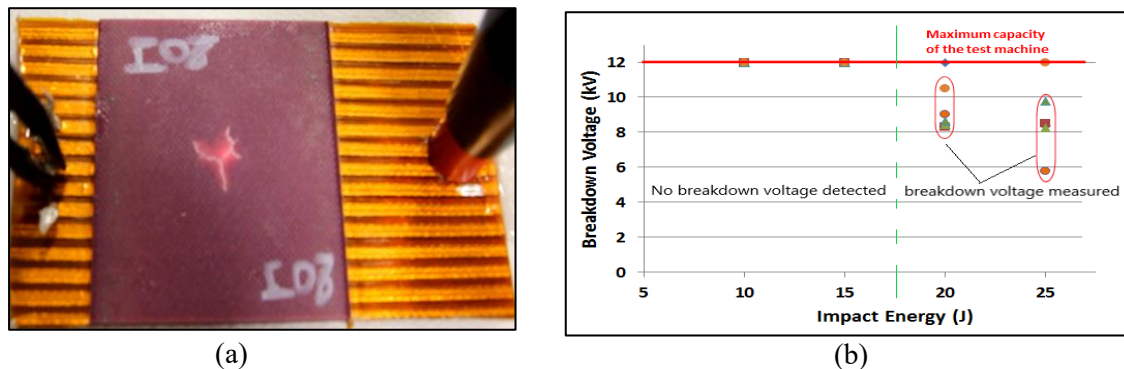
**Figure 9.** (a) Spark due to breakdown voltage localized in damage area (b) Identification of breakdown threshold versus impact energy.

Electrical shorting started occurring within the embedded cables for test specimens impacted at 20J under conventional impact test conditions as shown in figure 9.b. It always occurred between two conductors of the same cable (adjacent conductors of the top or bottom cable). Post-impact post-dielectric strength tests microscopic observations revealed that the electrical shorting occurred due to the internal tension-shear fibre failure observed previously. It is interesting to highlight that the resulting degradation was confined to the adjacent wires and did not spread to the other wires.
