Composite laminate with embedded electric cables submitted to low energy impact

Thibault Vogel, Jean-Christophe Walrick, Pascal Casari

Thibault Vogel, Jean-Christophe Walrick, Pascal Casari. Composite laminate with embedded electric cables submitted to low energy impact. 24ème Congrès Français de Mécanique, Aug 2019, Brest, France. hal-04308619

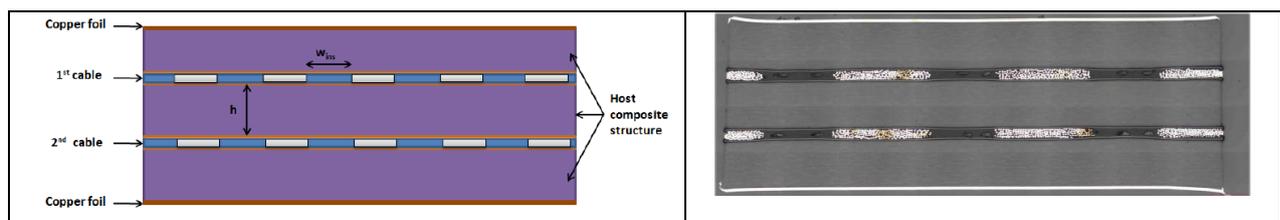
Fig. 1. Representative multifunctional sandwich system with 2 flat cable layers

This study focuses on a particular type of multifunctional composite laminated structure composed of 2 laminate embedding layers of flat cable (laminare + cable + laminare) as showed in. Fig. 1.

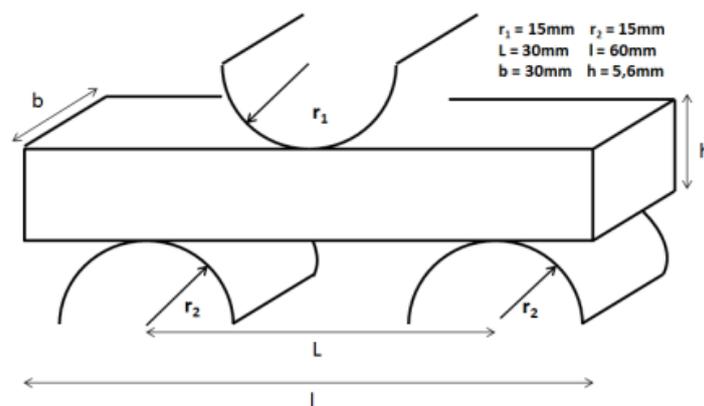
Fig. 2. Configuration of the Short 3 Point Bend Tests

The 3 points bend tests are investigated in a first stage for a better understanding of the influence of the integration, through the structure, of flat electrical cables on the damage and critical strength. This test, in short bending configuration involves inter-laminar shear strains expected critical at the interfaces of the electrical cable layers.

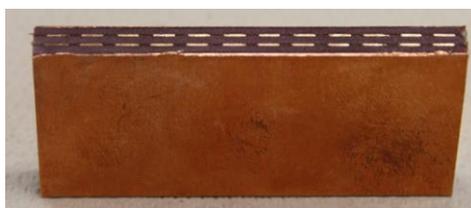
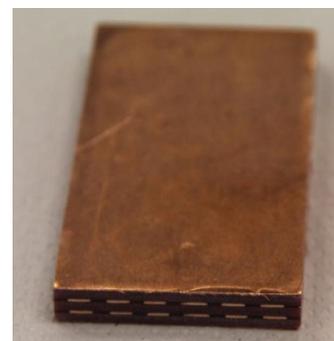
Fig. 3. Two configurations of multifunctional S3PB test specimens: (a) transverse and (b) longitudinal

Experimental results are compared on test specimens with and without embedded cables. The short 3 points bend tests (S3PB) are carried out according to normative reference ISO 14130. This loading is used for determination of apparent interlaminar shear strength of fibre-plastic composites by the short beam method. Hence, the width of the test specimens is chosen as 5 times the thickness and the length as 10 times the thickness. Besides, the electrical wires were either oriented in the transverse, or longitudinal direction regarding the specimen length to investigate on their influence on the bending stiffness of the structure (Figure. 3)

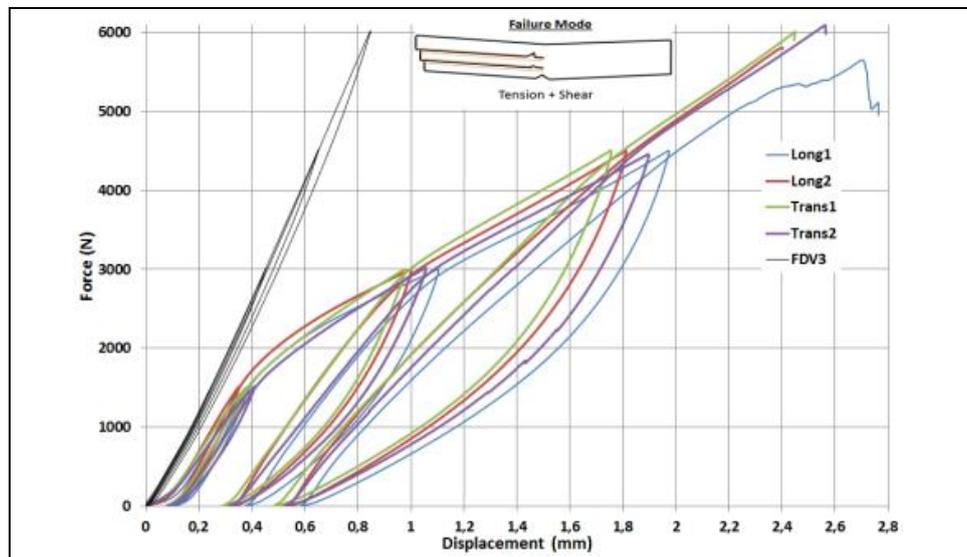
Fig. 4. Short 3 Point Bend for cyclic Test

Test specimens are tested under charge/discharge loading with increments of 1500 N, in order to compare to the results of the S3PB tests on multifunctional test samples compare to same thickness specimen without function embedded (blank specimen test).

The first observation that can be drawn is the highly non-linear behaviour of the multifunctional test specimens (transverse and longitudinal) as compared to the blank test specimens (sample ref. FDV3). Indeed, the hysteresis loops are much bigger for multifunctional specimens. Hysteresis loops indicates the presence of energy-dissipative mechanisms, which increase with increasing load.

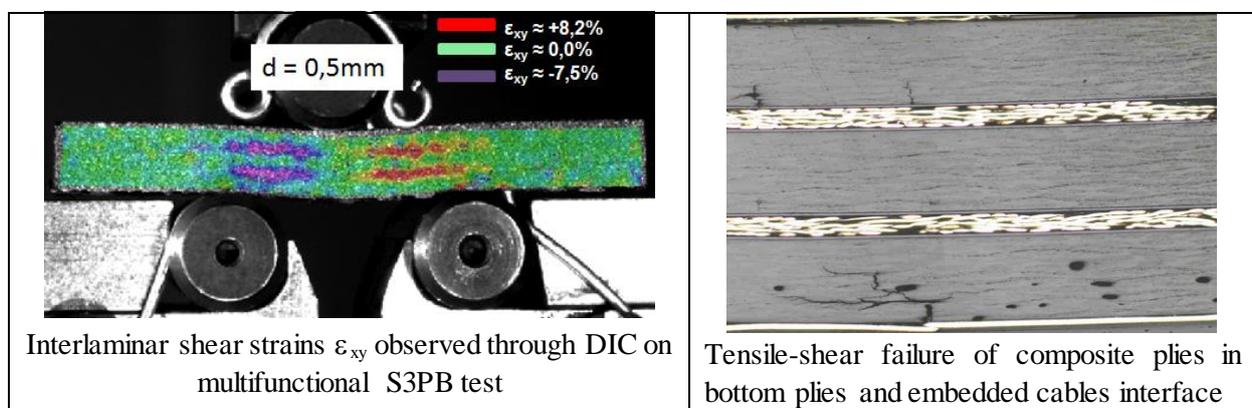
Fig. 5. Shear strain and failure distribution through the specimen thickness

These energy-dissipative mechanisms are mainly of two natures: firstly probable friction between the test specimen and the test machine supports. Secondly, damage mechanisms within the composite structure (friction between the warp and weft fibres, and fibre/matrix debonding [7]) and for multifunctional specimen, the inter-laminar shear deformation in the embedded cables and the associated damage which could be visually seen during test. These inter-laminar shear strains is revealed through Digital Image Correlations (DIC). In figure 5 where a qualitative measure of the inter-laminar strain field is presented for a displacement of the crosshead of $d = 0.5\text{mm}$. The two electrical cables involves a highly discontinuous load transfer between the three composite layups and a highly non-uniform distribution of the shear stresses through the thickness of the test specimen.

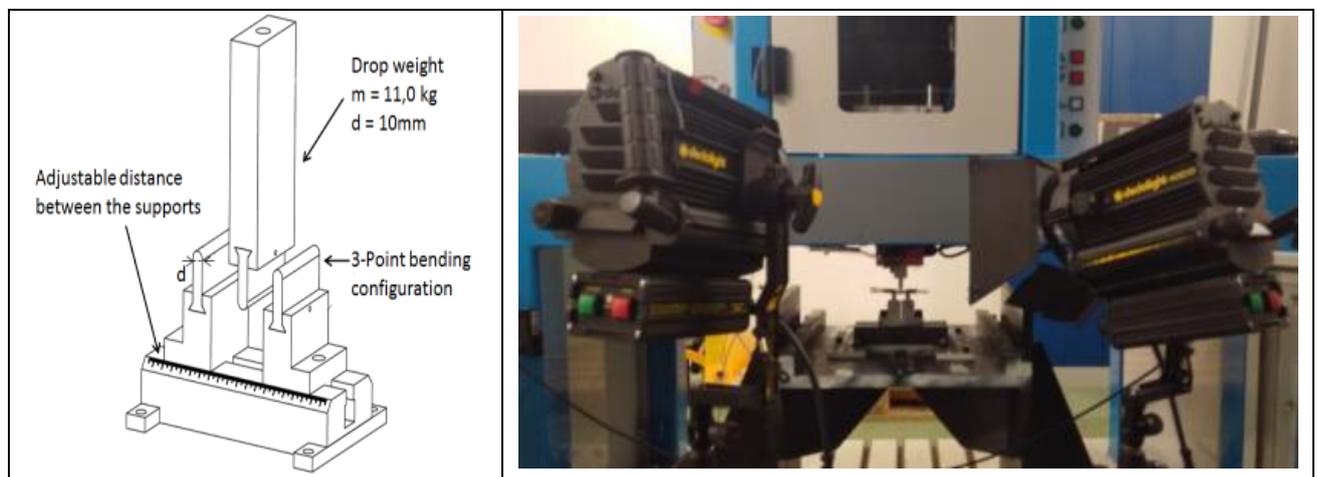
Fig . 6. Impact bending device on the drop test

The dynamic bending tests are performed on similar both blank and multifunctional test specimens. The bottom support was kept at 30 mm each other. A specific impact bending test setup was designed, figure 6. The setup was directly mounted on an Imatek IM10-30 drop-weight impact tester with two screwed connectors. The impactor and cylindrical test supports had cylindrical heads of 10 mm diameter, and the impactor total weight was 11,07 kg.

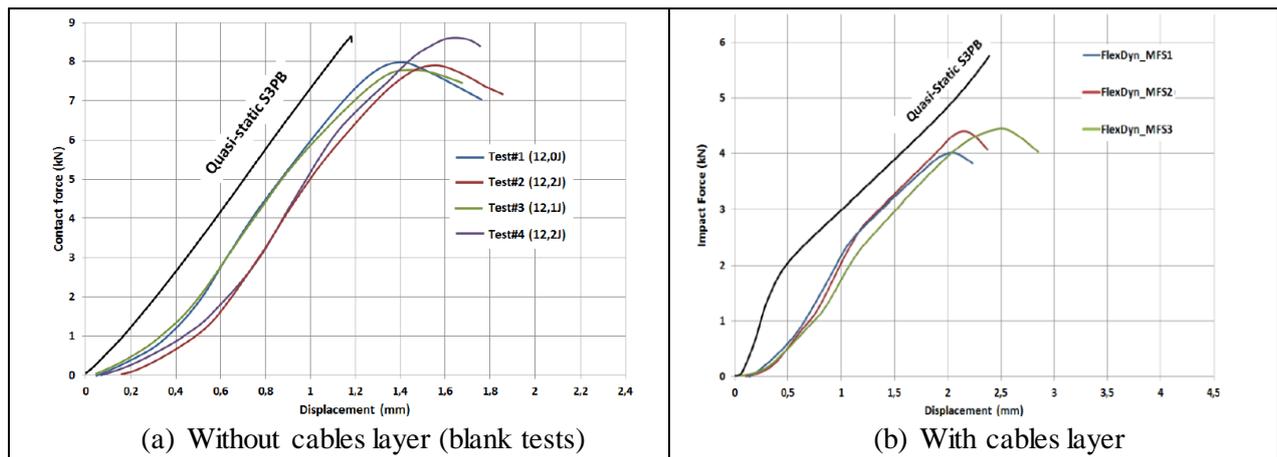
Fig. 7. Contact force-displacement curves for blank test specimen (a) and functional specimen (b)

The force-displacement curves of impact tests are performed on blank tests specimens (a) and multifunctional structure (b) are presented in Figure 7. The effective impact energies were measured between 12 and 13 joules.

For each configuration, test specimens exhibited a similar behaviour as regards to the force-displacement curves. For blank specimens, all test specimens fail at lower peak contact loads (8kN) than the quasi-static test specimens (8,75 kN). The same downward trend is present for the multifunctional specimen like for the quasi-static campaign. For the blank specimens, the main failure mode is a ply failure under tension on the bottom face under bending. For multifunctional test, similarly to the quasi-static measurements, the force-displacement curves can be divided into two parts: the initial loading up to slipping/cohesive damage within the cables, and loading up to ultimate failure. The experimental load-displacement curve seems to be altered due to a non-homogeneous distribution of the load up to 1.0 as shown by DIC analyse.

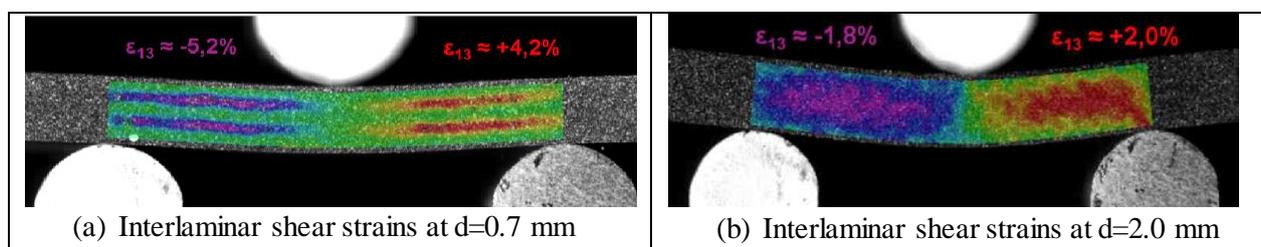
Fig . 8. Digital Image Correlations on (a) multifunctional and (b) blank test specimens

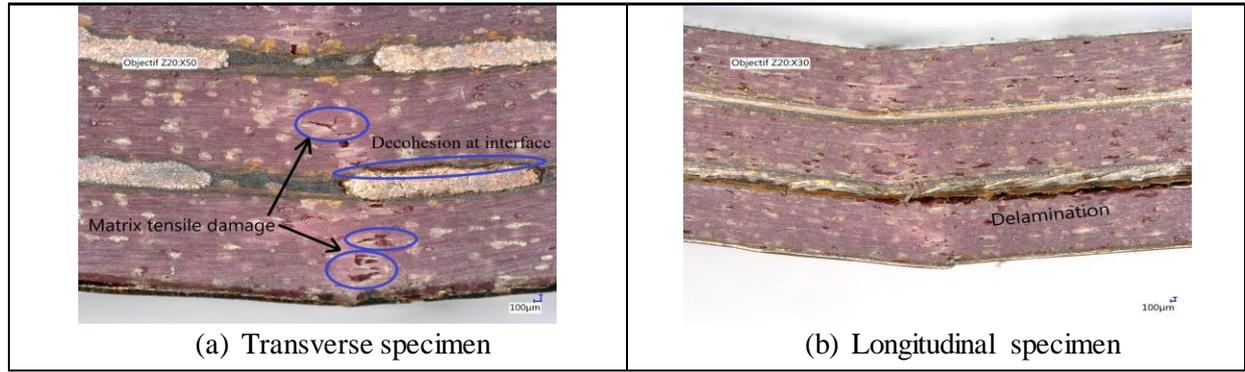
Fig .9. Damage repartition for multifunctional specimen (a) transverse

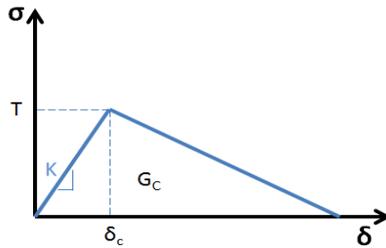
The cohesive constitutive law used here is a classical bi-linear mixed-mode traction-separation relationship [20] which is already available within Abaqus CAE, Damage initiation is taken into account with a maximum stress criterion (Eq.7), and damage propagation is modelled with an energy-based Benzeggagh-Kenane (BK) criterion (Eq.8).

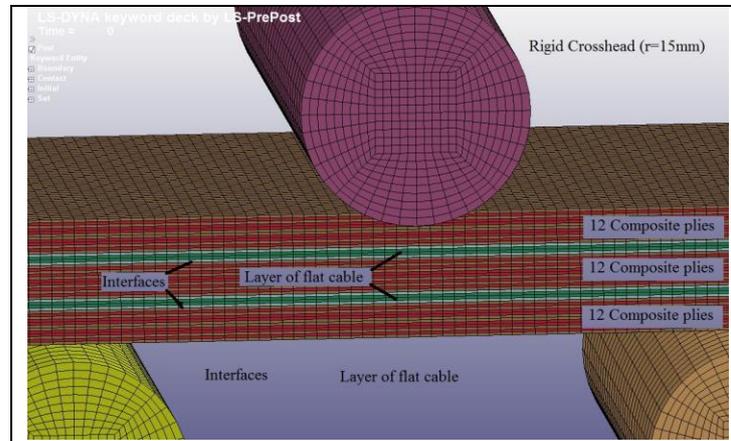
Fig. 10. Bending multifunctional sample model with stacking sequence of solid elements

Numerical models are achieved for short 3 points bend test in an explicit solver with the experimental setup. Solid finite elements are used for composite plies, embedded layers and interfaces between composite plies and embedded layer. Mat 162 as describe previously is associated for composite plies, with cohesive model for interface elements. Numerical results show below correspond to an impact of 13 Joules. Numerical correlations with experimental data help to define the best set of parameters to be used in cohesive zones.

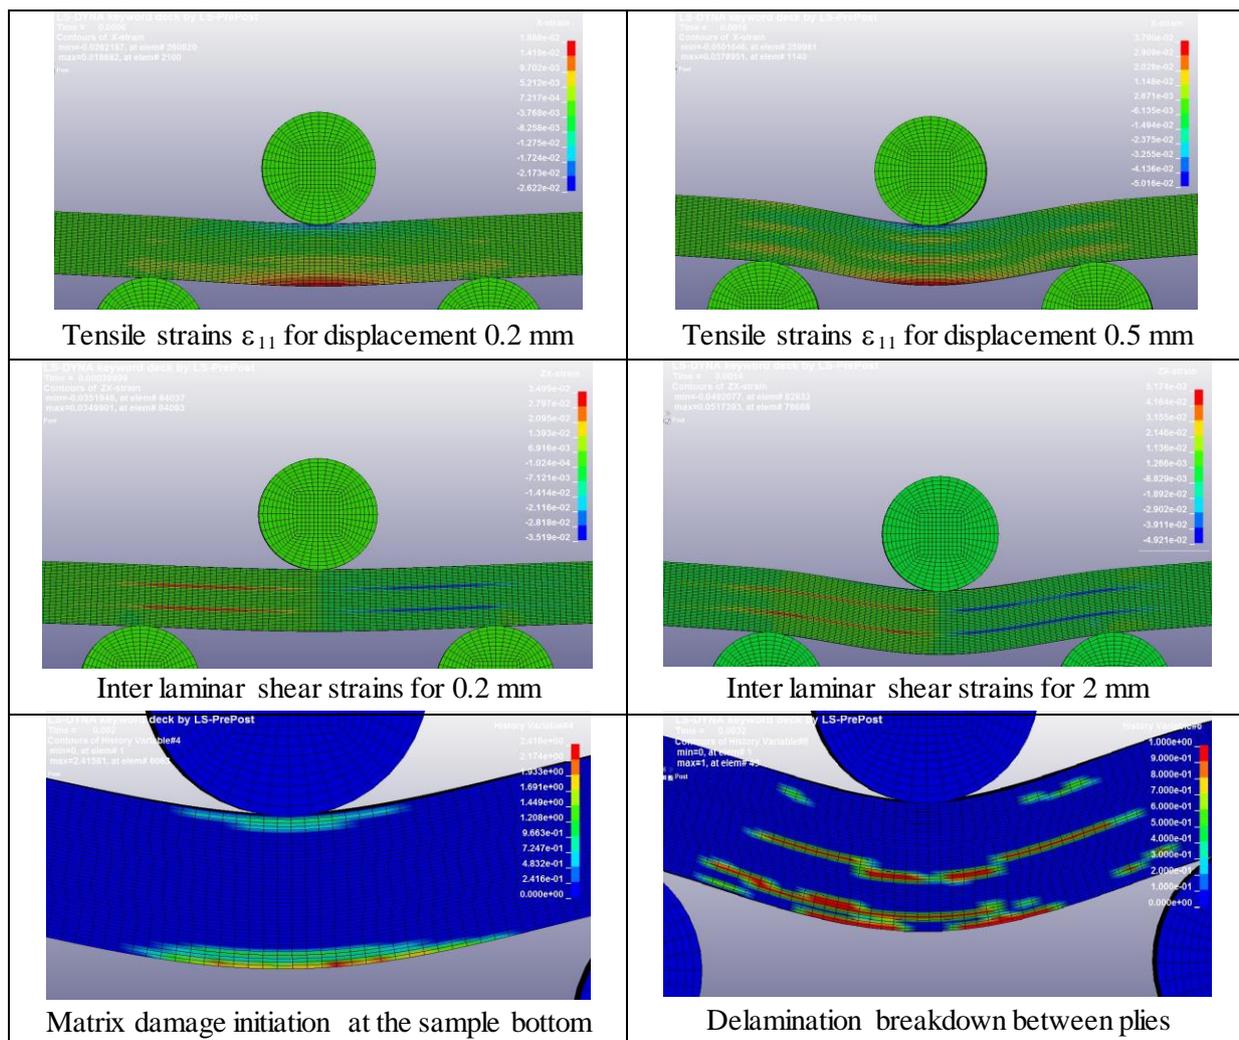
Fig . 11. Numerical strain field and damage results for multifunctional structure model

Under dynamic short 3 point bend test, as well quasi-static, the main strains fields through the sample thickness is mainly in tension at the bottom and inter-laminar shear between plies focused at the embedded cable layer interfaces. The strain gradient lead to local matrix damage initiation and delamination distribution similar to the experimental observations. The level of maximum inter laminar shear strain computed between -3.7% and 5% for displacement close to 2 mm seems similar to the level measured by DIC for experimental tests.

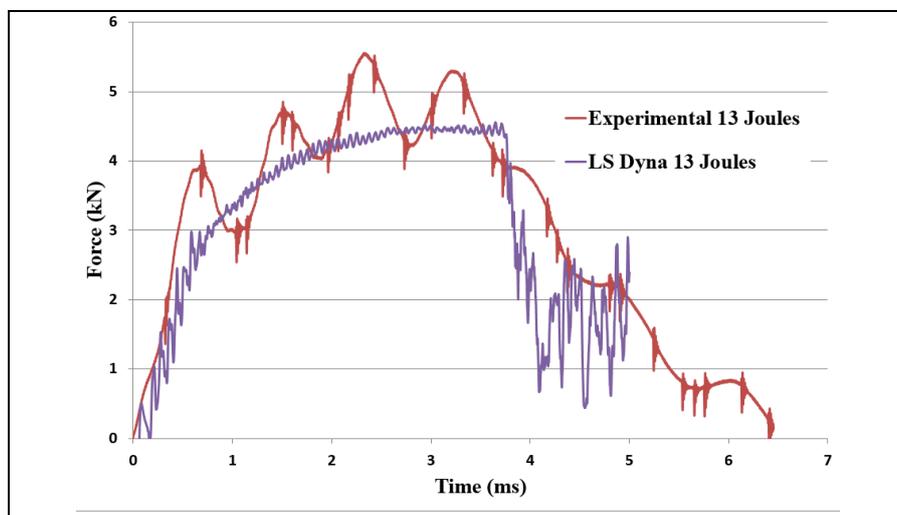
Fig . 12. Contact force history curves comparison

Numerical Force history curves are compared to the experimental for 13 Joules impact bending. Some fluctuations are present in the dynamic experimental curves due to periodic oscillations along the striker at impact and transmitted to the force sensor. So, this phenomenon is due to the influence of a striker resonant frequency. To prevent loss of information for comparison, the curve is not filtered. The numerical force follows similar progression regarding experimental behaviour, but seems underestimate of 10 % the maximal amplitude. Global collapse occurs at the same time, more softly for experimental behaviour.

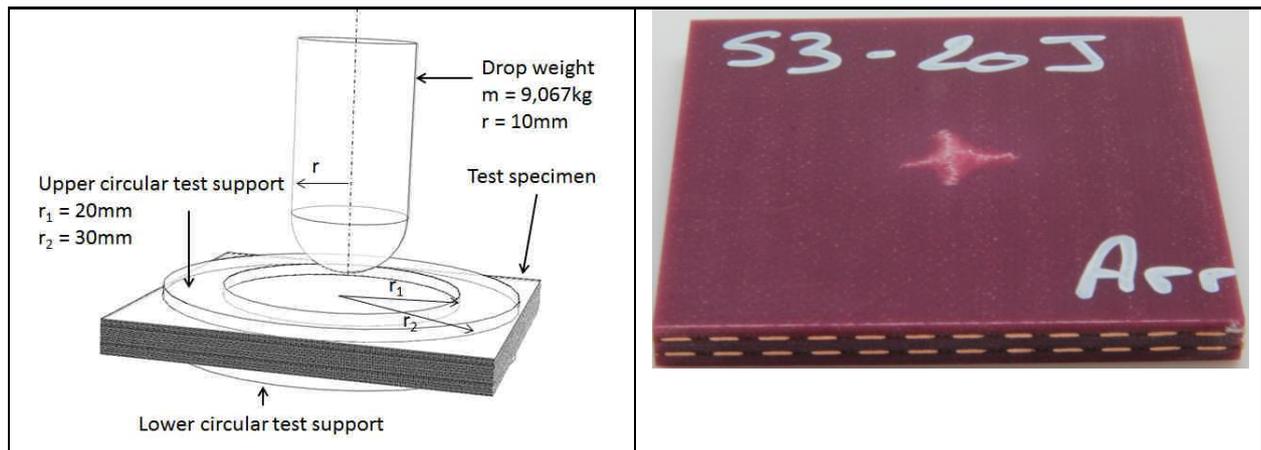
Fig 13. Droop weight impact test setup and impacted specimen with 20 Joules

Drop weight tests are performed on 60*60 mm² test specimens pneumatically clamped to the fixture by means of circular grips between two cylinders with $D_{int} = 40$ mm and $D_{ext} = 60$ mm (Figure 13). These tests are conducted with a constant impact mass of 9.067Kg at impact energies of 10J, 15J and 20J dropped from a height between 0,11m and 0,22m to reach the impact energies. The hemispherical hardened steel impactor has a diameter of 20mm.

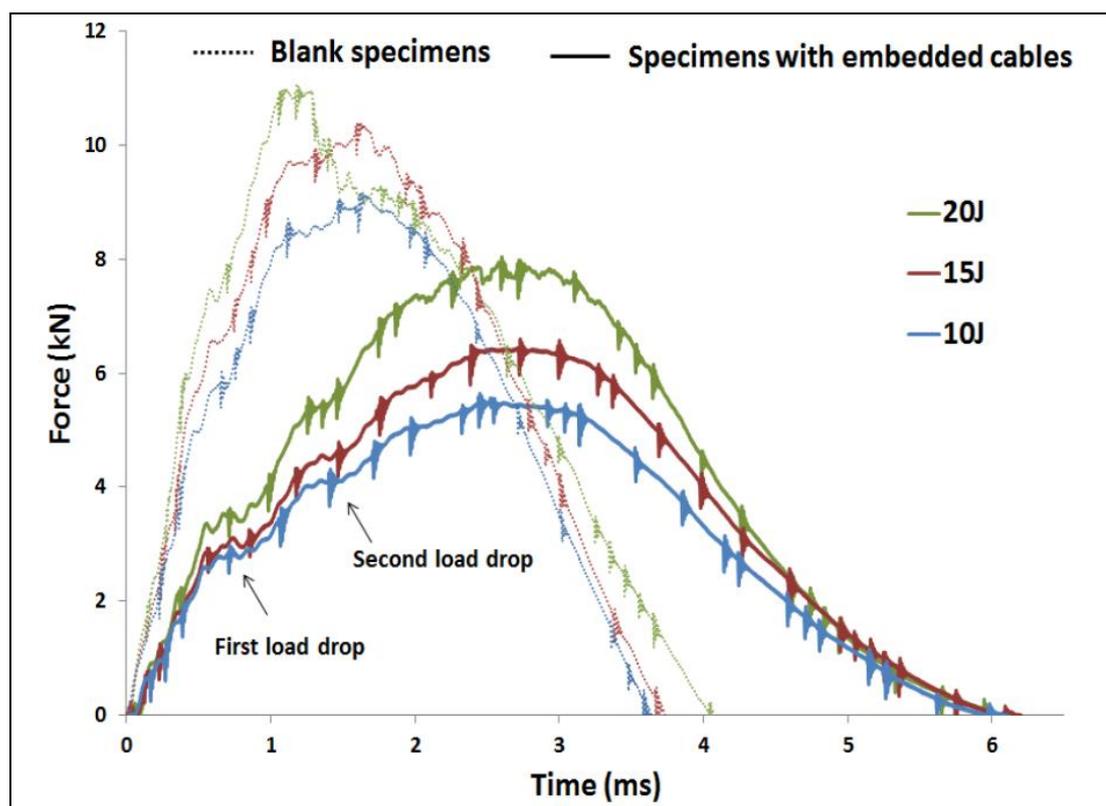
Fig . 14. Contact force histories of multifunctional and blank test specimens

The contact force history of three test specimens with two layers of embedded cables impacted at 10J, 15J and 20 Joules are plotted in figure 13. As compared to the test specimens without embedded cables, these test specimens show a much more dissipative behaviour with lower peak contact and higher impact durations for the three impact energies.

In particular, the multifunctional test specimens seem to exhibit a tri-linear behaviour, with two noticeable load drops. This tri-linear behaviour is most probably associated to both slipping and inter-laminar damage among the two embedded cables similar to quasi-static short 3 point bend tests, and to initiation of matrix cracking and delamination among the host composite structure as observed previously.

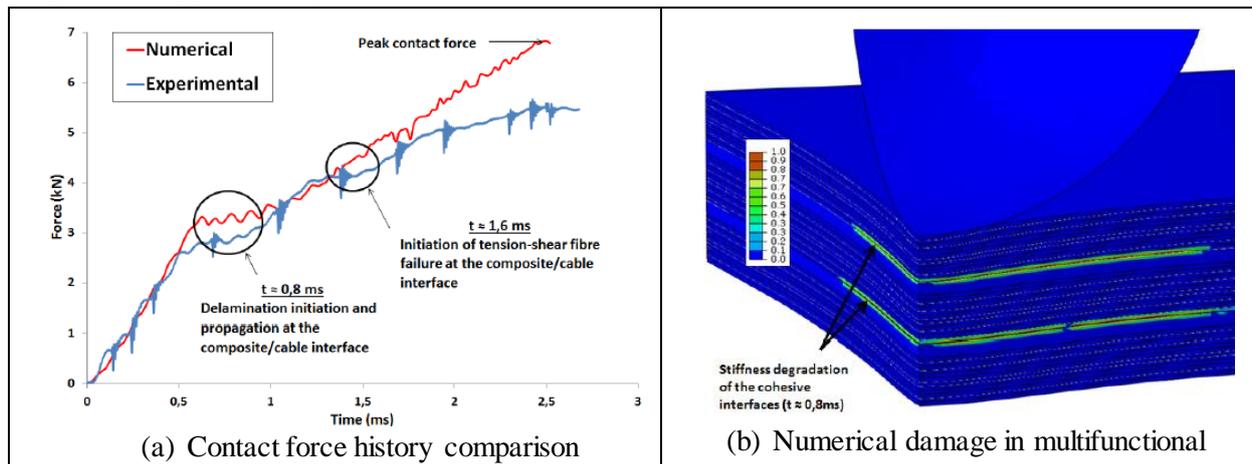
Fig .15. Damage influence take into account by the numerical model

As predicted in numerical model, transverse shear strains seem to initiate inter-laminar damage and delamination at the interface of the flat cable layers (Fig.15.a) and identify in the contact force histories (Fig. 15.b).

It is observed that the fibre tension-shear failure which seems to initiate at the interface with the embedded cables is a consequence of the sliding that occurs inside the embedded cables. Indeed, sliding among the cables first occurs and is well reproduced by the cohesive surface to-surface interaction. This triggers the first load drop observed experimentally at 0,8 ms. It induces higher inter-laminar and tensile strains on the adjacent composite plies, which leads to tension-shear fibre fracture captured at approximately 1,6ms

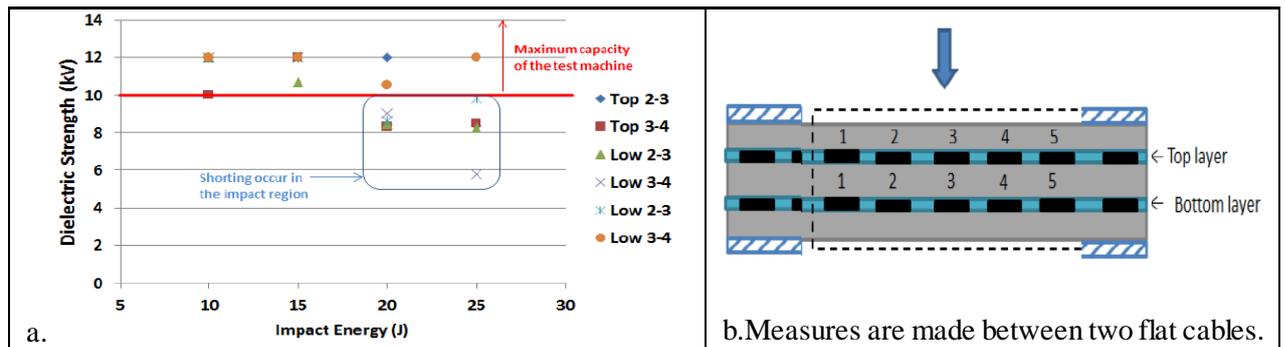
Fig . 16. (a) Results of the post-impact dielectric strength tests, (b) configuration of the post impact dielectric strength.

Post-impact dielectric strength tests were then performed on every impacted test specimens [23]. Different injection configurations were tested (between adjacent conductor on same layer and between superposed conductors), resulting in 13 dielectric strength tests per test specimens according to figure 16.b. (8 tests on adjacent conductors and 5 on superposed conductors).

These considerations led to the results presented in figure 16.a. where the dielectric strength (breakdown voltage in kV) is plotted versus the impact energy. So, no electrical shorting ever occurred on any test specimens impacted at 10J and 15J. For test specimens impacted at higher impact energies, electrical shorting did occur among the embedded cables (figure 16.a). It always occurred between two conductors of the same cable (adjacent conductors of the top or bottom cable).
