Composite laminate with embedded electric cables submitted to low energy impact

Thibault Vogel, Jean-Christophe Walrick, Pascal Casari

Thibault Vogel, Jean-Christophe Walrick, Pascal Casari. Composite laminate with embedded electric cables submitted to low energy impact. 24ème Congrès Français de Mécanique, Aug 2019, Brest, France. hal-04308619

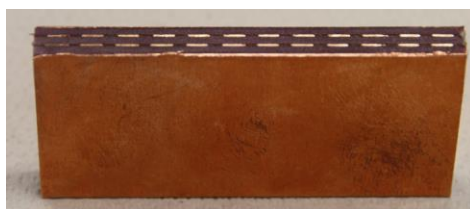
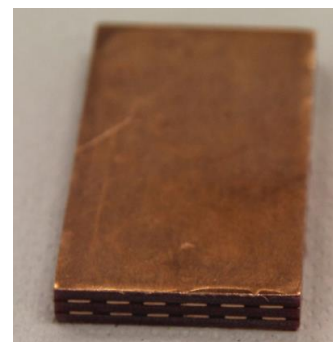
Fig. 3. Two configurations of multifunctional S3PB test specimens: (a) transverse and (b) longitudinal

Experimental results are compared on test specimens with and without embedded cables. The short 3 points bend tests (S3PB) are carried out according to normative reference ISO 14130. This loading is used for determination of apparent interlaminar shear strength of fibre-plastic composites by the short beam method. Hence, the width of the test specimens is chosen as 5 times the thickness and the length as 10 times the thickness. Besides, the electrical wires were either oriented in the transverse, or longitudinal direction regarding the specimen length to investigate on their influence on the bending stiffness of the structure (Figure. 3)

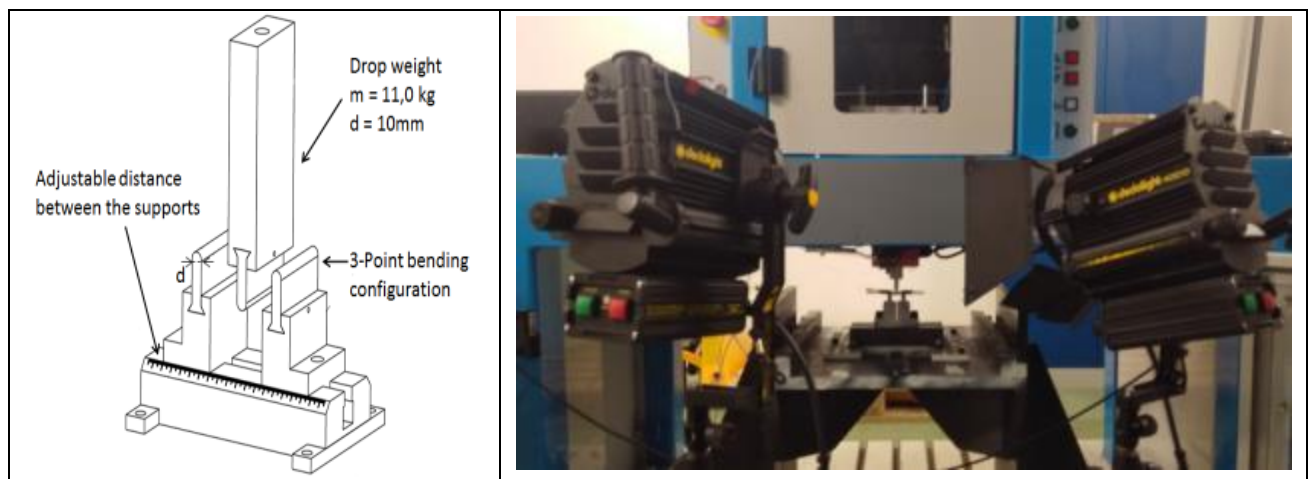
Fig . 6. Impact bending device on the drop test

The dynamic bending tests are performed on similar both blank and multifunctional test specimens. The bottom support was kept at 30 mm each other. A specific impact bending test setup was designed, figure 6. The setup was directly mounted on an Imatek IM10-30 drop-weight impact tester with two screwed connectors. The impactor and cylindrical test supports had cylindrical heads of 10 mm diameter, and the impactor total weight was 11,07 kg.

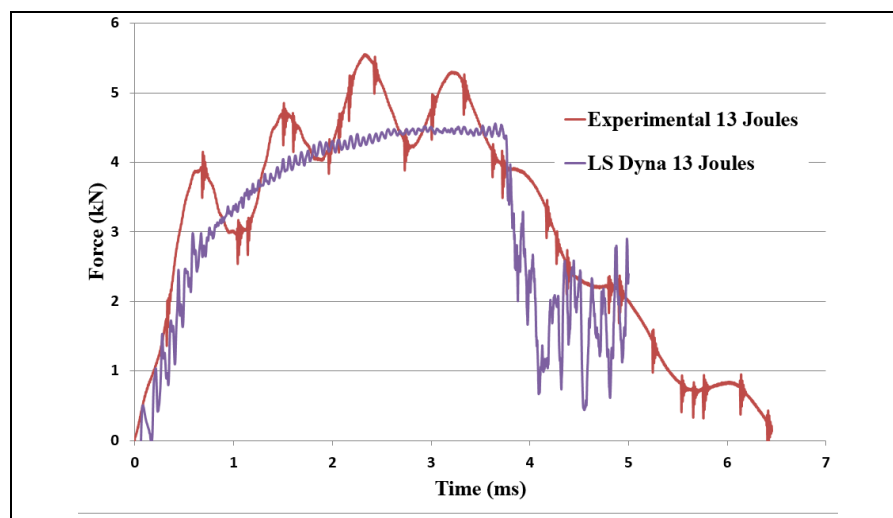
Fig . 12. Contact force history curves comparison

Numerical Force history curves are compared to the experimental for 13 Joules impact bending. Some fluctuations are present in the dynamic experimental curves due to periodic oscillations along the striker at impact and transmitted to the force sensor. So, this phenomenon is due to the influence of a striker resonant frequency. To prevent loss of information for comparison, the curve is not filtered. The numerical force follows similar progression regarding experimental behaviour, but seems underestimate of 10 % the maximal amplitude. Global collapse occurs at the same time, more softly for experimental behaviour.
