THE NEW RILEM TC 271-ASC RECOMMENDATION FOR THE DURABILITY ASSESSMENT OF POROUS BUILDING MATERIALS AGAINST SALT CRYSTALLIZATION

D. Gulotta¹ and RILEM TC 271-ASC members²

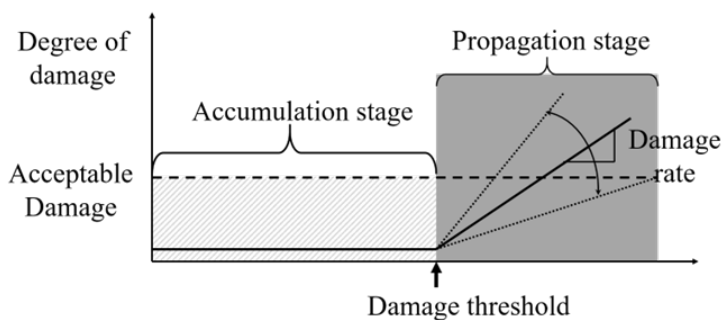
Figure 1: Two-step damage development of stone/brick substrates due to salt crystallization (from [1])

Building on the experience of reinforced concrete durability research, the TC has explored the feasibility of a two-stage approach (Fig. 1) to trigger damage development and progression, only after a certain degree of pore filling – as a result of salt accumulation – is reached.

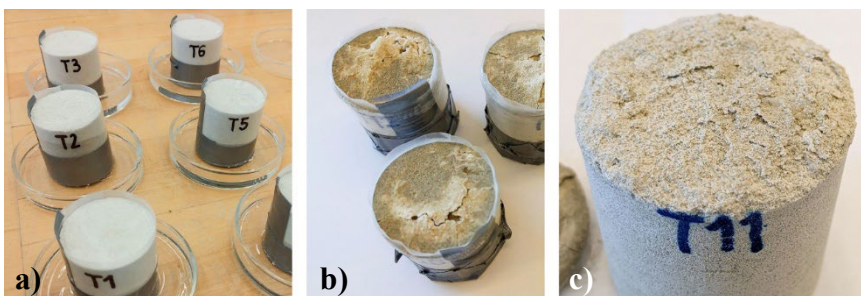
Figure 2: Photographic documentation of stone specimens (Tuffeau limestone) during the accumulation phase (a), after two propagation cycles (b), and at the end of the accelerated aging procedure (c).

The new procedure translates this theoretical assumption into two distinct testing phases: a preliminary salt accumulation phase, during which the porous substrate is contaminated with a salt solution with fixed concentration and capillary transport promotes its accumulation close to the evaporation surface without causing visible damage, followed by a propagation phase (Fig. 2).
