Structural Health Monitoring of glulam infrastructures with non-destructive embedded sensors

Guilhem Greffier, Marianne Perrin, Florent Eyma, Luis Espinosa, Placide Uwizeyimana. Structural Health Monitoring of glulam infrastructures with non-destructive embedded sensors. The International Symposium on Nondestructive Testing in Civil Engineering, Aug 2022, Zurich, Switzerland. 10.58286/27293 . hal-04324536

Predictive model associated to wood infrastructures damaging

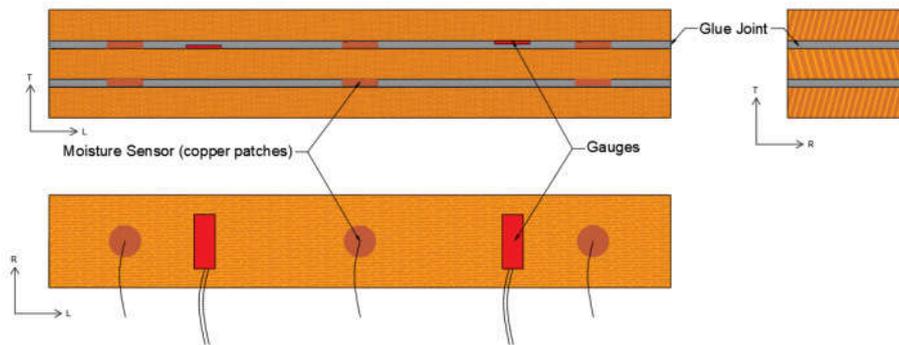
A five-years outdoor aging campaign was launched in August 2020. 198 glulam beams were made using three Douglas fir lamellae glued with PUR. These materials were chosen because they are widely used in glulam industry. The beams are 480mm long with a cross section of 30mm x 30mm. These dimensions are defined according to the standard EN408 [4] for our bending tests. The use of small samples allows us to have a high sensibility of our specimen to moisture changes so we could have important aging effects appearing within few years. We have three aging scenarios, 66 beams are exposed outside with a 600 N load (4 points bending), 66 beams are exposed outside without loading, 66 beams are aging inside in a thermo-hygro regulated room without load as a reference. The load applied to the beam is approximately 10% of the maximum load. It corresponds to 70 % of the maximum load (ELU) according to the Eurocodes. This low rate of loading should guarantee that our beams don't break under fatigue before the static bending tests as it could be observed for other small samples under W/D cycles [5]. Our outside aging conditions correspond to a class 3 exposition as defined by the Eurocode 5. These conditions of outside exposure without protection toward rain can be found in real life for glulam infrastructures such as bridges. No loaded samples in controlled environment were built because of space issues. Live humidity and temperature are monitored on site and the weather station of Tarbes-Ossun-Lourdes [6] helps us to keep track of raining events. The specimens are equipped with a monitoring system recording moisture content within the beams (**Figure 1**). The moisture measurement solution was developed in our laboratory. It consists in resistive sensors made of copper patches embedded within the glue joints. At a large scale, this solution allows the integration of multiple sensors during the making of the beams without altering its mechanical properties [7]. Gauges glued on lamellas on both side of the glue joints assesses the differential displacement in the radial direction of wood between the lamellas. This displacement may lead to the delamination of the joints.

Figure 1: Glulam specimen with embedded moisture and displacement sensors representation

We use thermocouple also embedded within glue joints as a temperature compensation for our measures. Our monitoring system allows us to record data each 10 minutes on a dedicated server. Measurement cards are linked to a transmission card which transfer data via radio signals to a receptor connected to a dedicated computer collecting data. Every 6 month, 6 beams of each aging situation are collected to asses aging effects on mechanical properties of glulam.

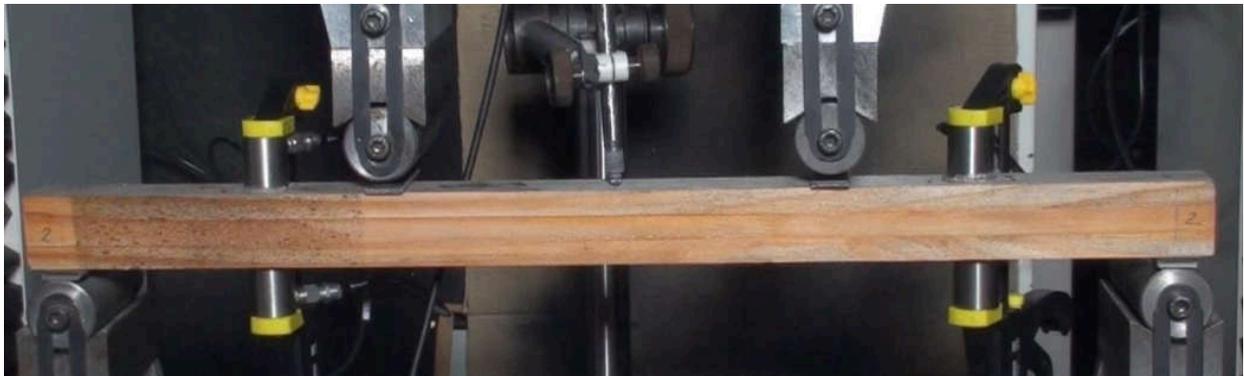
To evaluate the loss of mechanical properties of glulam in outside exposure, we record evolution of static bending strength and elastic modulus following the norm EN408 (**Figure 2**).

Figure 2: Four points bending experiment configuration

We apply a constant displacement of 0.09 mm/s. We measure the force applied and the displacement of the sample under loading. The deflection is measured with a LVDT with a 2cm course. We use the LVDT displacement measurement to evaluate the young modulus of the samples. The bending experiments are video recorded to analyse the cracks evolution during the tests, Infrared Camera and Acoustic emission sensors are used to detect and localize cracking events during the banding tests. Stereo-correlation is used to measure the shear modulus. Before destructive bending tests the evolution of delamination rate is measured, and we visually analyse the apparition of cracks, decay, or fungal growth.

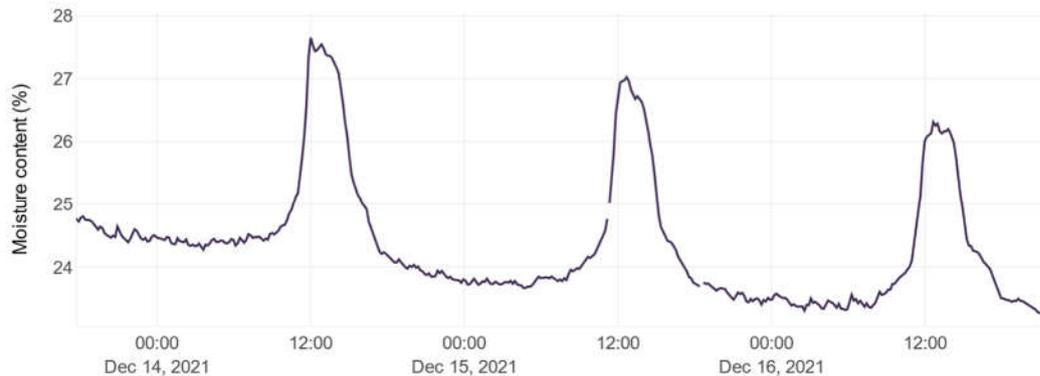
The data recorded during the first months of outside exposure showed three different scales of moisture variation. As our specimens are quite small, we could record daily variations due to moisture evolution between night day. The moisture changes observed have an amplitude of around 1.5 to 3 %MC (Figure 3).

Figure 3: Moisture variation over 3 days

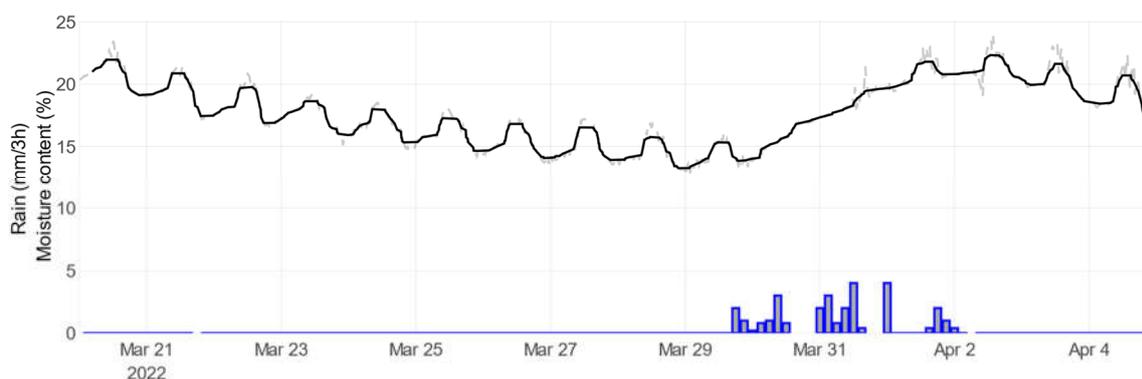
The upper scale of moisture change is due to daily weather changes, we could see moisture changes on short time ranges of few hours or days due to rainy or dry and warm weather. We could see an increase of over 10% MC within few days as shown in (Erreur ! Source du renvoi introuvable.) following rainy days.

Figure 4: Moisture content increase during a raining event

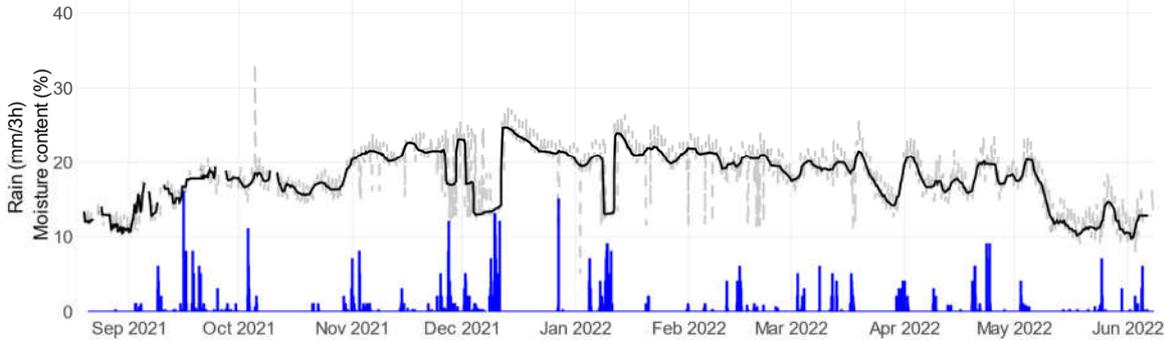
Then on a longer time scale we can follow the yearly cycle of moisture evolution with an average MC between 12 and 25 %. This 10-month cycle (Erreur ! Source du renvoi introuvable.) clearly shows the increase of MC during the winter and the drying of the sample during spring. The effect of raining events is also recognizable as rapid increase in MC short after these events is visible. This moisture content variation is consistent with moisture content measured on timber bridges such as the Obermatt bridge [8].

Figure 5: Moisture evolution over 9 months

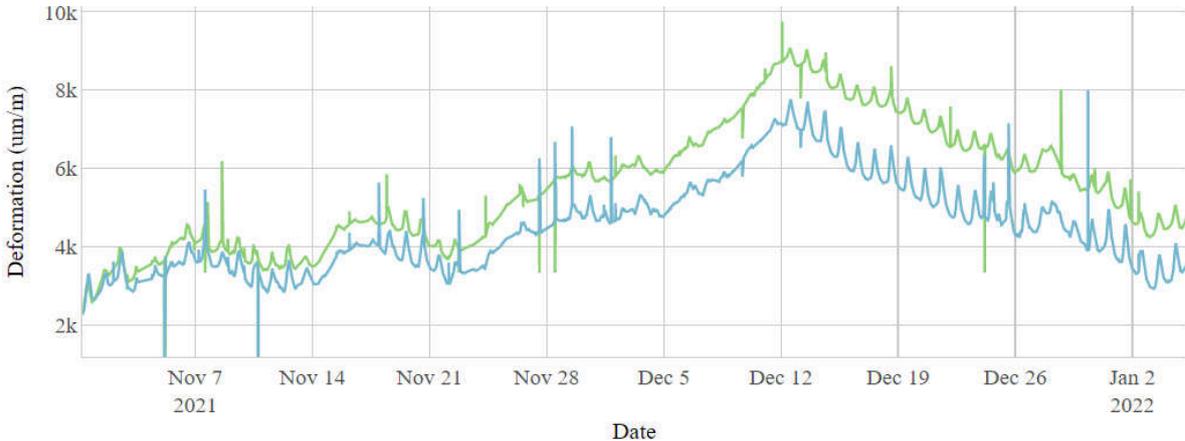
During heavy rain period in December and January, water accumulation disrupted the measurement system, therefore incoherent MC are displayed with sudden low values. The measurements on our gauges on lamellae across a glue joint showed first sign of differential displacement (**Figure 6**). Those displacement may result in a failure of the glue joint.

Figure 6: Gauges elongation on top and middle lamella of a sample

The displacement we observe during outside exposure have a lower amplitude than in climatic chamber however the repetition of the cycles over long time may end up to similar results with delamination appearing in the glue joints. The displacement measuring during accelerated W/D cycles was problematic it led to the failure of gauges after couple cycles. It appears that in real life conditions the moisture content and displacement measured are less severe than in accelerated cycles. Our data clearly showed the cycle of wetting drying a sample undergoes during autumn, winter, spring cycle and its influence on deformations with consistent data regarding the meteorological conditions.

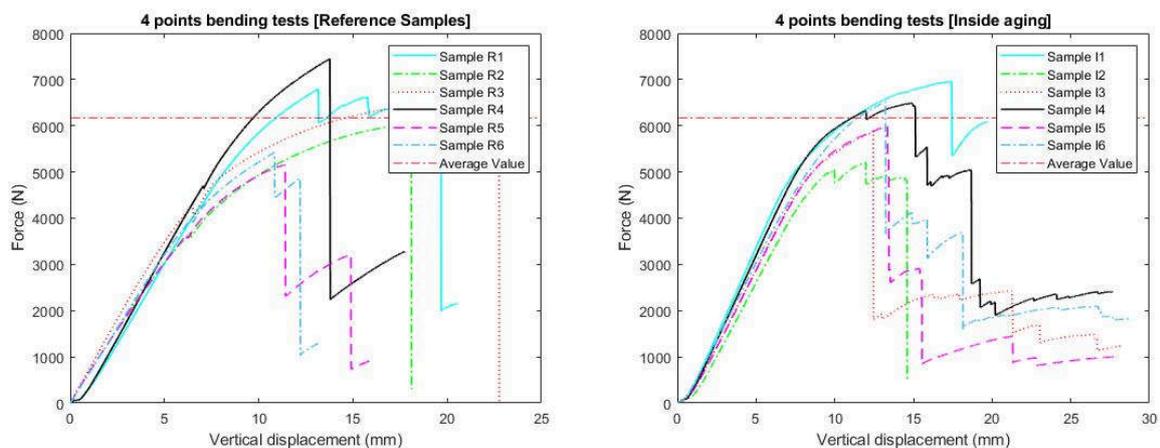
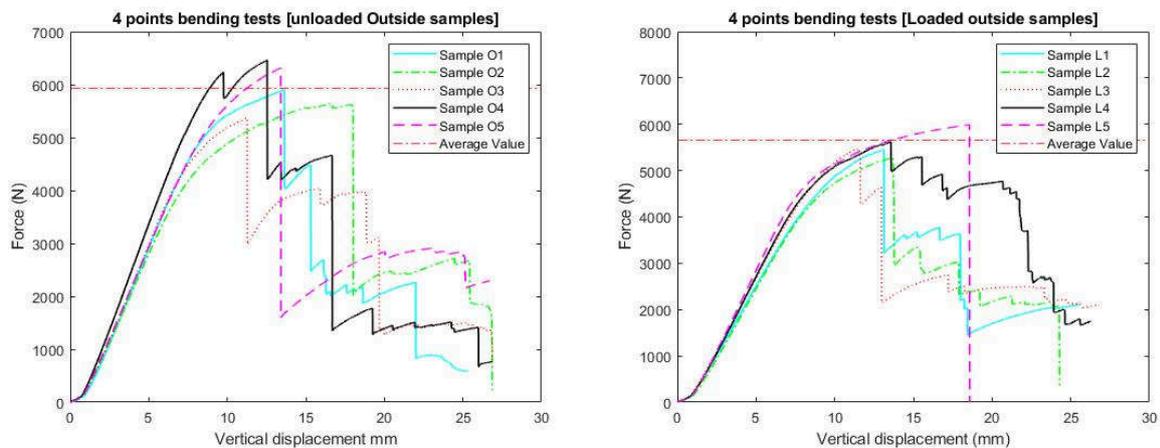
Four points bending experiments showed that for outside loaded samples, the breaking stress was significantly lower after 6 months. The breaking stress was 92.6 MPa in average for reference sample vs 83 MPa in average after 6 months. We also noticed a small loss of young modulus (9.6 vs 9.0). The properties for unloaded samples, outside aged and in constant conditions showed no significant loss. In average the mechanical resistance for outside loaded samples reduced by around 10% whereas no significant loss was observed for unloaded samples. (Figure 7). The loss of properties observed after one W/D cycle of accelerated aging for unloaded sample was about 10%.

Figure 7: Mechanical behaviour under 4 points bending for reference samples and 6-month aged samples under different scenarios

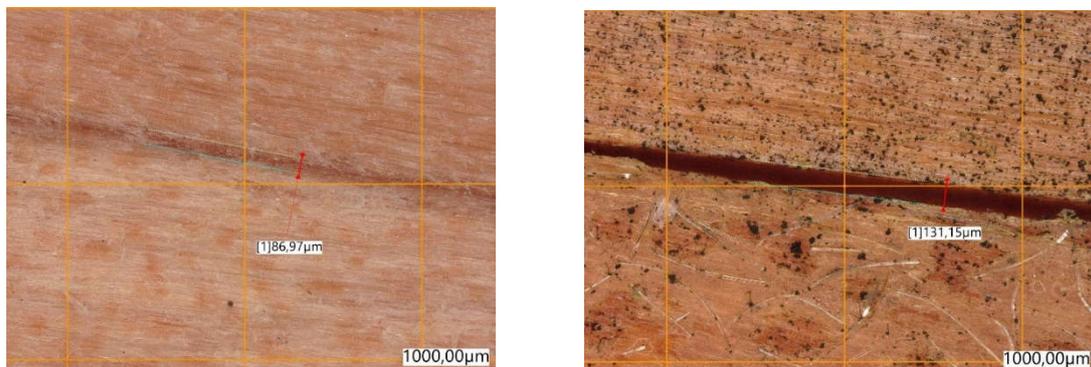
The damage after 6 months of outside exposure seems to be associated to mechanical and moisture loading combination known as mechano-sorptive effect [9] more than to W/D cycles only. On outside exposed samples, glue joints started to show some visible delamination (**Figure 8**).

Figure 8: Reference sample glue joint (left) delamination of a glue joint after 6 months of outside exposure (right)

We measured the length of delaminated glue joint on each beam to compare the rate of delaminated joints related to time of outdoor exposure. The delamination rate was quantified as the length of opened glue joint divided by the total glue joint length on a sample. The average value of delamination is 8.2%, no significant variation was observed between loaded and unloaded samples. Delamination rates between 1.8 to 24.5% were measured. Glue joints between the top lamella and the middle lamella seemed to be more affected by W/D cycles than glue joints between middle lamella and bottom lamella, 9.7% vs 6.7% delamination rates. This observation seems to be consistent with the configuration of our samples as the top lamella is more exposed to sun and rain than the two lamellae under. Thus, the displacement between the middle and bottom lamellae are more homogeneous.

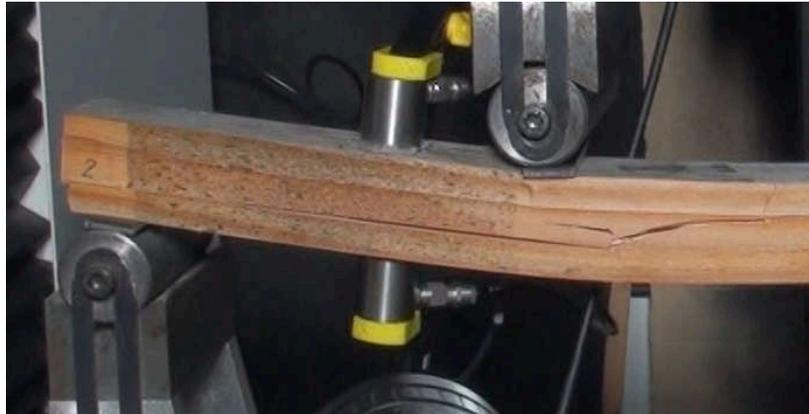
a complete loss of mechanical strength of the sample. The evolution of rupture behaviour was also observed after accelerated aging. Complete delamination of glue joints leading to the failure under four points bending were observed only on aged samples (**Figure 9**).

Figure 9: Glue joint delamination under load

The other important aspect we observe during our bending tests is the evolution of the rupture mechanism. Non-aged samples tend to break sequentially under load with different small longitudinal cracks opening and gradually reducing the sample strength. Aging leads to samples breaking brutally with a transversal crack followed by a massive longitudinal crack leading to
